ENTECH
ENGINEERING, INC.

**WASTEWATER STUDY
FLYING HORSE NORTH FILING NO. 3
EL PASO COUNTY, COLORADO**

August 23, 2023
Revised February 29, 2024

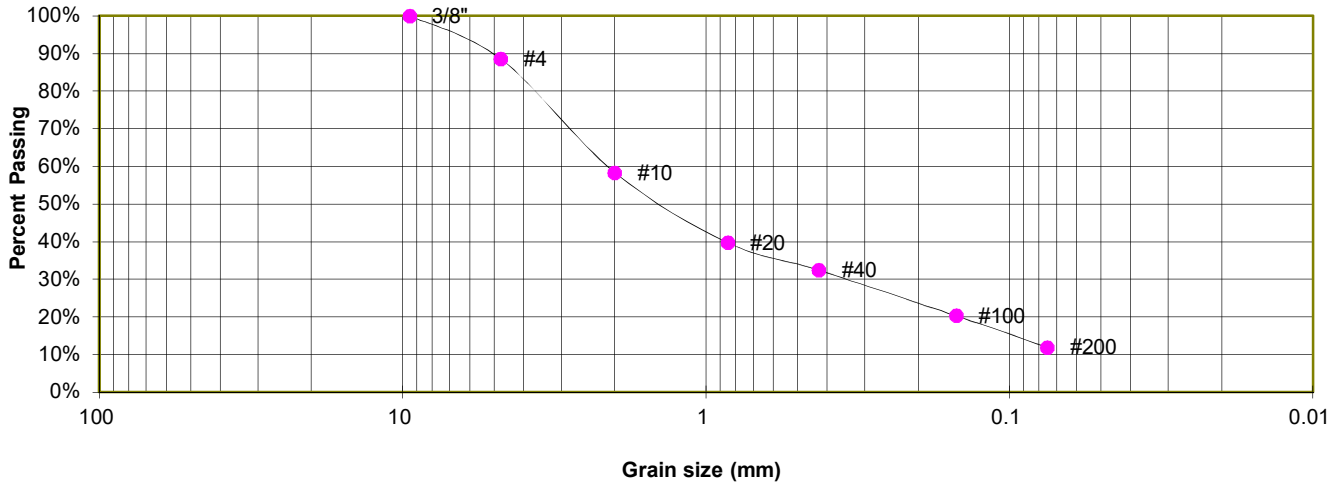
TEST PIT	TP-2	SOIL DESCRIPTION SAND, WITH SILT
DEPTH (FT)	7

**Sieve Analysis
Grain Size Distribution**

GRAIN SIZE ANALYSIS

U.S. Sieve #	Percent Finer
3"	
1 1/2"	
3/4"	
1/2"	
3/8"	100.0%
4	88.6%
10	58.4%
20	39.8%
40	32.4%
100	20.3%
200	11.9%

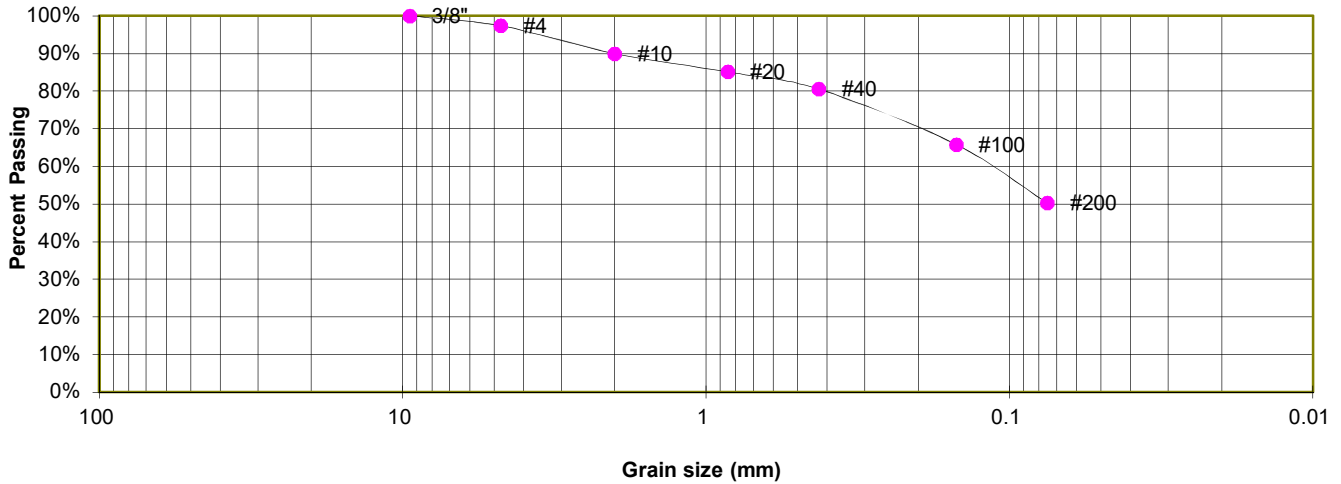
SOIL DESCRIPTION CLAY, SANDY

**Sieve Analysis
 Grain Size Distribution**

GRAIN SIZE ANALYSIS

U.S. Sieve #	Percent Finer
3"	
1 1/2"	
3/4"	
1/2"	
3/8"	100.0%
4	97.4%
10	90.0%
20	85.1%
40	80.5%
100	65.8%
200	50.3%

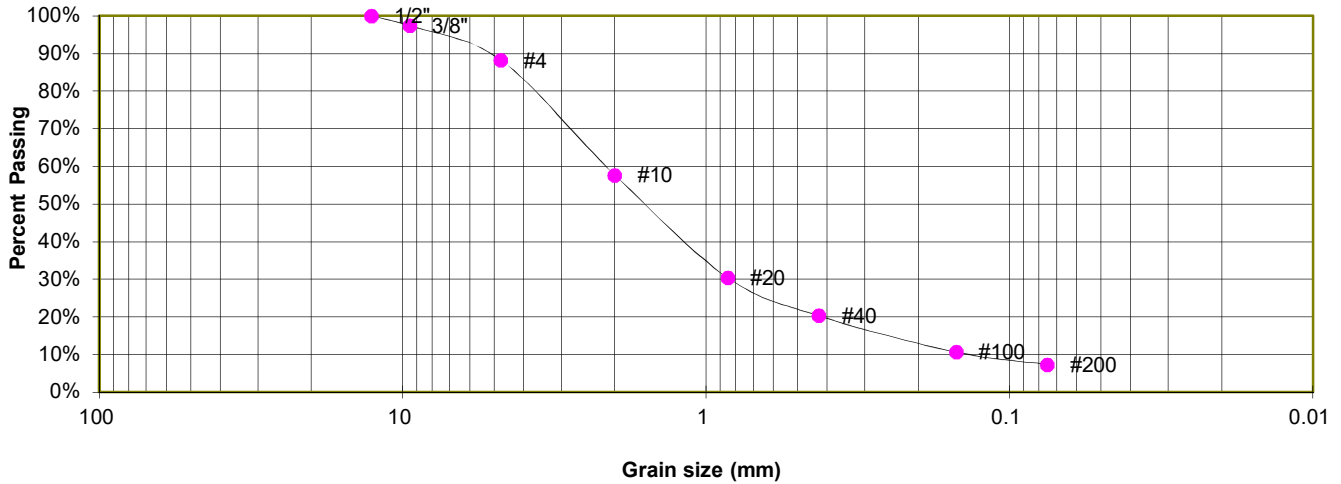
TEST PIT	TP-4	SOIL DESCRIPTION SAND, WITH SILT
DEPTH (FT)	3

**Sieve Analysis
Grain Size Distribution**

GRAIN SIZE ANALYSIS

U.S. Sieve #	Percent Finer
3"	
1 1/2"	
3/4"	
1/2"	100.0%
3/8"	97.4%
4	88.3%
10	57.7%
20	30.4%
40	20.3%
100	10.7%
200	7.4%

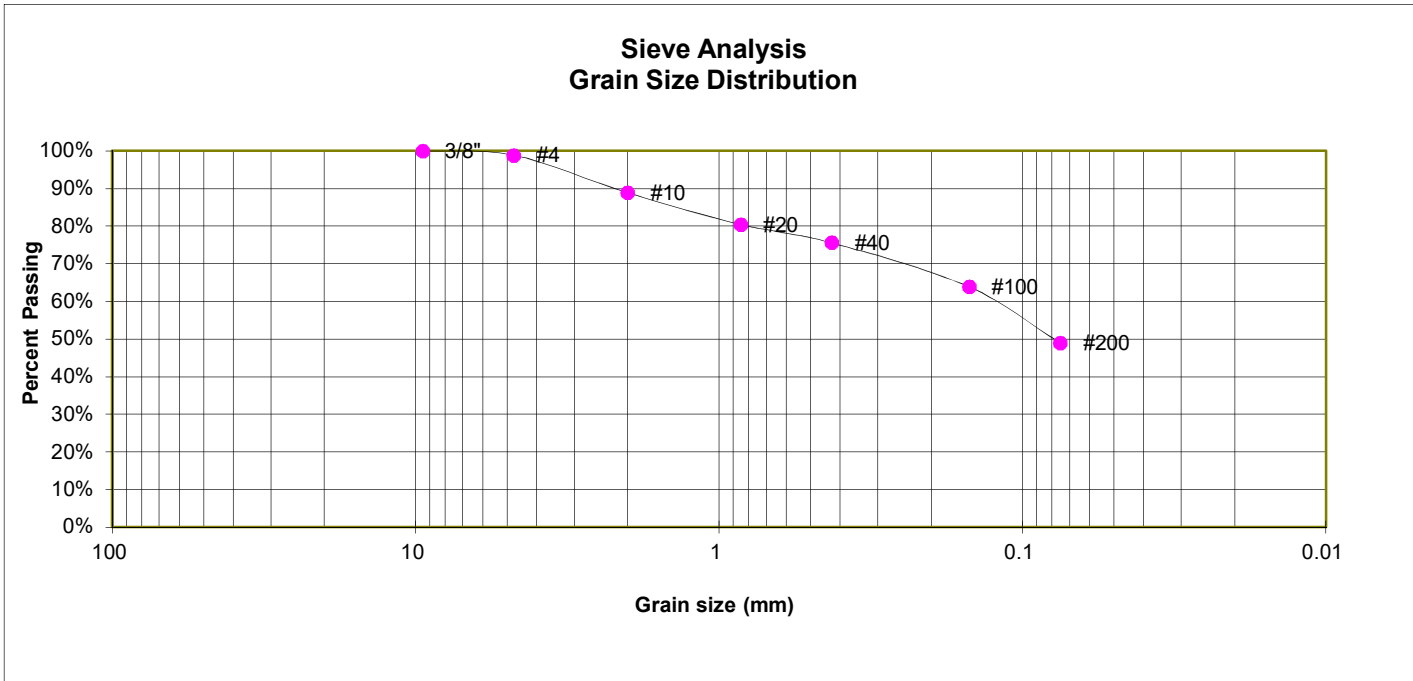
TEST PIT	TP-4	SOIL DESCRIPTION SAND, CLAYEY
DEPTH (FT)	5

GRAIN SIZE ANALYSIS

U.S. Sieve #	Percent Finer
3"	
1 1/2"	
3/4"	
1/2"	
3/8"	100.0%
4	98.9%
10	88.9%
20	80.5%
40	75.6%
100	63.9%
200	48.9%
