**PRELIMINARY SOIL, GEOLOGY, GEOLOGIC  
HAZARD, AND WASTEWATER STUDY  
MEADOWLAKE RANCH  
13202 JUDGE ORR ROAD  
EL PASO COUNTY, COLORADO**

July 30, 2018

Entech Job No. 180517  
AAprojects/2018/180517countysoil/geo

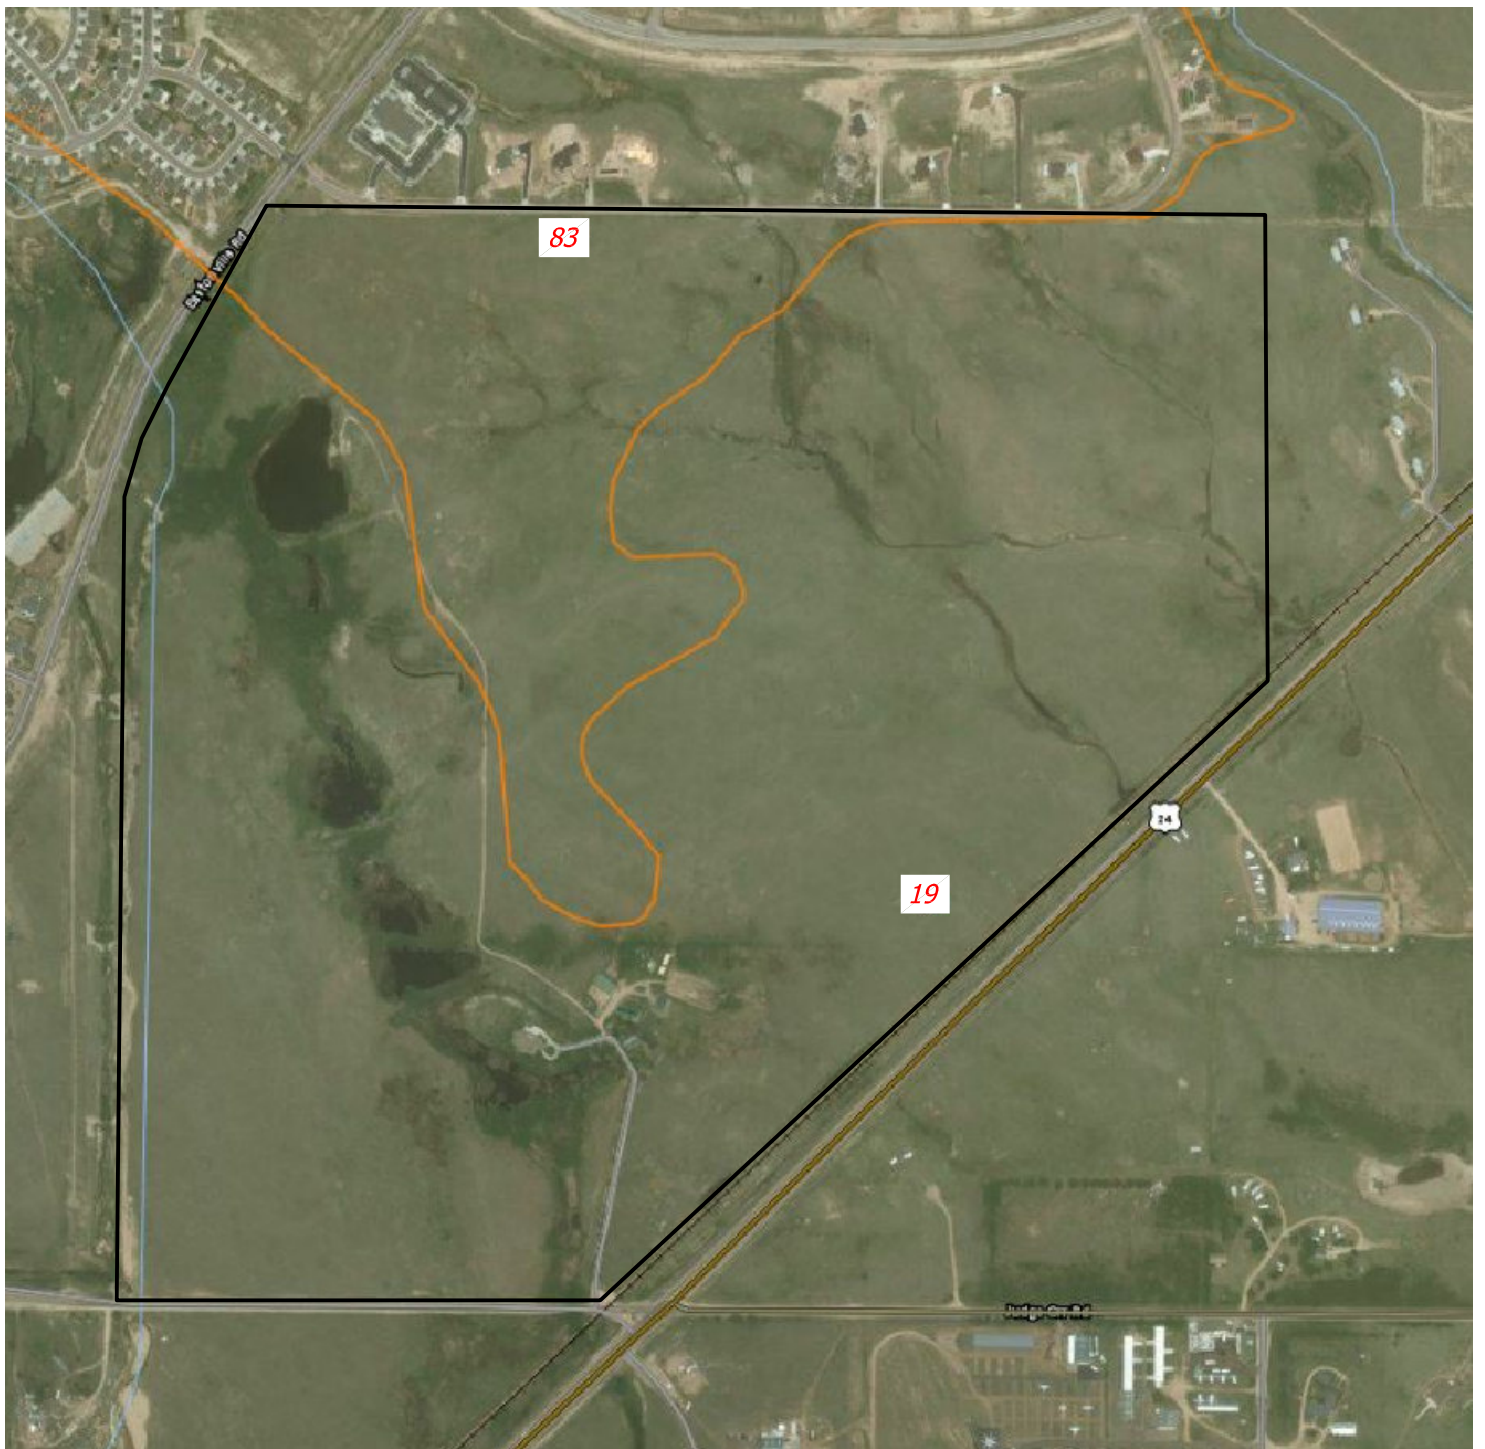
FIG NO.:  
4

SOIL SURVEY MAP  
MEADOWLAKE RANCH  
13202 JUDGE ORR ROAD  
EL PASO COUNTY, CO.  
FOR: DAN FERGUSON

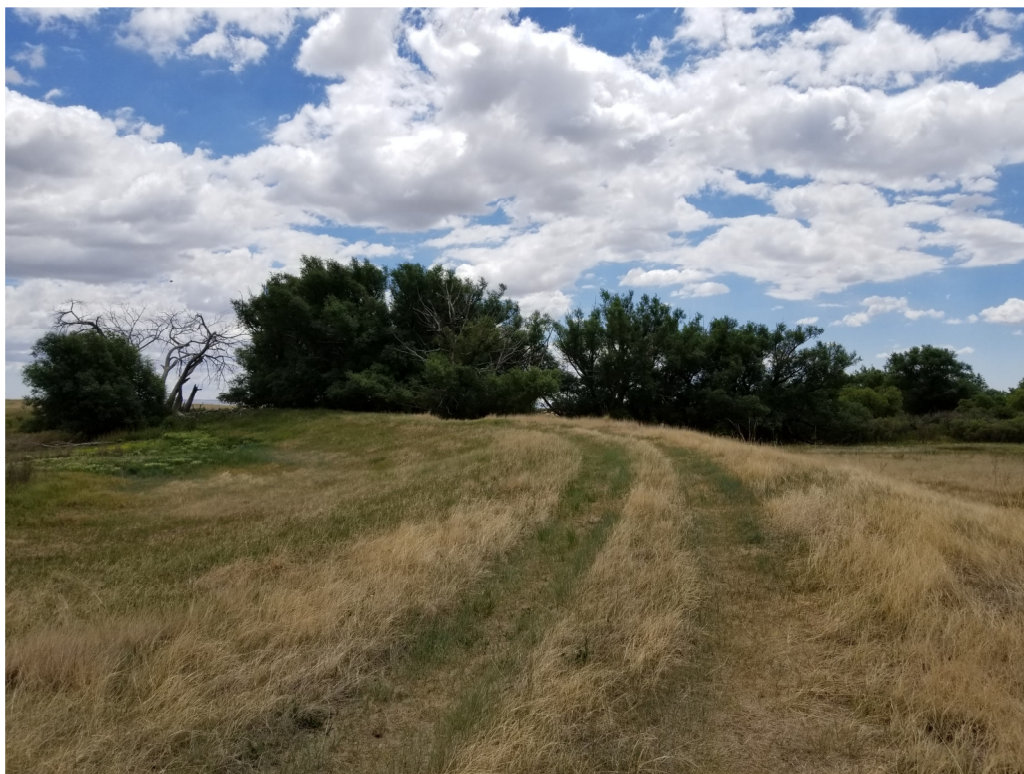
**Looking southeast  
towards an existing  
earthen dam in the  
western portion of the  
property.**
