## GEOLOGIC HAZARDS EVALUATION AND PRELIMINARY GEOTECHNICAL INVESTIGATION FOREST LAKES SUBDIVISION (PHASE 2) FOREST LAKES ROAD & WEST BAPTIST ROAD COLORADO SPRINGS, COLORADO

CTL|T Project No. CS18916-105

July 18, 2018  
Revised: December 11, 2018

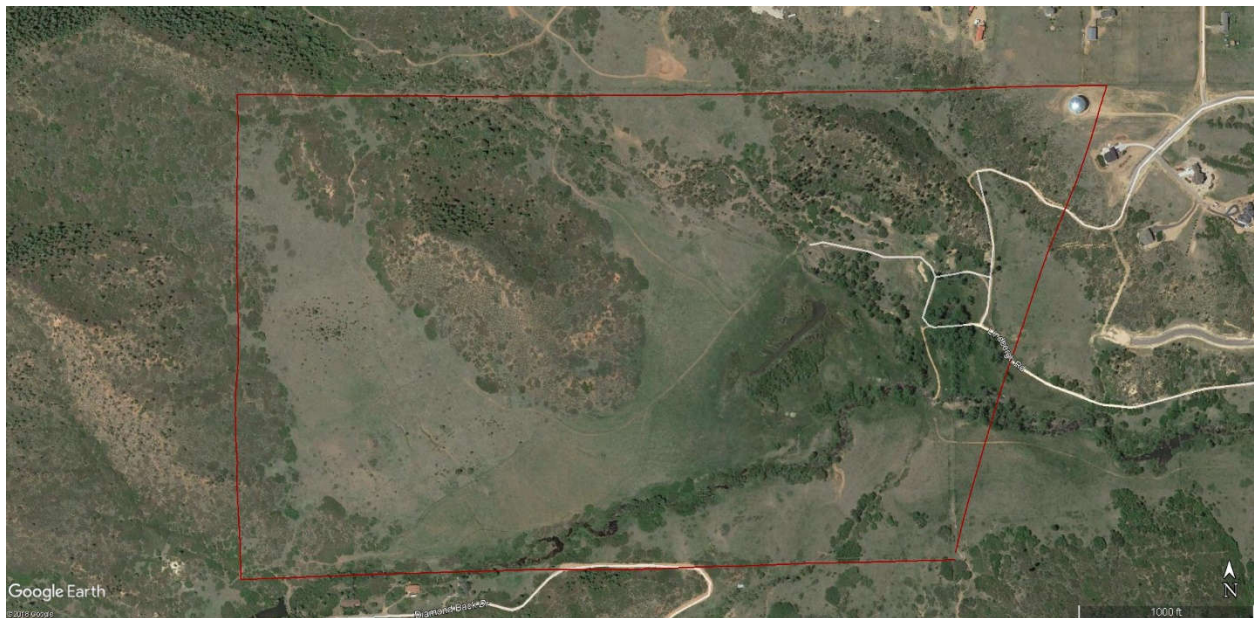
Excerpt from June 2017 Google Earth aerial photography showing the Phase 2 development area. Note man-made pits just west of the confluence of North Beaver and Beaver Creek.

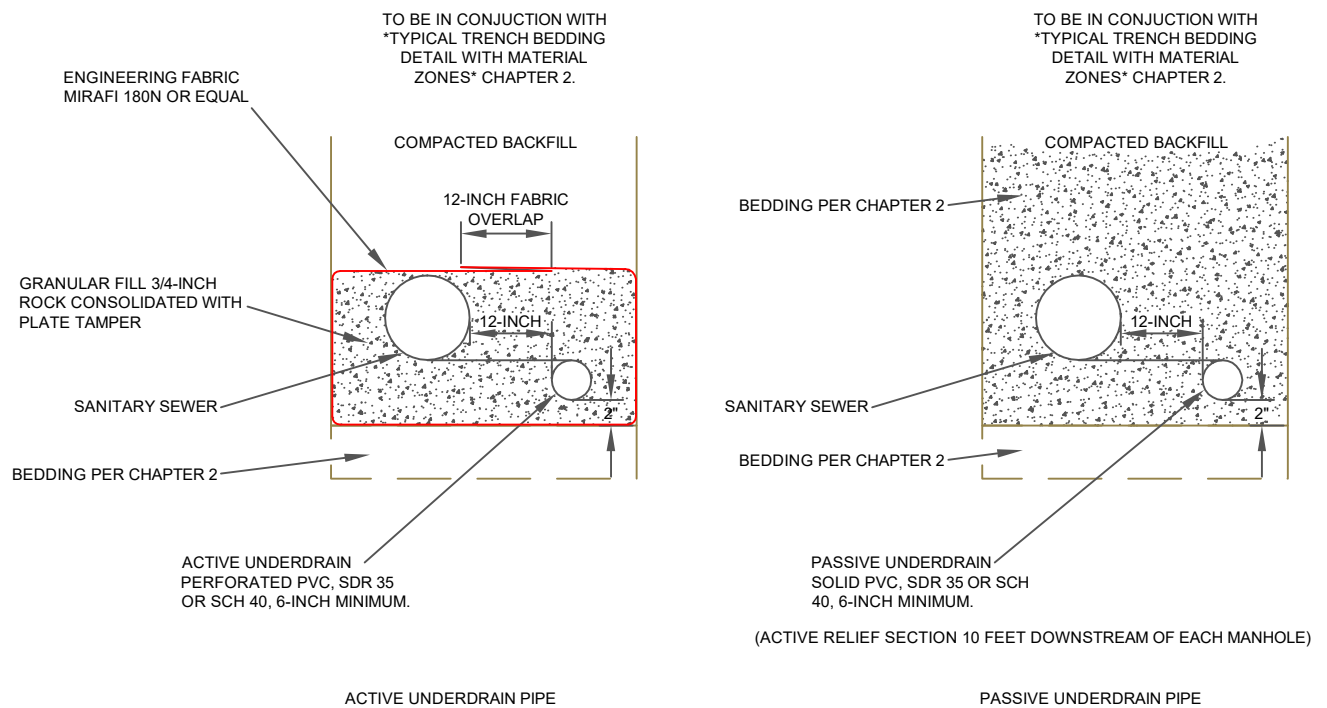
- POINT OF DISCHARGE TO PUBLIC SYSTEM REQUIRED.
- UNDERDRAIN SERVICE LINE CONNECTIONS SHALL BE 3" SCH 40.

If high moisture conditions or groundwater is encountered in the sanitary sewer trench, we recommend an active underdrain system with perforated or slotted pipe for these areas. Active underdrains could help to lower the shallow groundwater elevation found in portions of the development. A cutoff collar should be constructed around the sewer pipe and underdrain pipe immediately downstream of the point where the underdrain pipe exits the sewer trench or changes from active to passive. Solid pipe should be used down-gradient of this cutoff collar to the point of discharge. The underdrain should be maintained at least 3 to 5 feet below the lowest nearby foundation elevation. Conceptual drain details are presented in Figs. 4 and 5.

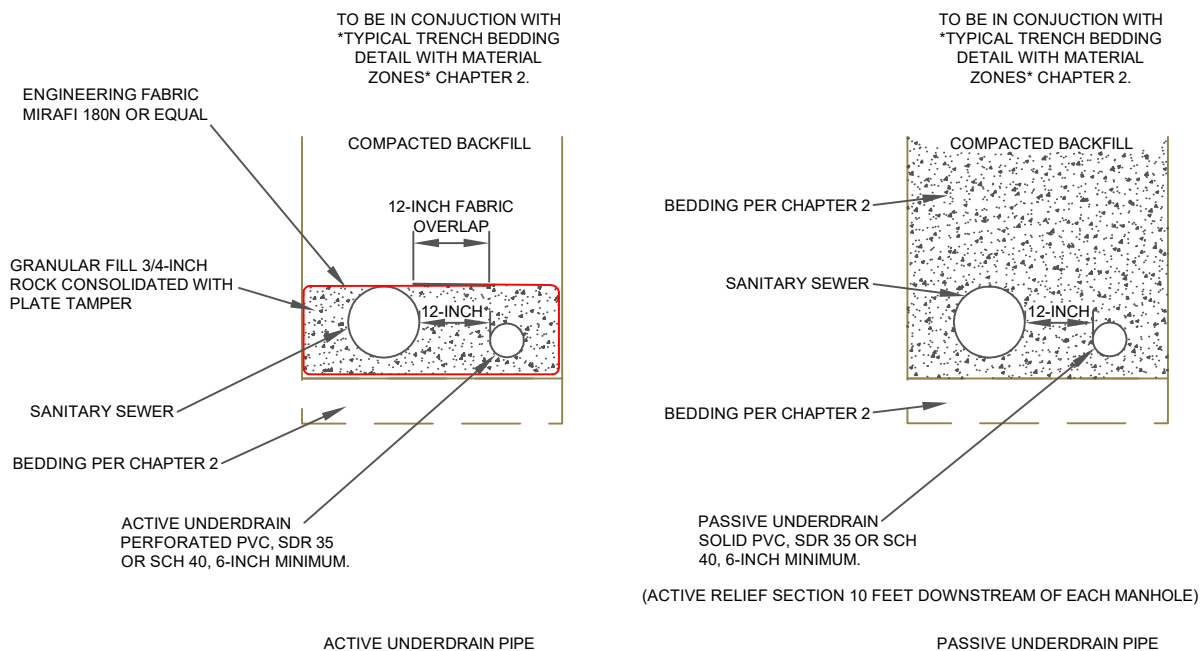
- POINT OF DISCHARGE TO PUBLIC SYSTEM REQUIRED.
- UNDERDRAIN SERVICE LINE CONNECTIONS SHALL BE 3" SCH 40.
