WASTEWATER EVALUATION REPORT
FOR
HAY CREEK VALLEY DEVELOPMENT
AT
2855 HAY CREEK ROAD
EL PASO COUNTY, COLORADO

September 2023

Project No. 22.886.076

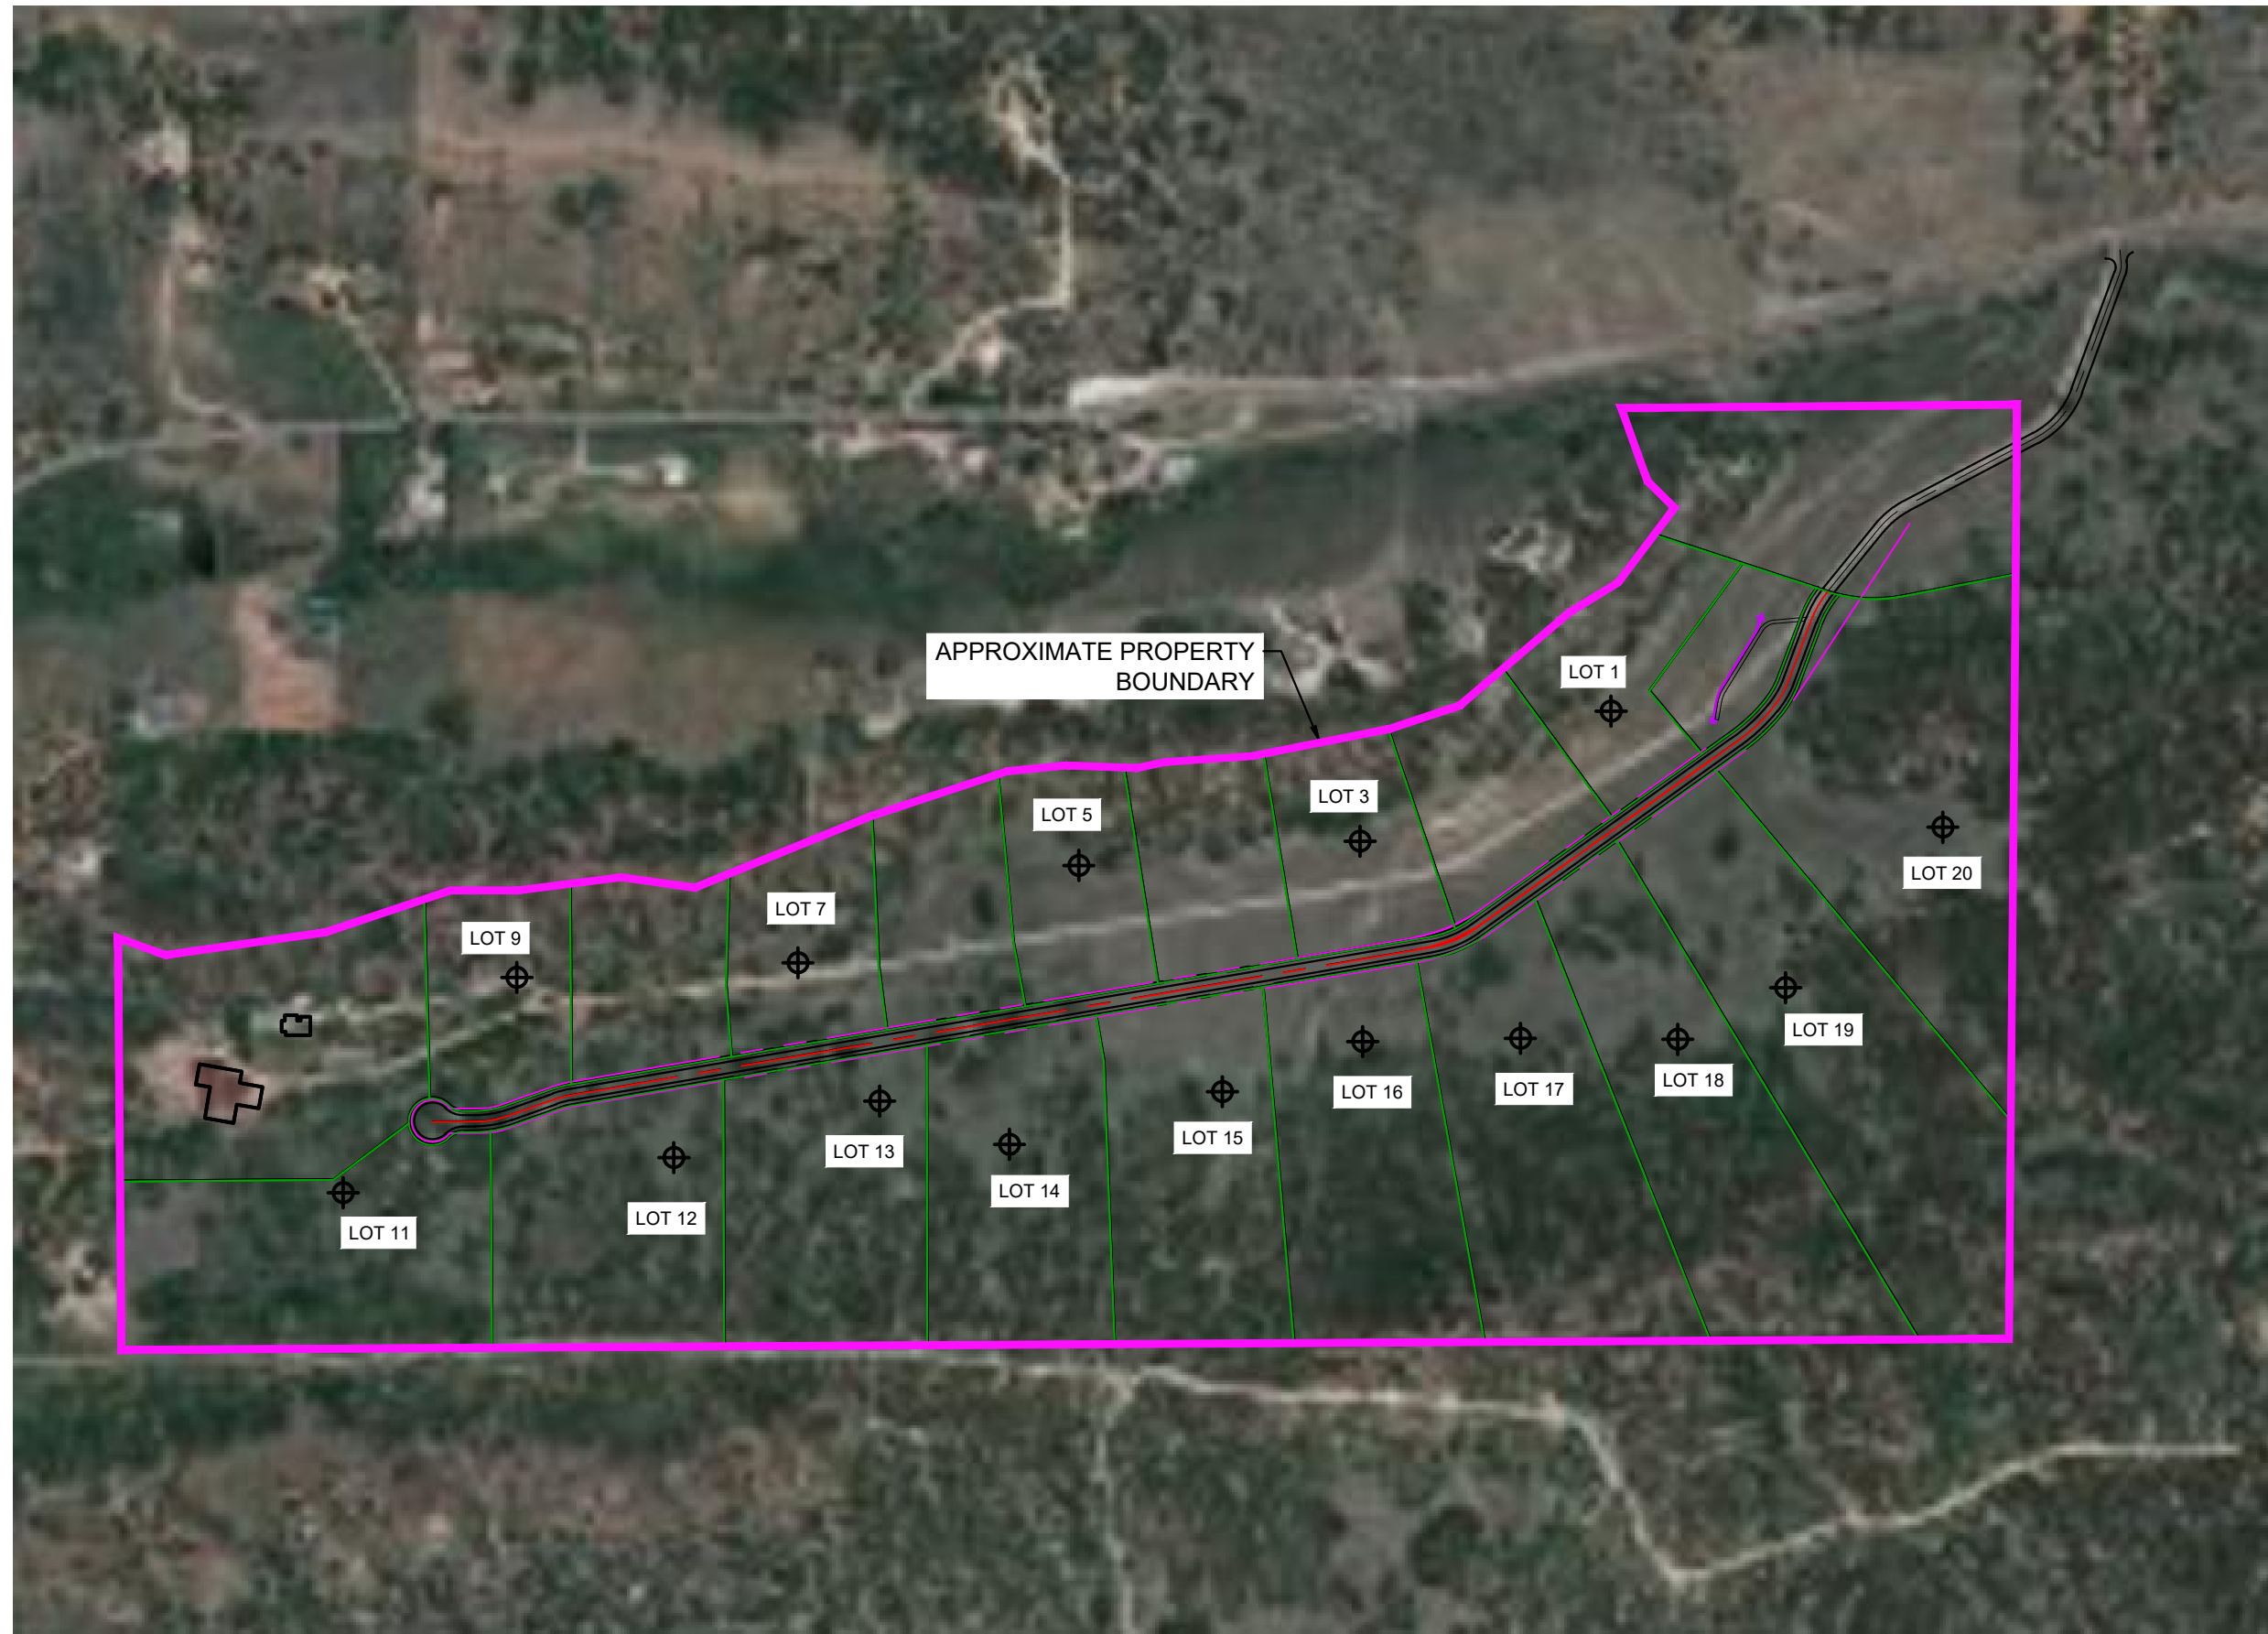
BORINGS LOCATION MAP

APPROXIMATE PROPERTY BOUNDARY

LEGEND
BORING LOCATIONS

EXPLORATION LOCATION PLAN
MARCH 2023

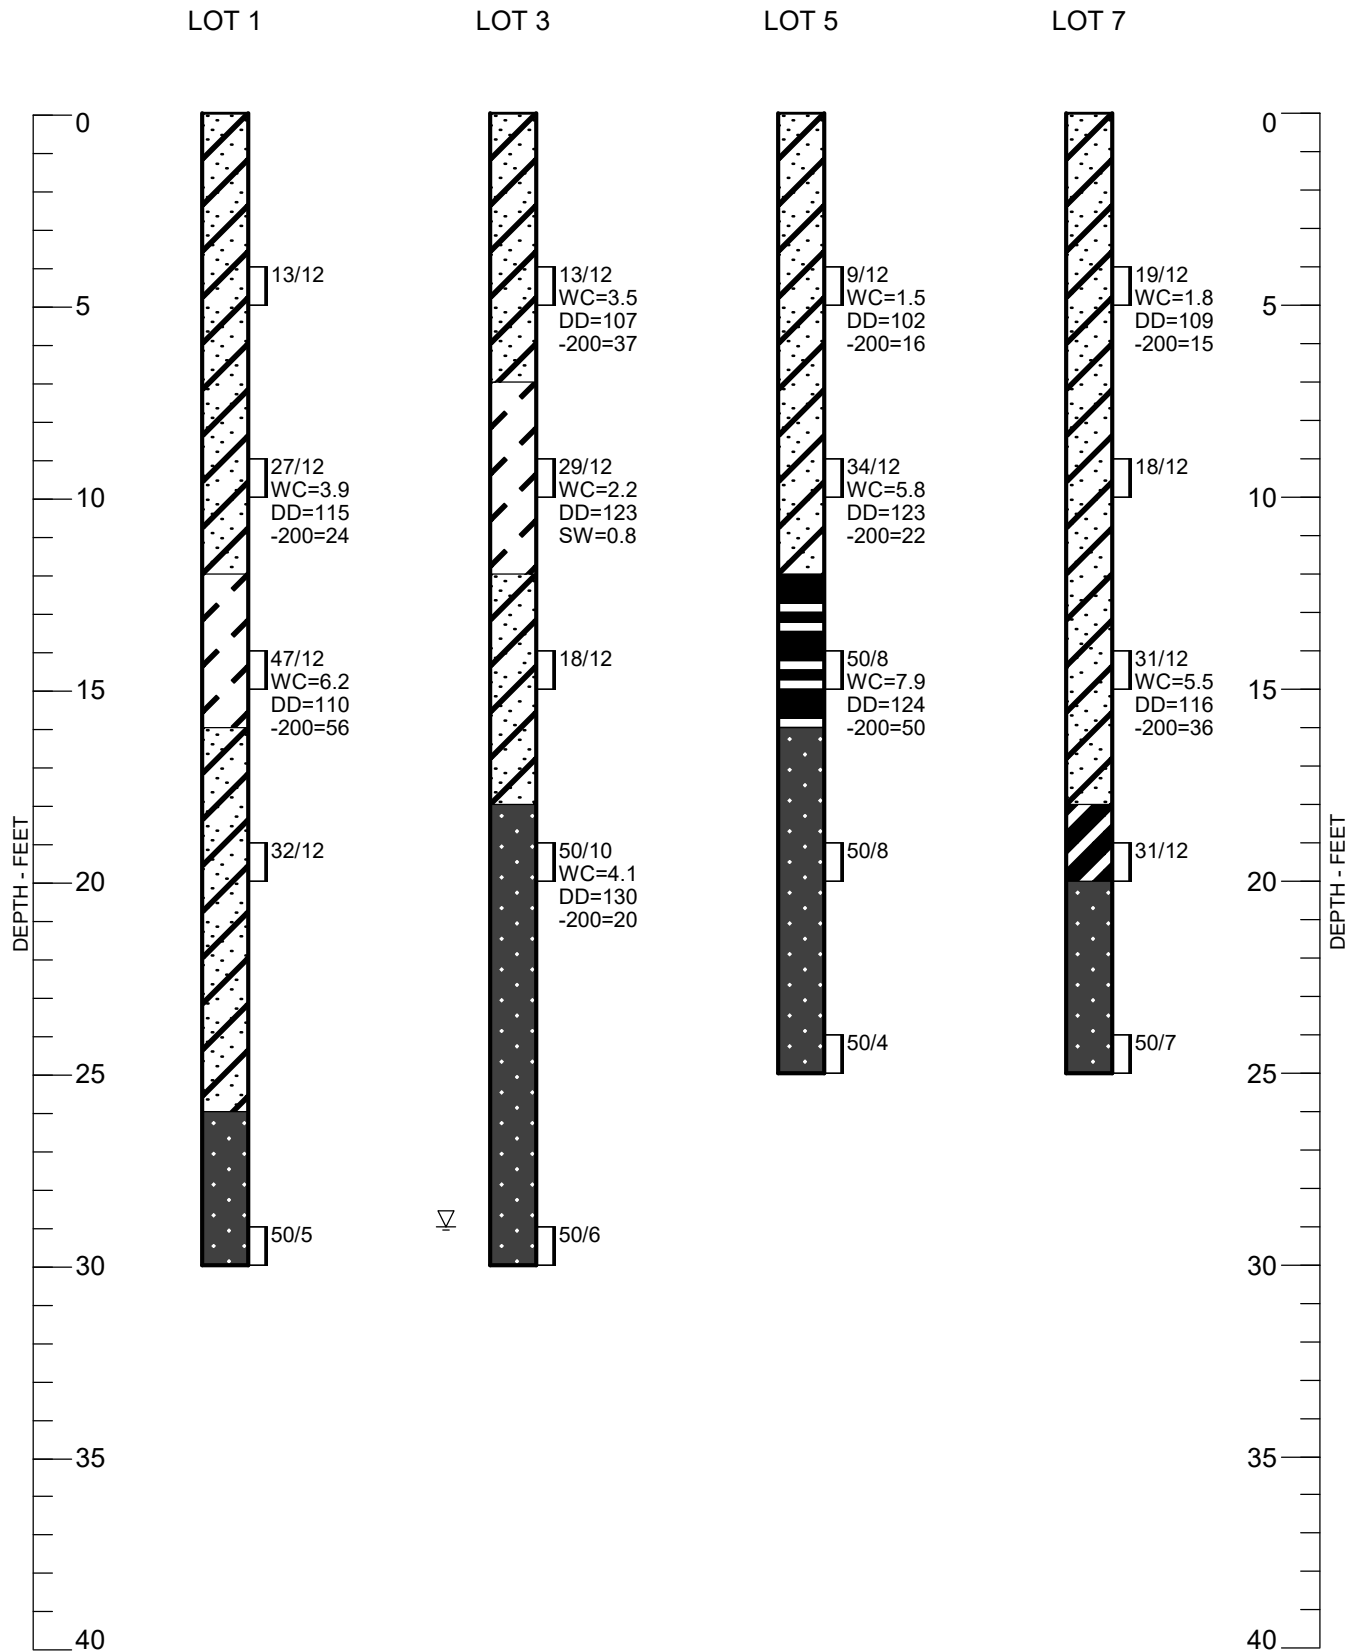
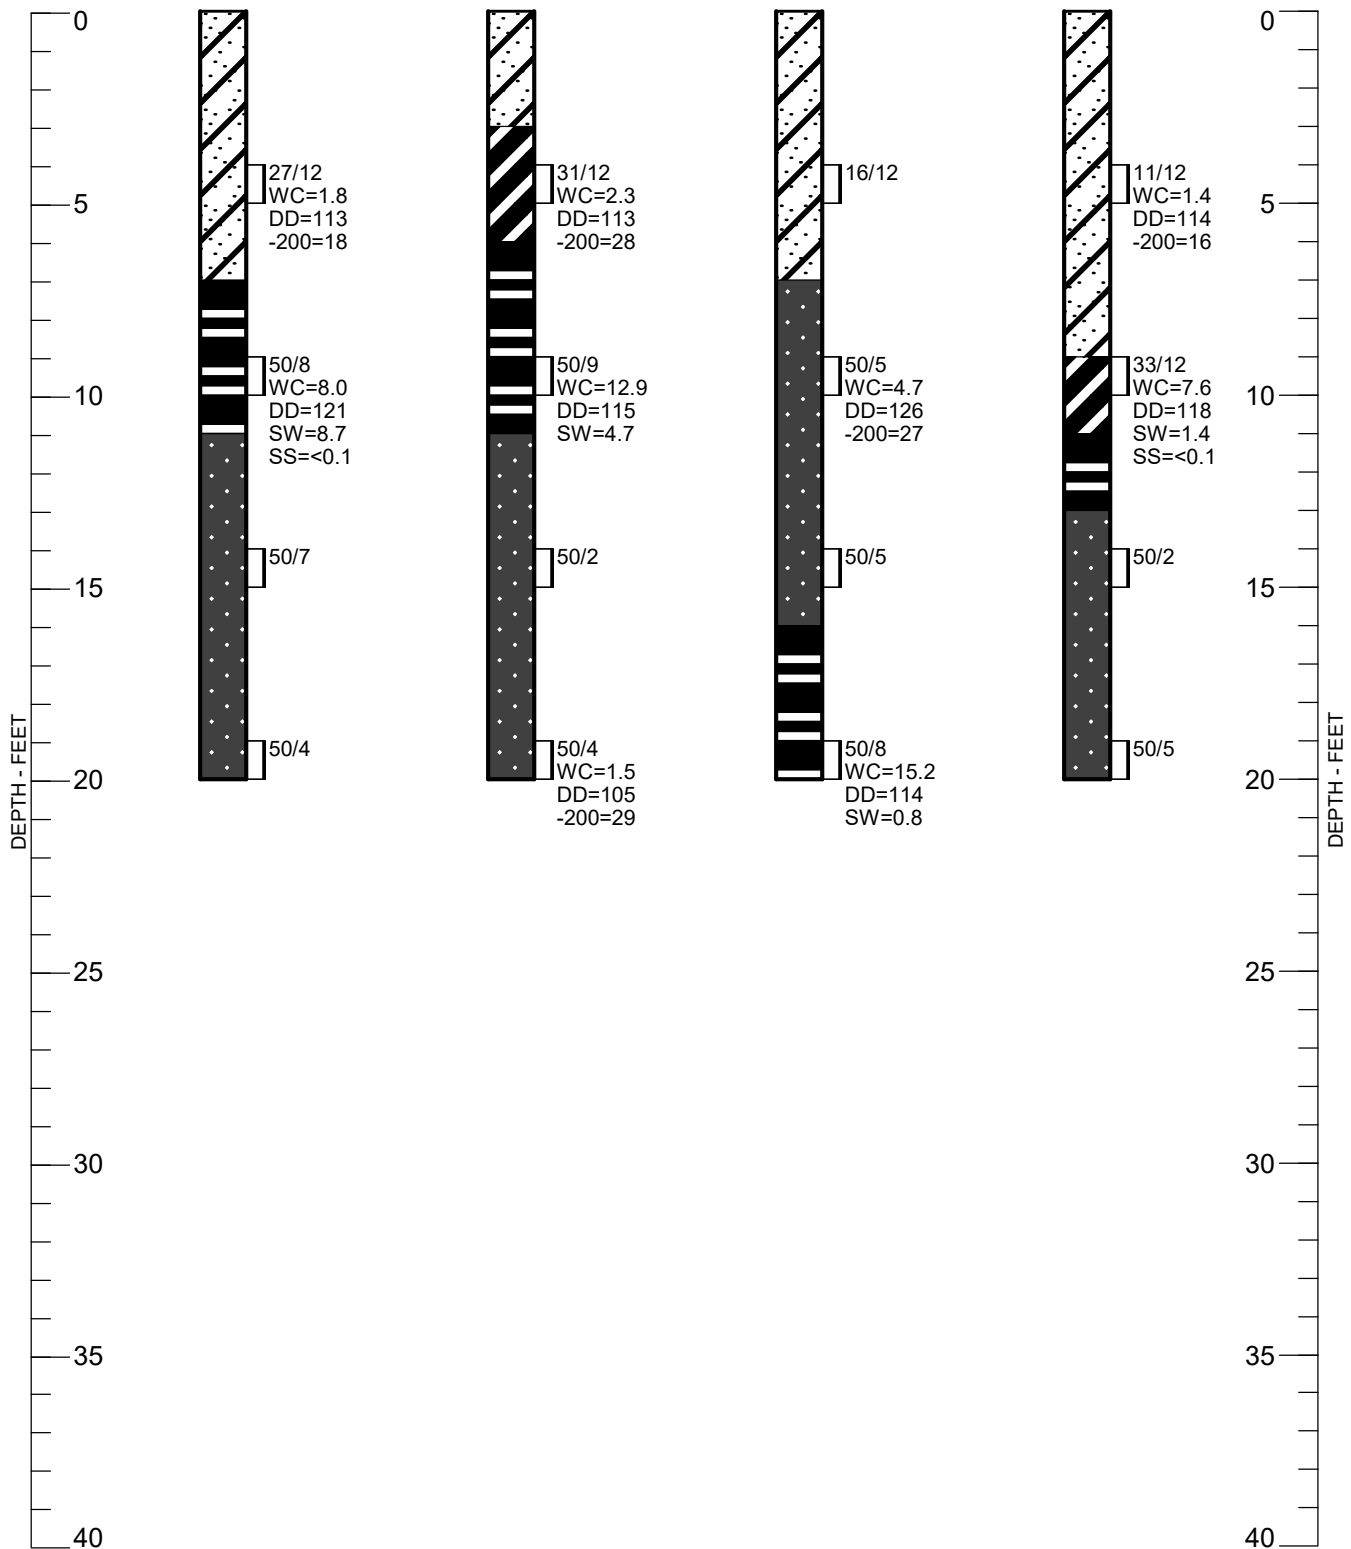
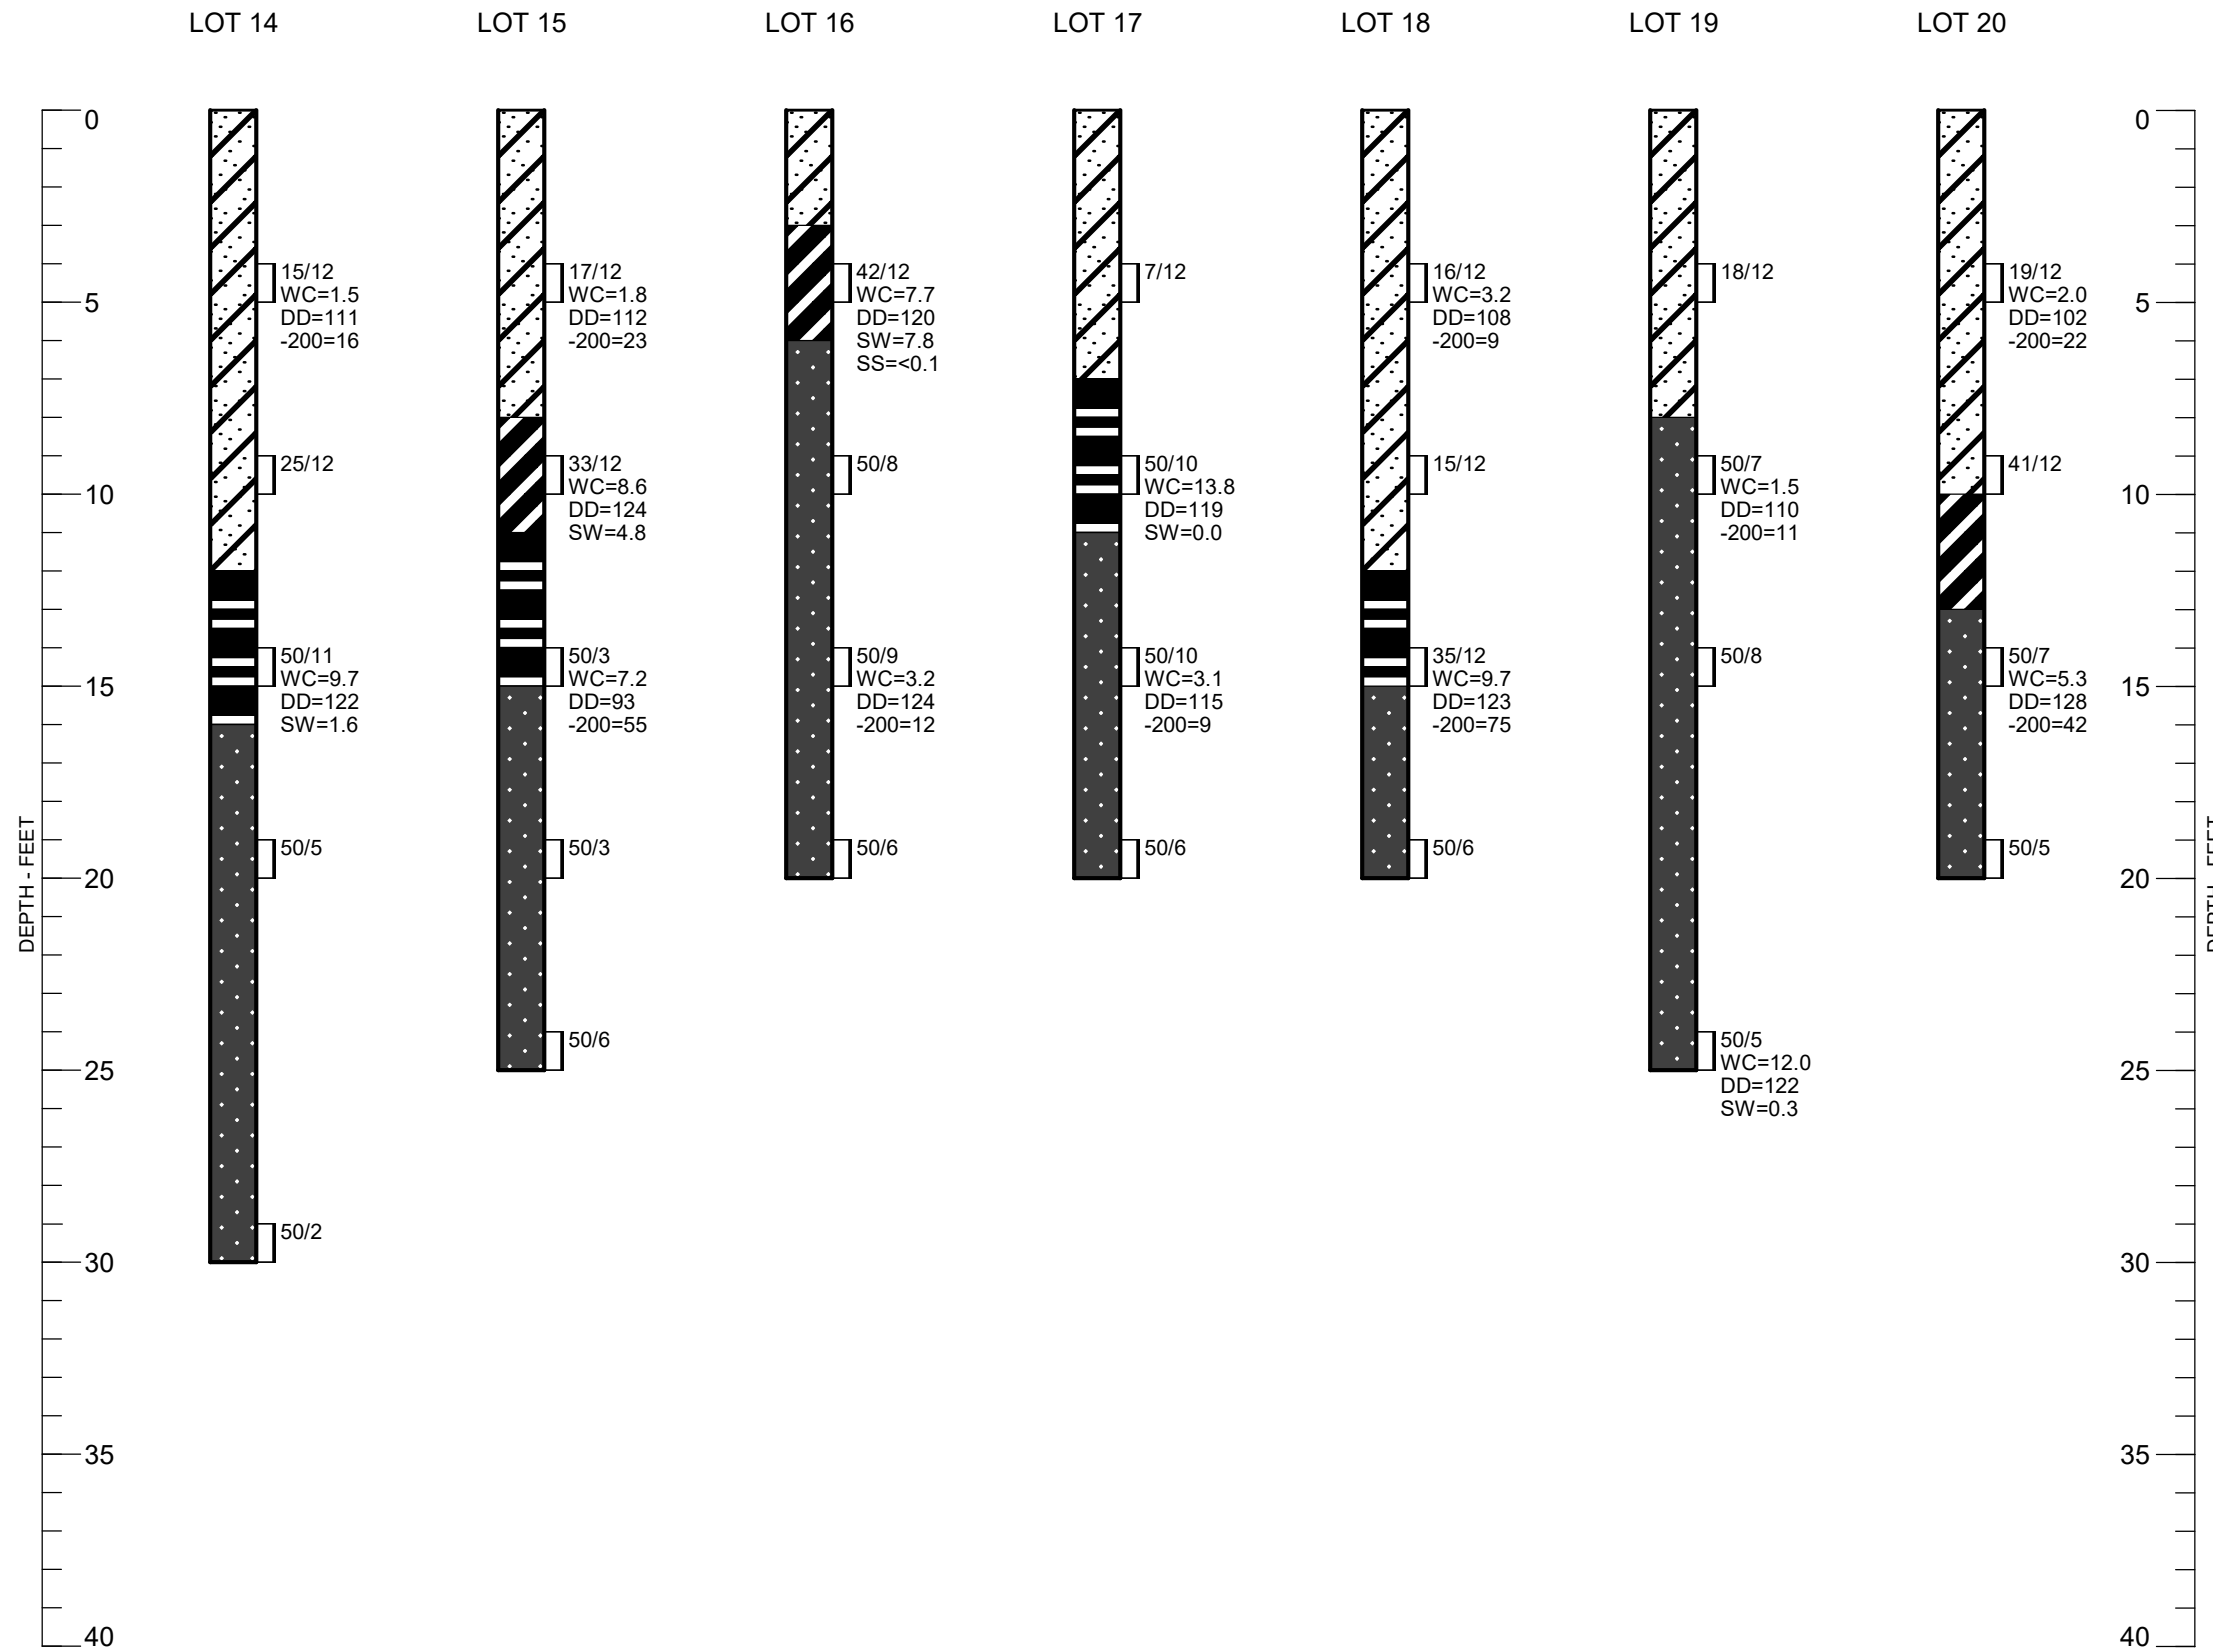
Logs of Explorations

- SAND, SLIGHTLY SILTY TO VERY SILTY, LOOSE TO VERY DENSE, SLIGHTLY MOIST TO MOIST, LIGHT BROWN TO BROWN, OCCASIONAL LENSES OF SANDY CLAY (SP-SM, SM).
- CLAY, SANDY TO VERY SANDY, VERY STIFF, SLIGHTLY MOIST TO MOIST, BROWN (CL).
- WEATHERED BEDROCK, CLAYSTONE AND SANDSTONE, SANDY (CLAYSTONE) OR SILTY TO CLAYEY (SANDSTONE), MEDIUM HARD, MOIST, LIGHT BROWN TO RED BROWN.
- BEDROCK. CLAYSTONE, SANDY TO VERY SANDY, MEDIUM HARD TO VERY HARD, MOIST, LIGHT BROWN TO BROWN, RED BROWN, GRAY BROWN.
- BEDROCK. SANDSTONE, SLIGHTLY SILTY TO SILTY, CLAYEY TO VERY CLAYEY, HARD TO VERY HARD, SLIGHTLY MOIST TO MOIST, LIGHT BROWN TO BROWN, RED BROWN, GRAY TO GRAY BROWN.
- DRIVE SAMPLE. THE SYMBOL 13/12 INDICATES 13 BLOWS OF A 140-POUND HAMMER FALLING 30 INCHES WERE REQUIRED TO DRIVE A 2.5-INCH O.D. SAMPLER 12 INCHES.
- GROUNDWATER LEVEL MEASURED AT TIME OF DRILLING.

1. THE BORINGS WERE DRILLED OCTOBER 3, 7, AND 14, 2022 USING A 4-INCH DIAMETER, CONTINUOUS-FLIGHT AUGER AND A DIEDRICH D-90, TRUCK-MOUNTED DRILL RIG.
2. THESE LOGS ARE SUBJECT TO THE EXPLANATIONS, LIMITATIONS, AND CONCLUSIONS AS CONTAINED IN THIS REPORT.
3. WC - INDICATES MOISTURE CONTENT. (%)
 DD - INDICATES DRY DENSITY. (PCF)
 SW - INDICATES SWELL WHEN WETTED UNDER APPROXIMATE OVERBURDEN PRESSURE. (%)
 -200 - INDICATES PASSING NO. 200 SIEVE. (%)
 SS - INDICATES WATER-SOLUBLE SULFATE CONTENT. (%)

Appendix A of this report includes logs of the borings describing the subsurface conditions. The lines defining boundaries between soil and rock types on the logs are based upon drill behavior and interpolation between samples and are therefore approximate. Transition between soil and rock types may be abrupt or may be gradual.

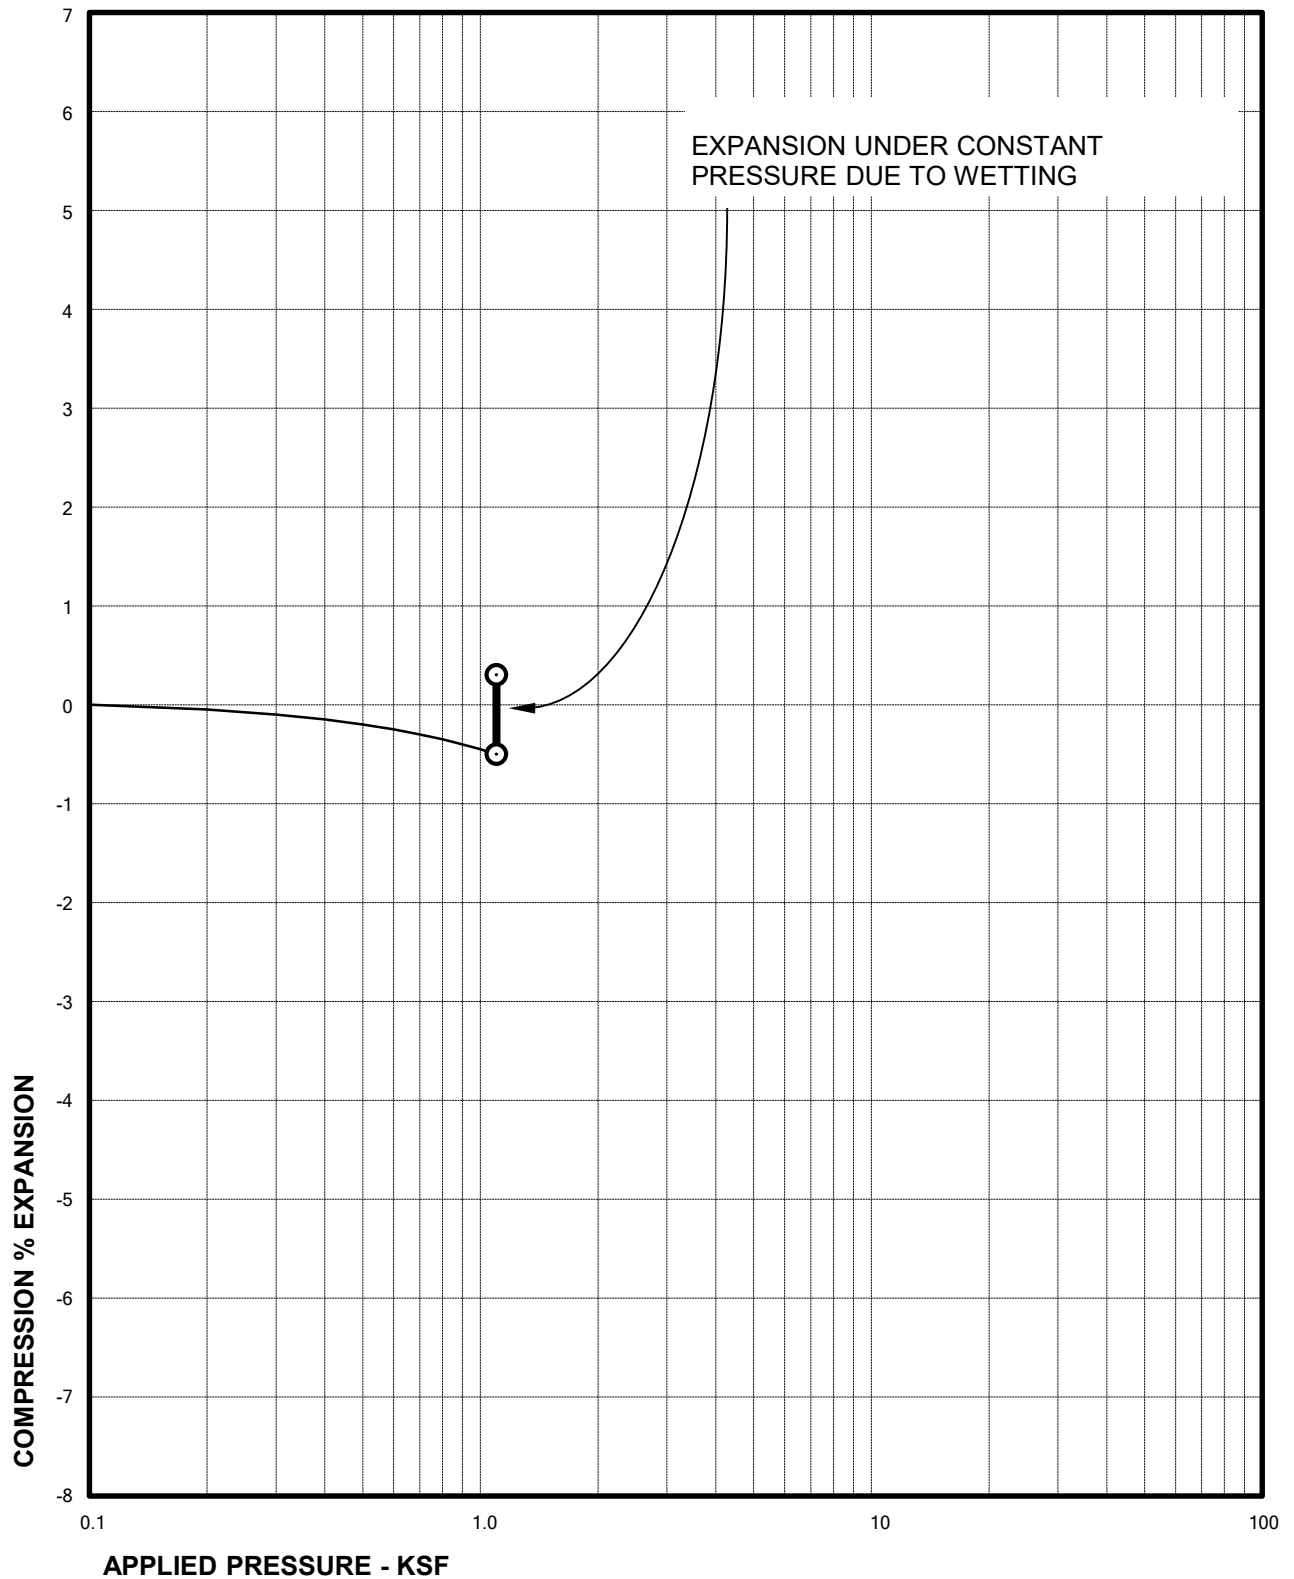
Swell Consolidation Test Results

Sample of CLAY, SANDY (CL)
From LOT 3 AT 9 FEET

DRY UNIT WEIGHT= 123 PCF
MOISTURE CONTENT= 2.2 %

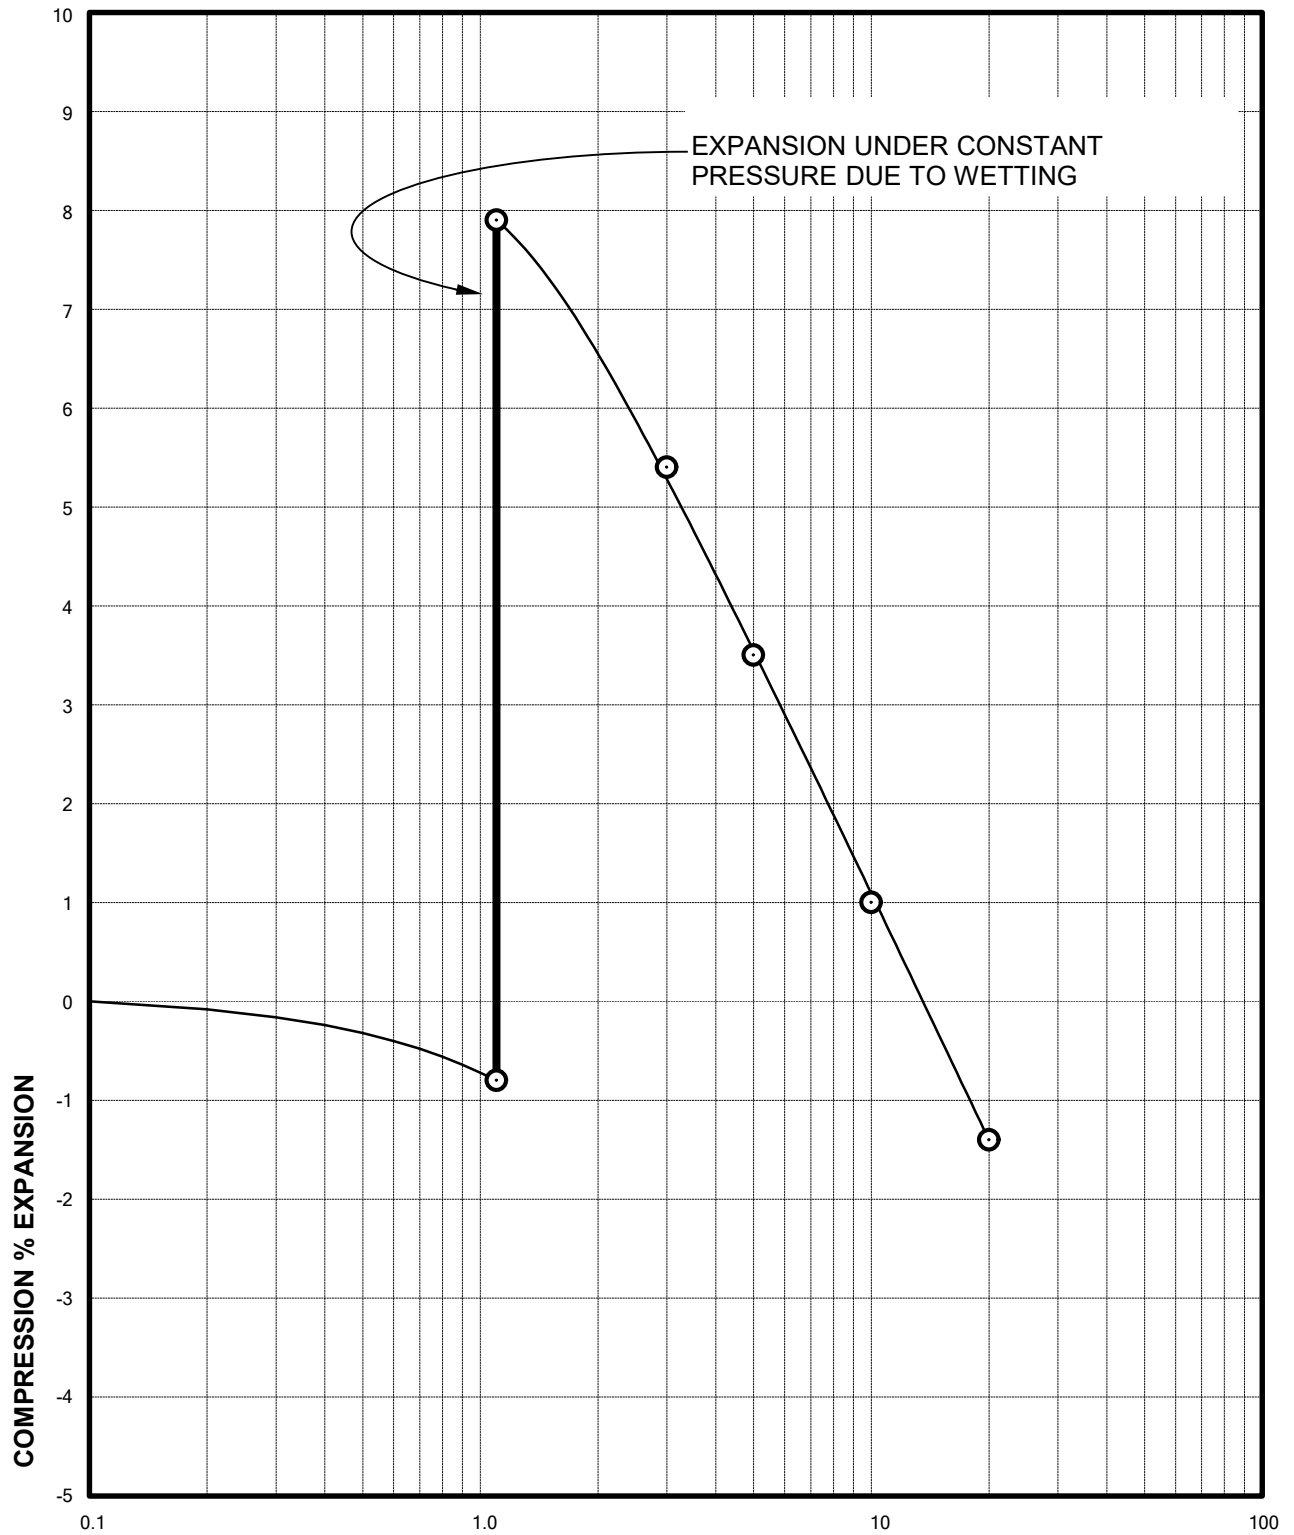
Swell Consolidation Test Results

APPLIED PRESSURE - KSF
Sample of CLAYSTONE, SANDY
From LOT 9 AT 9 FEET

DRY UNIT WEIGHT= 121 PCF
MOISTURE CONTENT= 8.0 %

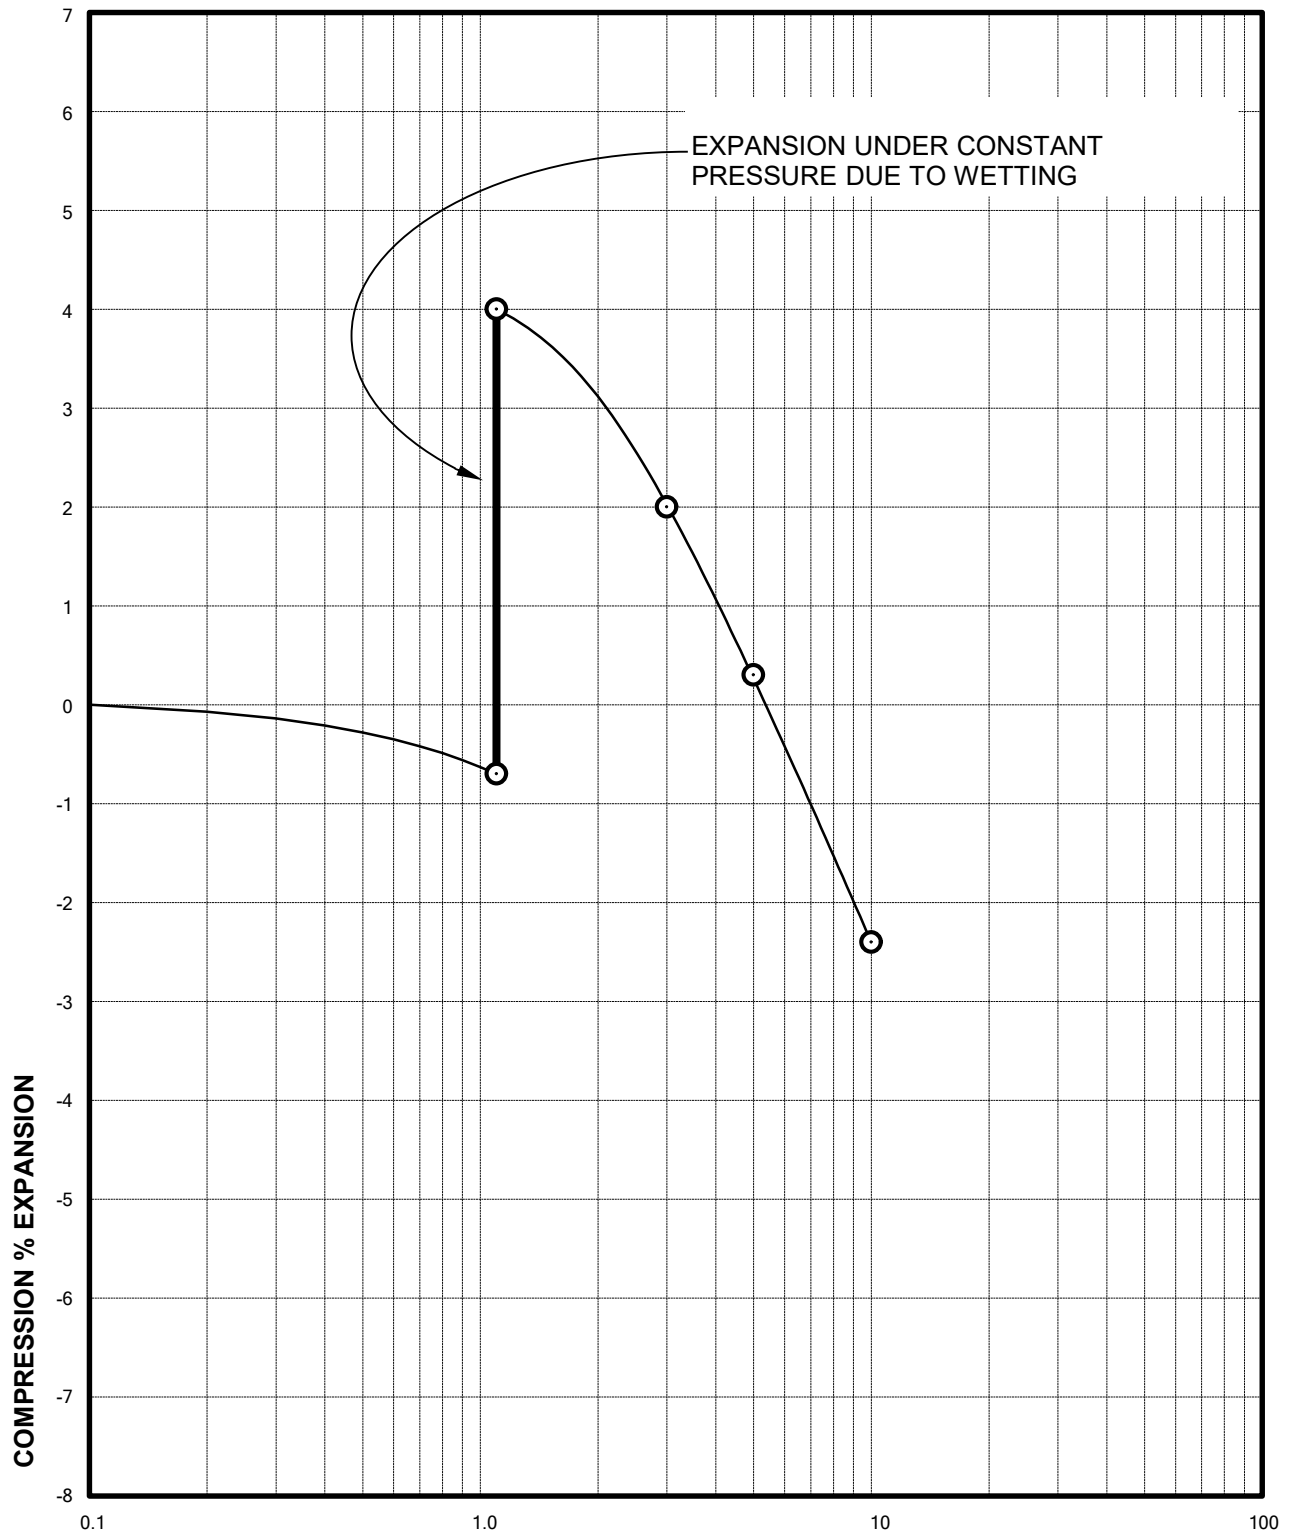
Swell Consolidation Test Results

APPLIED PRESSURE - KSF
Sample of CLAYSTONE, SANDY
From LOT 11 AT 9 FEET

DRY UNIT WEIGHT= 115 PCF
MOISTURE CONTENT= 12.9 %

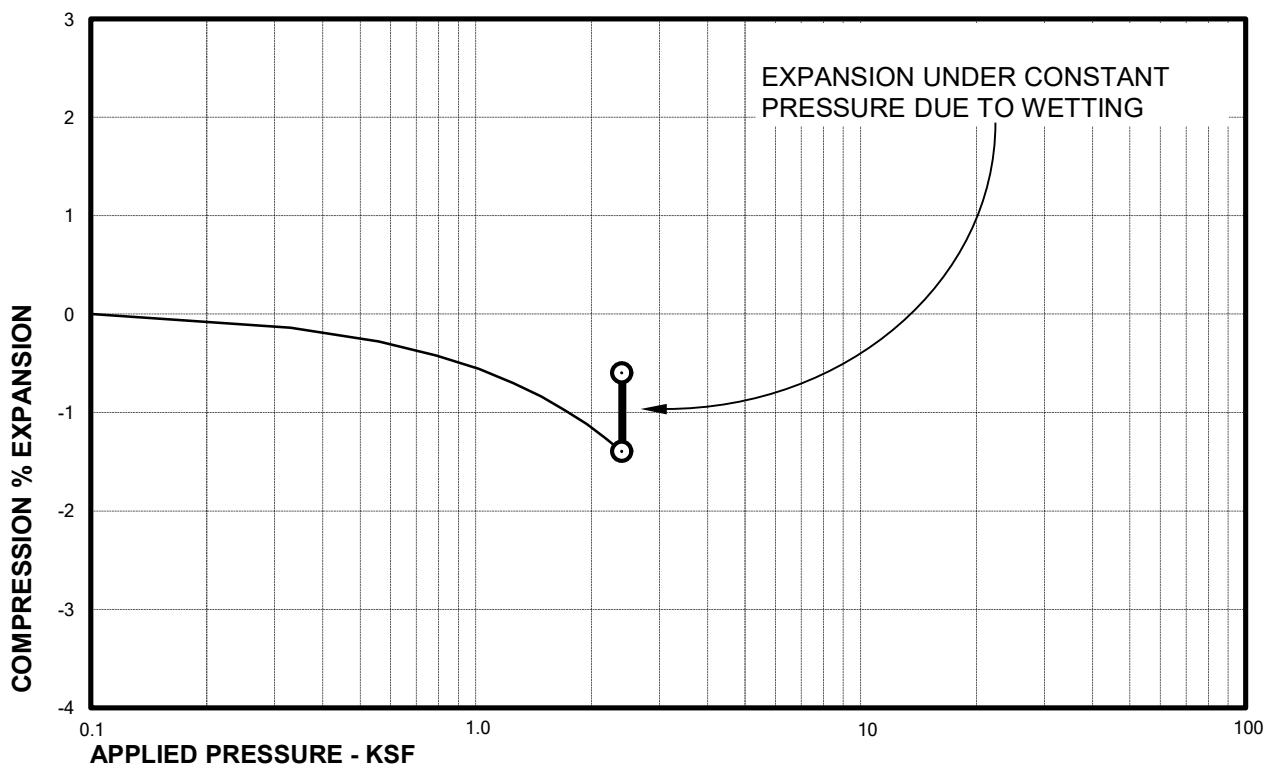
Sample of CLAYSTONE, SANDY
From LOT 12 AT 19 FEET

DRY UNIT WEIGHT= 114 PCF
MOISTURE CONTENT= 15.2 %

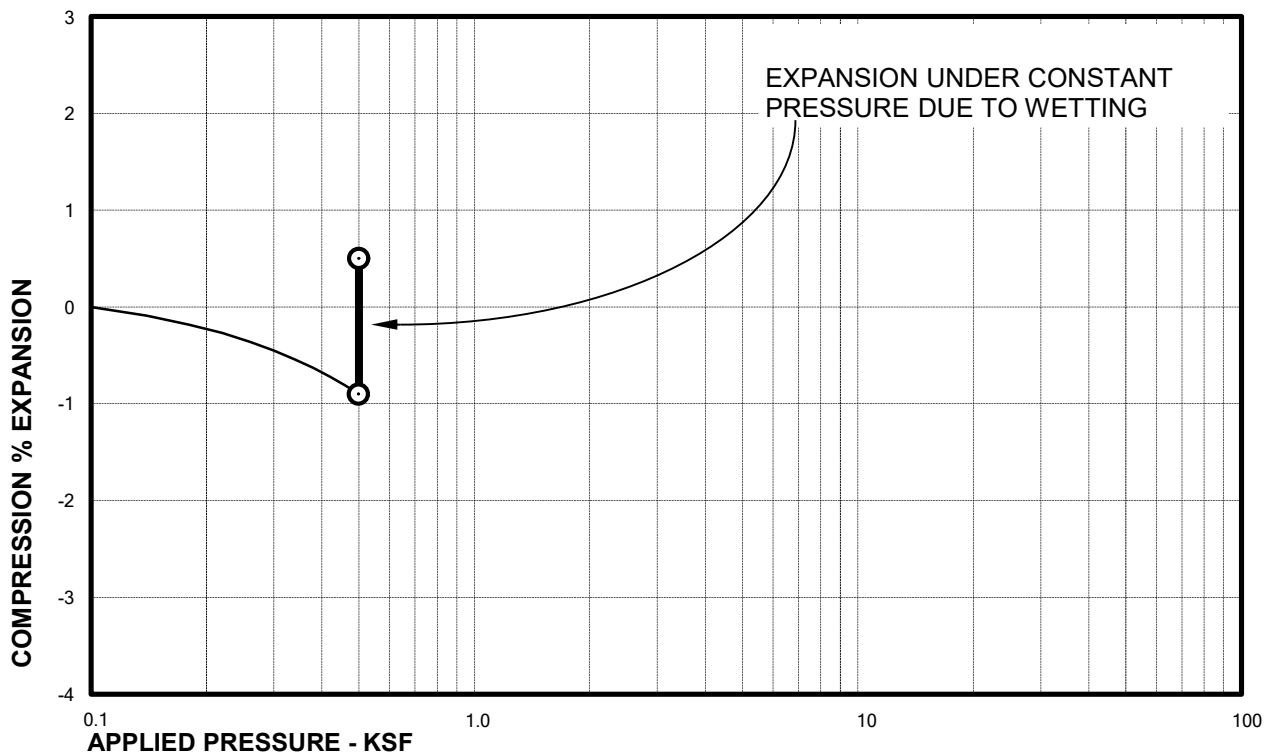
Sample of WEATHERED CLAYSTONE
From LOT 13 AT 9 FEET

DRY UNIT WEIGHT= 118 PCF
MOISTURE CONTENT= 7.6 %

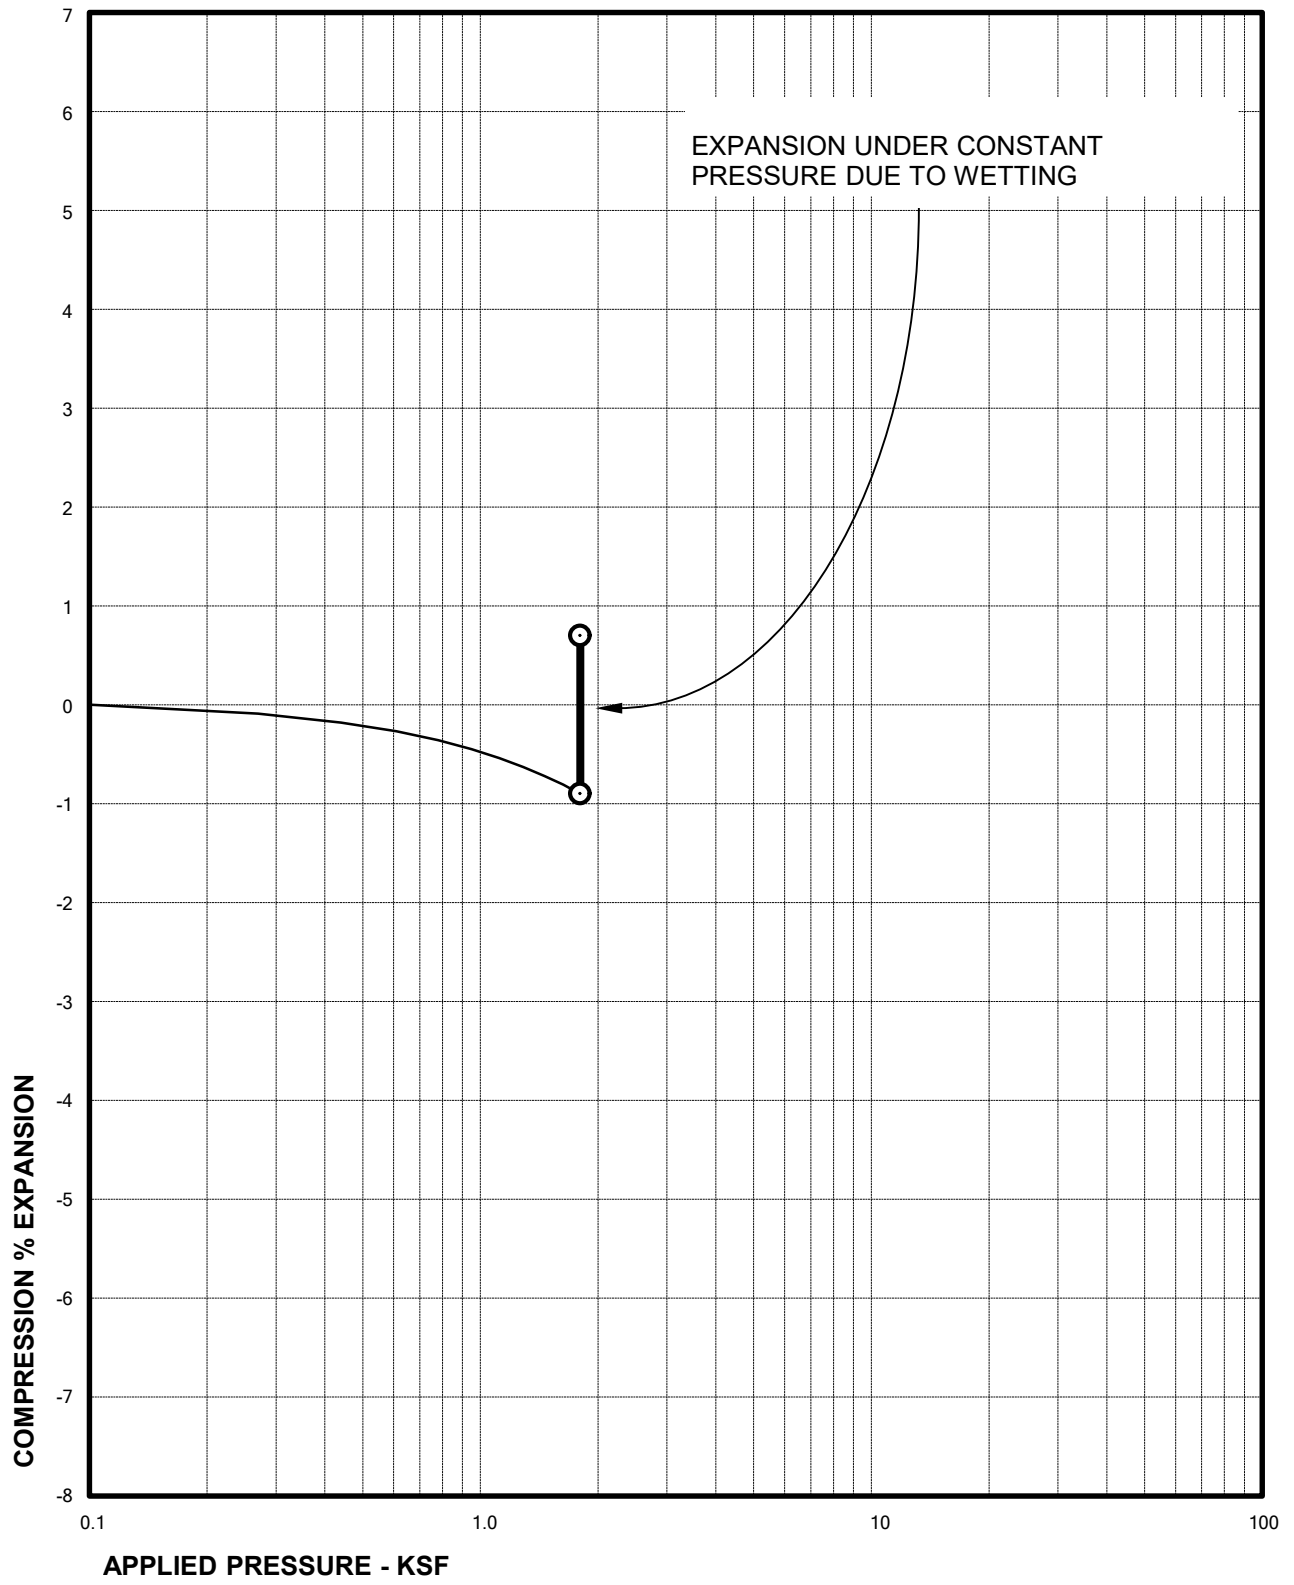
Swell Consolidation Test Results

Sample of CLAYSTONE, SANDY
From LOT 14 AT 14 FEET

DRY UNIT WEIGHT= 122 PCF
MOISTURE CONTENT= 9.7 %
