WASTEWATER EVALUATION REPORT
FOR
HAY CREEK VALLEY DEVELOPMENT
AT
2855 HAY CREEK ROAD
EL PASO COUNTY, COLORADO

September 2023

Project No. 22.886.076

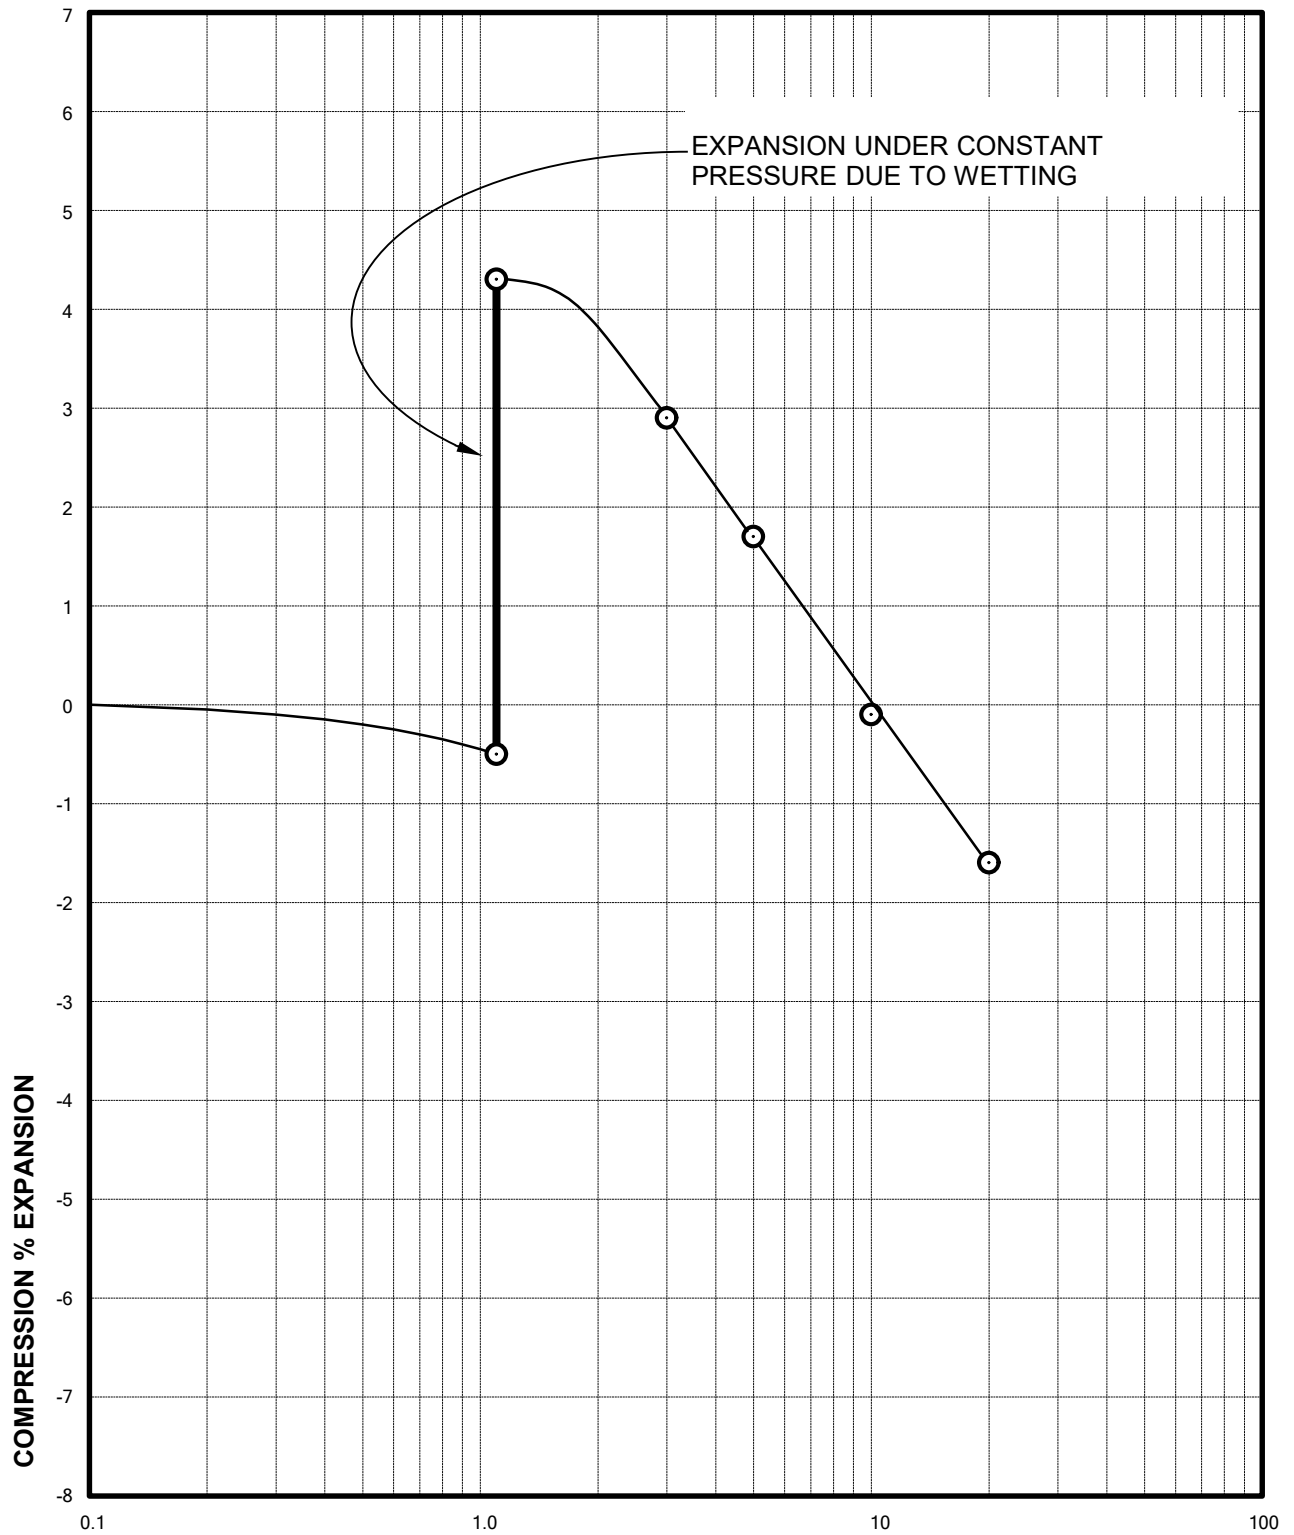
Swell Consolidation Test Results

APPLIED PRESSURE - KSF
Sample of WEATHERED CLAYSTONE
From LOT 15 AT 9 FEET

DRY UNIT WEIGHT= 124 PCF
MOISTURE CONTENT= 8.6 %

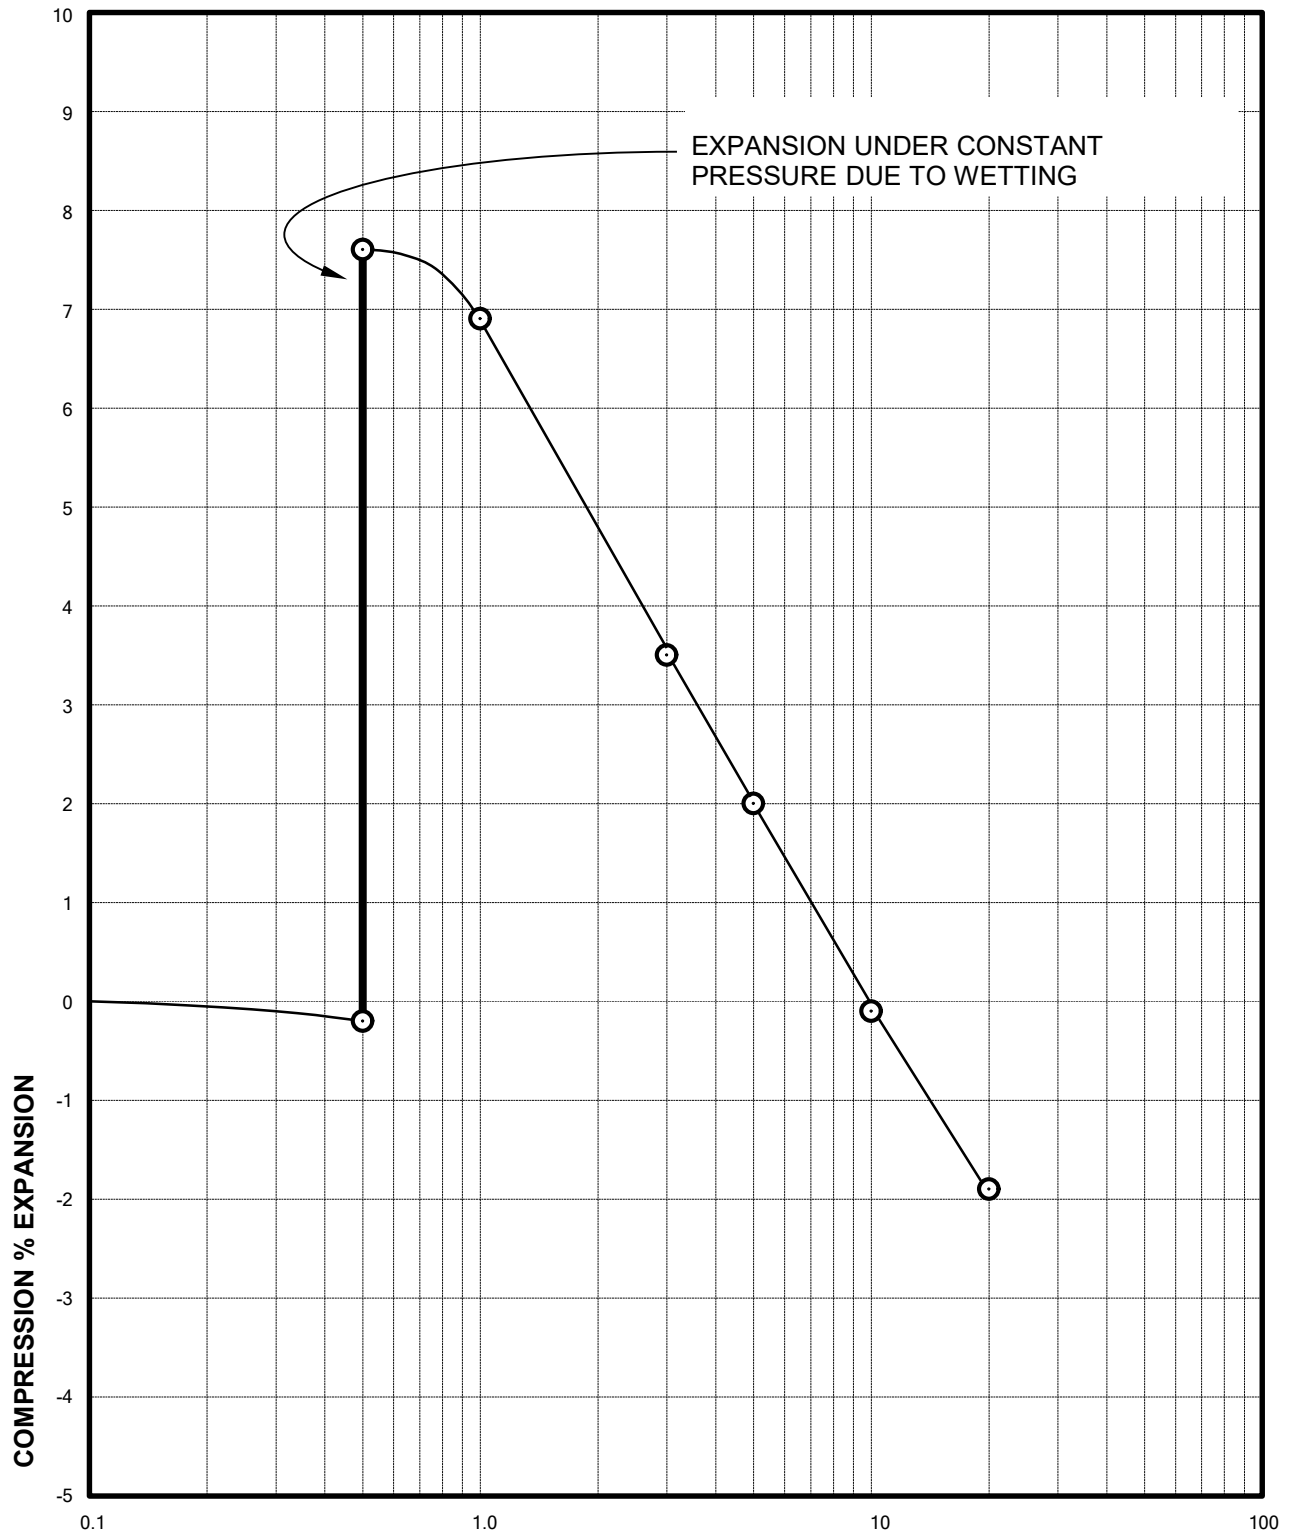
Swell Consolidation Test Results

APPLIED PRESSURE - KSF
Sample of WEATHERED CLAYSTONE
From LOT 16 AT 4 FEET

DRY UNIT WEIGHT= 120 PCF
MOISTURE CONTENT= 7.7 %

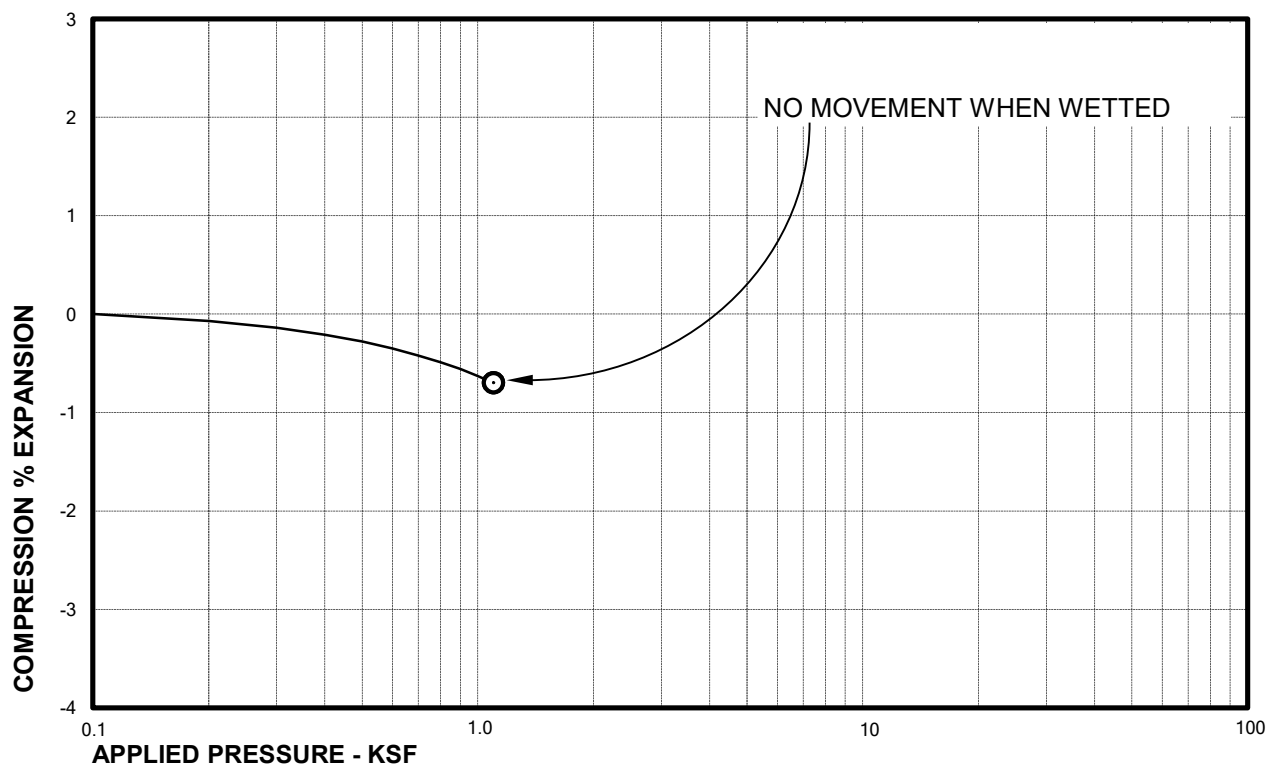
Sample of CLAYSTONE, SANDY
From LOT 17 AT 9 FEET

DRY UNIT WEIGHT= 119 PCF
MOISTURE CONTENT= 13.8 %

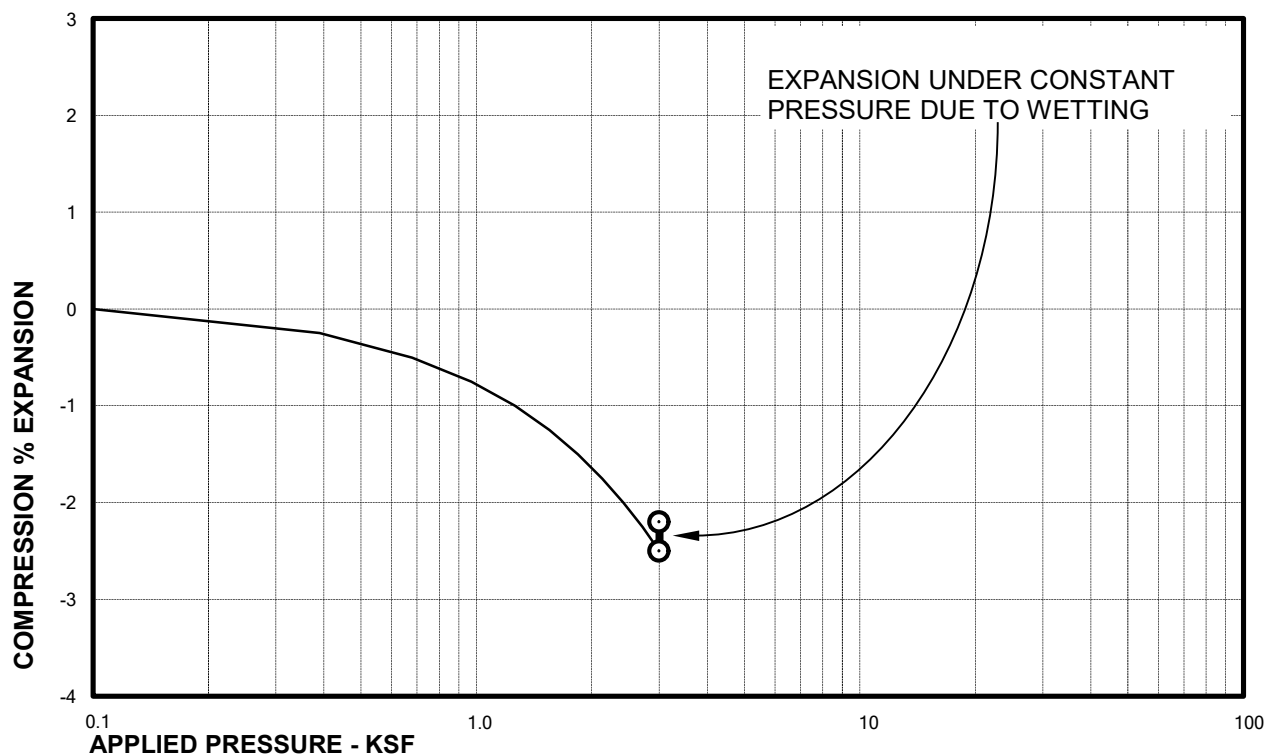
Sample of SANDSTONE, CLAYEY
From LOT 19 AT 24 FEET

DRY UNIT WEIGHT= 122 PCF
MOISTURE CONTENT= 12.0 %
