**ENTECH**  
ENGINEERING, INC.

**WASTEWATER STUDY  
HODGEN ROAD 7-LOT SUBDIVISION  
PARCEL NO. 61250-01-003  
EL PASO COUNTY, COLORADO**

Entech Job No. 250183

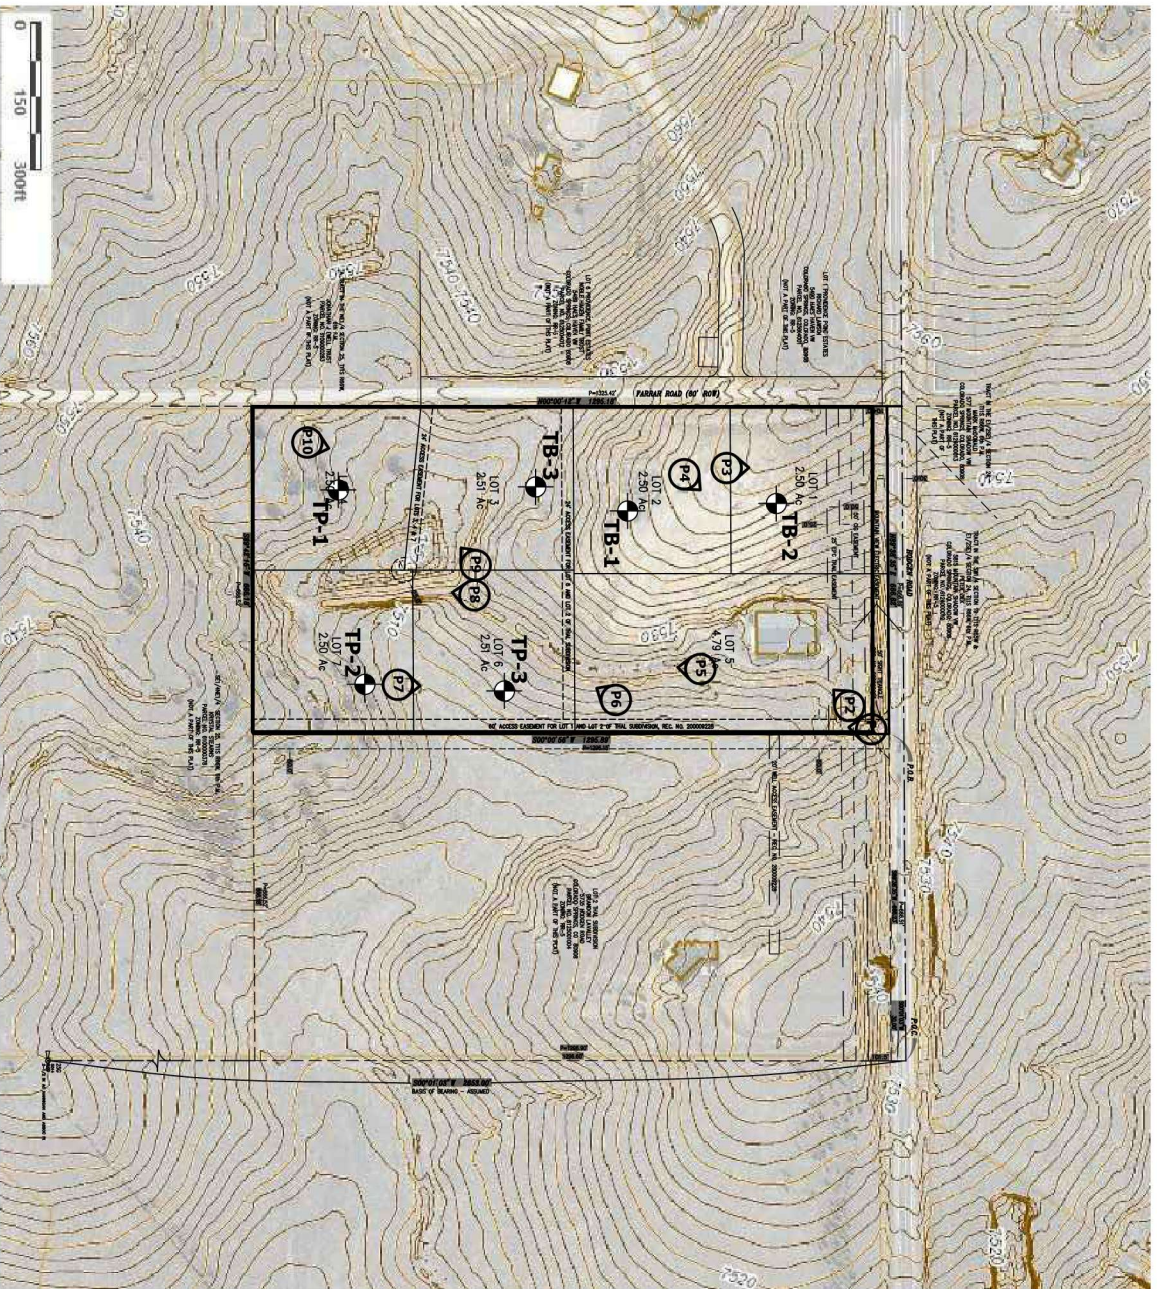
JOB NO.  
 250183  
 FIG. 3

TB- APPROXIMATE TEST BORING LOCATION AND NUMBER

SITE AND EXPLORATION PLAN  
 HODGEN ROAD, 7-LOT SUBDIVISION  
 MATT AND BILL DUNSTON

The proposed site development will consist of seven single-family rural residential lots ranging in size from 2.5 to 4.8 acres with the existing residence located on Lot 5 to remain. The proposed new lots will utilize individual water wells and OWTS. The proposed lot configuration is shown on the Site and Exploration Plan (Figure 4). Grading plans were not available at the time of this investigation. Site grading will be limited to access easements for Lot 2 – 7.

The locations of the test borings and test pits are indicated on the Site and Exploration Plan (Figure 4). The Test Boring and Test Pit Logs are included in Appendix B, and Laboratory Test Results are included in Appendix C. The results of the testing will be discussed later in this report.

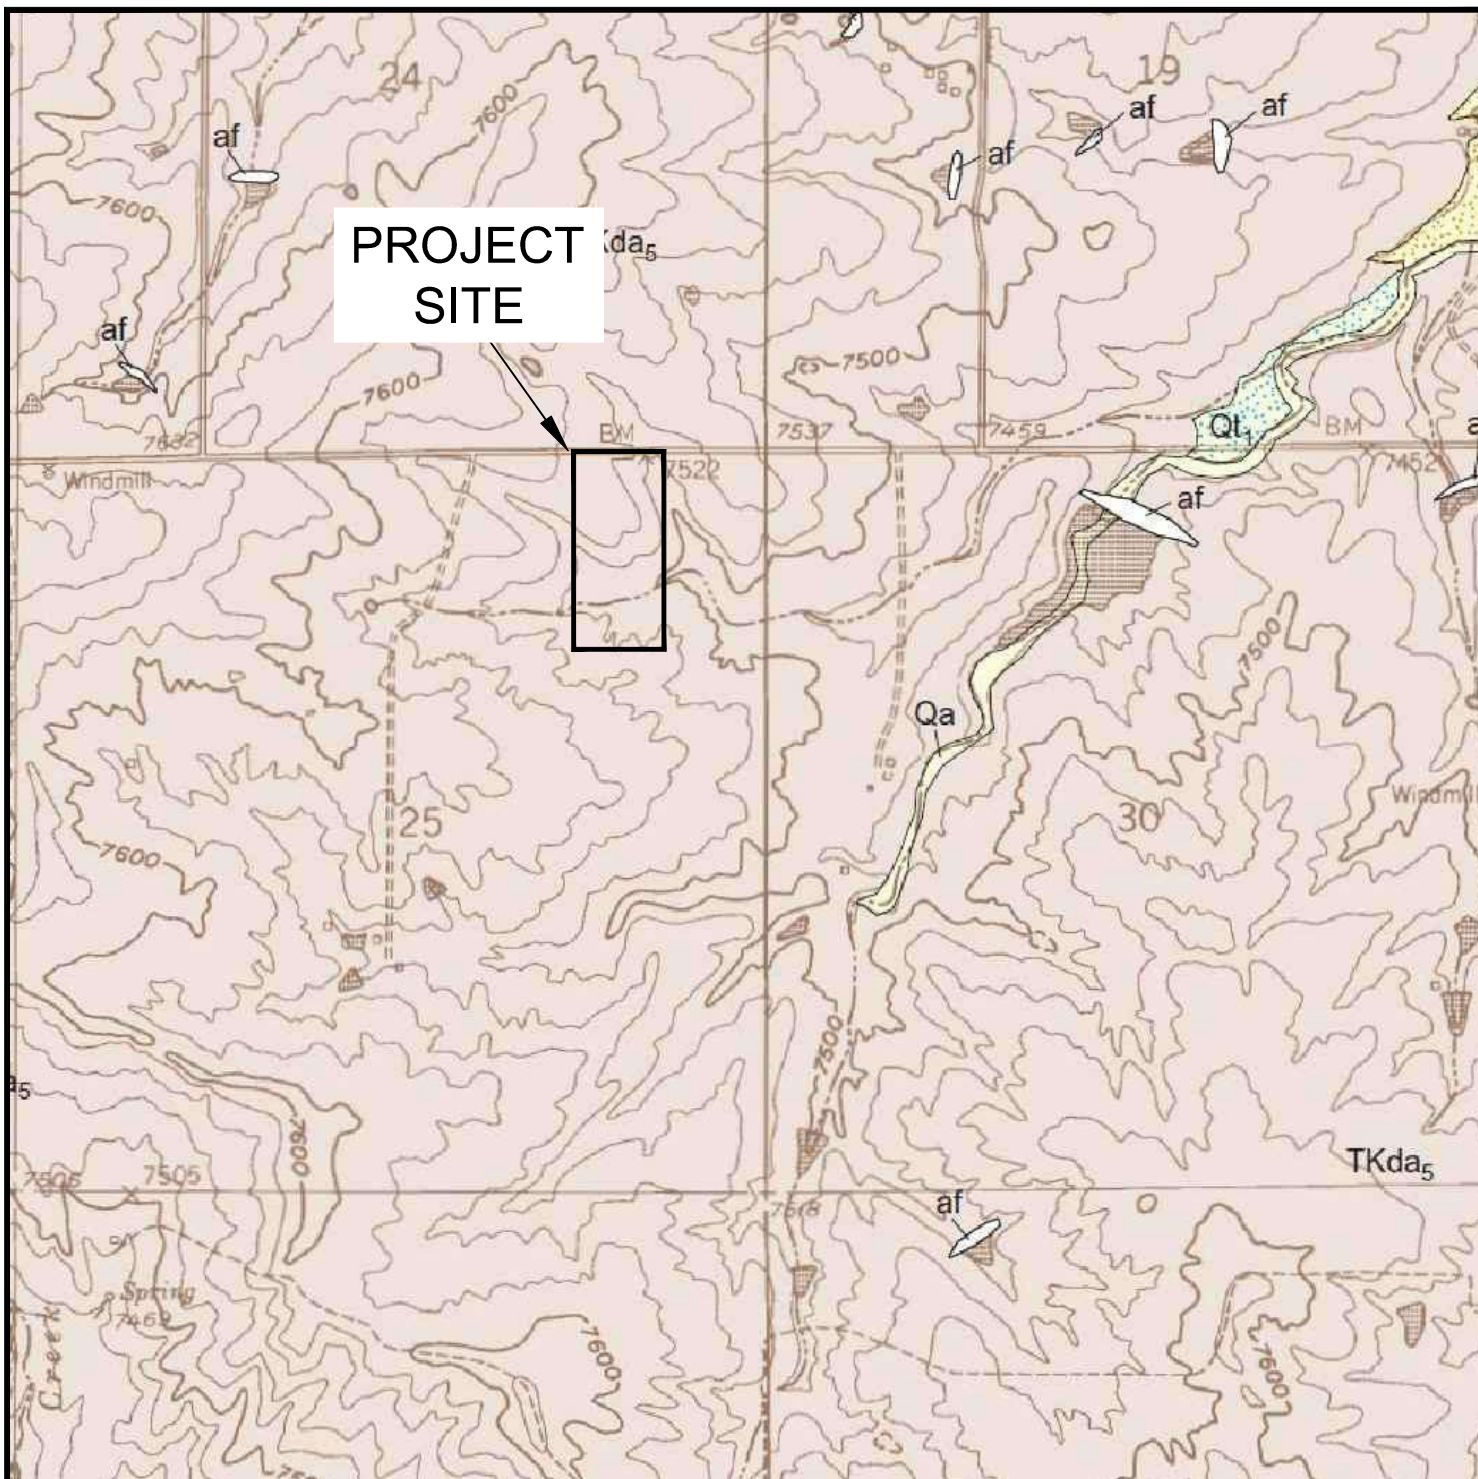
**FIG. 5**

**GEOLOGIC MAP OF THE  
BLACK FOREST QUADRANGLE**  
HODGEN ROAD, 7-LOT SUBDIVISION  
MATT AND BILL DUNSTON

The Black Forest Quadrangle Geology Map showing the site is presented in Figure 5 (Reference 4). The Geology Map prepared for the site is presented in Figures 8 and 9. Three mappable units were identified on this site that are described as follows:

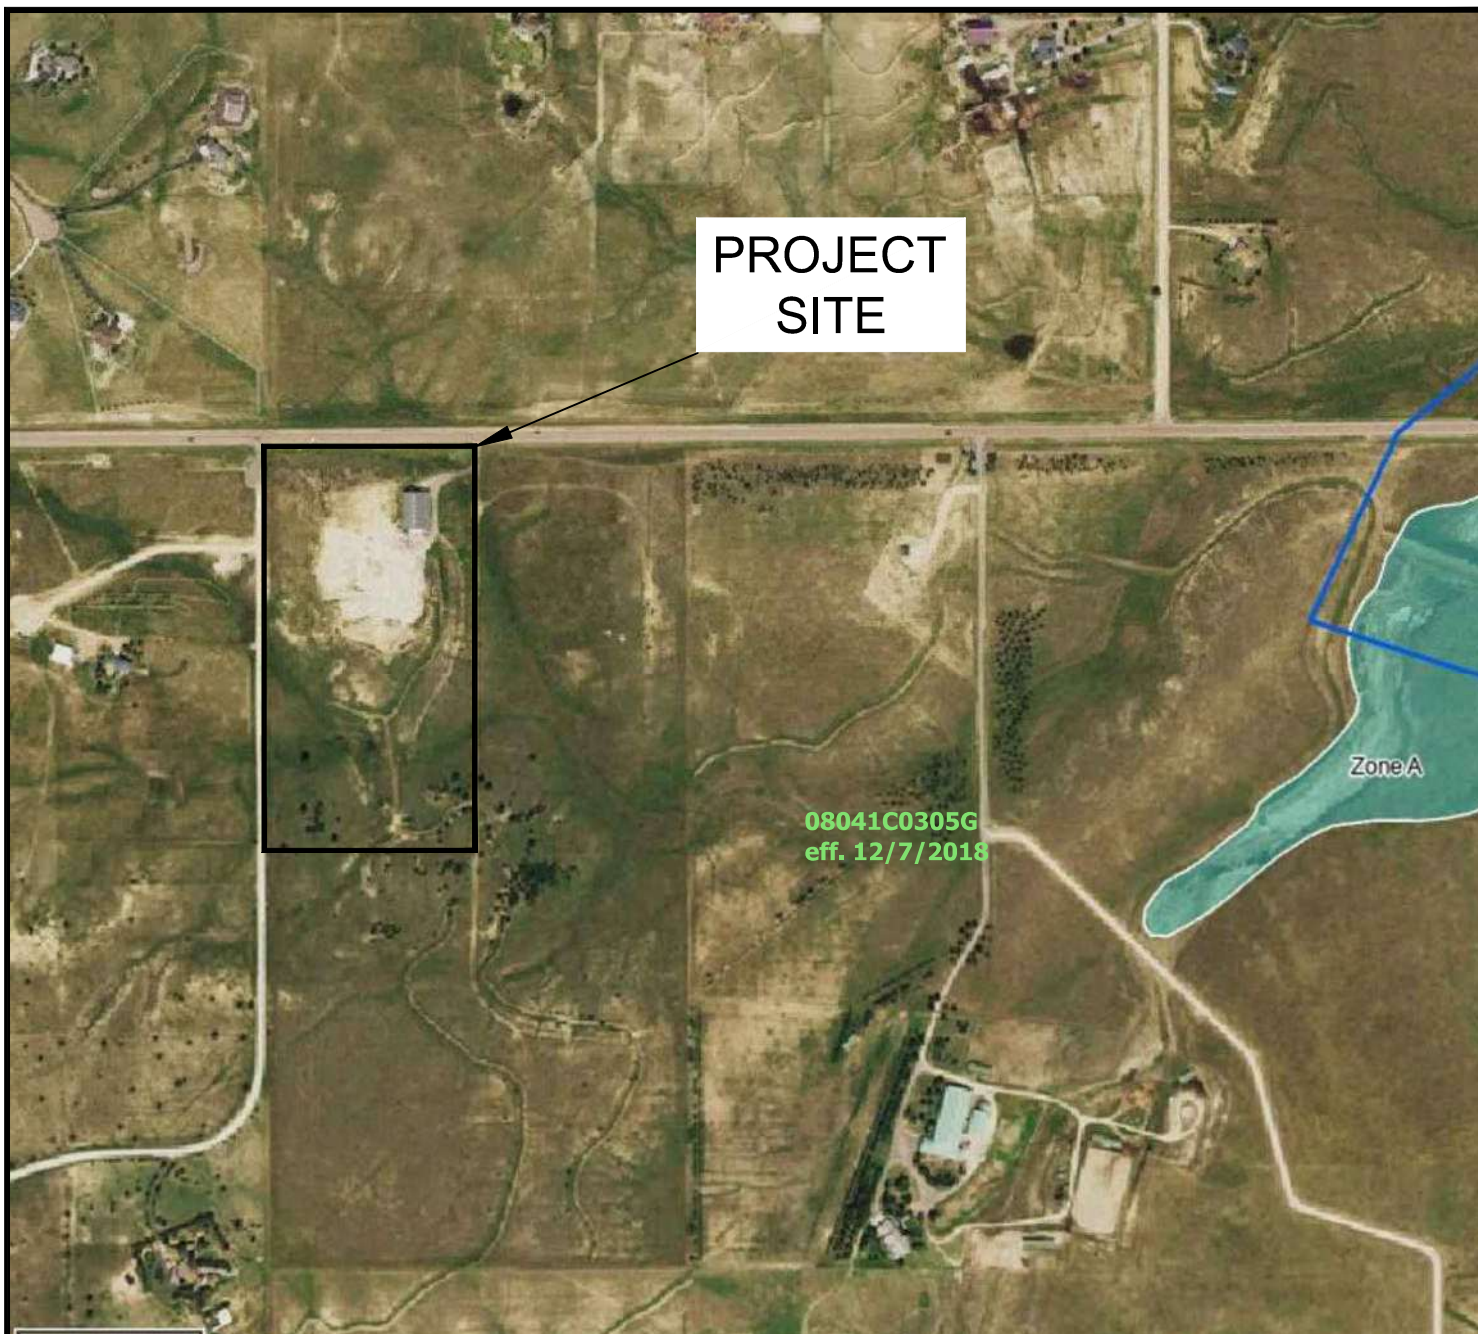
**FIG. 7**

## FEMA FLOODPLAIN MAP

The site is not located within any mapped floodplains according to the FEMA Map No. 08041CO305G, dated December 7, 2018 (Figure 7, Reference 8). The topography of the site varies from gently to moderately sloping, generally to the east and southeast, along drainages in the northeastern and southern portions of the site. An earthen dam is located in the southern portion of the site and erosion control berms are in the eastern and southern portions of the site. The drainages on site generally flow in southeasterly, and easterly directions across the site. Water was not observed flowing in the drainages at the time of this investigation; however, an area of ponded water was observed on the eastern side earthen dam. Additionally, saturated conditions and minor amounts of water were observed in the minor drainage swales and along the uphill side of the erosion berms. The drainages and minor drainages observed across the site have been indicated as seasonal shallow areas on the Geology/Engineering Geology Map (Figure 6). The major drainages are anticipated to be located in “open space” and drainage easements.

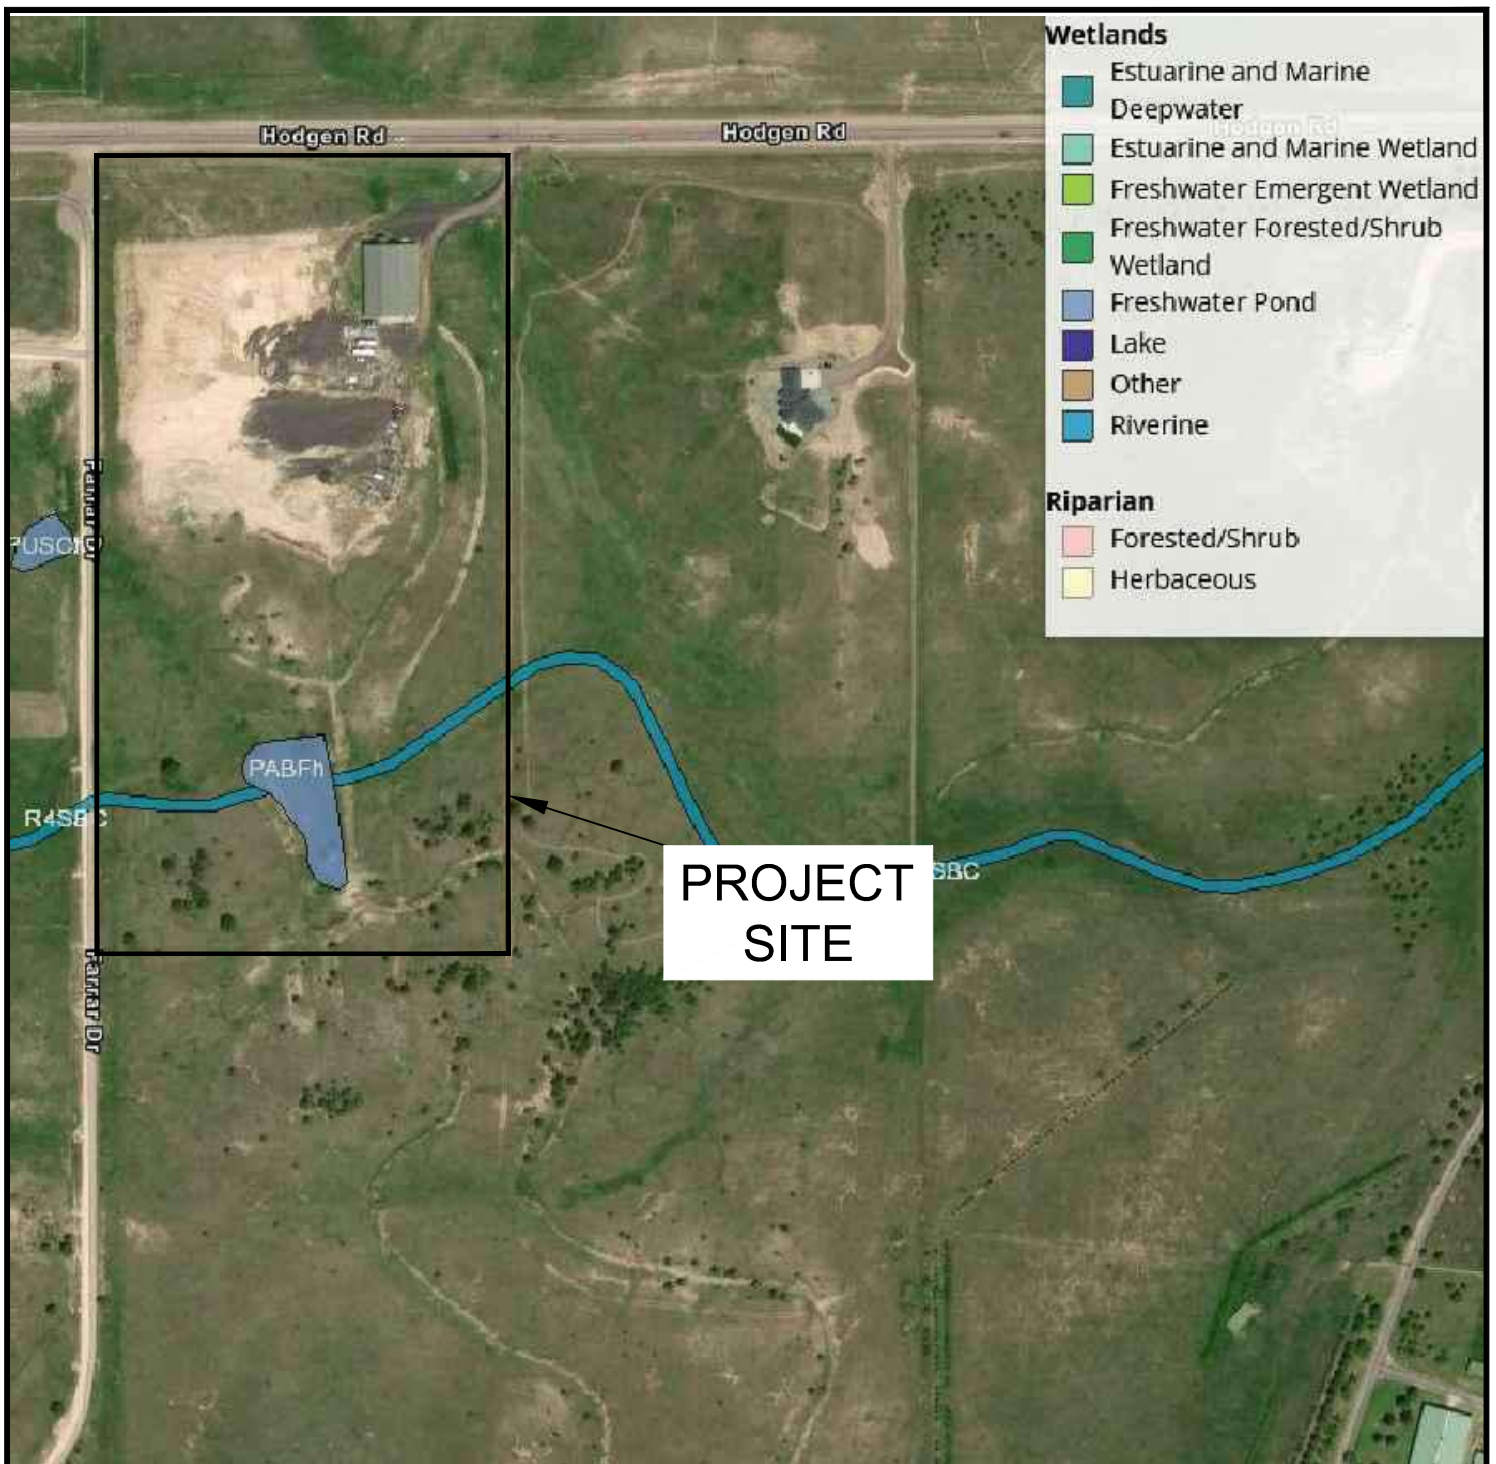
**FIG. 8**

## USFWS WETLANDS MAP

Portions of the drainages and pond in the southern portion of the site have been included in the National Wetland Inventory as Freshwater Emergent Wetland habitats classified as **PABFh** (Palustrine – P, Aquatic Bed – AB, Semi Permanently Flooded – F, Diked/Impounded – h), and **R4SBC** (Riverine – R, Intermittent – 4, Stream Bed – SB, Seasonally Flooded – C) (Figure 8, Reference 9). These areas will impact the proposed construction of access for Lots 3, 4, and 7 and are further discussed below.

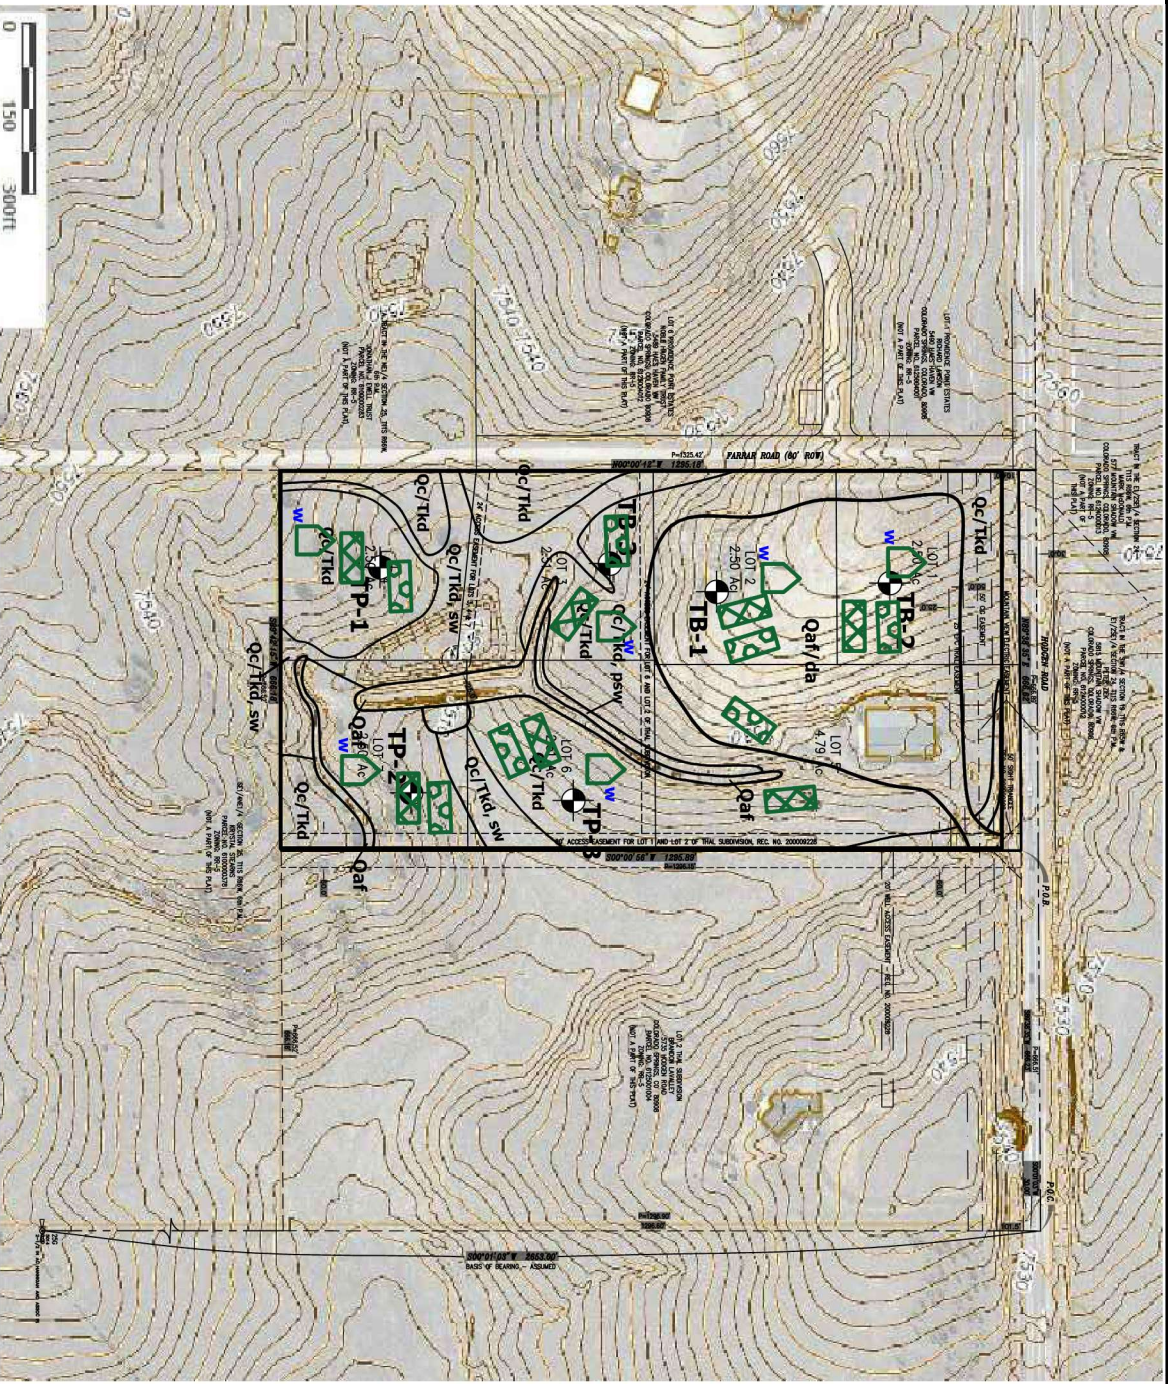
JOB NO.  
250183  
FIG. 9

- LEGEND:
- POSSIBLE OWTs LOCATIONS
  - POSSIBLE OWTs ALTERNATE LOCATION
  - WATER WELLS MUST BE A MINIMUM OF 100 FT FROM OWTs ABSORPTION FIELDS
  - POSSIBLE HOUSE LOCATIONS

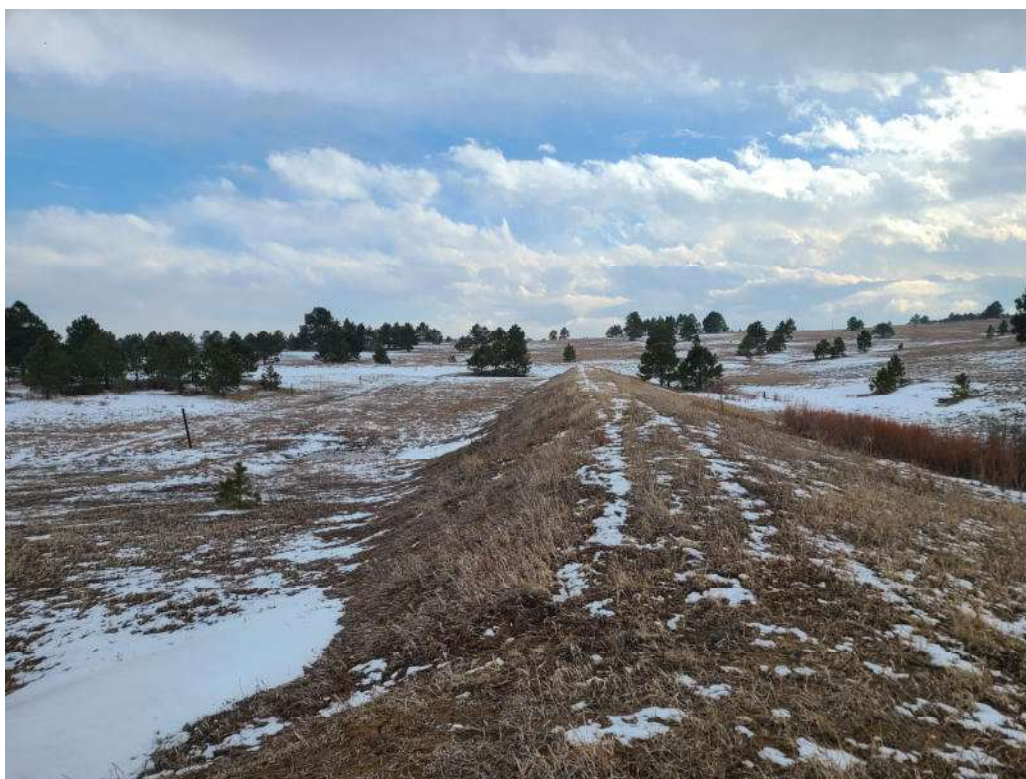
**Looking south from  
the northern side of  
the earthen dam.**

The topography of the site varies from gently to moderately sloping, generally to the east and southeast, along drainages in the northeastern and southern portions of the site. An earthen dam is located in the southern portion of the site and erosion control berms are in the eastern and southern portions of the site. The drainages on site generally flow in southeasterly, and easterly directions across the site. Water was not observed flowing in the drainages at the time of this investigation; however, an area of ponded water was observed on the eastern side earthen dam. Additionally, saturated conditions and minor amounts of water were observed in the minor drainage swales and along the uphill side of the erosion berms. The site boundaries are indicated on the USGS Map (Figure 2). Previous land uses have included rural residential, storage and material stockpiling, and grazing and pastureland. The site primarily contains field grasses, weeds, cacti, and with areas of ponderosa pines in the southern portion of the site. Site photographs taken February 17, 2025 are included in Appendix A.

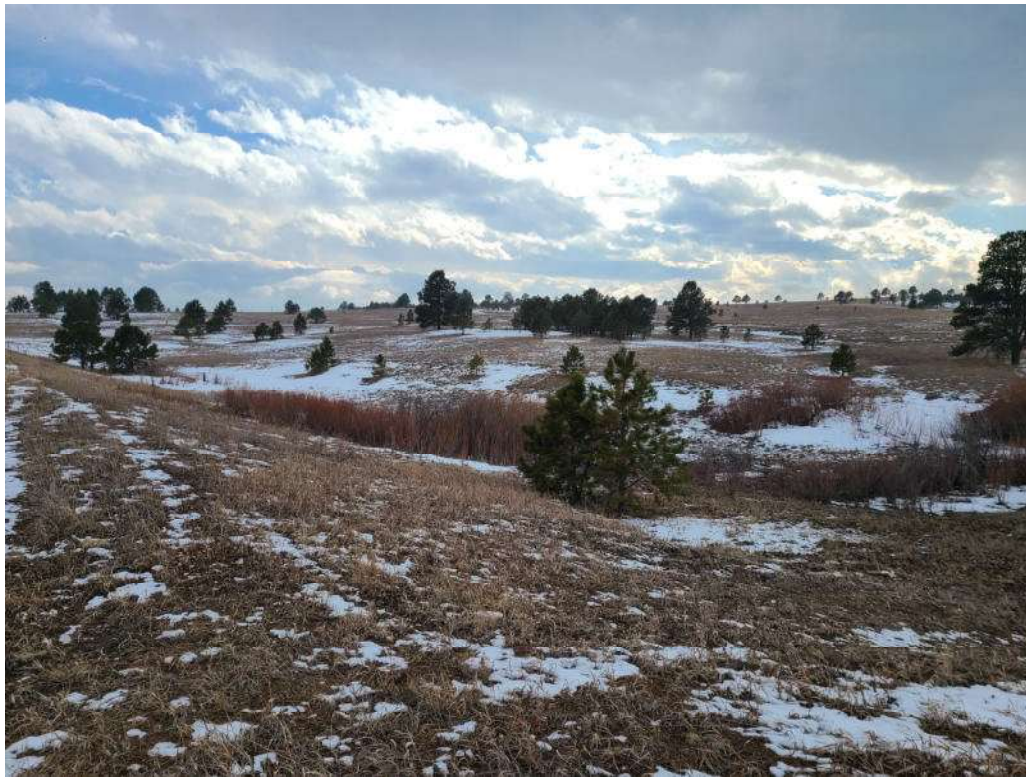
**Looking southwest  
from the northern side  
of the earthen dam.**

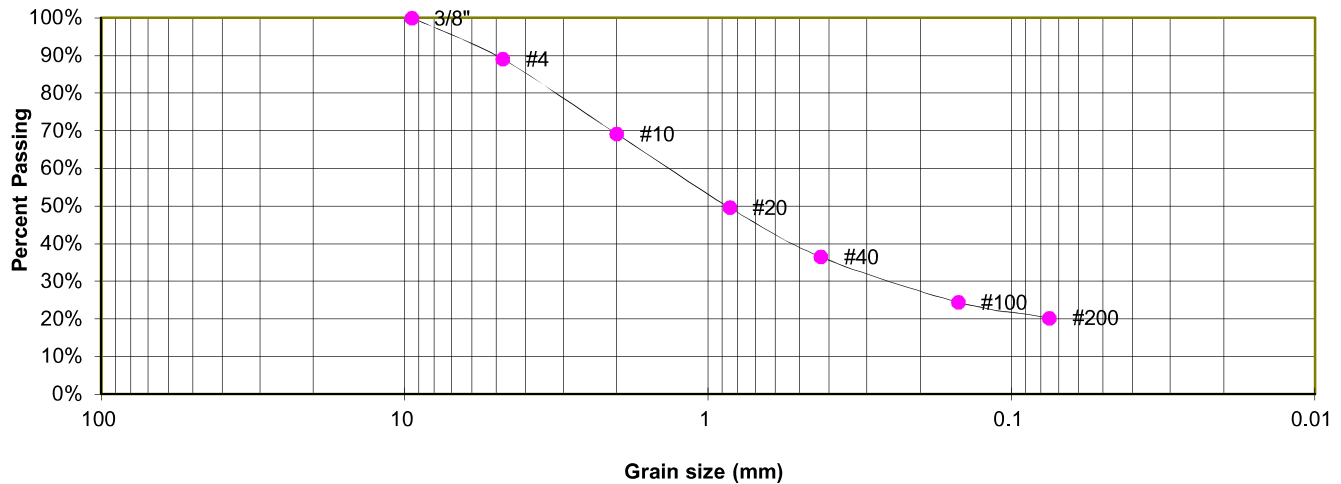
SOIL DESCRIPTION FILL, SAND, SILTY  
SOIL TYPE 1

### Sieve Analysis Grain Size Distribution

Laboratory testing was performed to classify and determine the engineering characteristics of the soils. Laboratory tests included moisture content testing (ASTM D2216), grain-size analysis (ASTM D422), and Atterberg Limits testing (ASTM D4318). Swell testing included both FHA Swell Tests and Swell/Consolidation Tests. Results of the laboratory testing are included in Appendix C.

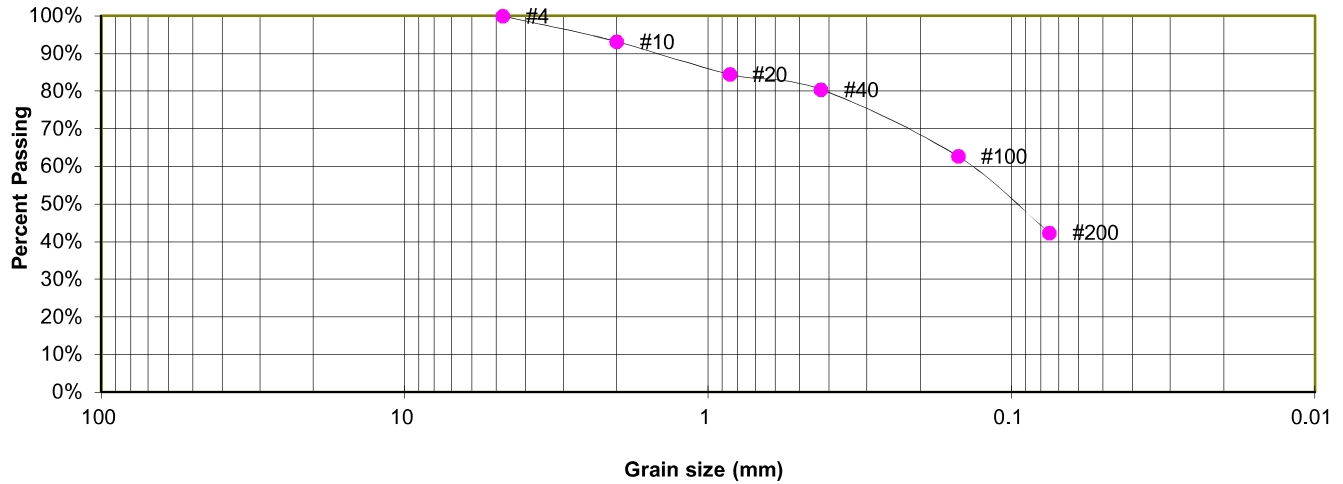
SOIL DESCRIPTION SAND, SILTY  
SOIL TYPE 2

**Sieve Analysis  
Grain Size Distribution**

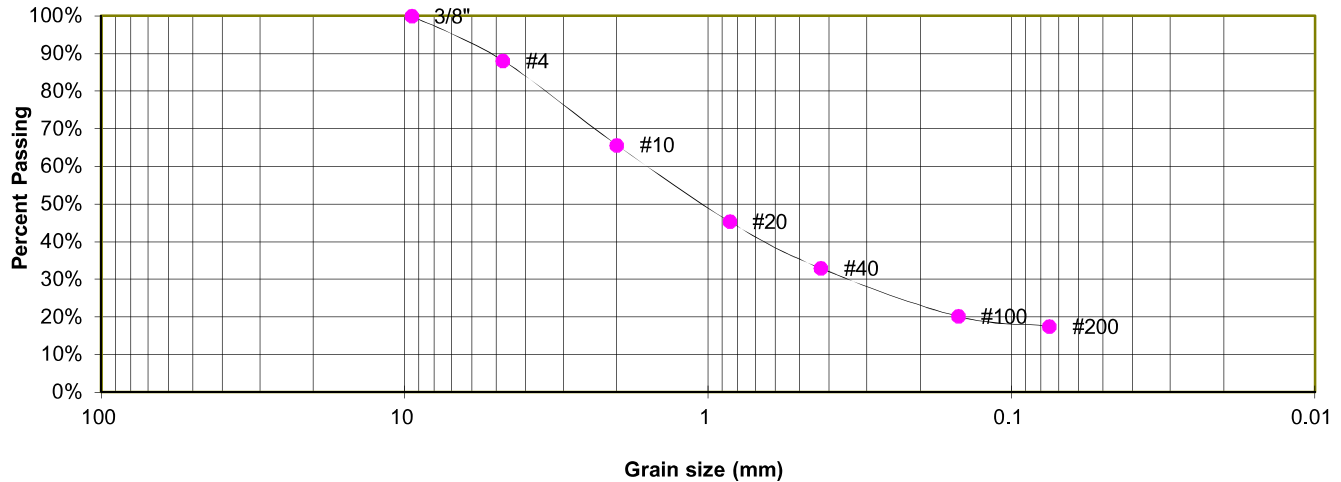
| SOIL TYPE 2 |

### Sieve Analysis Grain Size Distribution

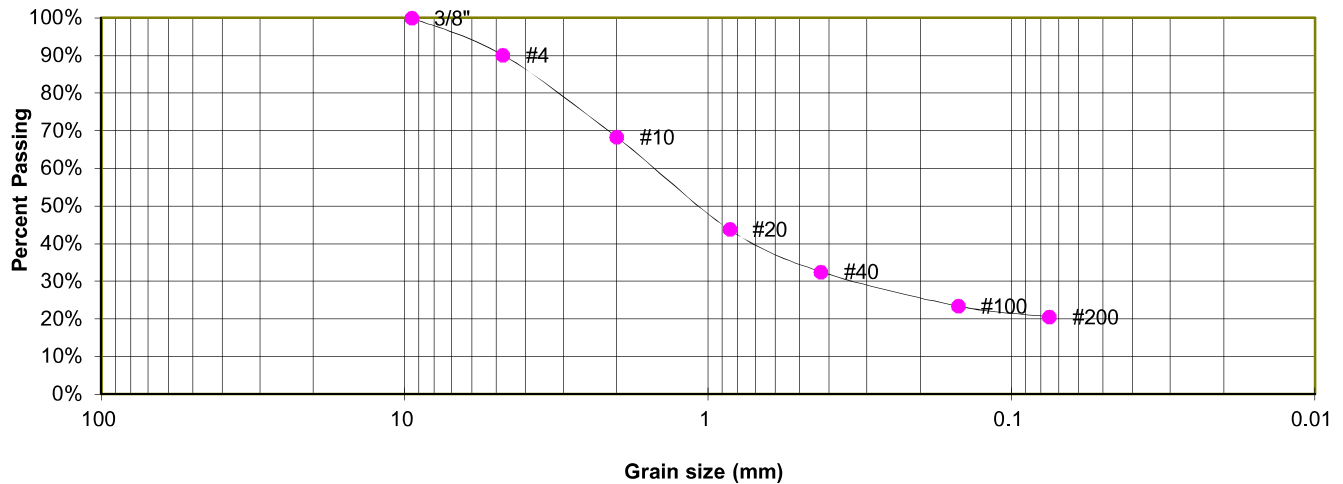
SOIL DESCRIPTION SANDSTONE (SAND, SILTY)  
SOIL TYPE 3

**Sieve Analysis  
Grain Size Distribution**

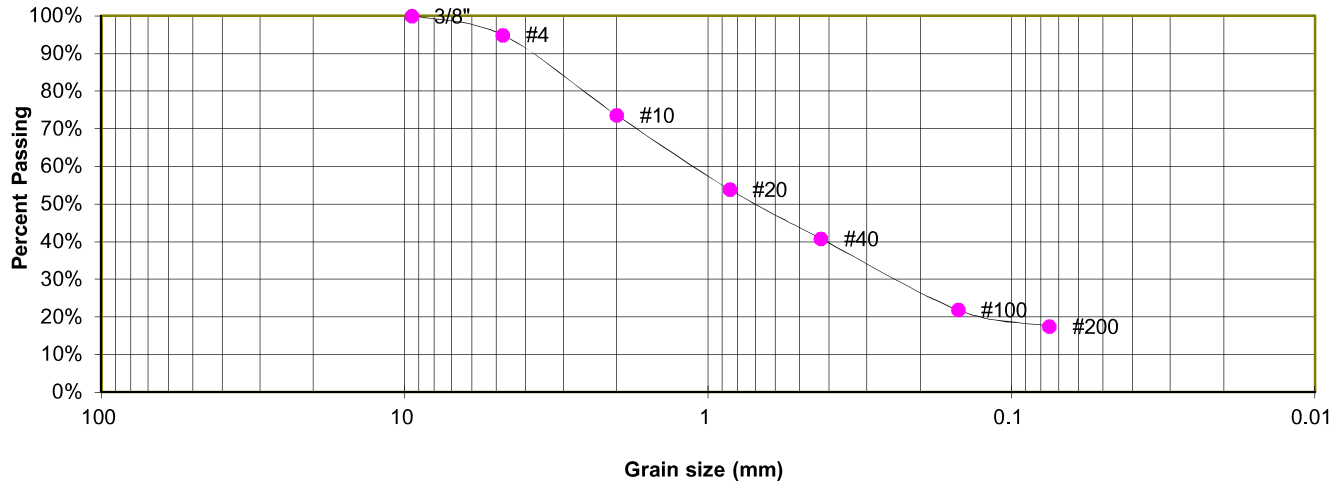
SOIL DESCRIPTION SANDSTONE (SAND, SILTY)  
SOIL TYPE 3

### Sieve Analysis Grain Size Distribution

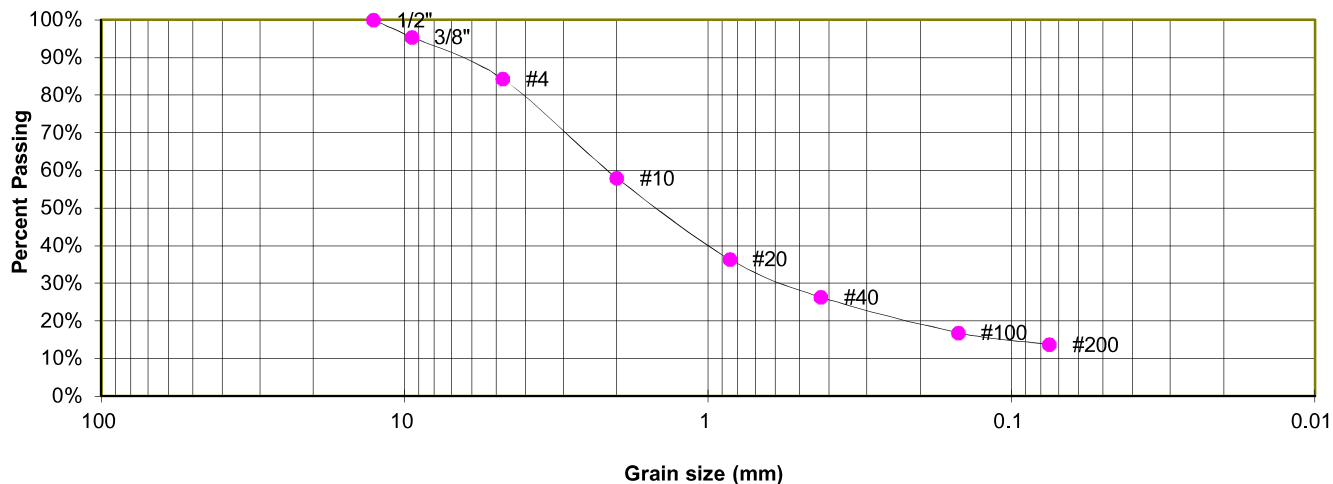
SOIL DESCRIPTION SAND, SILTY  
USDA SOIL TYPE # R-1

**Sieve Analysis  
Grain Size Distribution**

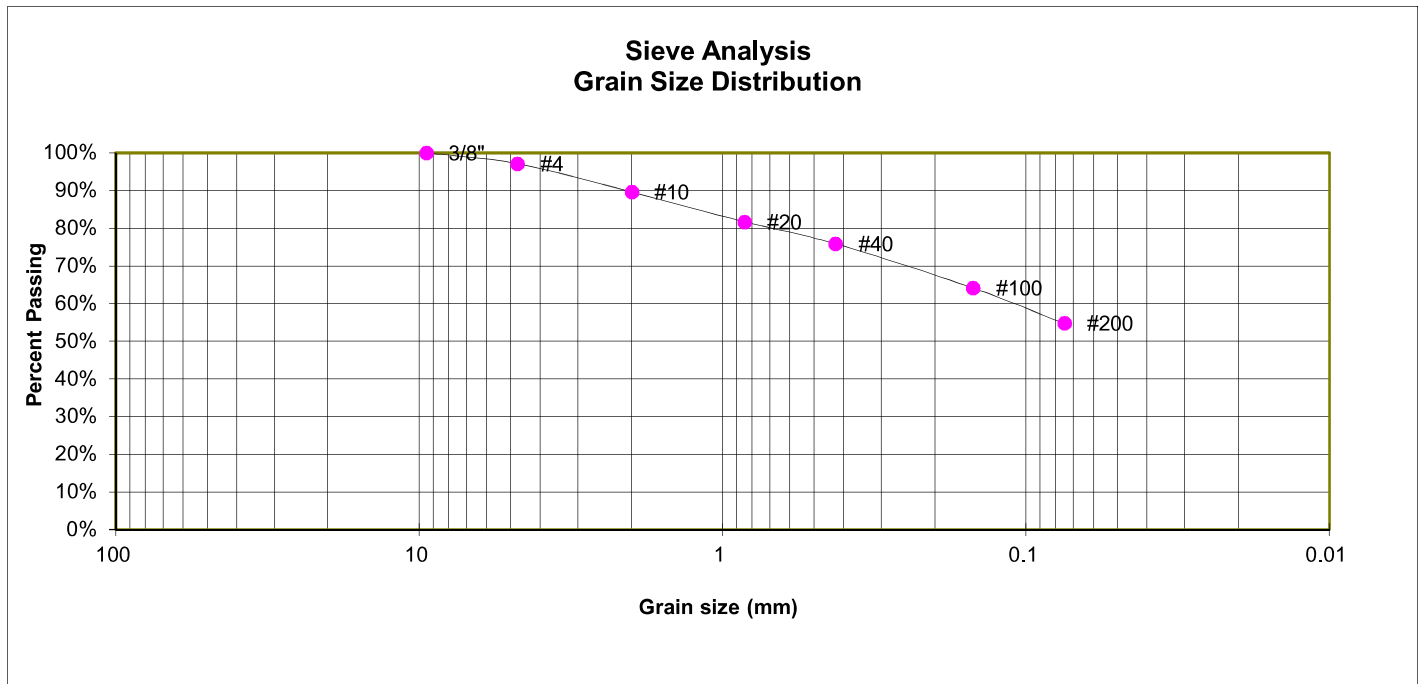
| TEST PIT | TP-2 | SOIL DESCRIPTION | CLAY, SANDY |
| DEPTH (FT) | 2.5 | USDA SOIL TYPE # | 4 |

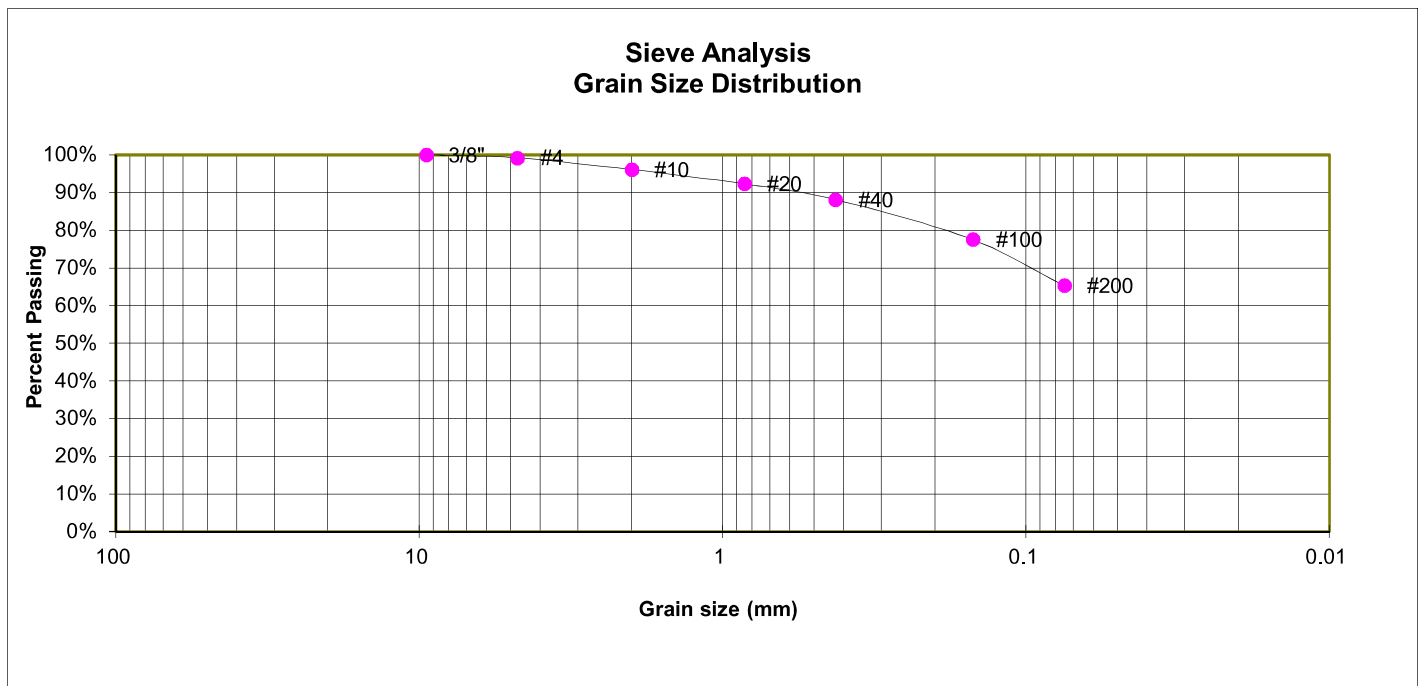
| TEST PIT | TP-3 | SOIL DESCRIPTION | CLAY, SANDY |
| DEPTH (FT) | 6.5 | USDA SOIL TYPE # | 4 |
