# Wastewater Evaluation Report

**Proposed Grandwood Subdivision  
NE of Higby Road and Fairplay Drive**

**El Paso County, Colorado**

**VIVID Project No.: D18-2-175**

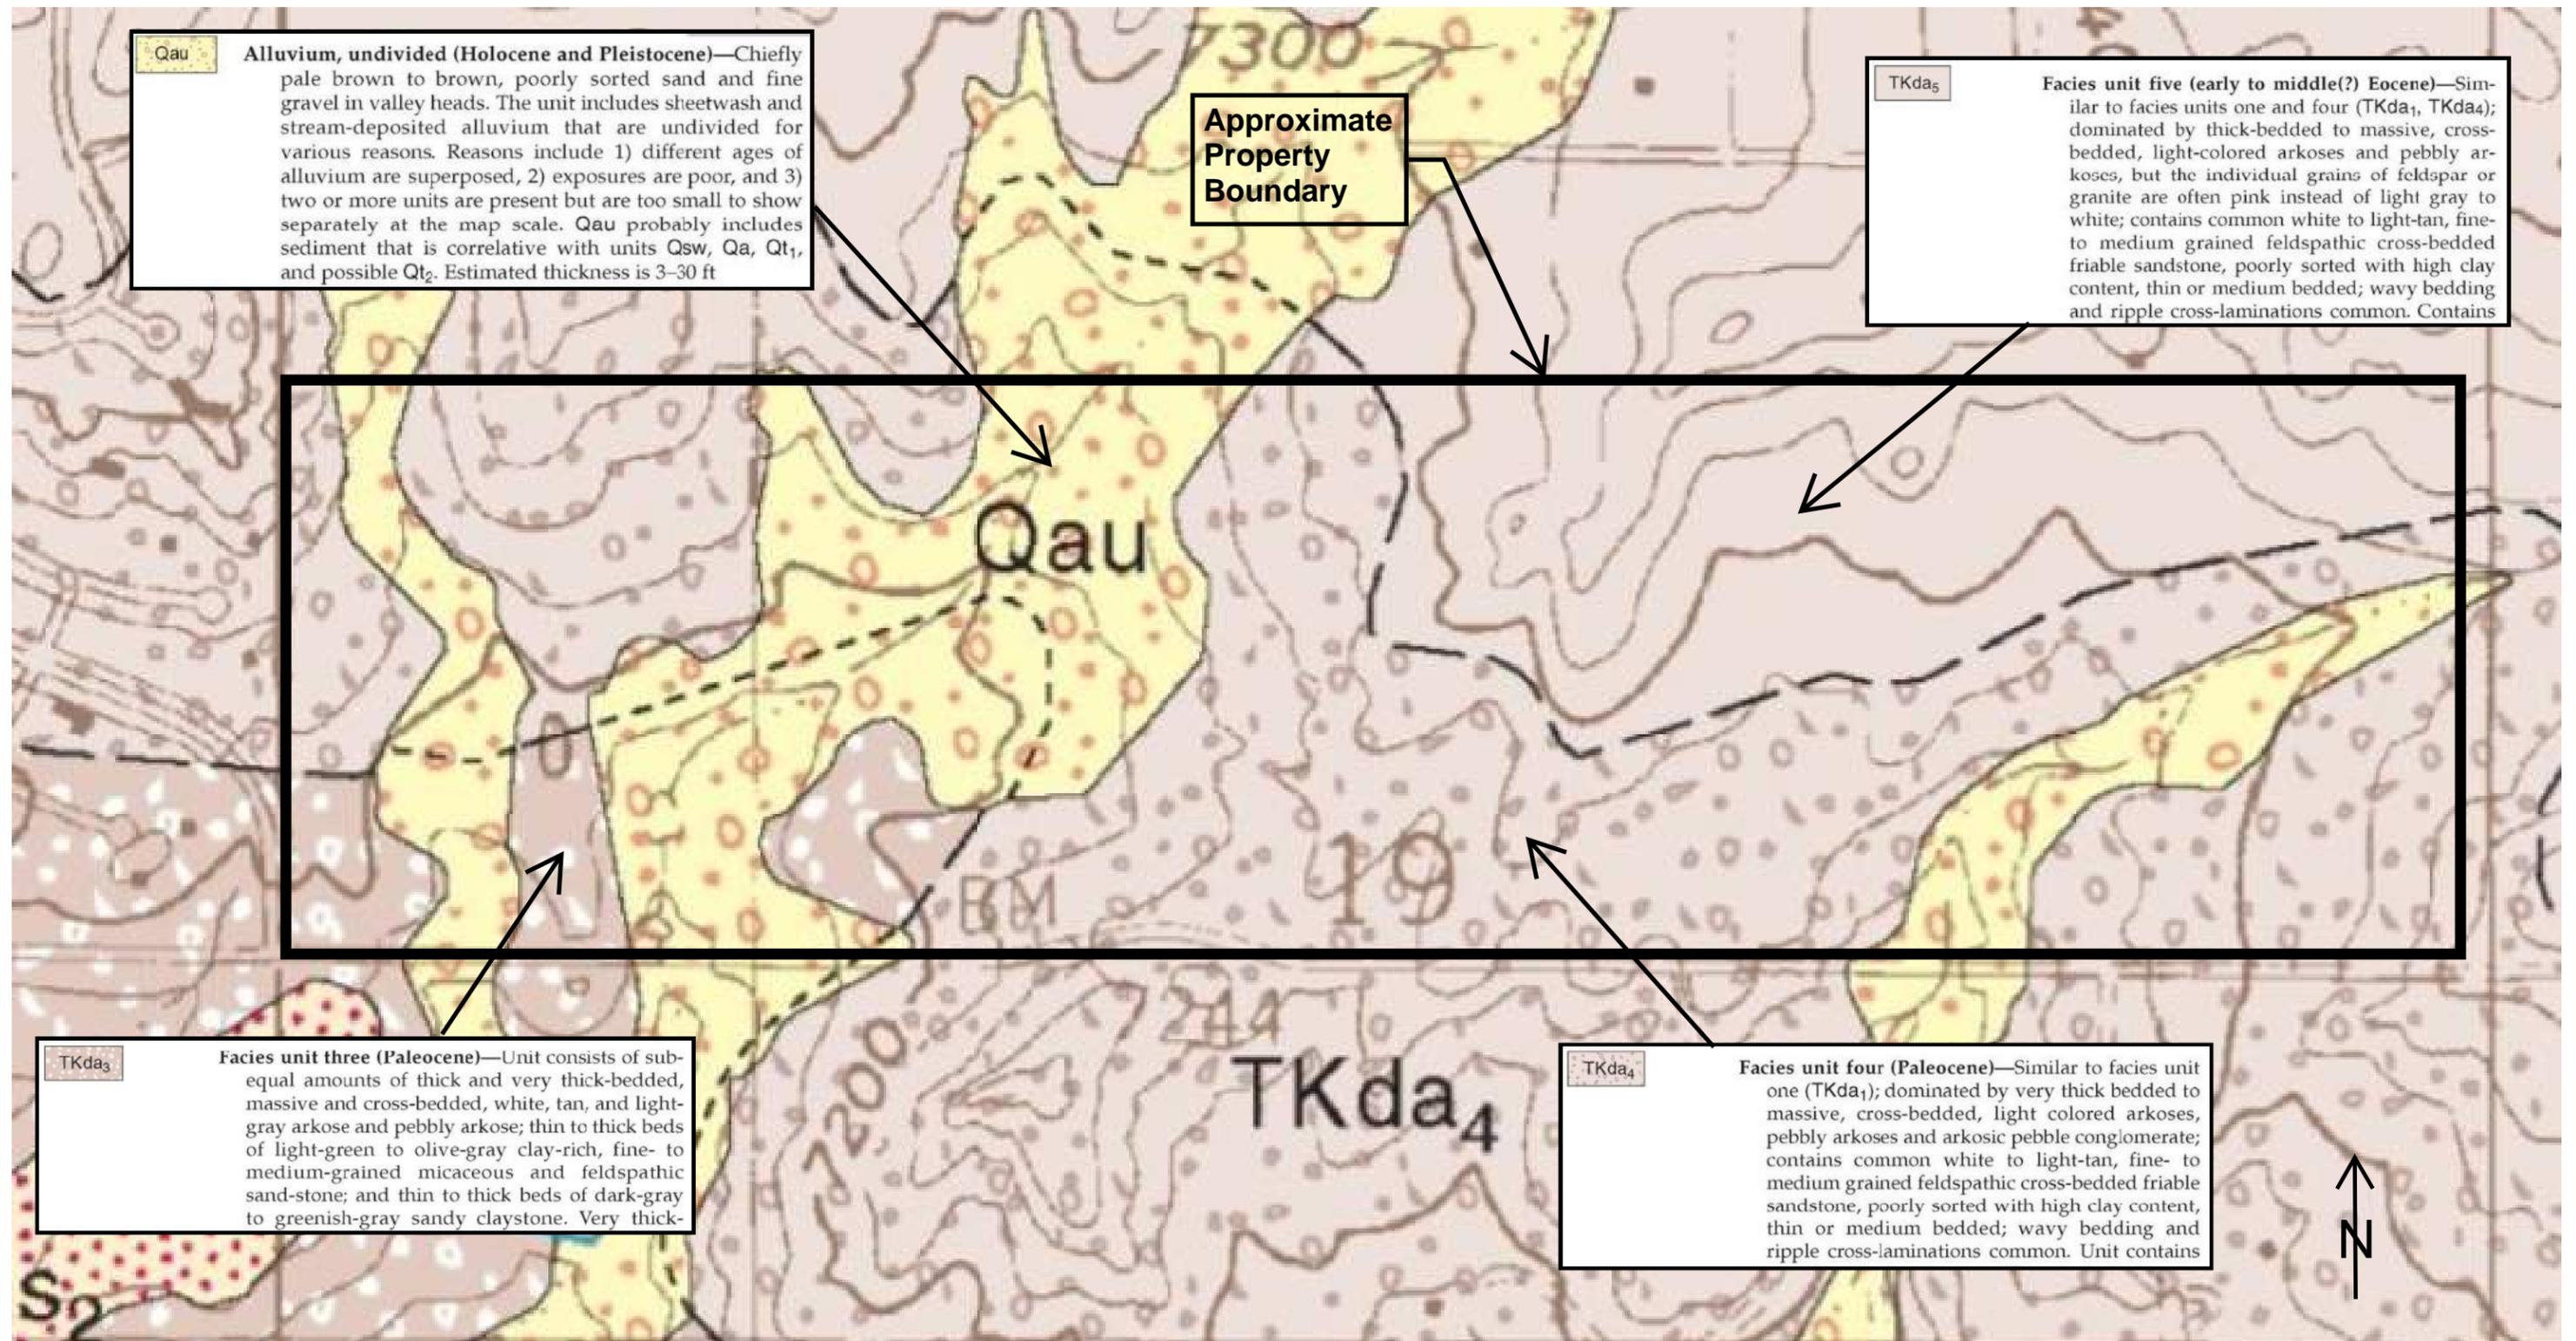
Not to Scale. Base image from [https://ngmdb.usgs.gov/Prodesc/proddesc\\_76327.htm](https://ngmdb.usgs.gov/Prodesc/proddesc_76327.htm) (Geologic Map of the Monument Quadrangle, El Paso County, Colorado, 2003)

The locations evaluated as part of this study generally found soils and percolation rates that are favorable for conventional septic system construction. Geologic mapping as presented on Figures 3a and 3b indicate that shallower bedrock of the Dawson Formation (see areas of Tkd4 on Figure 3a) will be encountered at various locations that were outside accessible limits of this evaluation. These areas are anticipated to have higher occurrences of shallow bedrock and lower percolation rates that would require engineered systems.

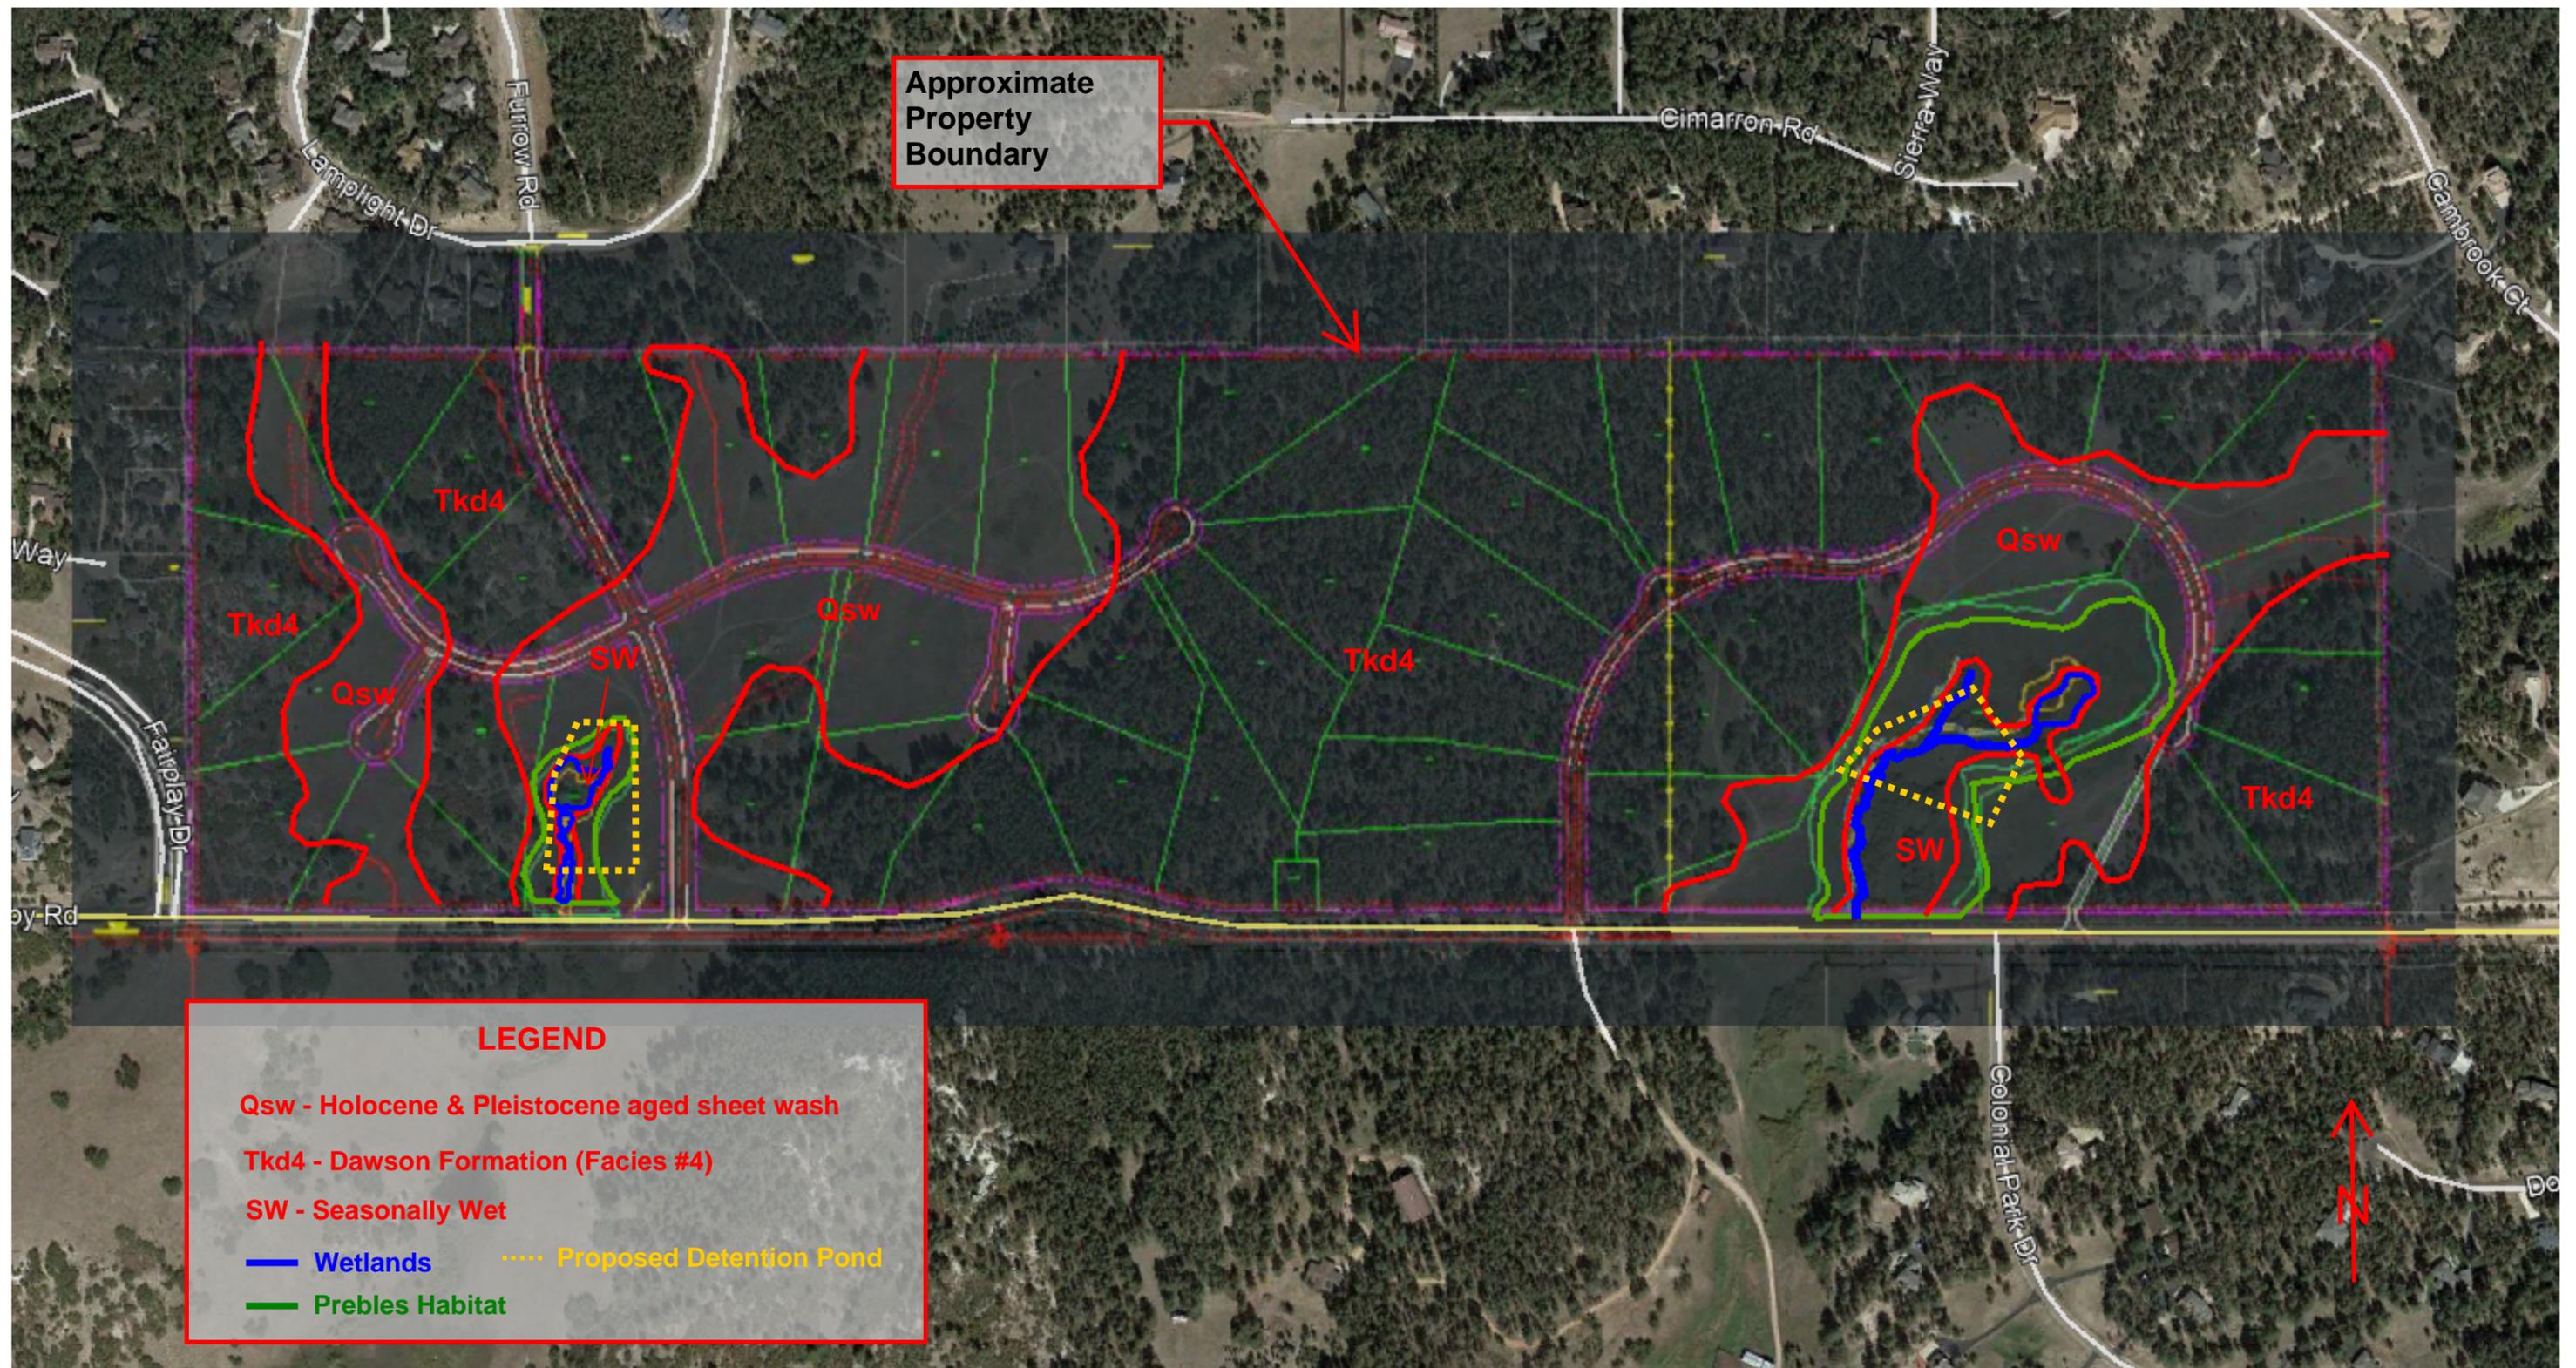
Figure  
**3b**

Not to Scale. Base image dated 06/09/2017 and obtained from Google Earth, 2019.  
 Site-specific Geology Mapping by Jim Frohbieter, Professional Geologist

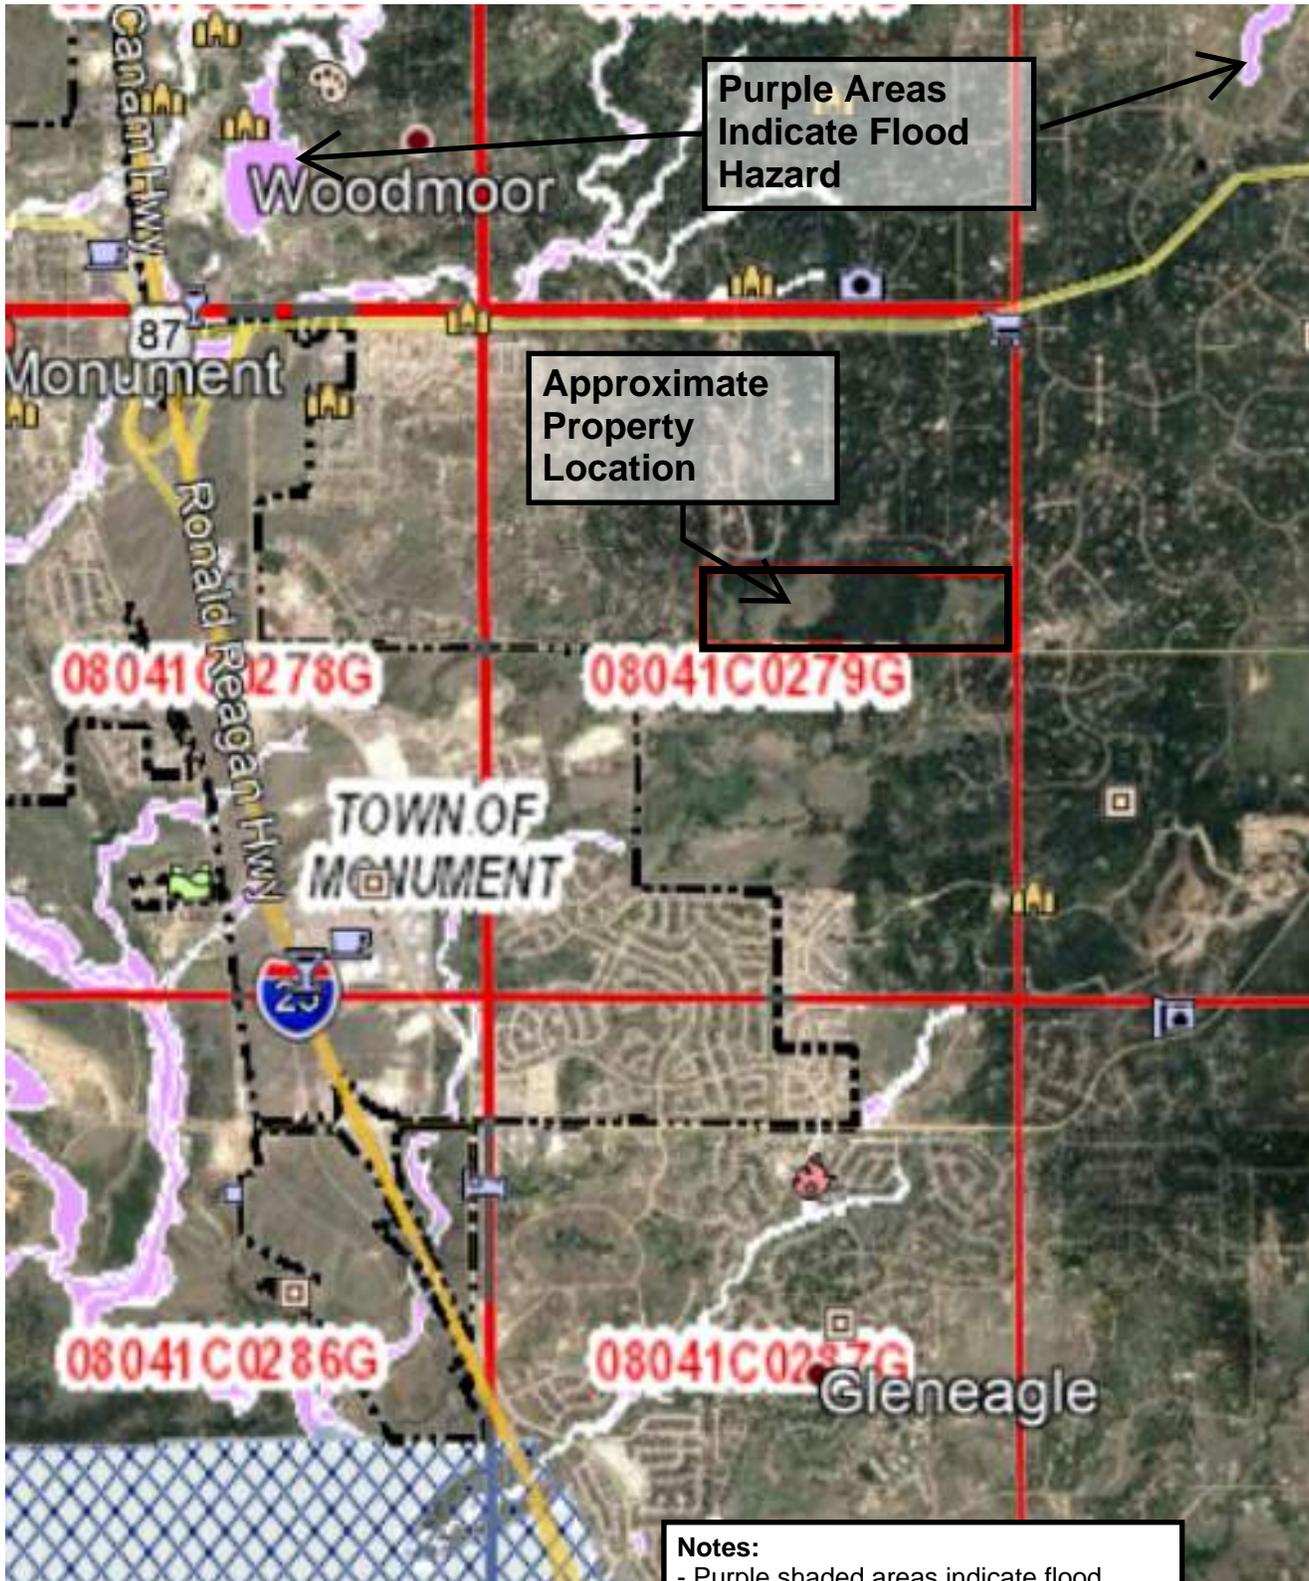
Figure  
**6**

**Notes:**  
 - Purple shaded areas indicate flood hazard risk  
 - Site has no mapped flood hazards

<b>FLOOD HAZARD MAP</b>
Grandwood Subdivision El Paso County, Colorado

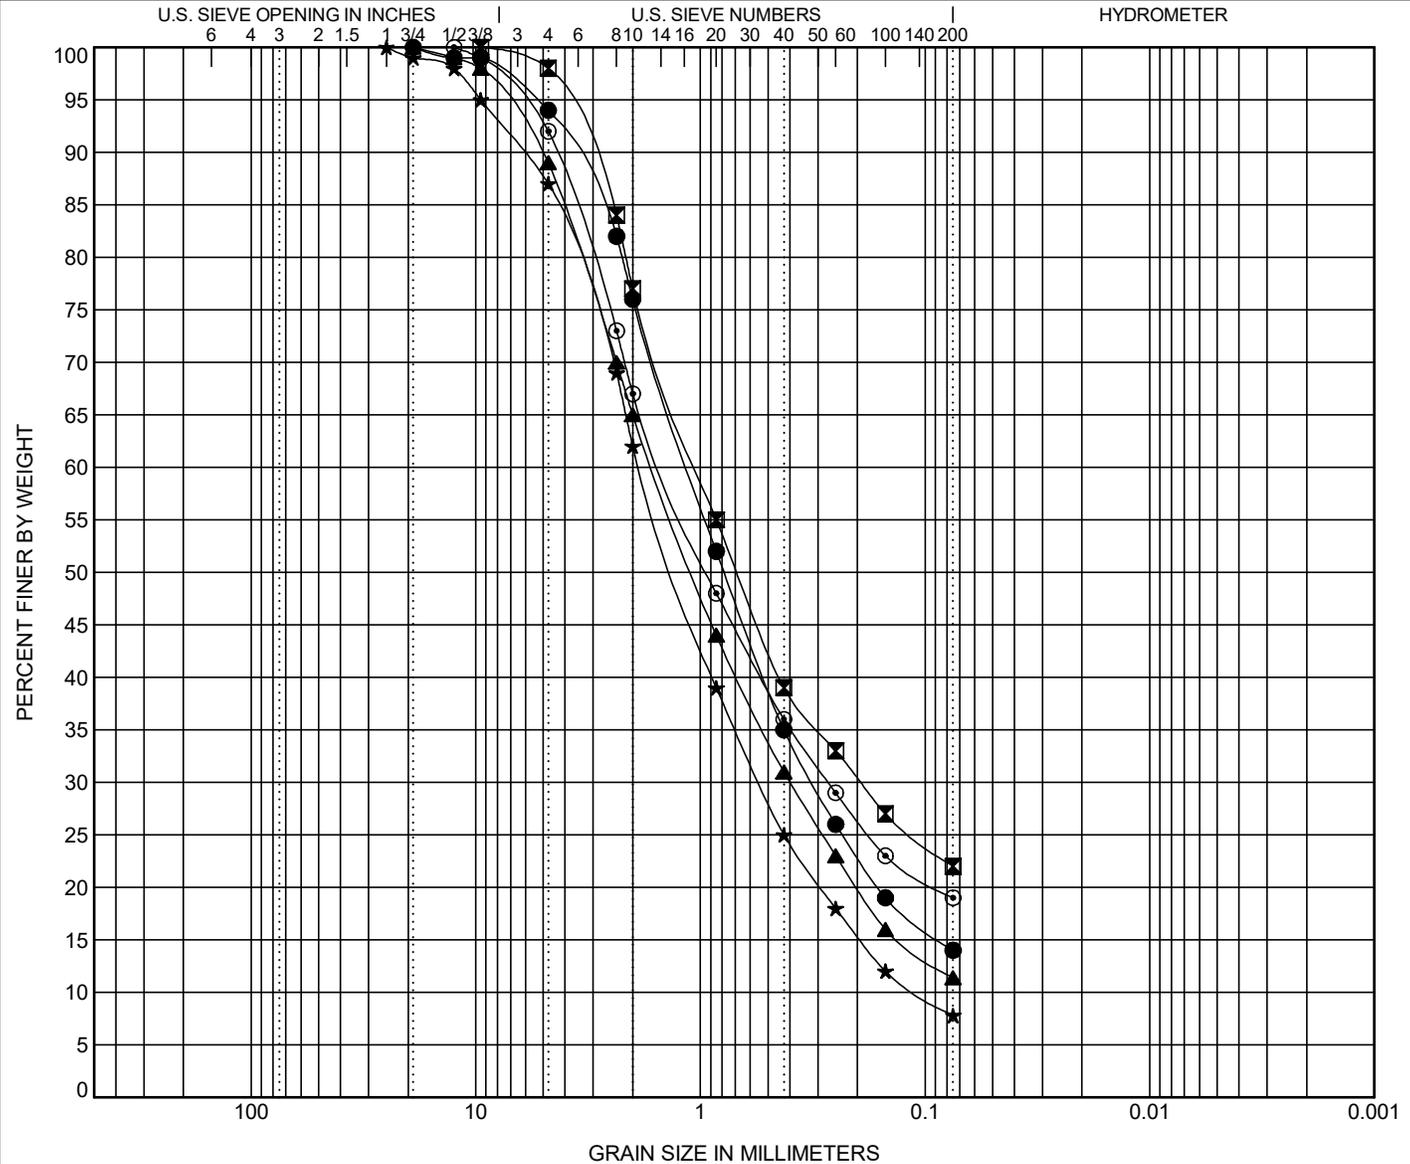
BOREHOLE	DEPTH	Classification	LL	PL	PI	Cc	Cu
● B-1	9.0	SILTY SAND(SM)	NP	NP	NP		
☒ B-2	9.0	CLAYEY SAND(SC)	43	26	17		
▲ B-3	4.0	WELL-GRADED SAND with SILT(SW-SM)	NP	NP	NP	1.60	26.86
★ B-3	14.0	WELL-GRADED SAND with SILT(SW-SM)	NP	NP	NP	1.48	17.22
◎ B-4	2.0	SILTY SAND(SM)	NP	NP	NP

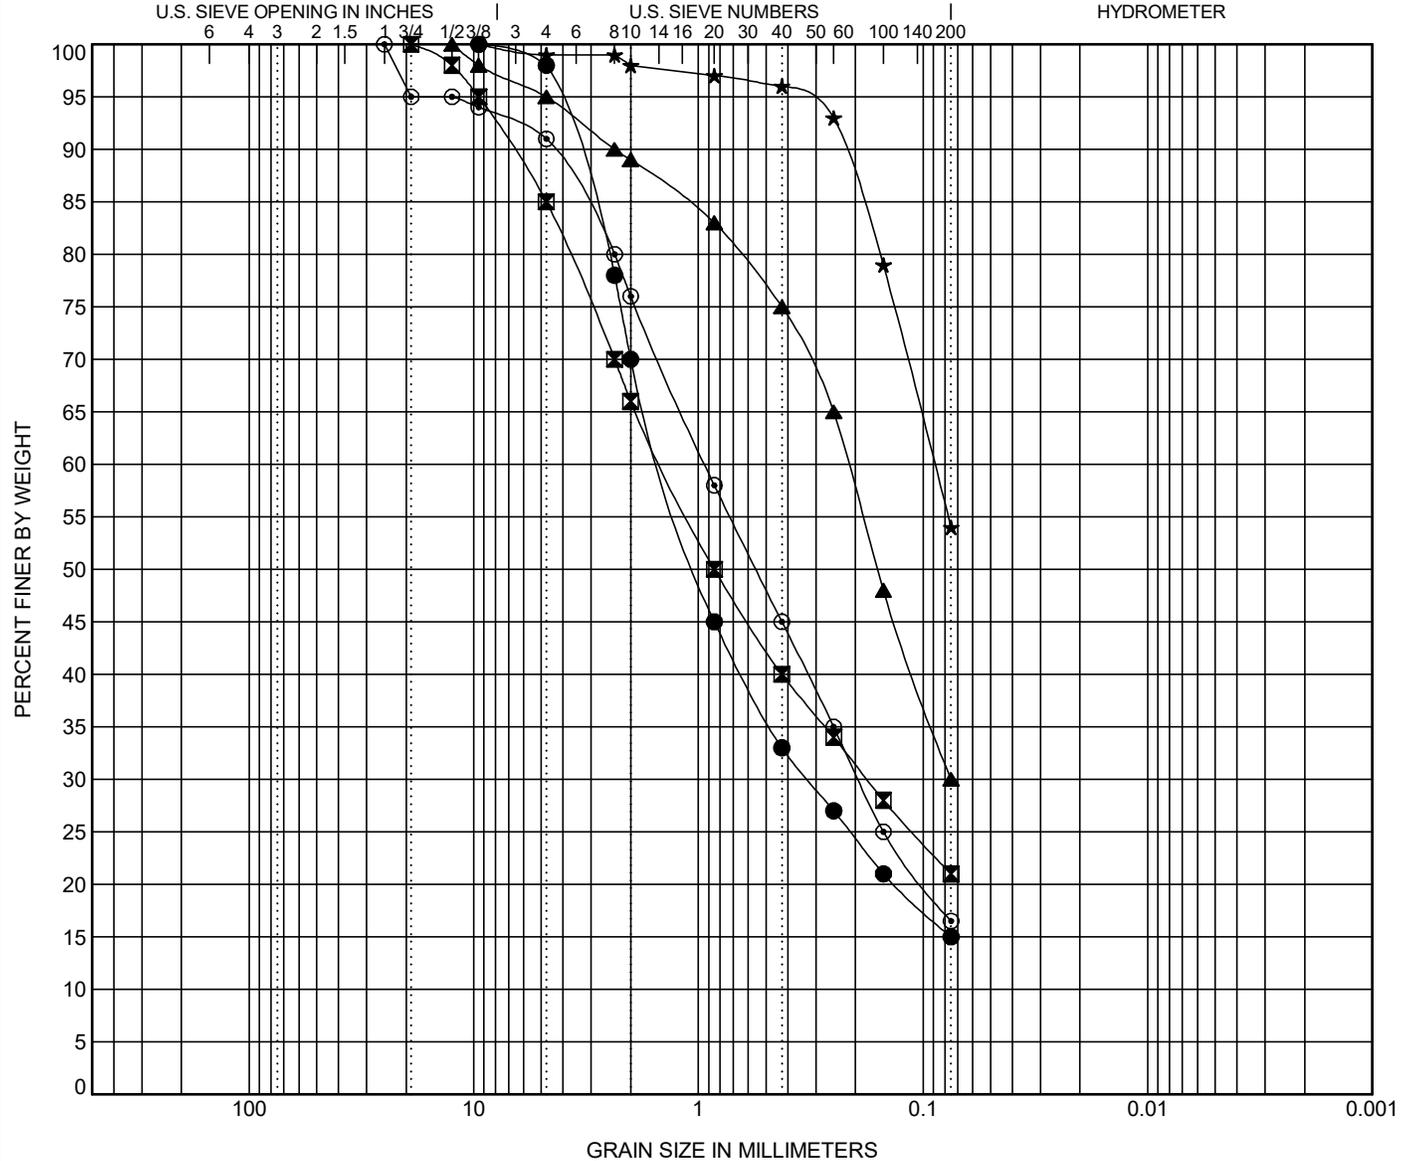
BOREHOLE	DEPTH	Classification	LL	PL	PI	Cc	Cu
● B-4	14.0	SILTY SAND(SM)	NP	NP	NP		
■ B-6	9.0	SILTY, CLAYEY SAND with GRAVEL(SC-SM)	25	19	6		
▲ B-7	4.0	SILTY SAND(SM)	NP	NP	NP		
★ B-7	14.0	SANDY SILT(ML)	33	24	9		
○ TP-1	2.0	SILTY SAND(SM)	NP	NP	NP

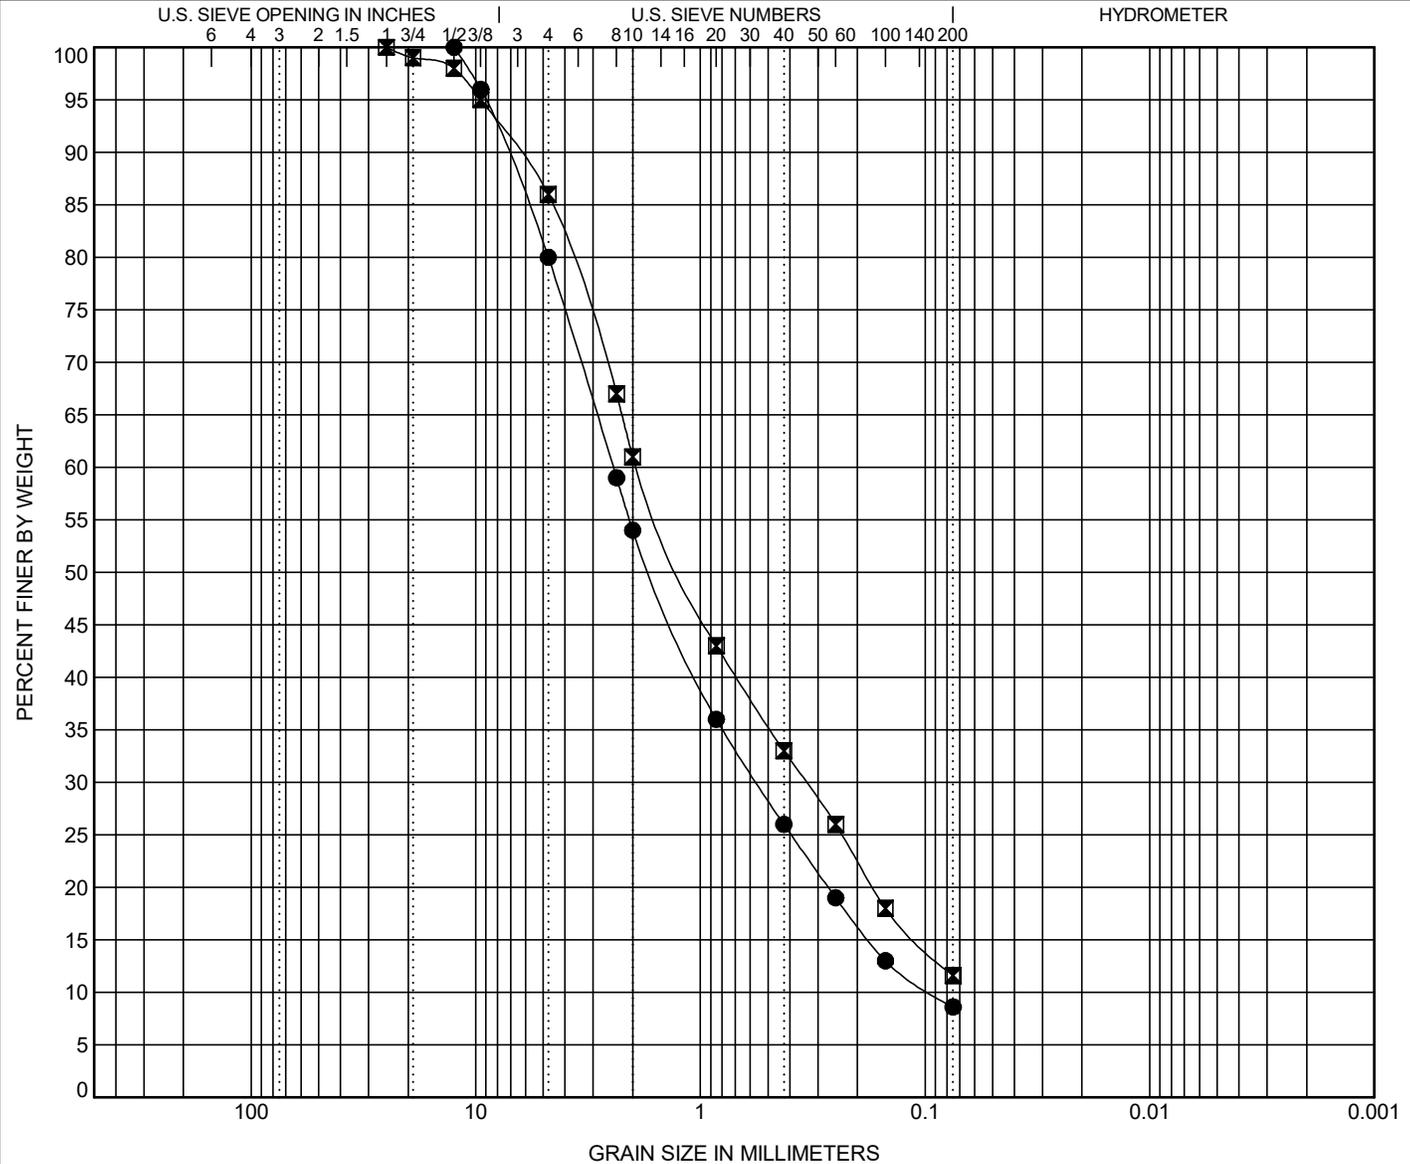
BOREHOLE	DEPTH	Classification	LL	PL	PI	Cc	Cu
● TP-2	3.0	<b>WELL-GRADED SAND with SILT and GRAVEL(SW-SM)</b>	NP	NP	NP	1.38	26.09
☒ TP-3	4.0	<b>POORLY GRADED SAND with SILT(SP-SM)</b>	NP	NP	NP	0.95	30.24
