# Wastewater Evaluation Report

**Proposed Grandwood Subdivision  
NE of Higby Road and Fairplay Drive**

**El Paso County, Colorado**

**VIVID Project No.: D18-2-175**

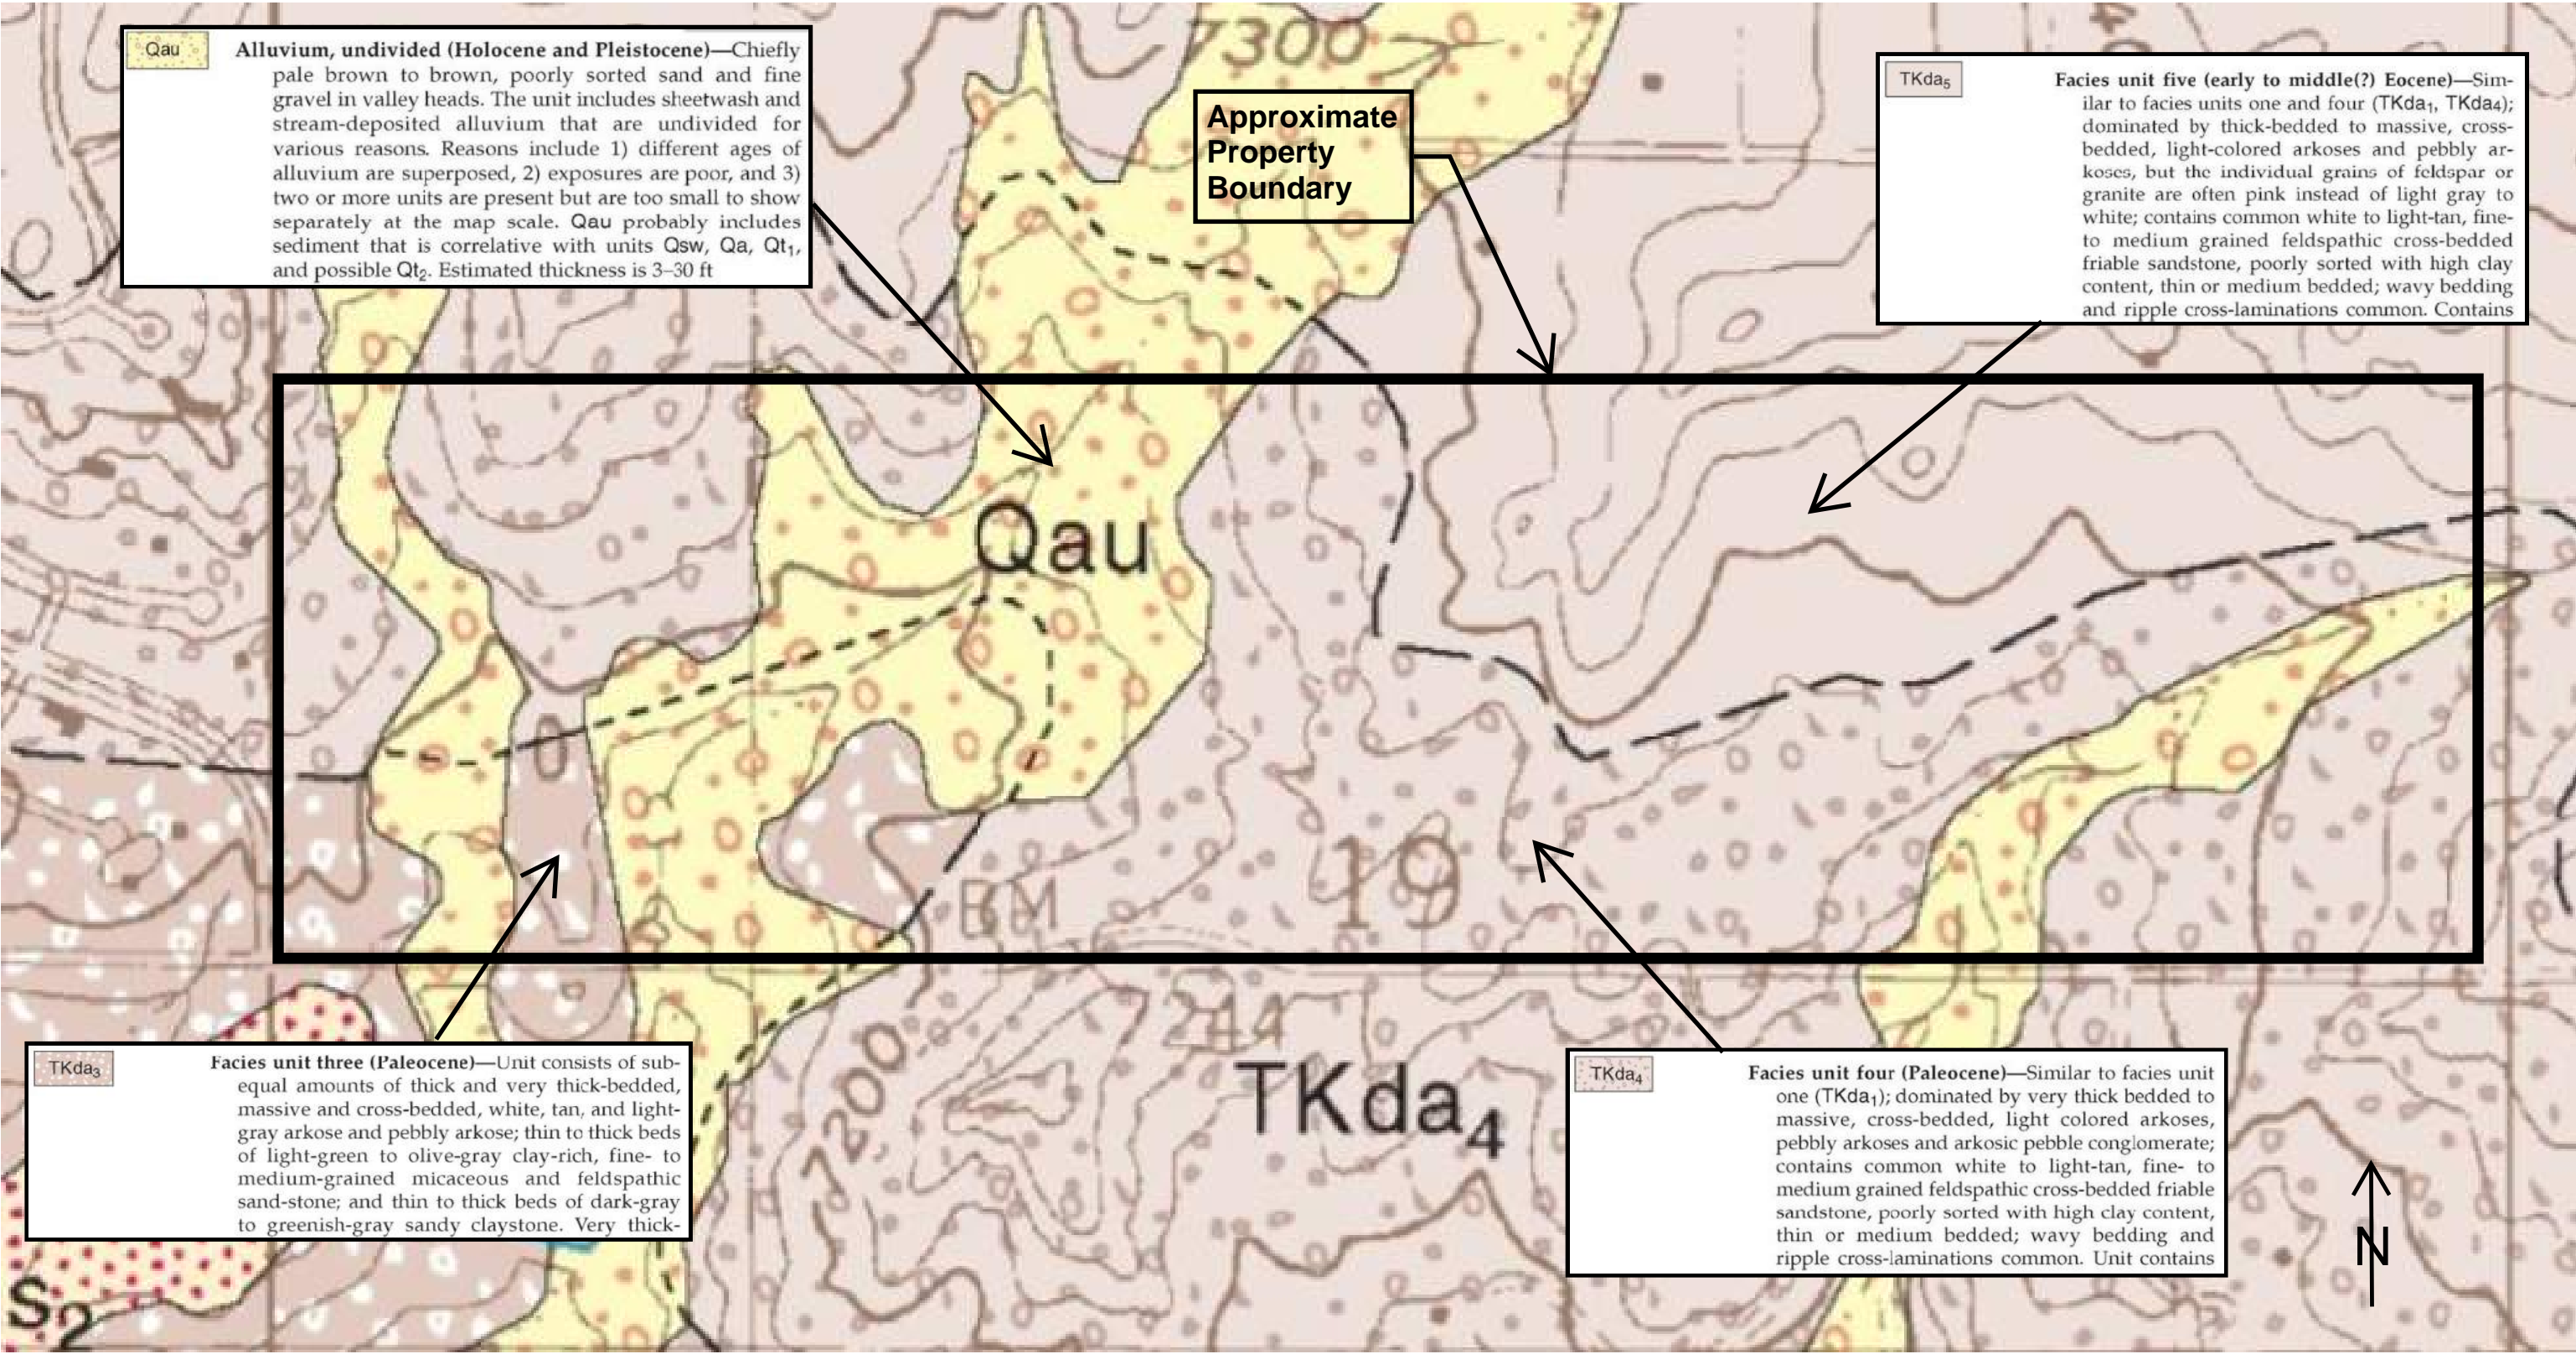
<div>VIVID Engineering Group, Inc. 1053 Elktion Drive Colorado Springs, Colorado 80907 719.896.4356</div>	Project No: D18-2-175	REGIONAL GEOLOGY MAP	Figure <b>3a</b>
	Date: 1/15/19		
	Drawn by: WJB	Grandwood Subdivision El Paso County, Colorado	
	Reviewed by: BTM

Not to Scale. Base image from [https://ngmdb.usgs.gov/Prodesc/proddesc\\_76327.htm](https://ngmdb.usgs.gov/Prodesc/proddesc_76327.htm) (Geologic Map of the Monument Quadrangle, El Paso County, Colorado, 2003)

The locations evaluated as part of this study generally found soils and percolation rates that are favorable for conventional septic system construction. Geologic mapping as presented on Figures 3a and 3b indicate that shallower bedrock of the Dawson Formation (see areas of Tkd4 on Figure 3a) will be encountered at various locations that were outside accessible limits of this evaluation. These areas are anticipated to have higher occurrences of shallow bedrock and lower percolation rates that would require engineered systems.

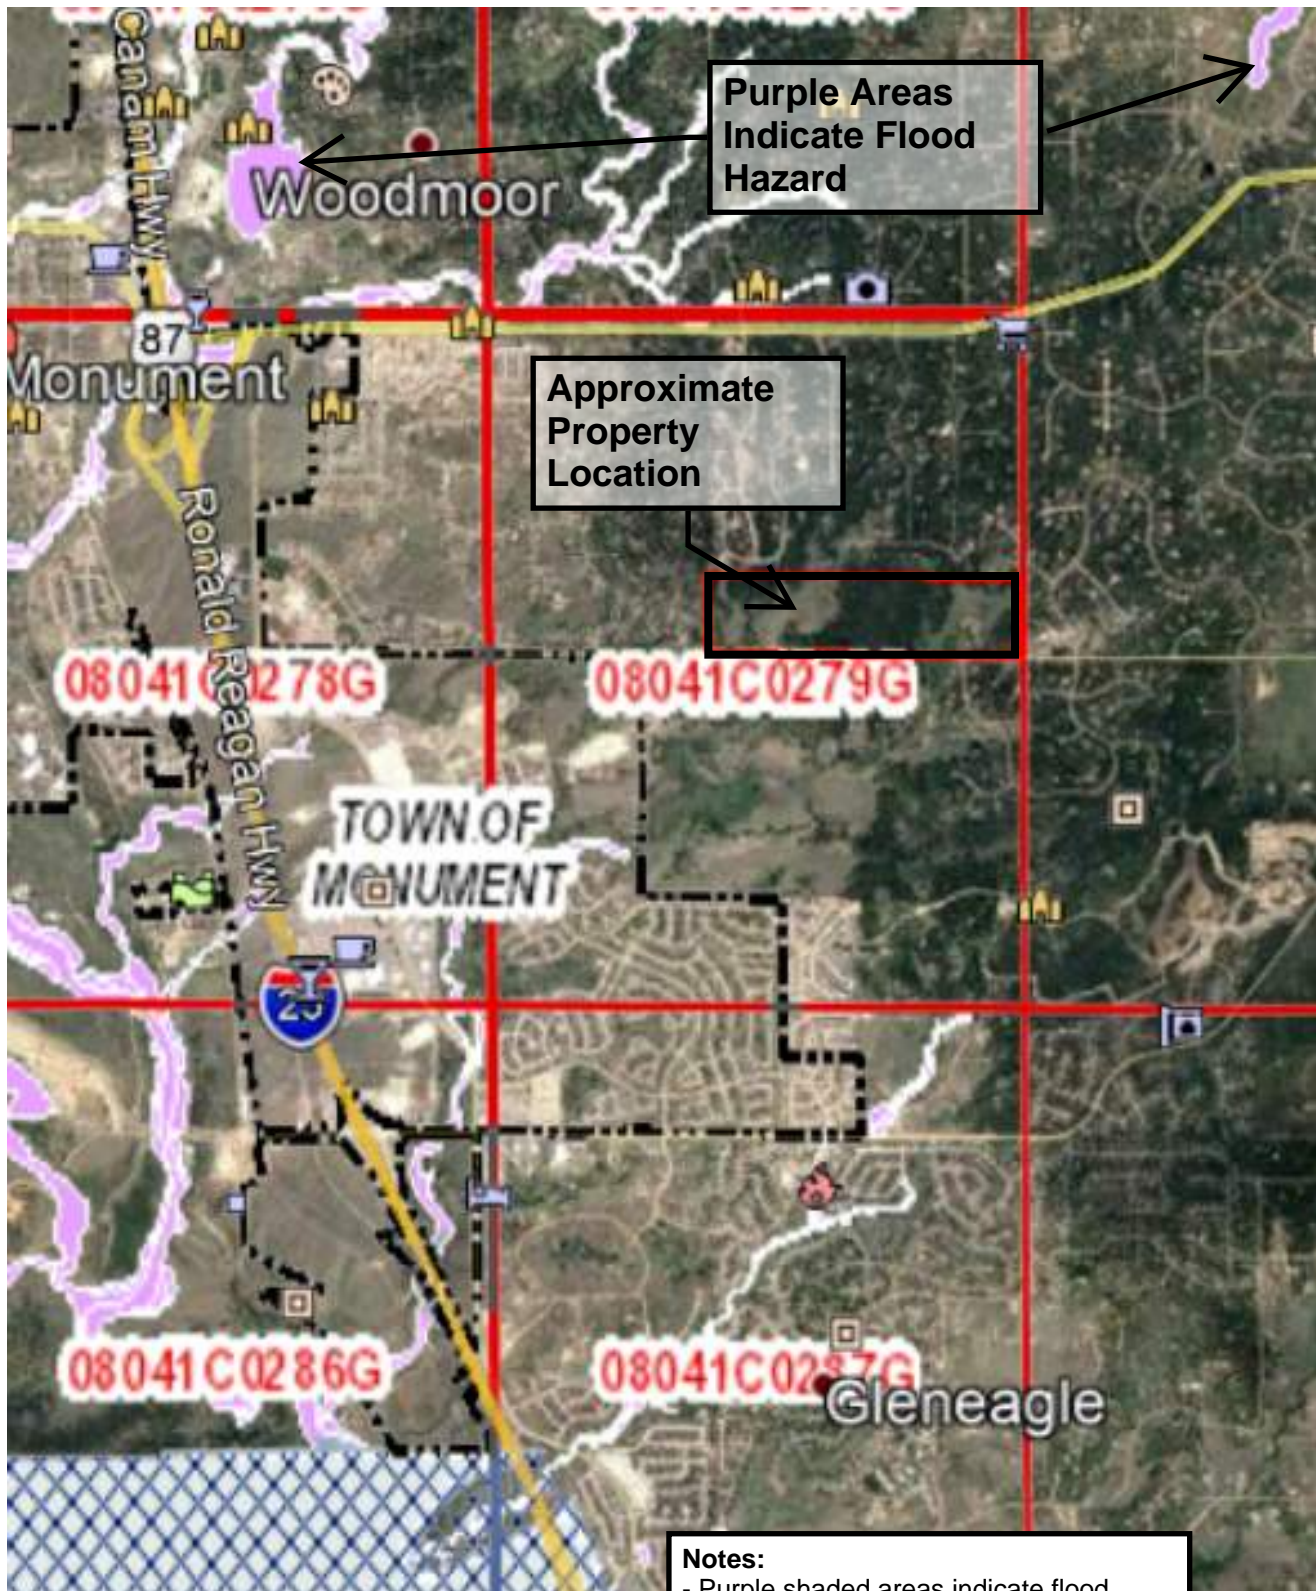
**FLOOD HAZARD MAP**

**Notes:**

- Purple shaded areas indicate flood hazard risk
- Site has no mapped flood hazards
