# Geology and Soils Evaluation Report

**Proposed Grandwood Subdivision  
NE of Higby Road and Fairplay Drive**

**El Paso County, Colorado**

**VIVID Project No.: D18-2-175**

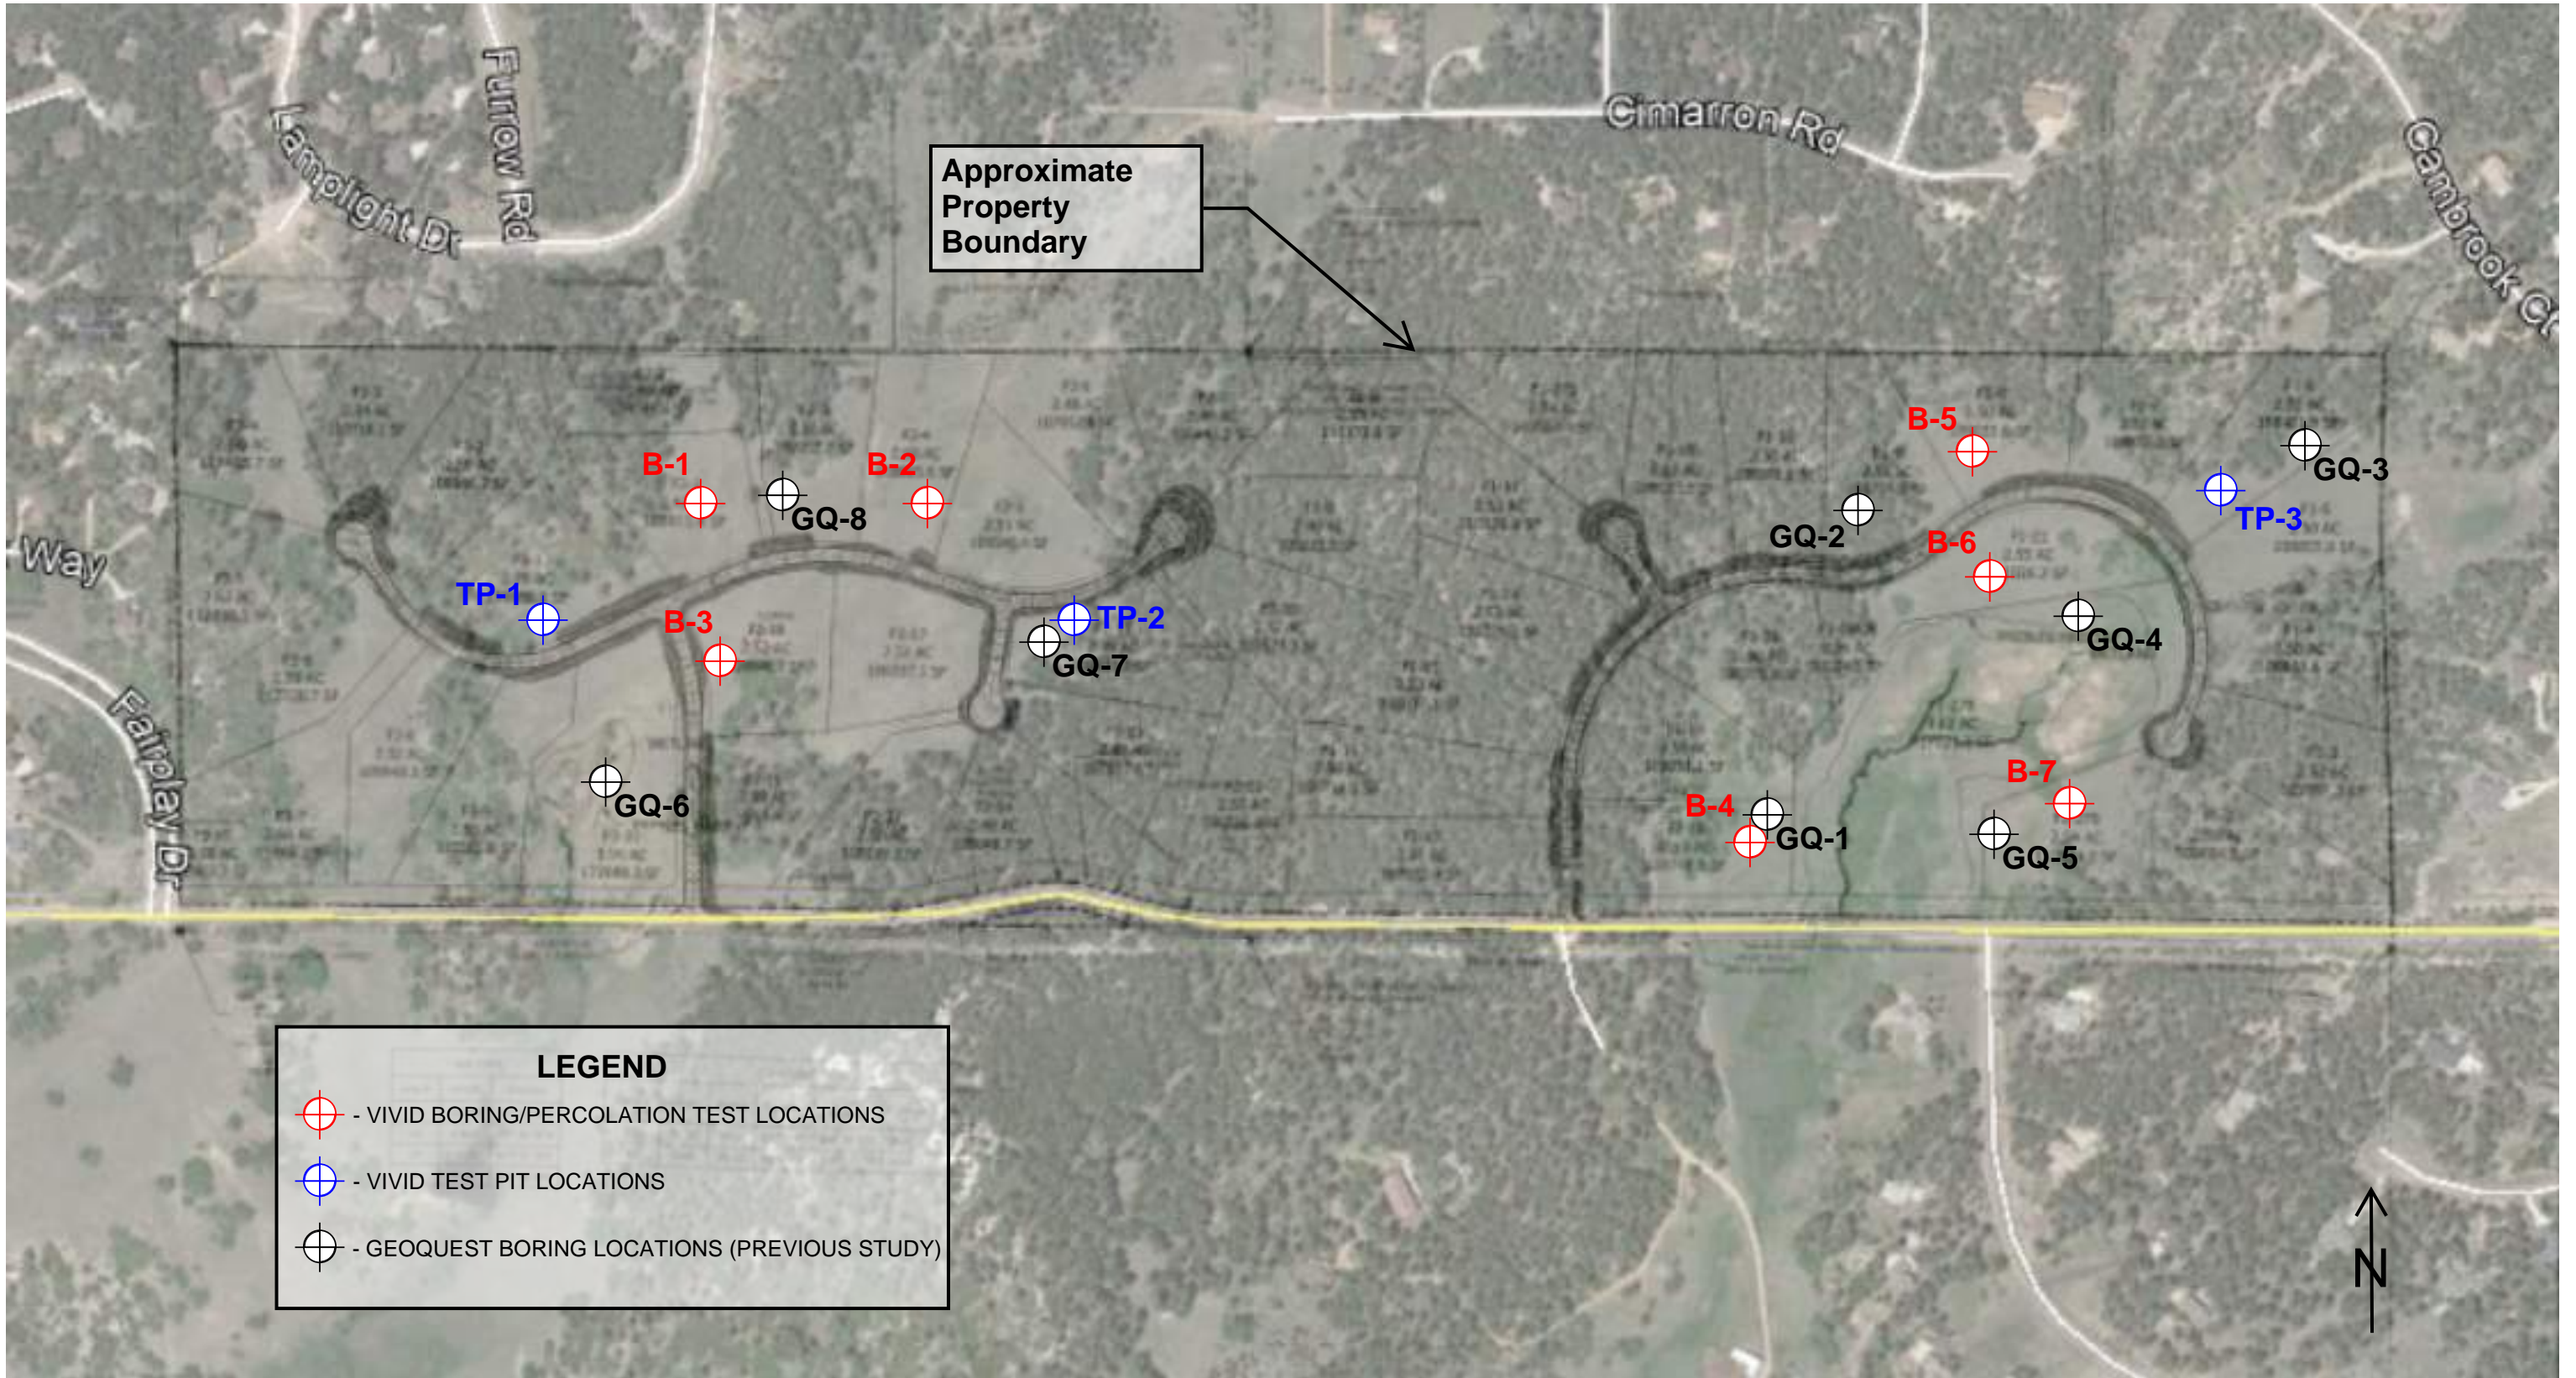
Not to Scale. Base image dated 06/09/2017 and obtained from Google Earth, 2019.

The proposed project includes the development of a 151-acre parcel into a residential subdivision. 48 lots are planned, that will be approximately 2.5 acres in size. The property has no current improvements and is in a generally native condition. The development will include construction of access roadways and utilities. Residential lots will require individual water well and septic systems. A preliminary site layout is shown on Figure 2, attached to this report.

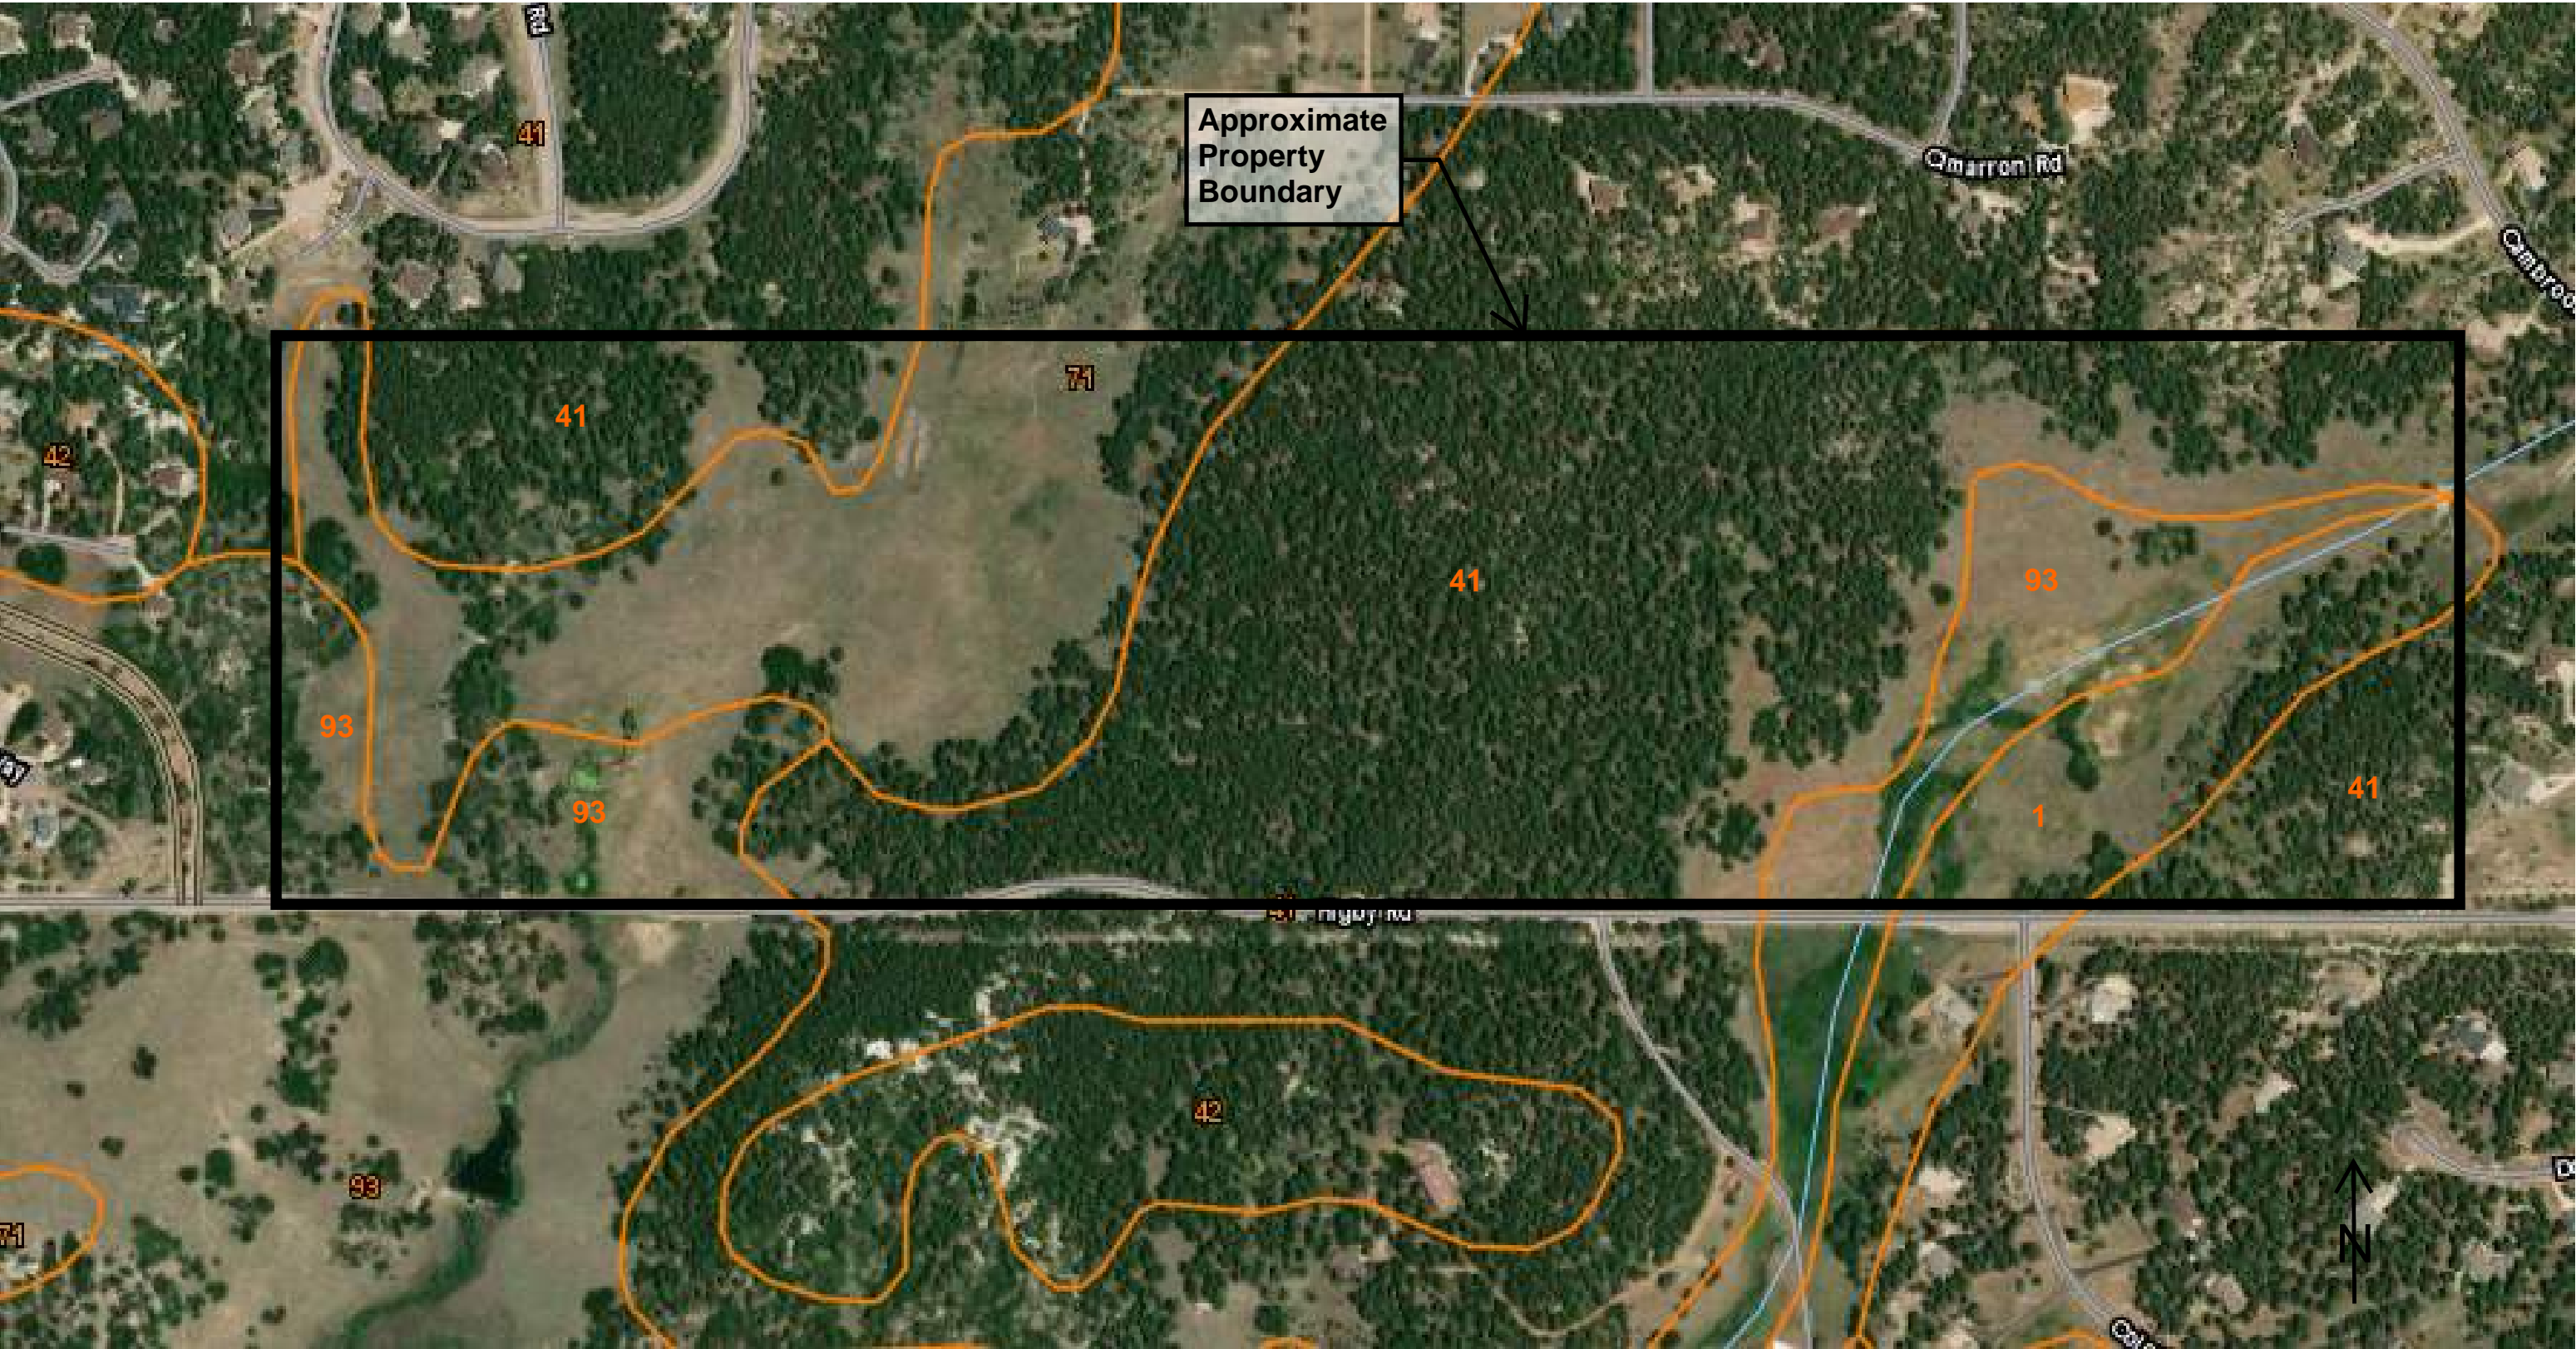
4a

Not to Scale. Base image from <https://websoilsurvey.sc.egov.usda.gov/App/WebSoilSurvey.aspx>

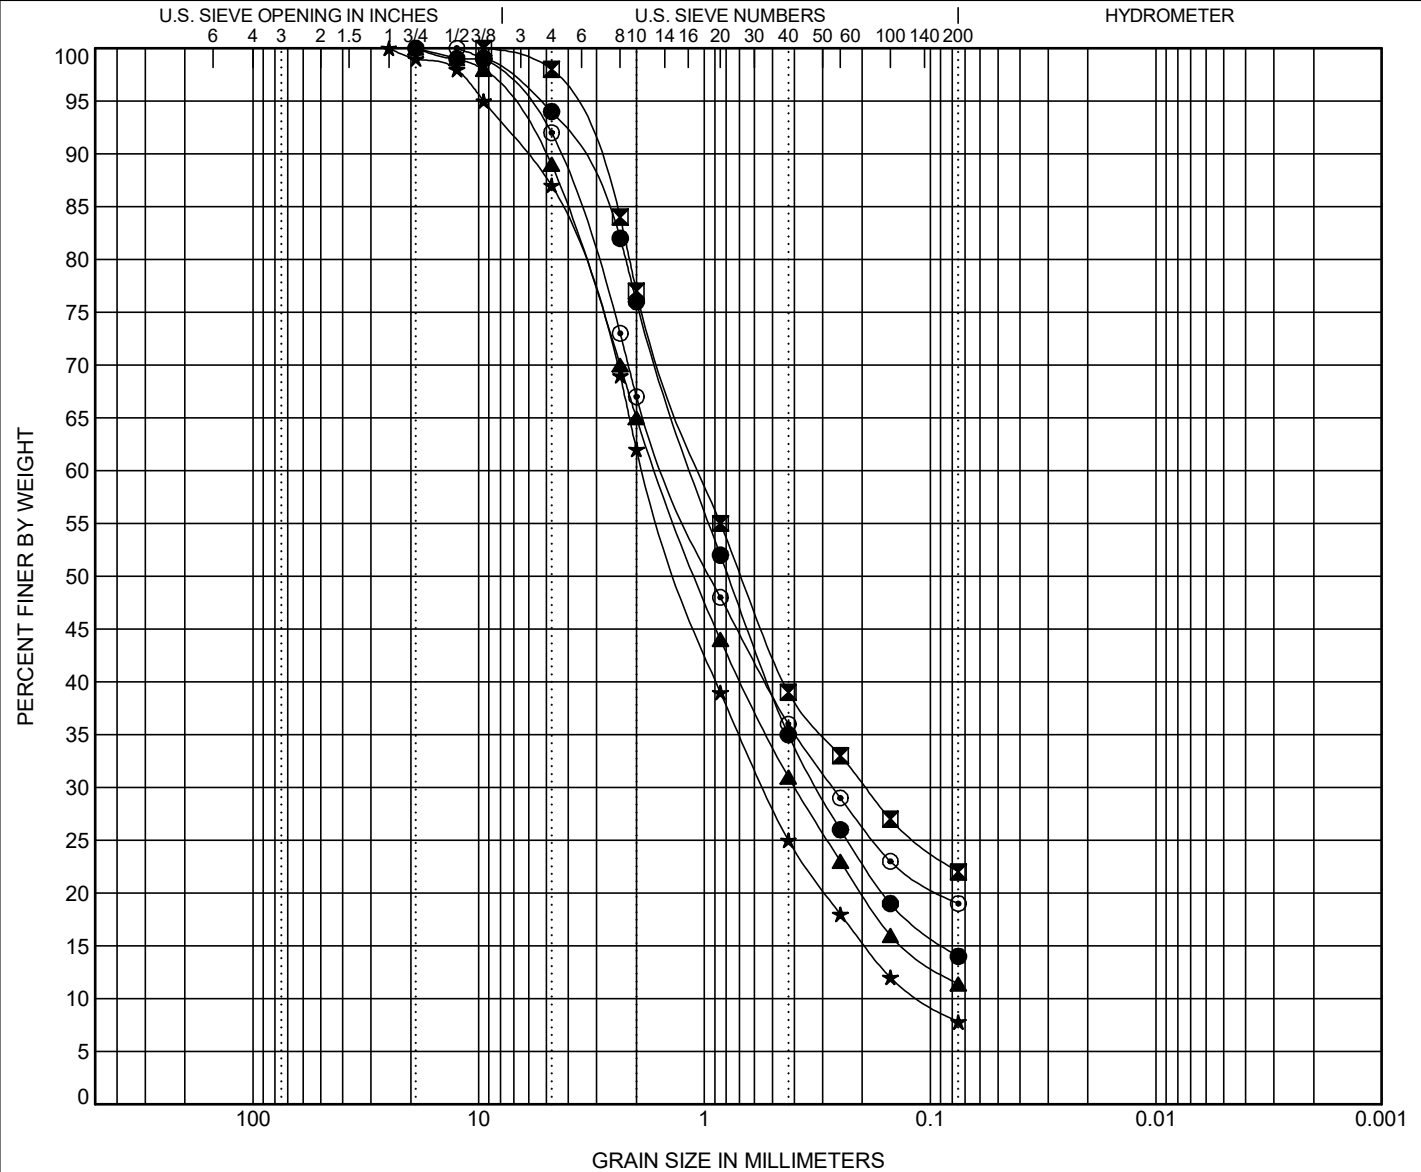
COBBLES	GRAVEL		SAND			SILT OR CLAY
	coarse	fine	coarse	medium	fine

BOREHOLE	DEPTH	Classification					LL	PL	PI	Cc	Cu
● B-1	9.0	SILTY SAND(SM)					NP	NP	NP		
☒ B-2	9.0	CLAYEY SAND(SC)					43	26	17		
▲ B-3	4.0	WELL-GRADED SAND with SILT(SW-SM)					NP	NP	NP	1.60	26.86
★ B-3	14.0	WELL-GRADED SAND with SILT(SW-SM)					NP	NP	NP	1.48	17.22
◎ B-4	2.0	SILTY SAND(SM)					NP	NP	NP		
BOREHOLE	DEPTH	D100	D60	D30	D10	%Gravel	%Sand	%Silt		%Clay	
● B-1	9.0	19	1.131	0.316		6.0	80.0	14.0			
☒ B-2	9.0	9.5	1.032	0.194		2.0	76.0	22.0			
▲ B-3	4.0	19	1.631	0.398		11.0	77.6	11.4			
★ B-3	14.0	25	1.857	0.544	0.108	13.0	79.2	7.8			
◎ B-4	2.0	12.5	1.459	0.27		8.0	73.0	19.0

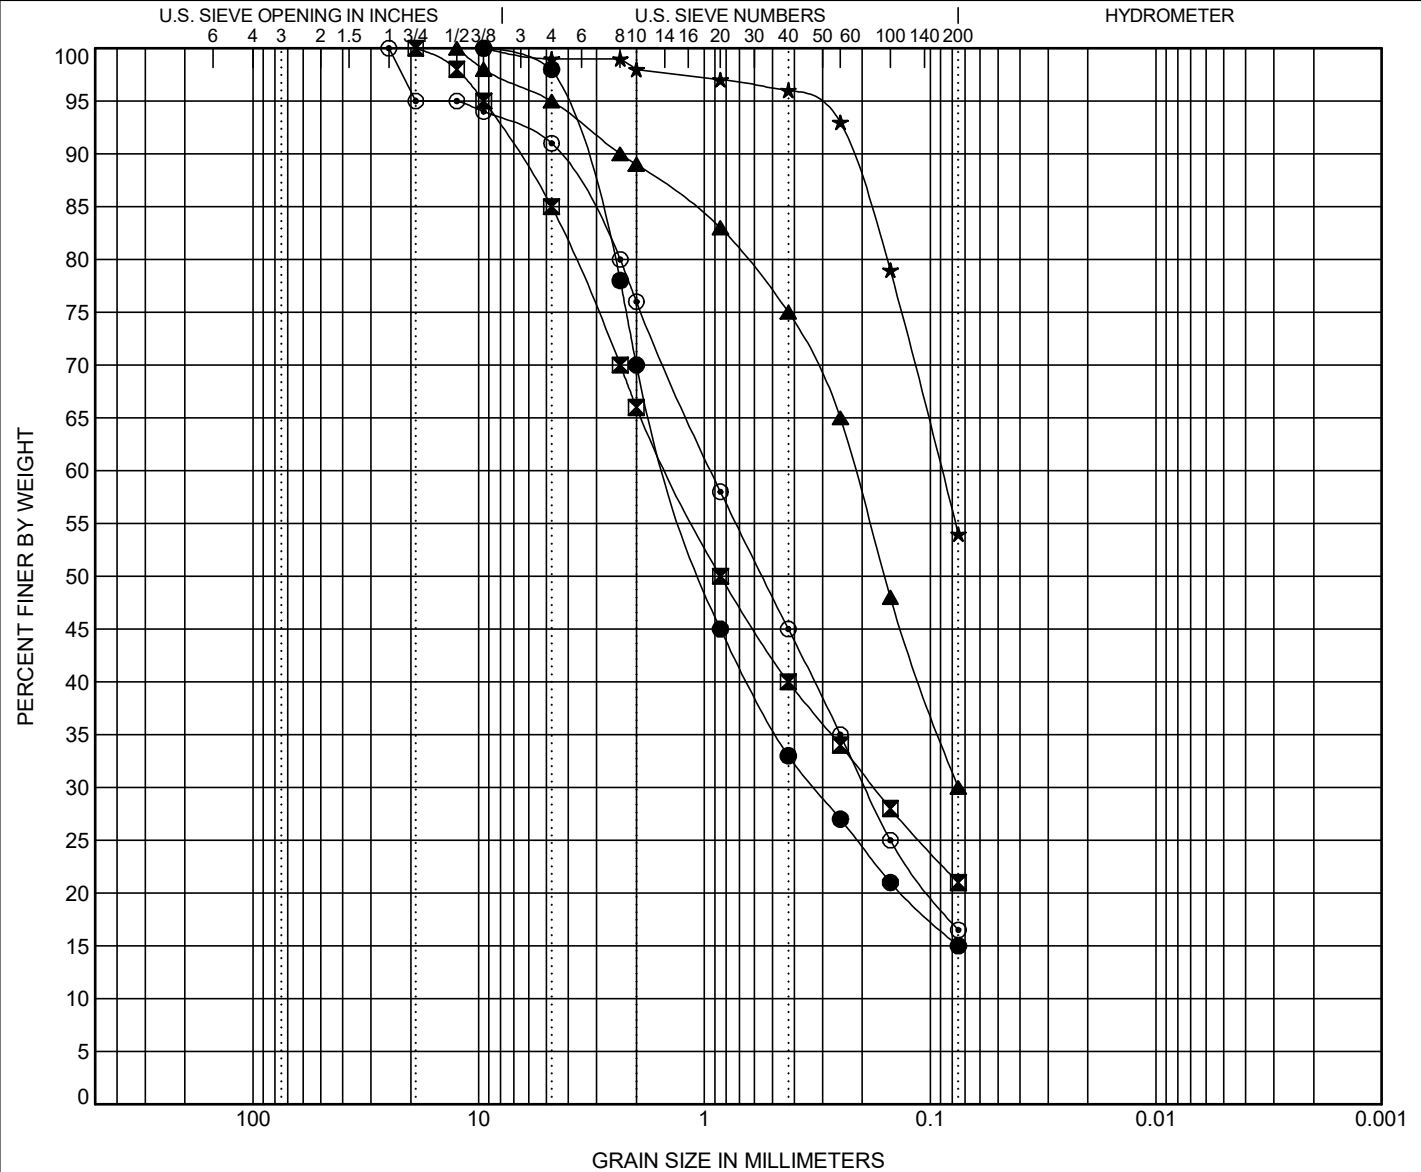
COBBLES	GRAVEL		SAND			SILT OR CLAY
	coarse	fine	coarse	medium	fine

BOREHOLE	DEPTH	Classification					LL	PL	PI	Cc	Cu
● B-4	14.0	SILTY SAND(SM)					NP	NP	NP		
☒ B-6	9.0	SILTY, CLAYEY SAND with GRAVEL(SC-SM)					25	19	6		
▲ B-7	4.0	SILTY SAND(SM)					NP	NP	NP		
★ B-7	14.0	SANDY SILT(ML)					33	24	9		
◎ TP-1	2.0	SILTY SAND(SM)					NP	NP	NP		
BOREHOLE	DEPTH	D100	D60	D30	D10	%Gravel	%Sand	%Silt		%Clay	
● B-4	14.0	9.5	1.42	0.326		2.0	83.0	15.0			
☒ B-6	9.0	19	1.451	0.178		15.0	64.0	21.0			
▲ B-7	4.0	12.5	0.215	0.075		5.0	65.0	30.0			
★ B-7	14.0	9.5	0.089			1.0	45.0	54.0			
◎ TP-1	2.0	25	0.935	0.194		9.0	74.5	16.5

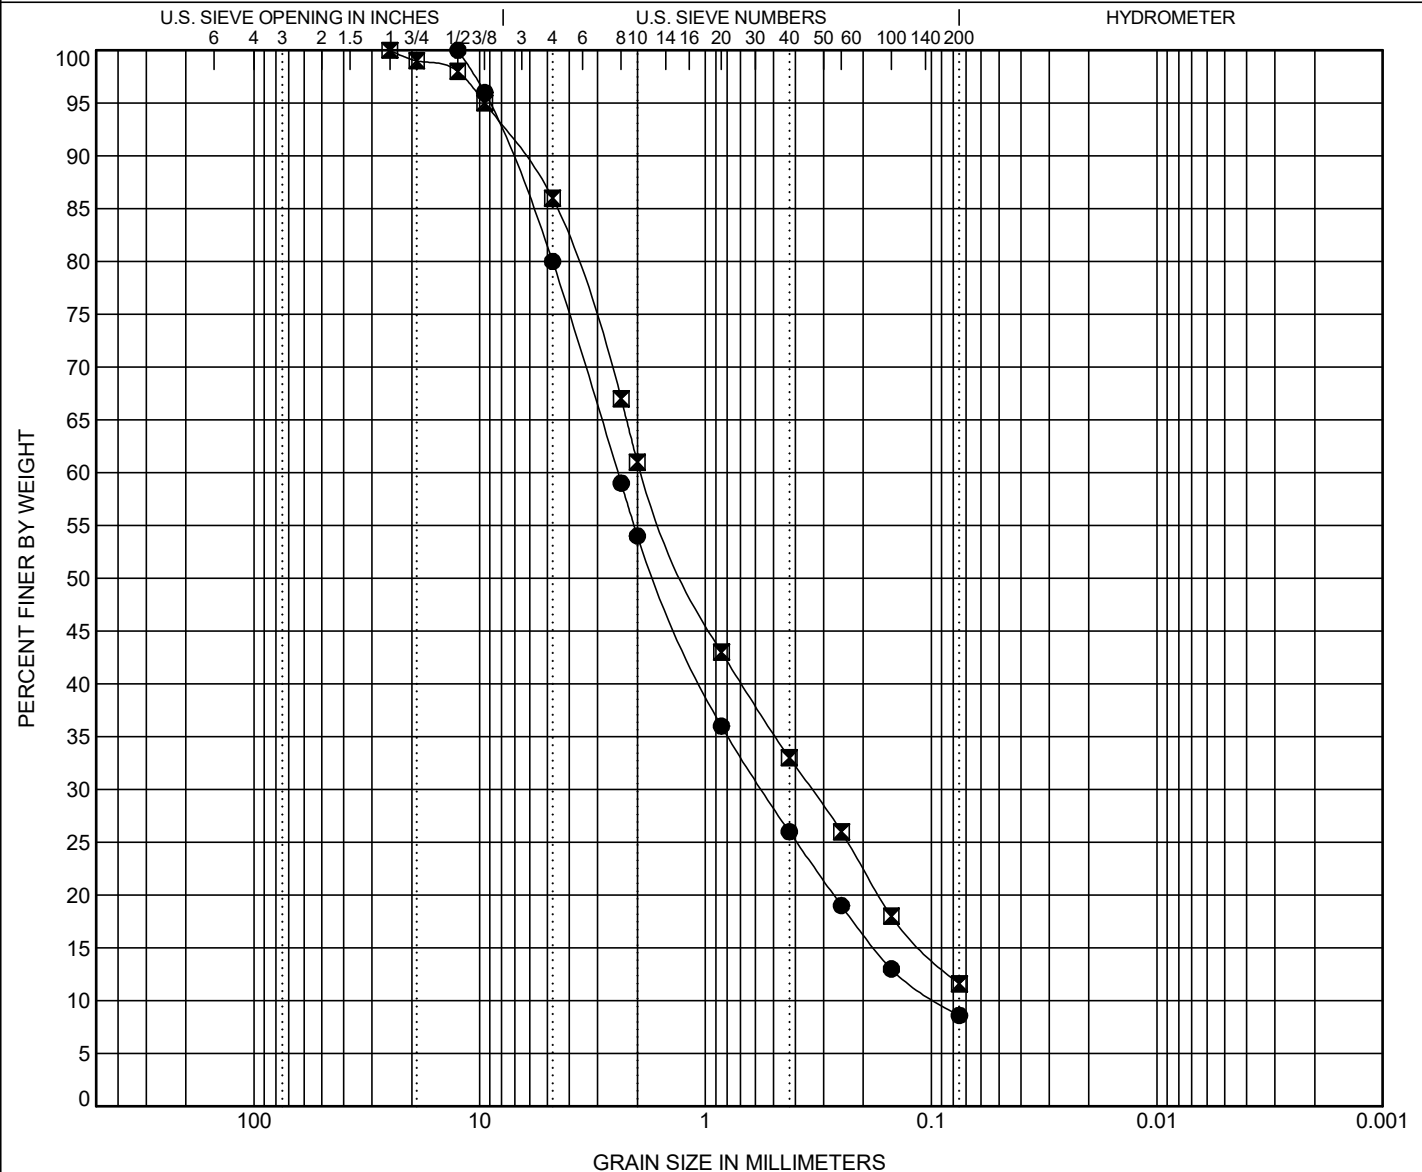
COBBLES	GRAVEL		SAND			SILT OR CLAY
	coarse	fine	coarse	medium	fine

BOREHOLE	DEPTH	Classification					LL	PL	PI	Cc	Cu
● TP-2	3.0	WELL-GRADED SAND with SILT and GRAVEL(SW-SM)					NP	NP	NP	1.38	26.09
☒ TP-3	4.0	POORLY GRADED SAND with SILT(SP-SM)					NP	NP	NP	0.95	30.24
BOREHOLE	DEPTH	D100	D60	D30	D10	%Gravel	%Sand	%Silt		%Clay	
● TP-2	3.0	12.5	2.44	0.561	0.094	20.0	71.4	8.6			
☒ TP-3	4.0	25	1.907	0.339		14.0	74.4	11.6
