MARY JANE RANCH SUBDIVISION

ONSITE WASTEWATER TREATMENT SYSTEMS REPORT

JANUARY 29, 2024

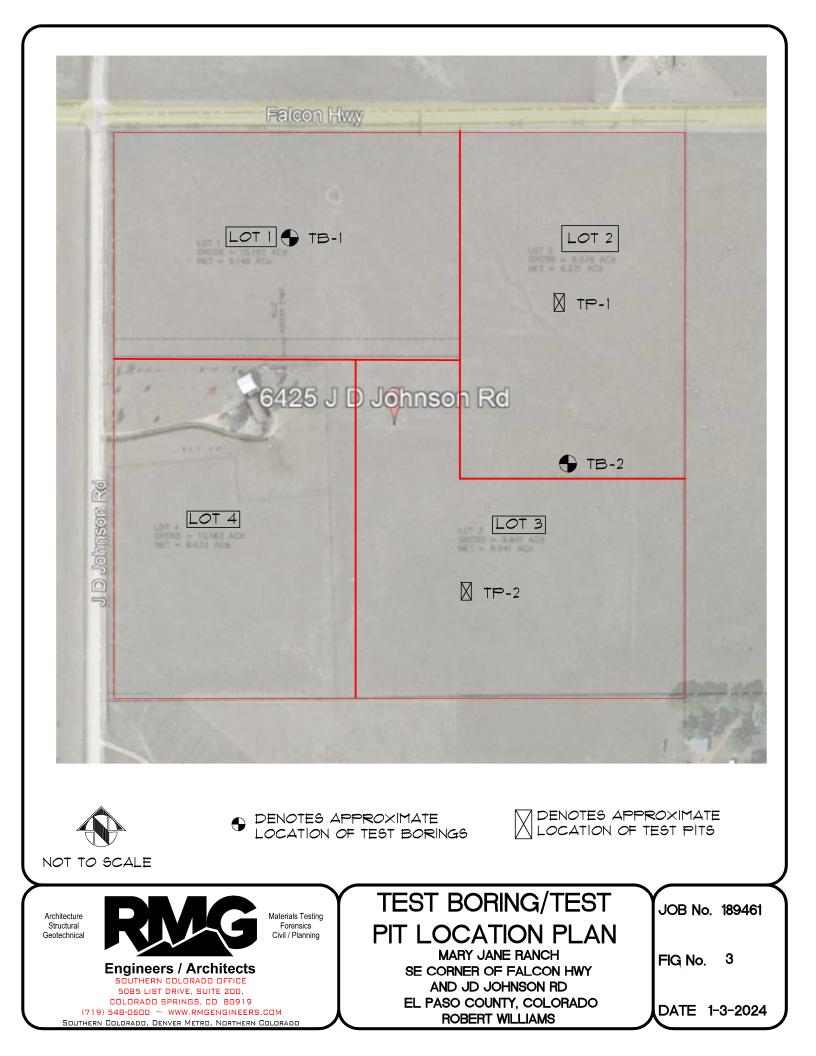
SOILS DESCRIPTION

SILTY SAND

SILTY TO CLAYEY SAND

The soils were evaluated to determine the soils types and structure. Neither bedrock nor limiting layers were encountered in the test pits. The soil descriptions of the test pit evaluation are presented in Figure 6, Test Boring/Test Pit Logs. The Wastewater study is presented in Appendix B, a summary of the study is provided in section **9.0 On-site Wastewater Water Treatment Systems**.

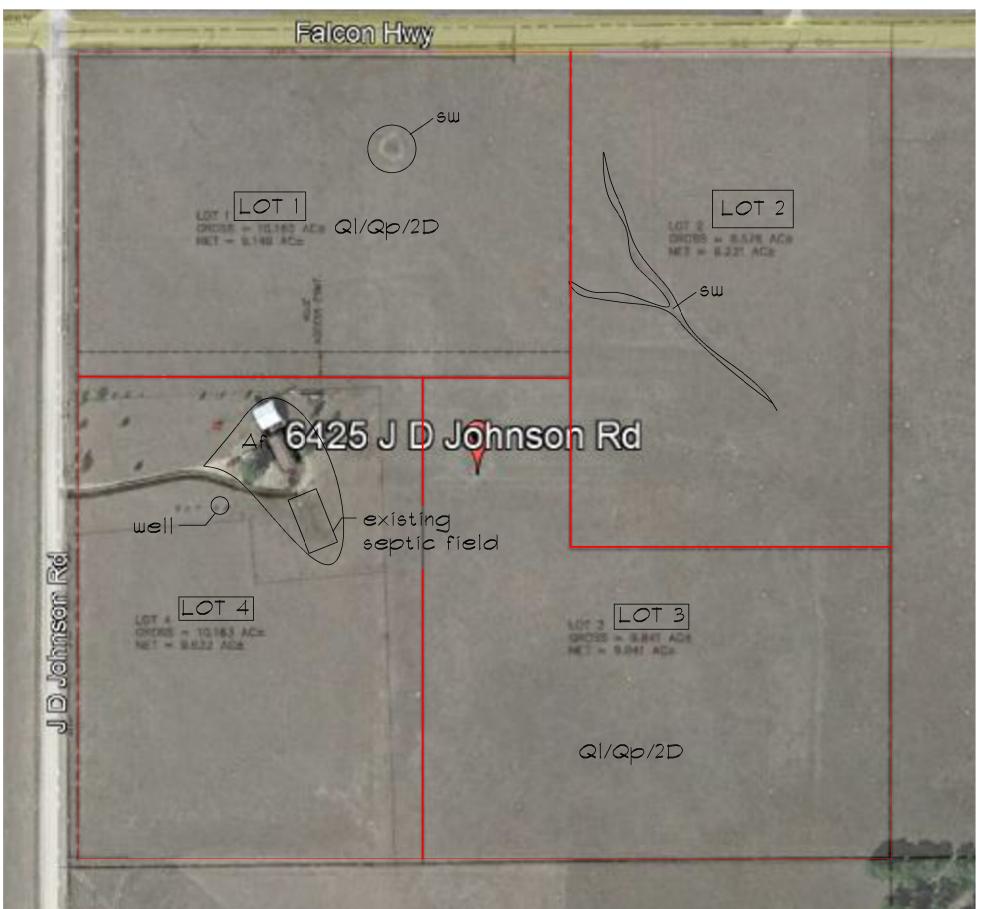
Ql: Louviers Alluvium (Paleocene to Eocene) - light brown to tan, thin gravelly deposits on terraces, poorly sorted with low clay contents. Thickness is estimated to be approximately 70 feet above streams on the plains.

Op: Piney Creek Alluvium (Holocene) - silty to gravelly hummus-rich alluvium along all valleys, poorly sorted with low clay contents. Estimated thickness was not noted on the geologic map.

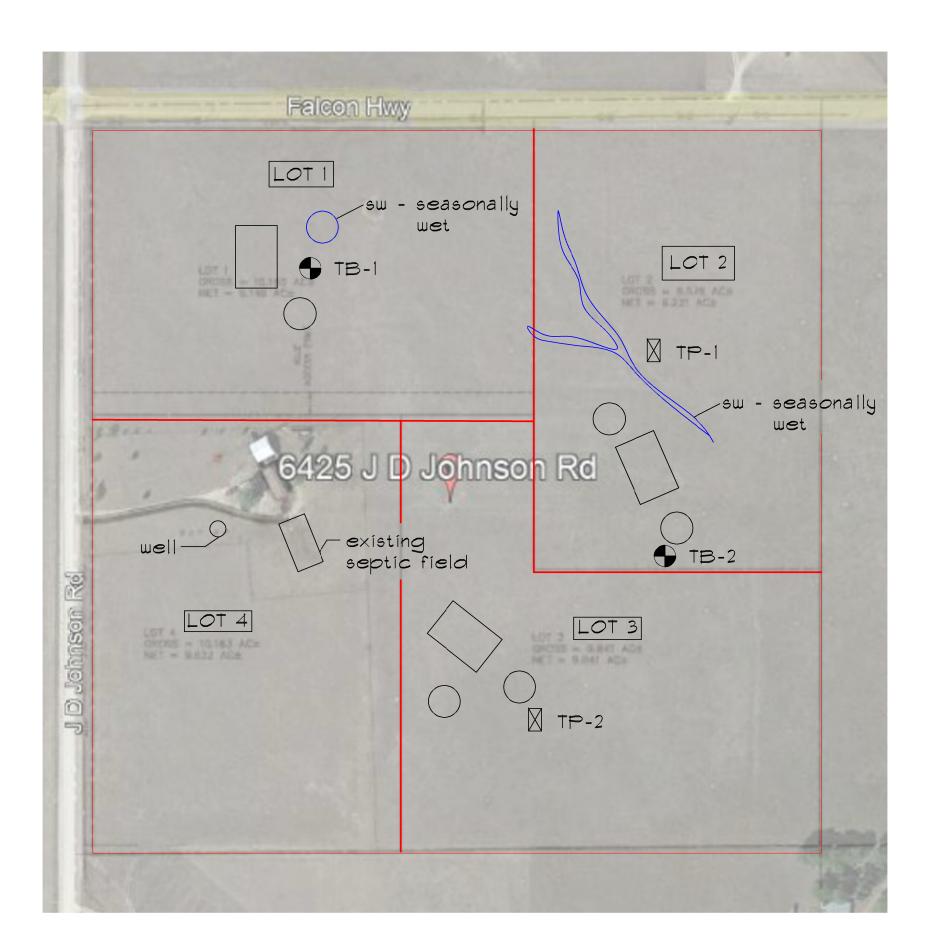
JOB №. 189461 Engineers / Architects Architecture Structural Geotechnical MARY JANE RANCH CORNER OF FALCON HWY AND JD JOHNSON RD EL PASO COUNTY, COLORADO ROBERT WILLIAMS S ENGINEER: DRAWN BY: TPM KMZ TPM CHECKED BY: SSUED: 1-3-2024 SEPTIC SUITABILIT MAP SHEET NO. FIG-6

residence for visual presentation

Denotes random location of OWTS for visual presentation. Each lot has sufficient acreage for a primary and alternate OWTS locations
