## SOIL AND GEOLOGY STUDY

**Mary Jane Ranch  
SE Corner of Falcon Hwy & JD Johnson Rd  
El Paso County, Colorado**

**JOB NO. 189461**

**January 3, 2024**

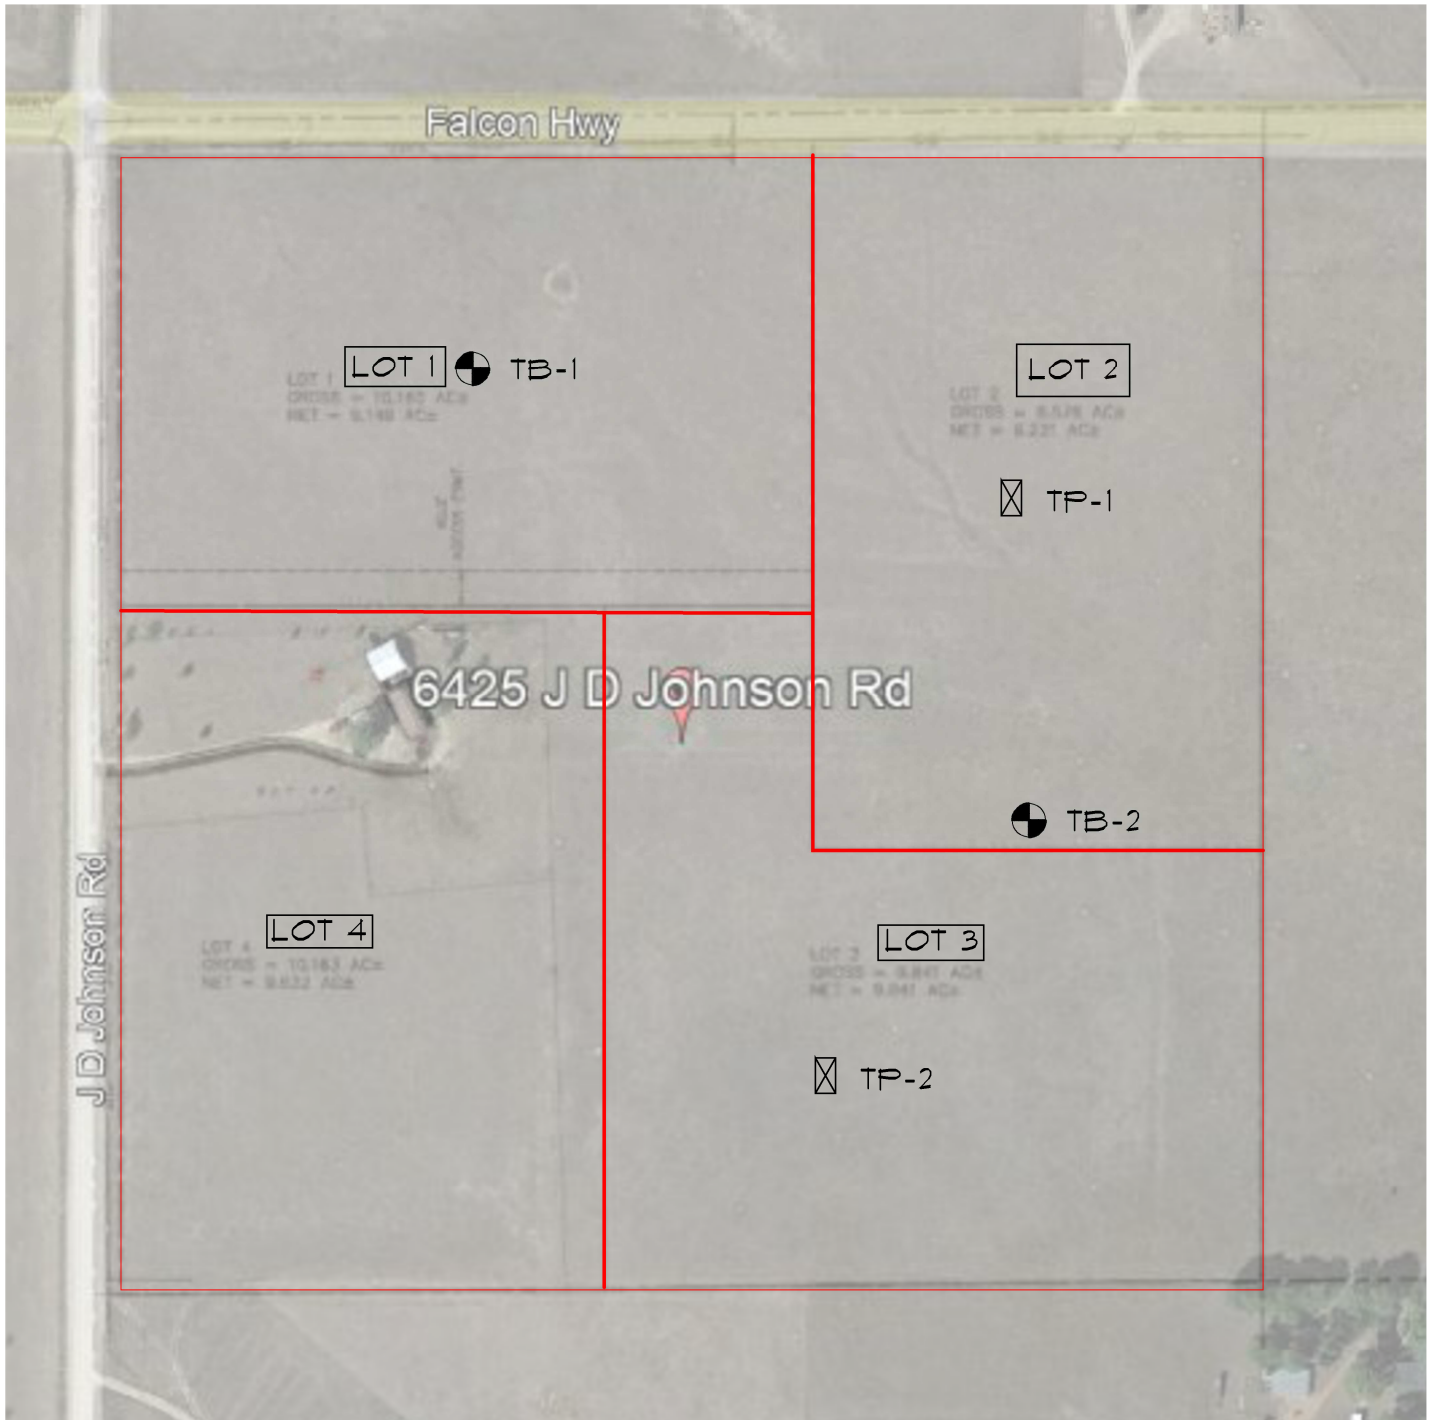
DENOTES APPROXIMATE  
LOCATION OF TEST BORINGS

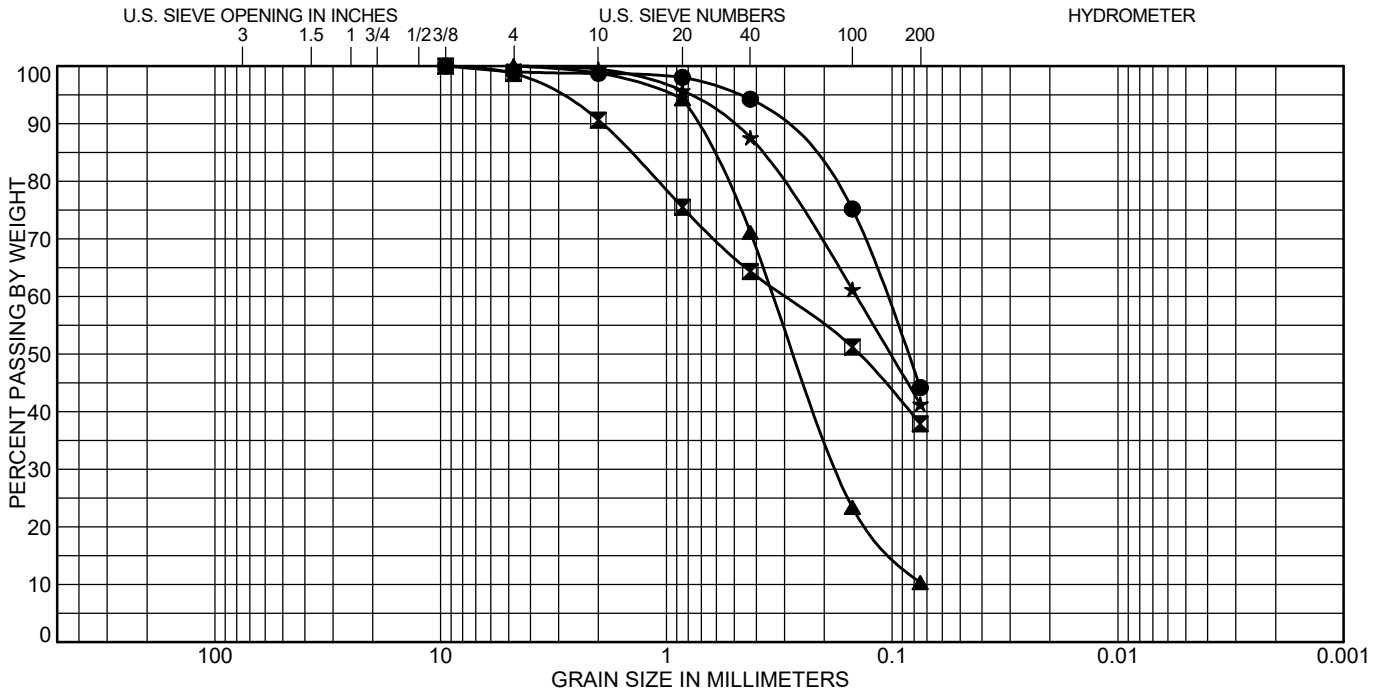
FIGURE No. 8

COBBLES	GRAVEL		SAND			SILT OR CLAY
	coarse	fine	coarse	medium	fine

Test Boring	Depth (ft)	Classification	LL	PL	PI
● 1	9.0	SILTY SAND(SM)	NP	NP	NP
☒ 1	14.0	CLAYEY SAND(SC)	29	16	13
▲ 2	4.0	POORLY GRADED SAND with SILT(SP-SM)	NP	NP	NP
★ 2	19.0

The moisture content for the recovered samples was obtained in the laboratory. Grain-size analysis, Atterberg Limits, and Denver Swell/Consolidation tests were performed on selected samples for purposes of classification and to develop pertinent engineering properties. A Summary of Laboratory Test Results is presented in Figure 7. Soil Classification Data are presented in Figure 8.

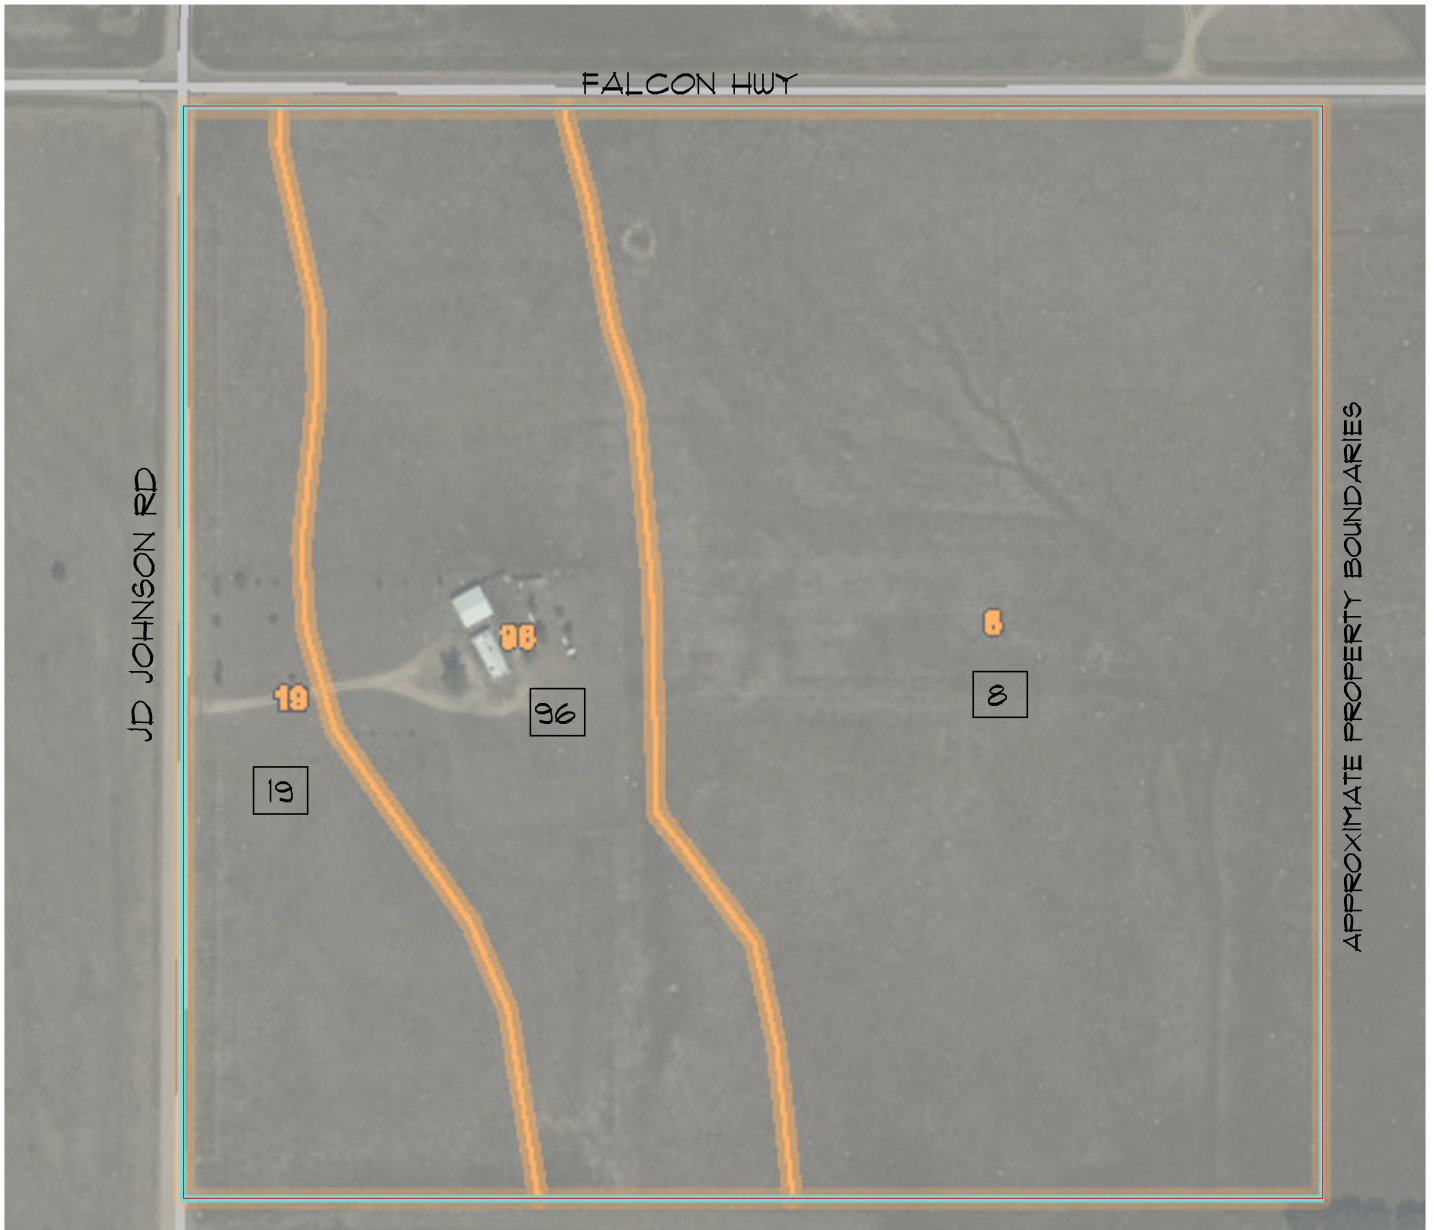
FIG No. 9

- 8 - Blakeland loamy sand with 1 to 9 percent slopes
- 19 - Columbine gravelly sandy loam, 0 to 3 percent slopes
- 96 - Truckton loamy sand, 0 to 3 percent slopes

The USDA Soil Survey Map is presented in Figure 9.

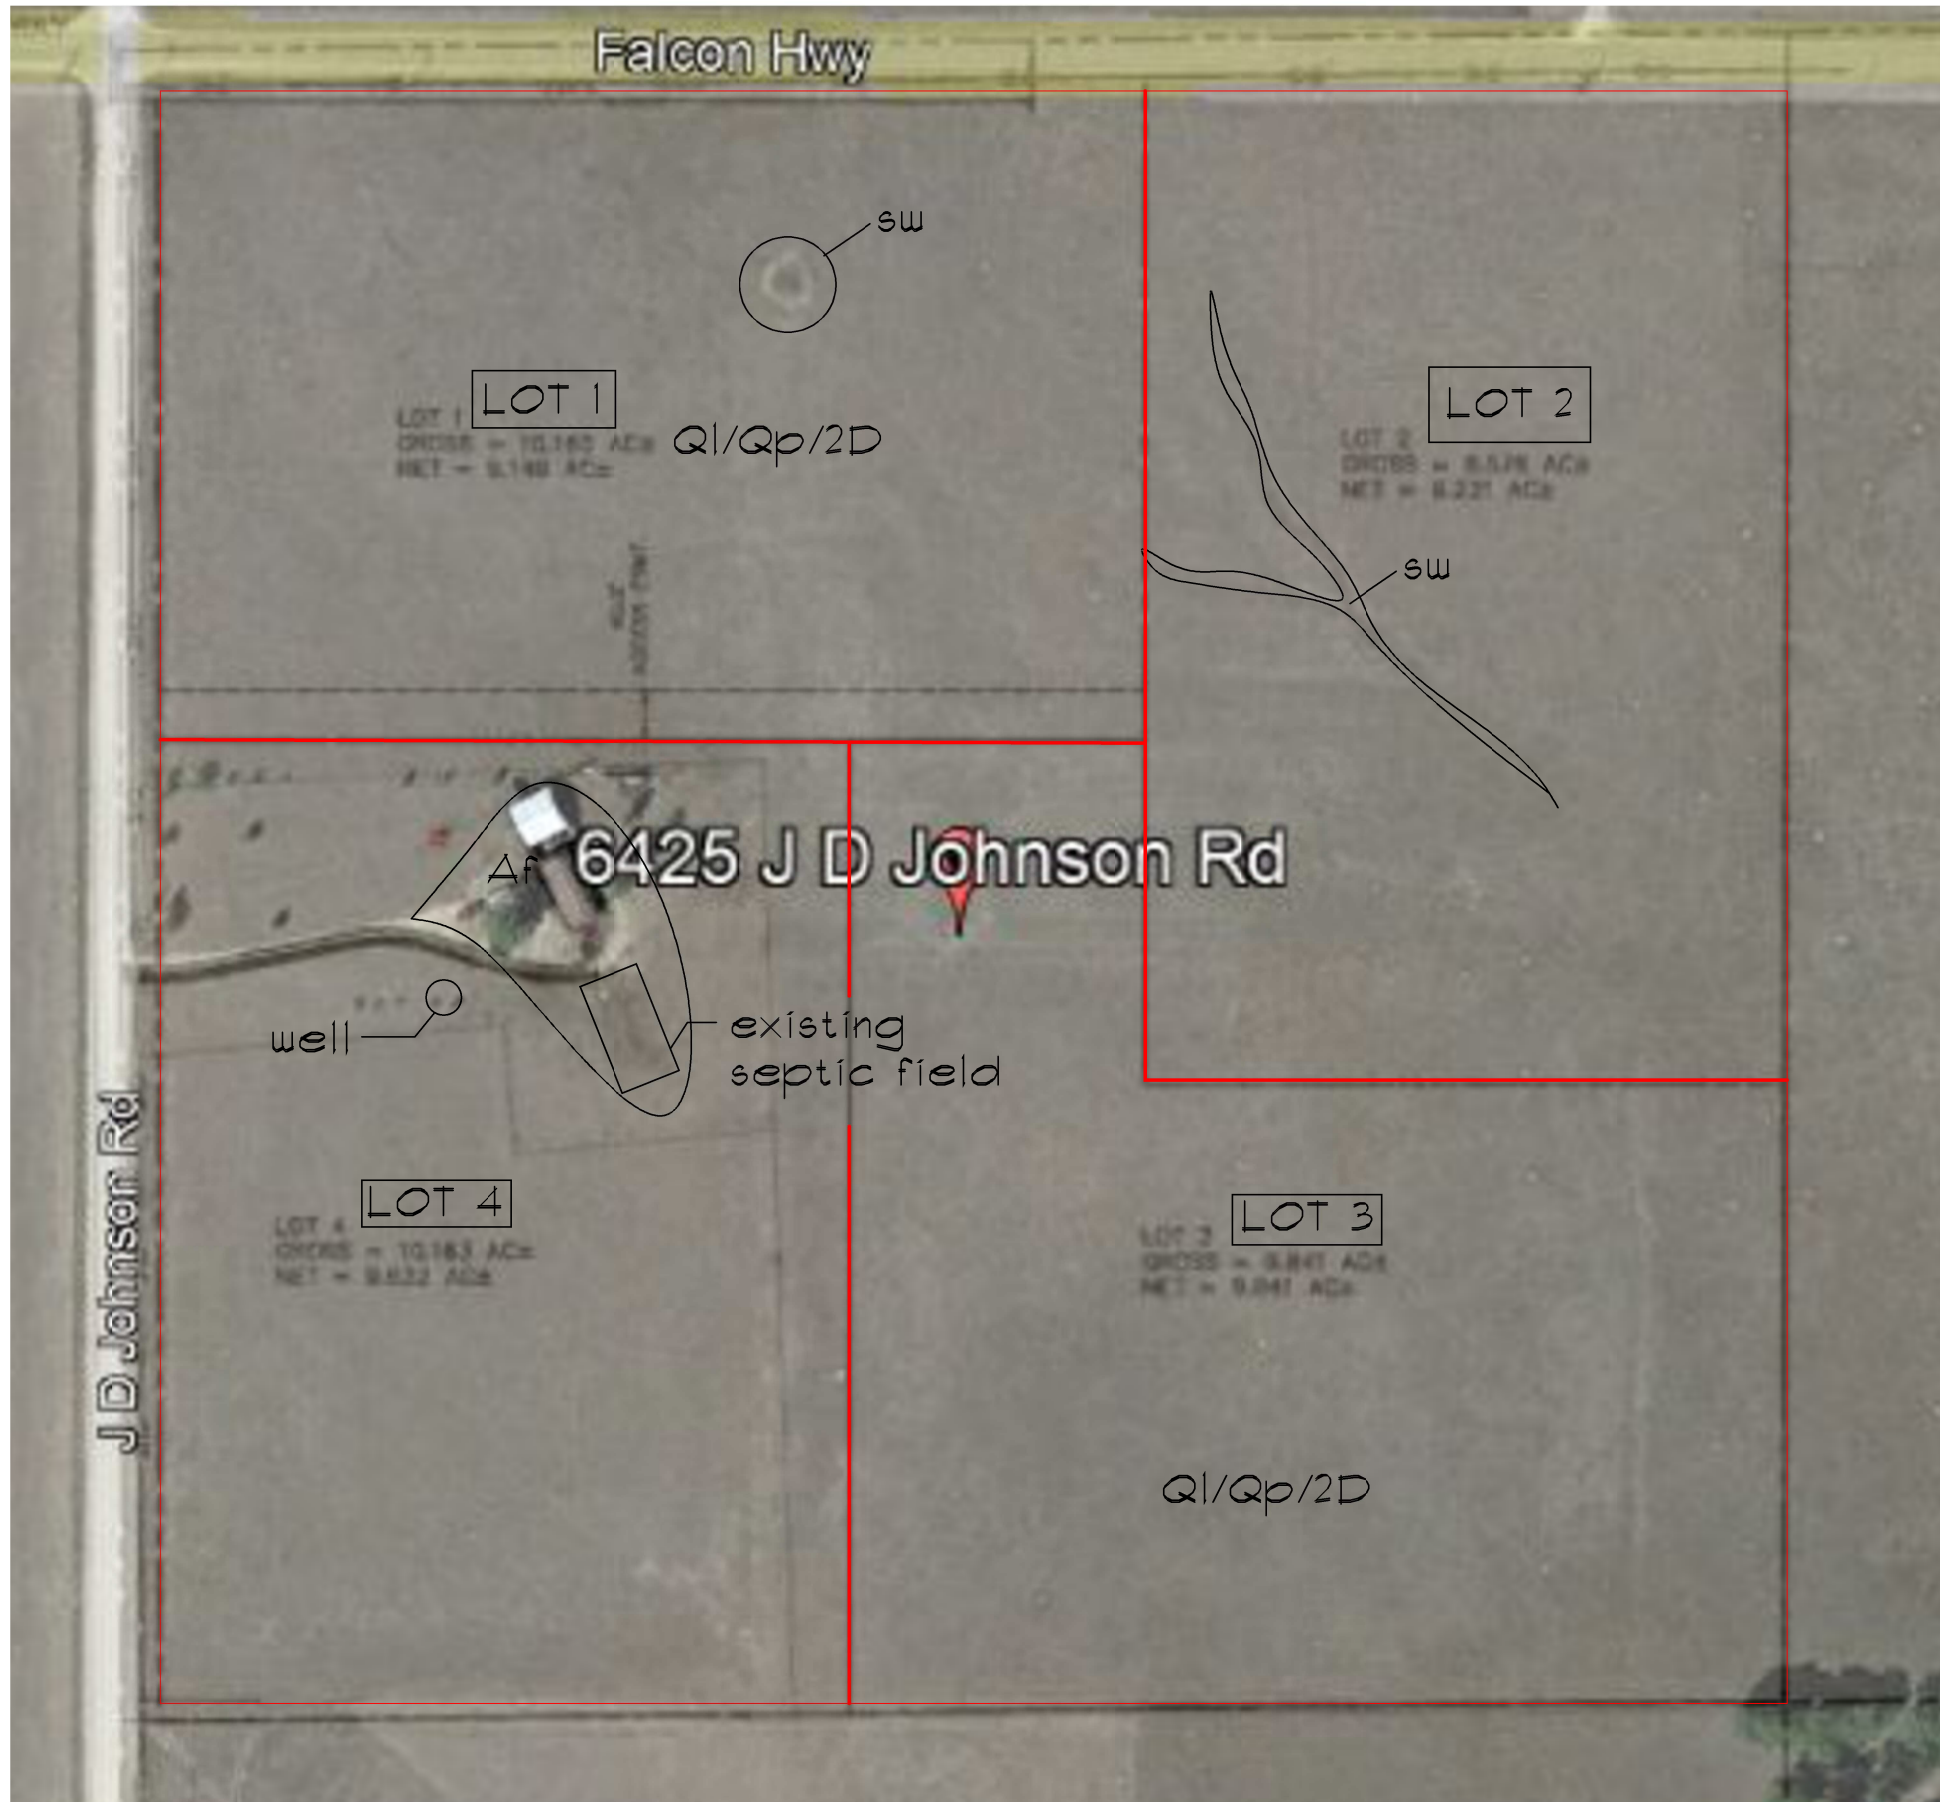
SHEET No.  
**FIG-10**

Geologic Conditions

*Ql: Louviers Alluvium (Paleocene to Eocene)* - light brown to tan, thin gravelly deposits on terraces, poorly sorted with low clay contents. Thickness is estimated to be approximately 70 feet above streams on the plains.

ENGINEERING AND  
GEOLOGY MAP

Based on review of relevant geologic maps, we identified the geologic conditions (listed below) affecting the development, as shown on the Engineering and Geology Map, Figure 10.

One engineering geology unit was mapped at the site and is shown on the Engineering and Geology Map, Figure 10.
