Re: Reliance Letter
Subsurface Soil Investigation
6895 Space Village Av

El Paso County, Colorado

It is our understanding that El Paso County is reportedly requiring completion of a geology and soils report for the previously completed development and the existing structure (built in 1985), despite the fact that no additional development or modifications to the structure are currently proposed. Due to this requirement, Rocky Mountain Group - RMG was retained to explore the subsurface conditions at the site and develop this document.

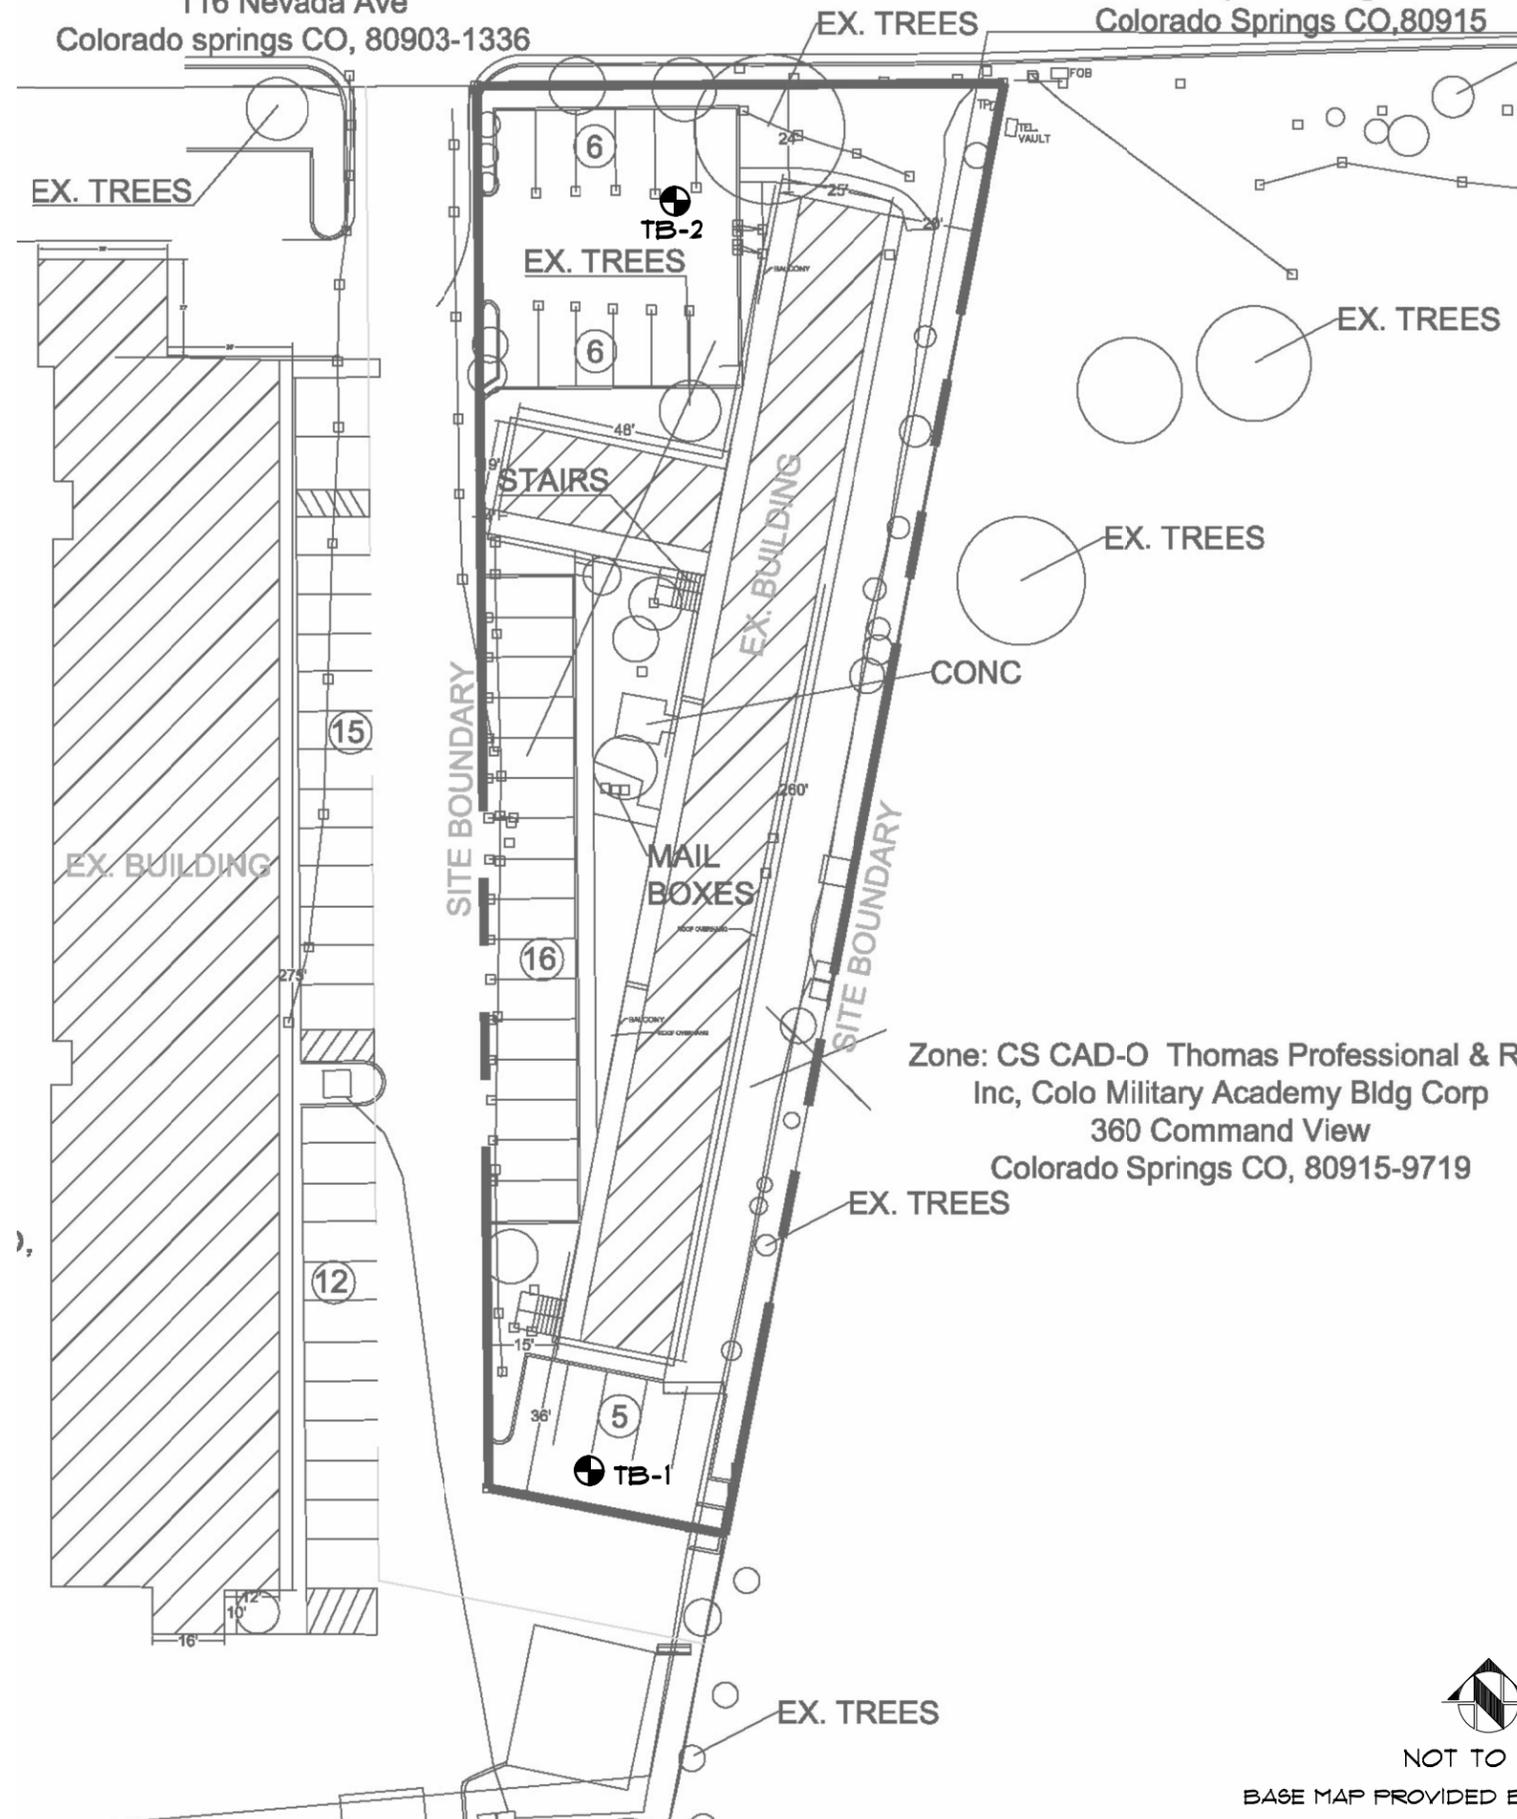
⊕ DENOTES APPROXIMATE LOCATION OF TEST BORING PERFORMED FOR THIS INVESTIGATION

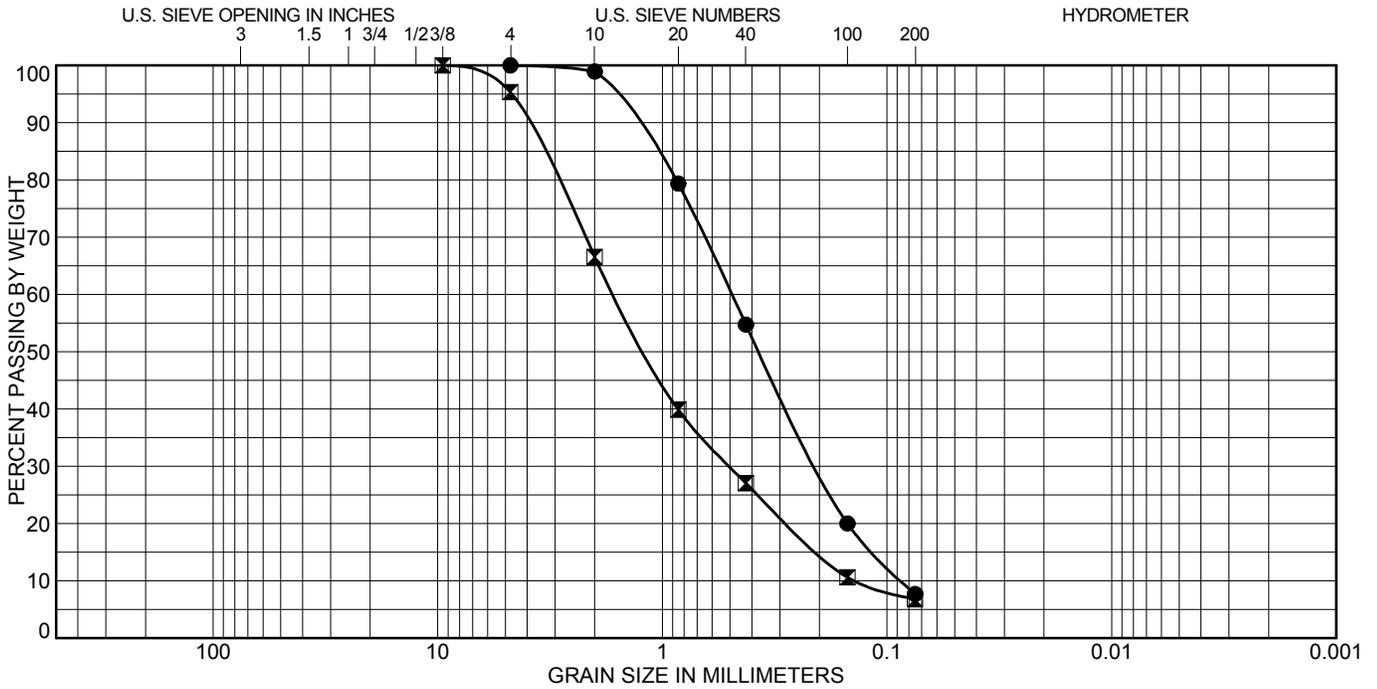
COBBLES	GRAVEL		SAND			SILT OR CLAY
	coarse	fine	coarse	medium	fine

Test Boring	Depth (ft)	Classification	LL	PL	PI
● 1	4.0	POORLY GRADED SAND with SILT(SP-SM)	NP	NP	NP
☒ 2	9.0	WELL-GRADED SAND with SILT(SW-SM)	NP	NP	NP

Soil laboratory testing was performed as part of this investigation. The laboratory tests included moisture content, dry density, grain-size analyses, Atterberg Limits, and one Swell/Consolidation test. A Summary of Laboratory Test Results is presented in Figure 5. Soils Classification Data is presented in Figure 6. The soils encountered were visually classified at the time of drilling as non-cohesive sand with various amounts of silt.

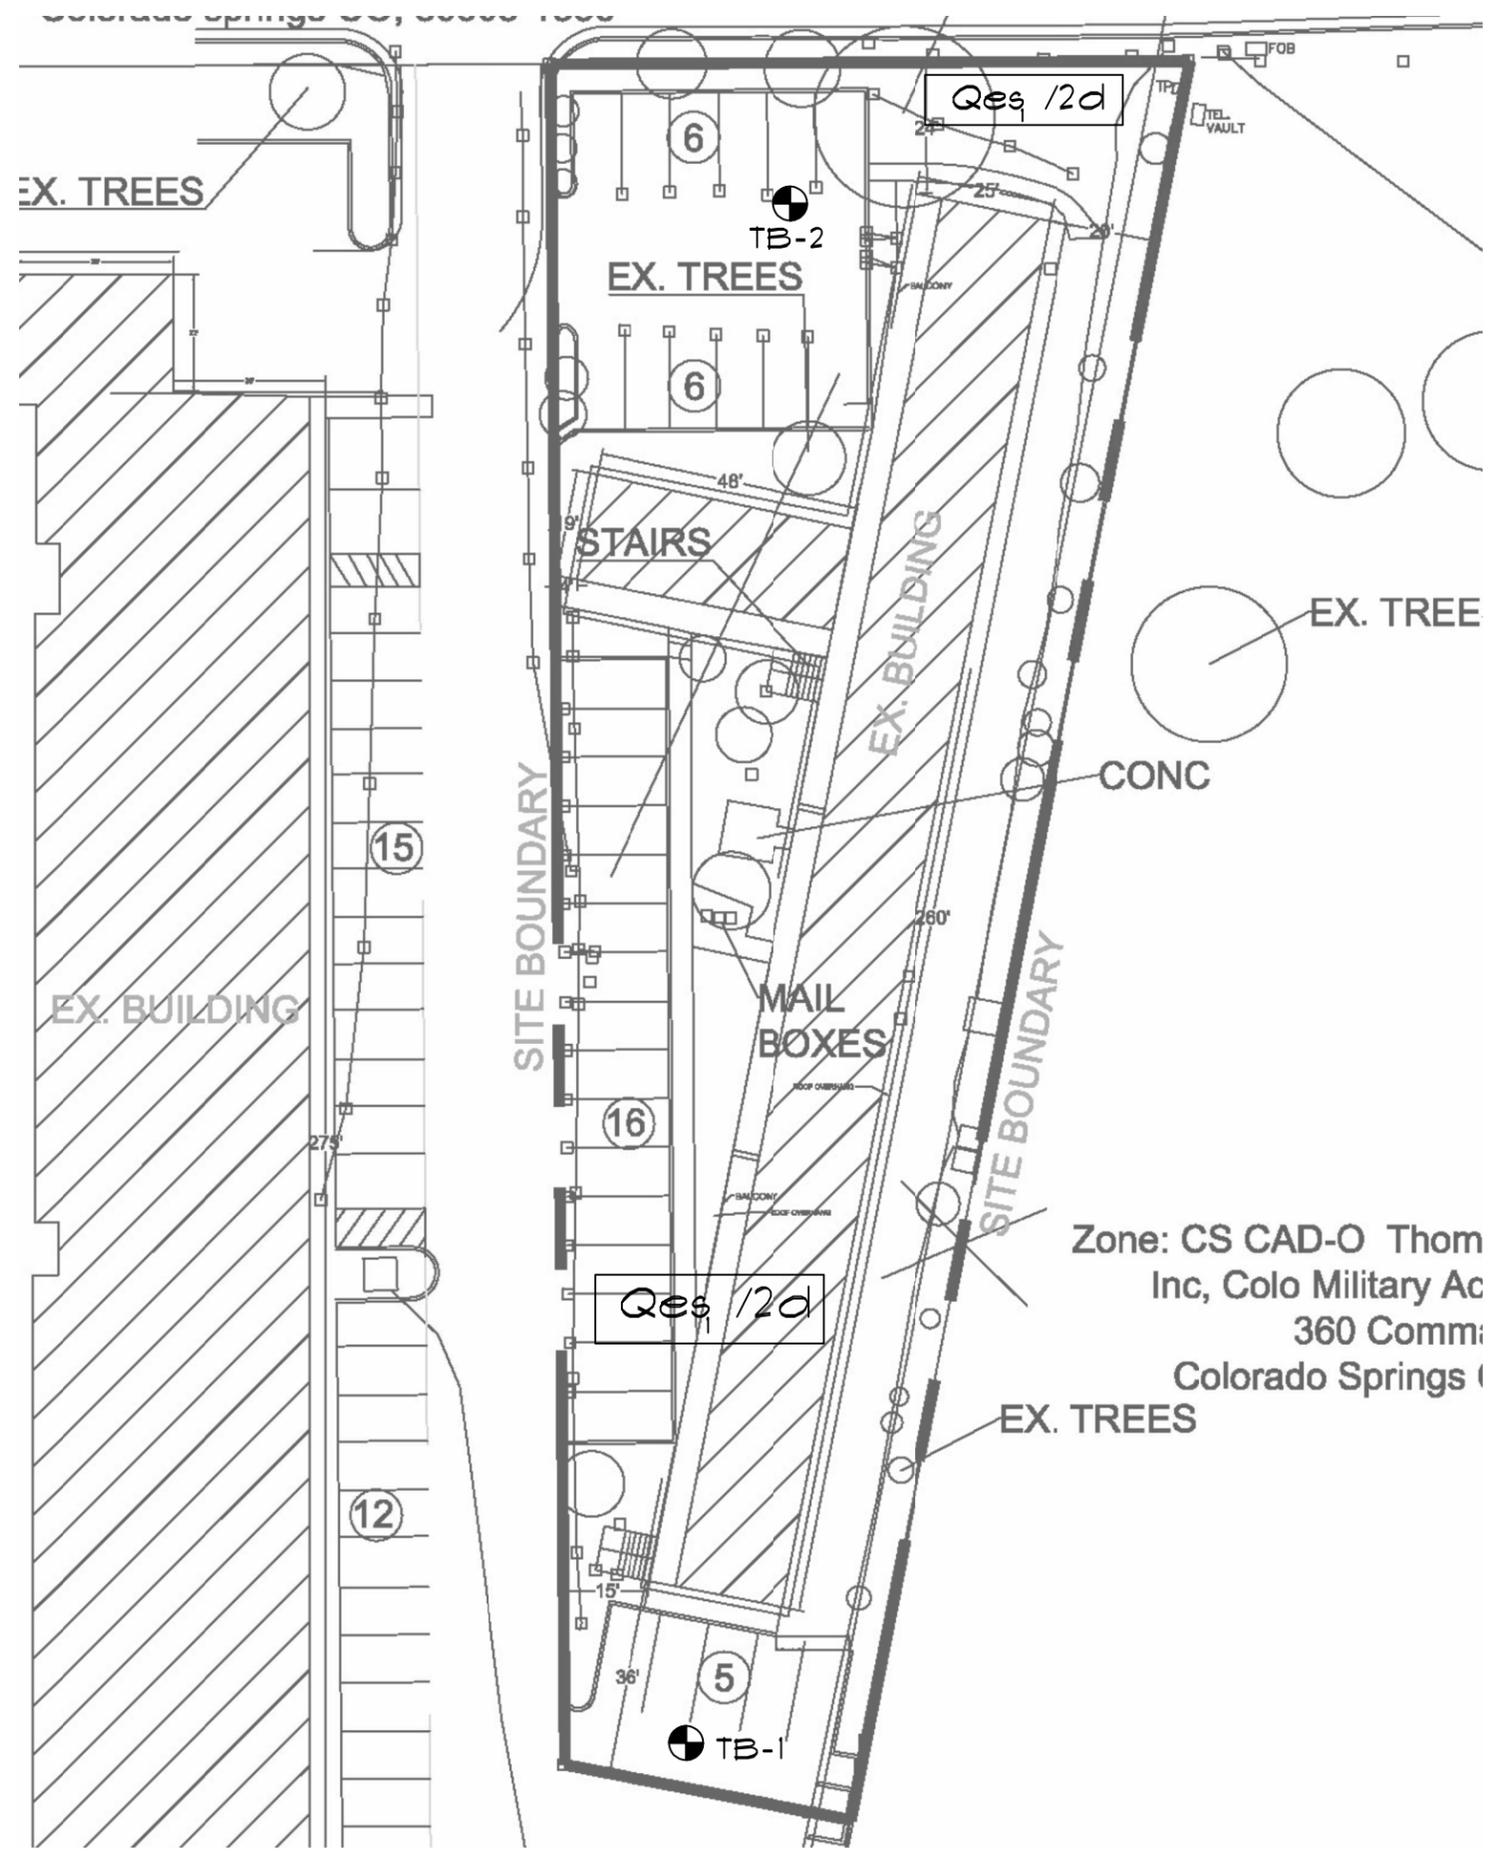
GEOLOGIC

Qes - Younger eolian sand - coarse to very coarse sand that appears to have been deposited by sand sheets. Encountered up to 20-feet in the test borings

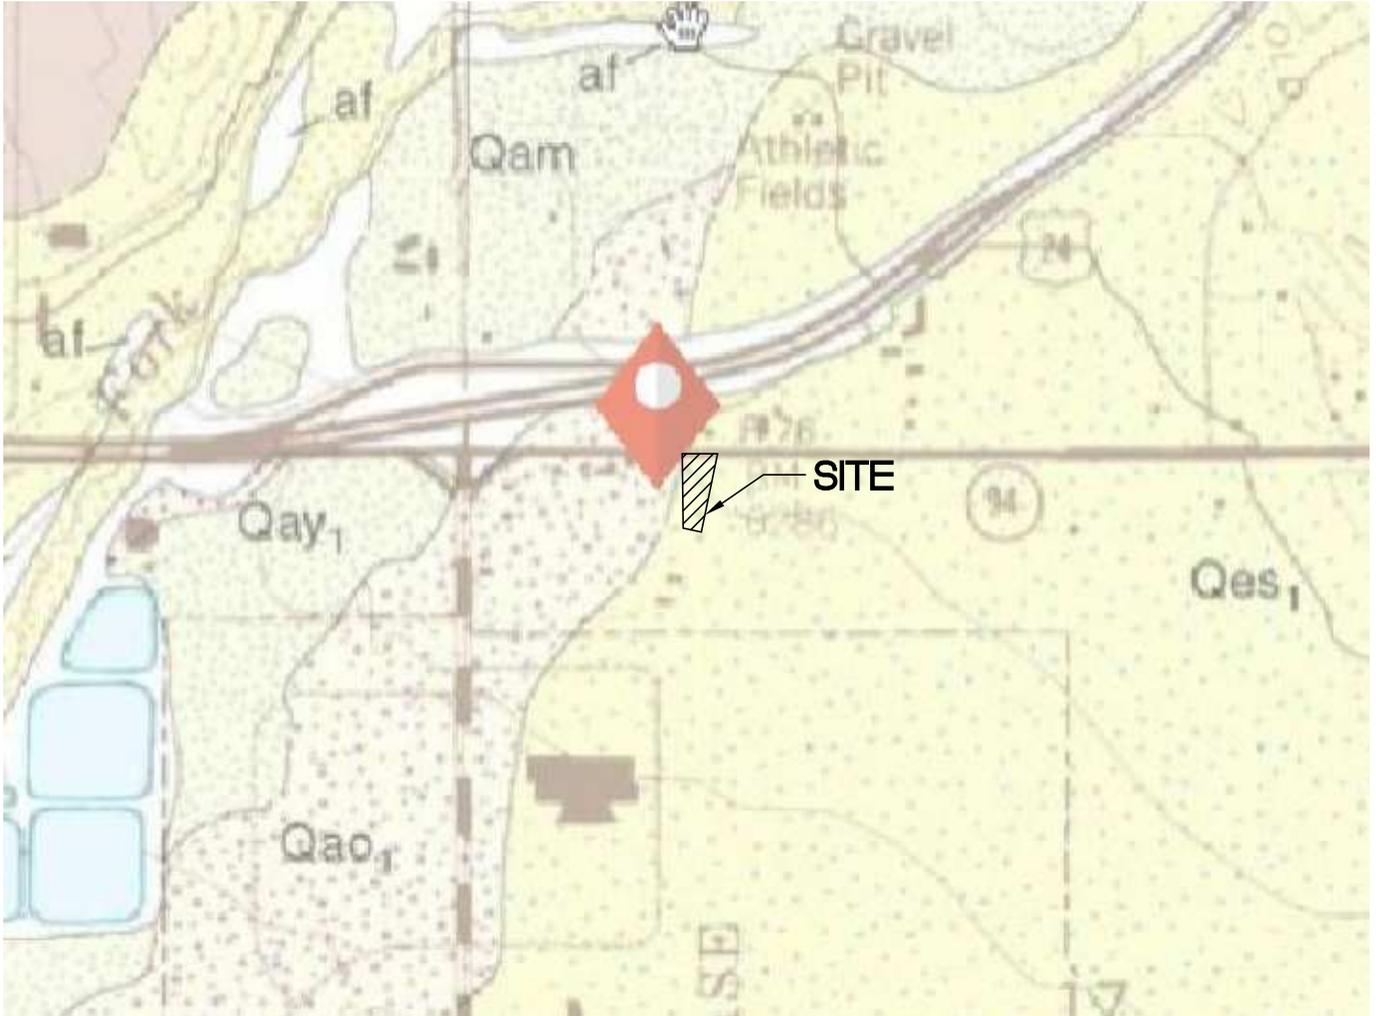
FIG No. 8

NOT TO SCALE

BASE MAP PROVIDED BY: CGS

The USDA Soil Survey Map is presented in Figure 8.
