## **SOILS AND GEOLOGY STUDY**

**Falcon Reserve  
EPC Schedule No. 5225400001  
El Paso County, Colorado**

**JOB NO. 188276**

**July 14, 2022**

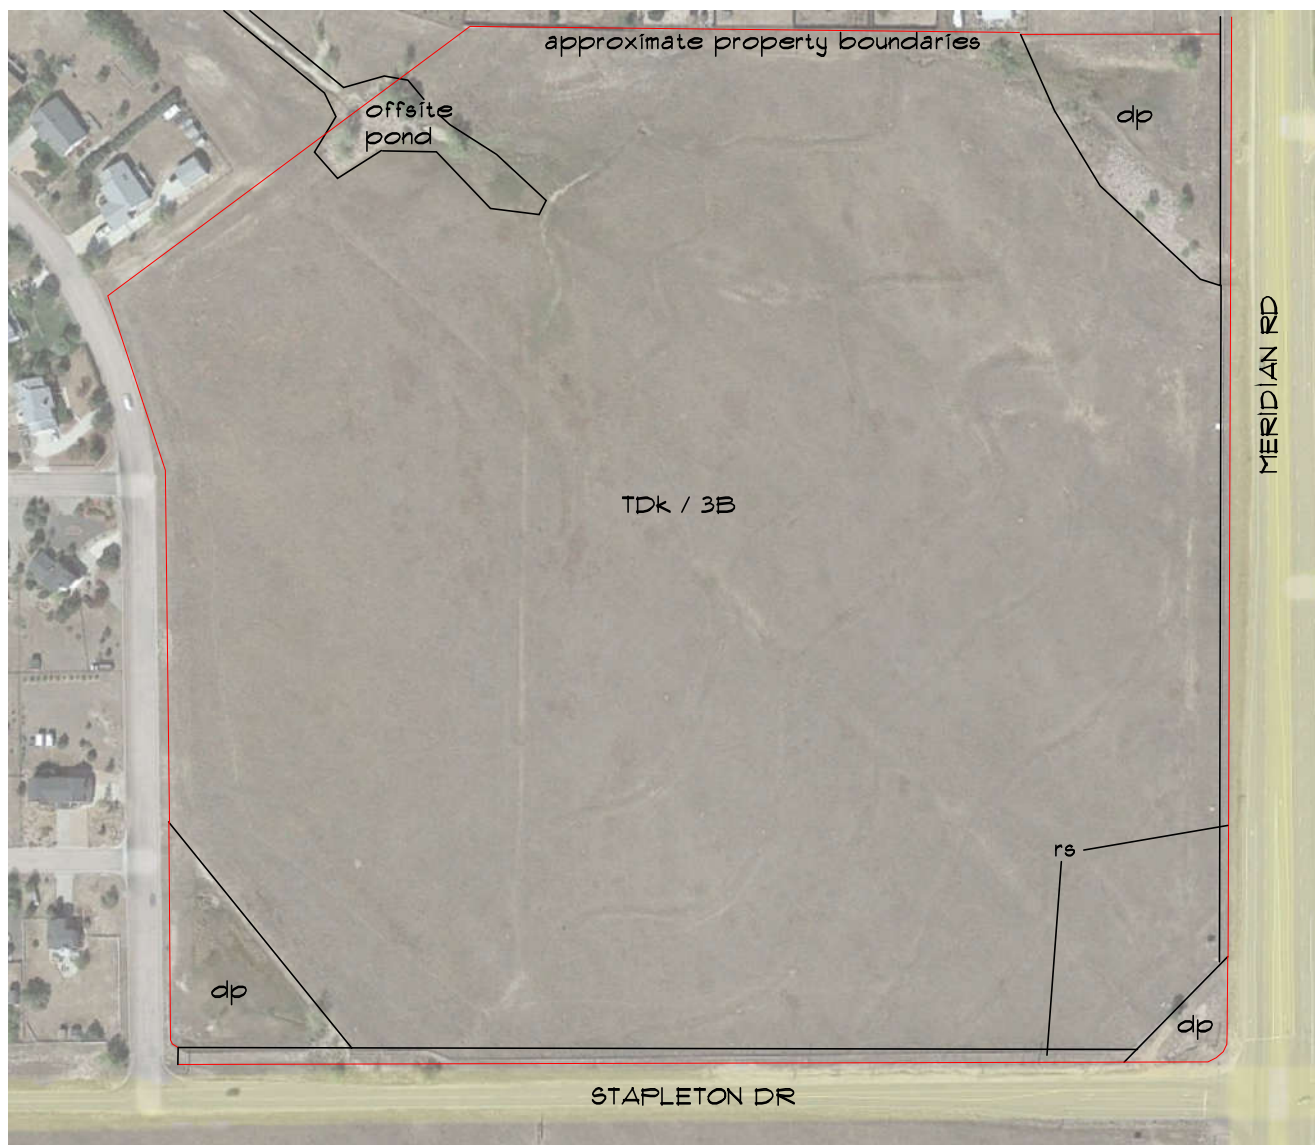
FIG No. 10

Geologic  
Tda - Dawson Arkose

Engineering  
3B - Stable alluvium, colluvium and bedrock on flat to moderate slopes (0% to 12%)

Based on our field observations, the USDA map and the Geologic Map of the Falcon quadrangle, an interpreted geologic map of significant surficial deposits and features was mapped for the site. The identified geologic conditions affecting the development are presented in the Engineering Geology Map, Figure 10.

The engineering geology is presented in the Engineering Geology Map, Figure 10.
