SOILS AND GEOLOGY STUDY

**Cornerstone Estates
Northwest of the Intersection of Goodson Rd and Rex Rd
El Paso County, Colorado**

JOB NO. 184228

November 5, 2021

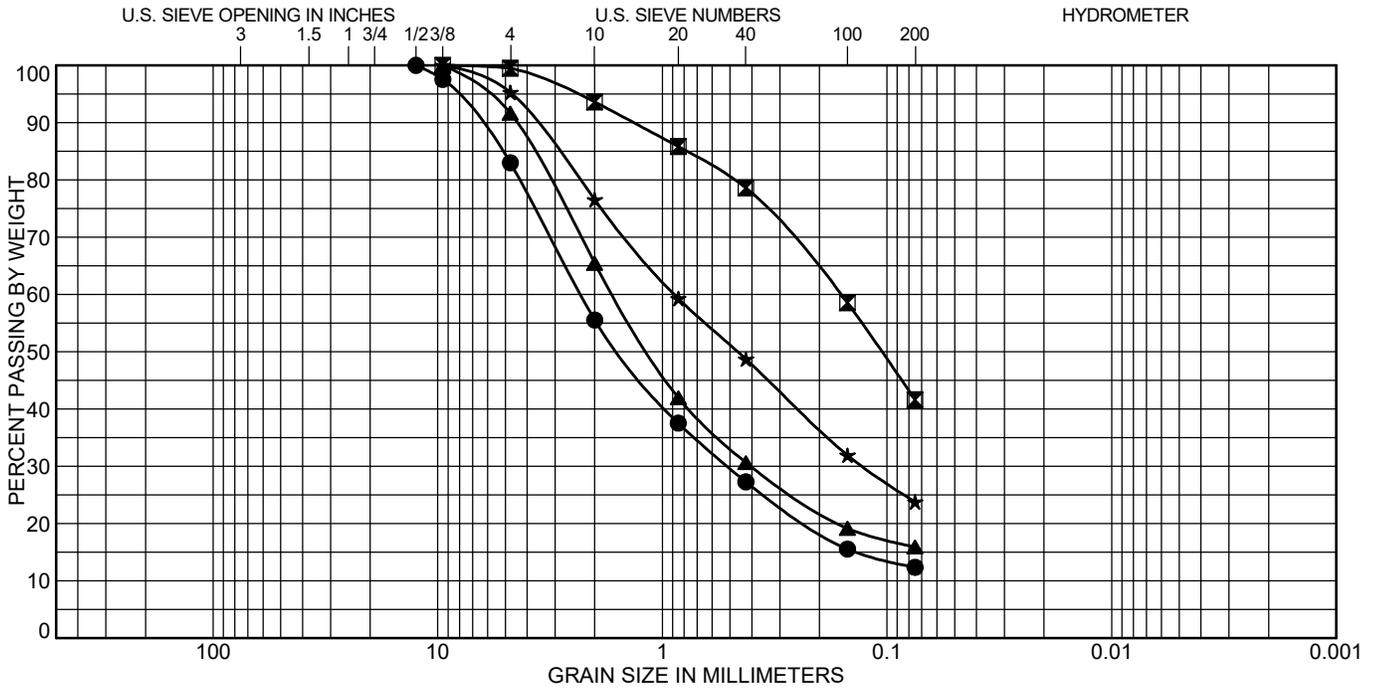
FIGURE No. 9

COBBLES	GRAVEL		SAND			SILT OR CLAY
	coarse	fine	coarse	medium	fine

Test Boring	Depth (ft)	Classification	LL	PL	PI
● 3	9.0				
☒ 7	4.0	CLAYEY SAND(SC)	32	15	17
▲ 12	9.0	CLAYEY SAND(SC)	36	15	21
★ 15	4.0	CLAYEY SAND(SC)	27	18	9

Soil laboratory testing was performed as part of this investigation. Laboratory testing included moisture content, grain-size analysis and Atterberg Limits. A Summary of Laboratory Test Results is presented in Figure 8. Soil Classification Data is presented in Figure 9.

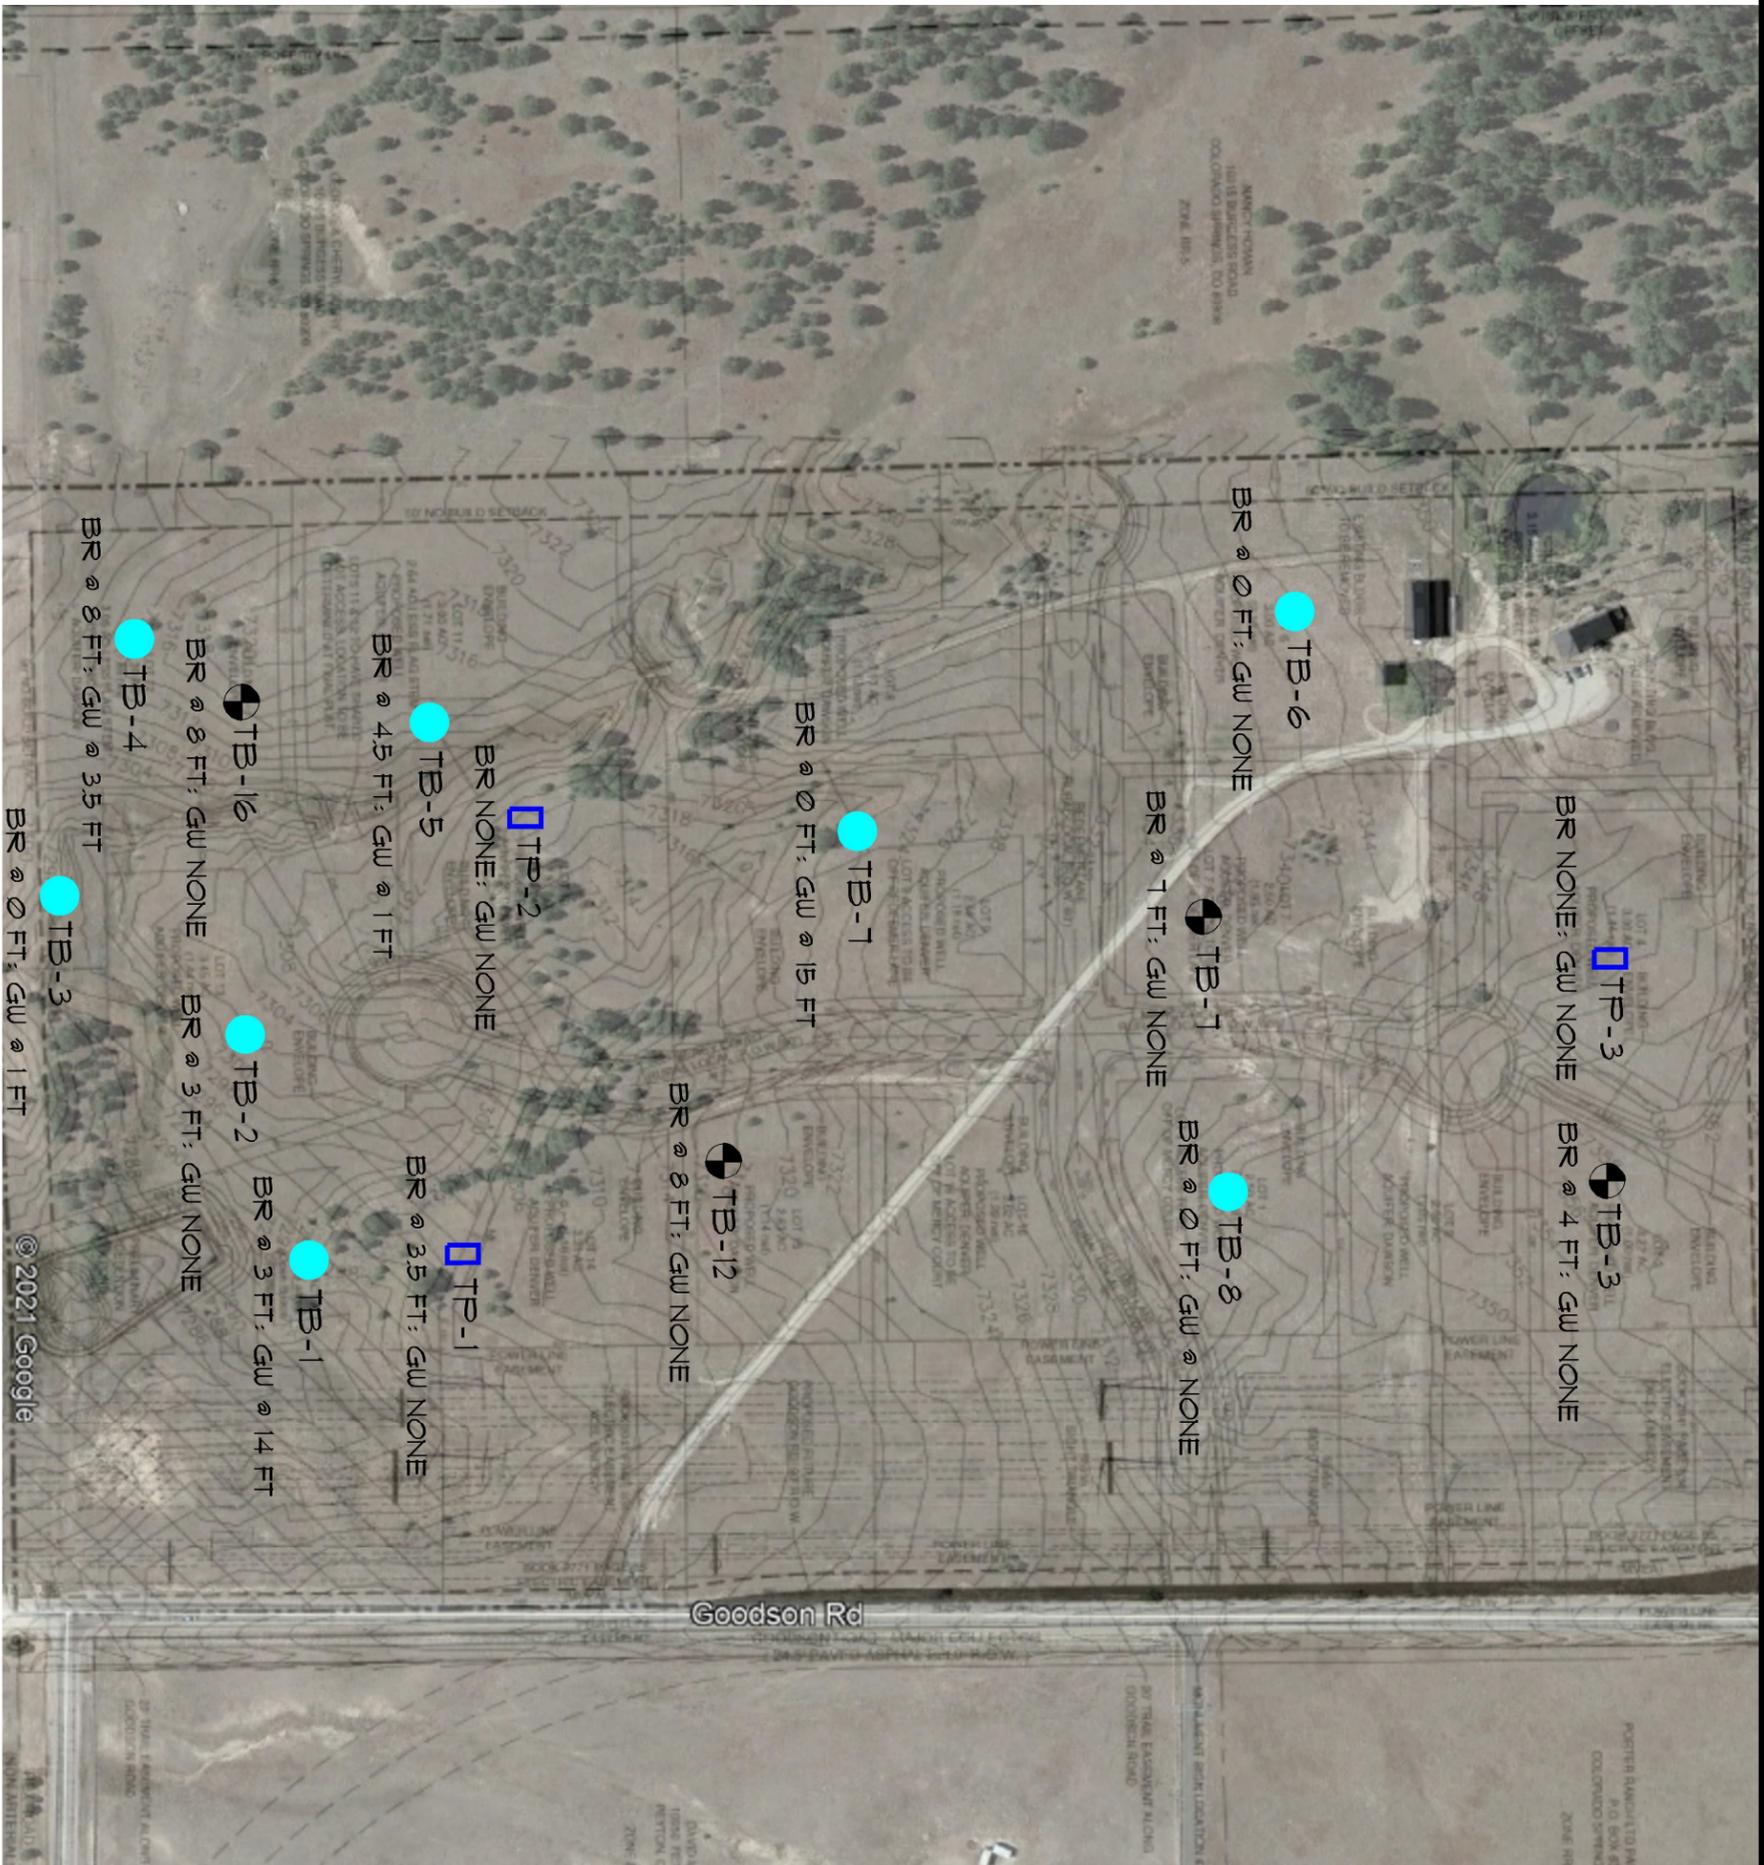
SHEET No.
FIG-13

TEST BORING AND
 TEST PIT LOCATION
 MAP

DENOTES APPROXIMATE
 LOCATION OF TEST BORINGS
 PERFORMED FOR THIS
 INVESTIGATION

Based on our site observations and review of the Black Forest Quadrangle and Google Earth images dating back to September 1999, springs do not appear to originate on the subject site. Groundwater was not encountered at the time of drilling for this investigation. However, areas of shallow groundwater were encountered in our 2008 investigation. In these areas, we would anticipate the potential for periodically high subsurface moisture conditions and frost heave potential. Depths of groundwater for the 2008 investigation are presented in Figure 13, Test Boring and Test Pit Location Map.

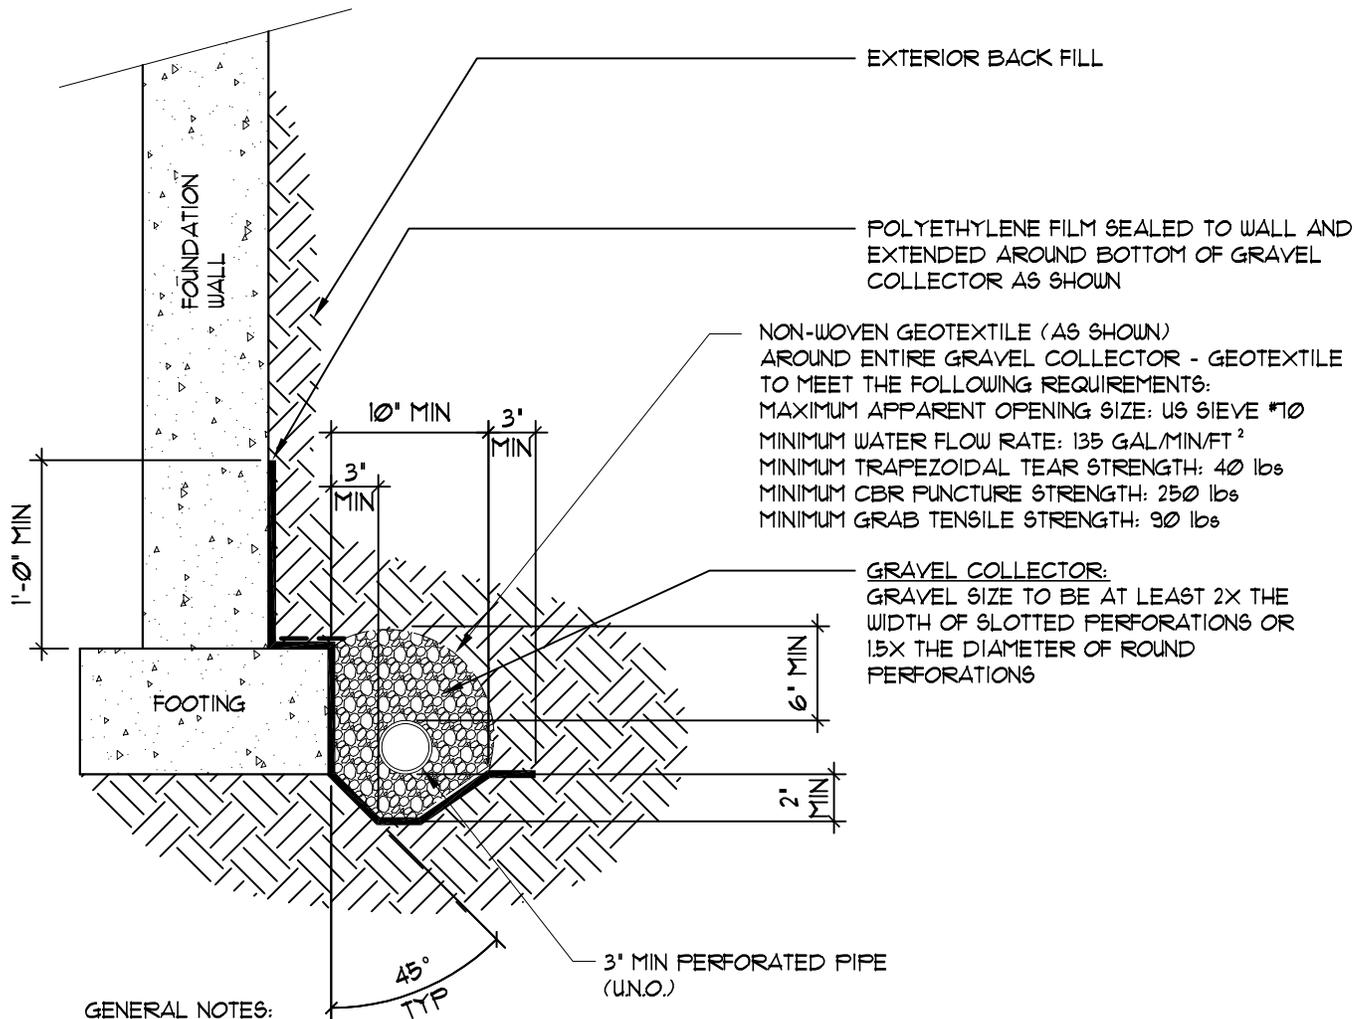
FIG No. 14

1. BOTTOM OF DRAIN PIPE SHALL BE AT OR BELOW BOTTOM OF FOOTING AT ALL LOCATIONS
2. ALL DRAIN PIPE SHALL BE PERFORATED PLASTIC, WITH THE EXCEPTION OF THE DISCHARGE PORTION WHICH SHALL BE SOLID, NON-PERFORATED PIPE.

PERIMETER DRAIN

Foundations must have a minimum 30-inch depth for frost protection. Perimeter drains are recommended around portions of the structures which will have habitable or storage space located below the finished ground surface. This includes crawlspace areas but not the walkout trench, if applicable. Perimeter drains are recommended for portions of the structures which will have below-grade spaces to help reduce the intrusion of water into areas below grade. A typical perimeter drain detail is presented in Figure 14.

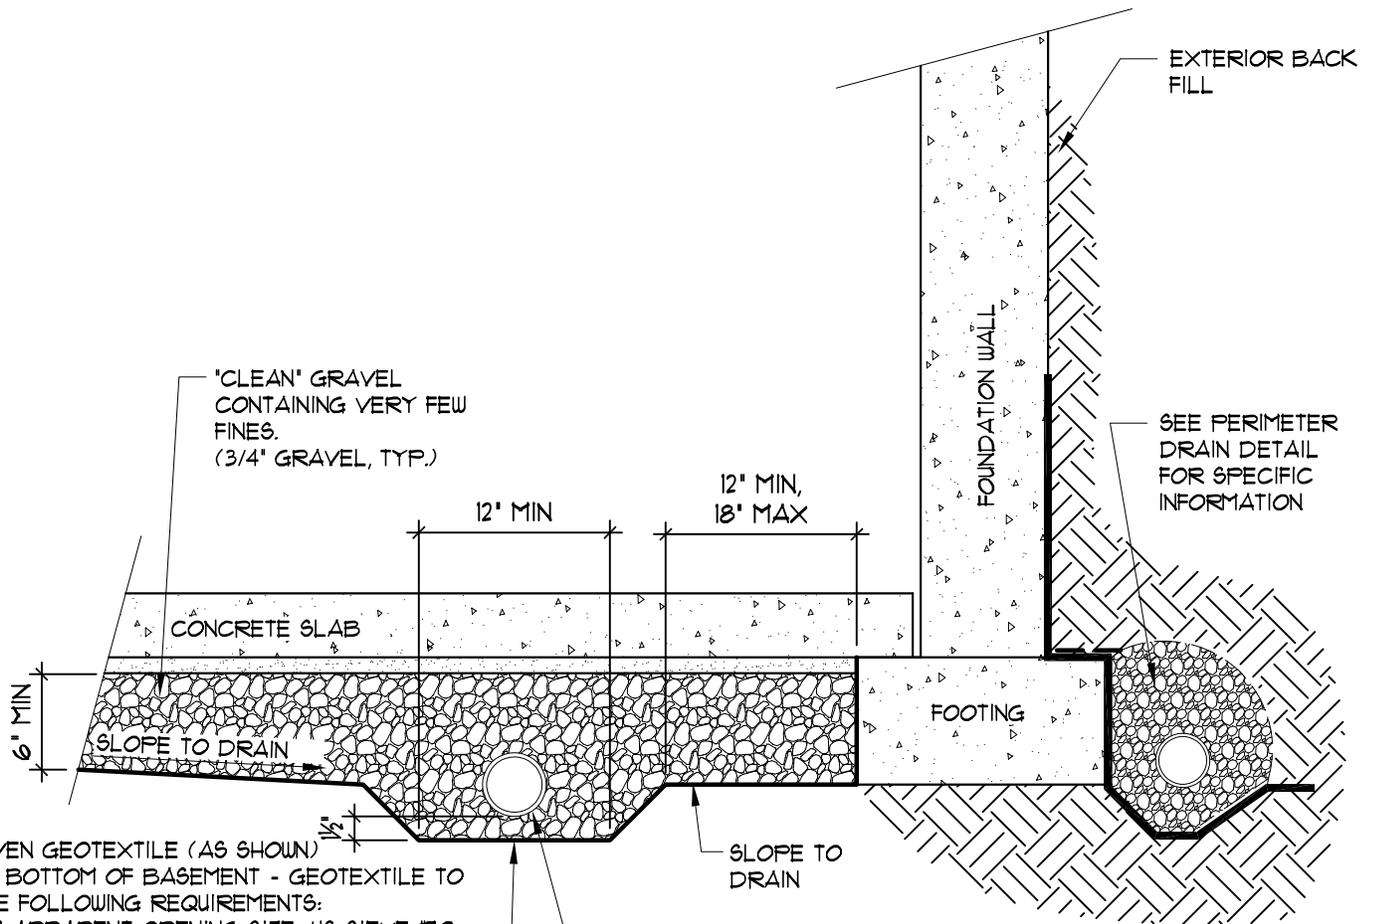
FIG No. 15

NON-WOVEN GEOTEXTILE (AS SHOWN) ACROSS BOTTOM OF BASEMENT - GEOTEXTILE TO MEET THE FOLLOWING REQUIREMENTS:
 MAXIMUM APPARENT OPENING SIZE: US SIEVE #10
 MINIMUM WATER FLOW RATE: 135 GAL/MIN/FT²
 MINIMUM TRAPEZOIDAL TEAR STRENGTH: 40 lbs
 MINIMUM CBR PUNCTURE STRENGTH: 250 lbs
 MINIMUM GRAB TENSILE STRENGTH: 90 lbs

3' DIAMETER RIGID PERFORATED PIPE CONNECTED TO A SUITABLE GRAVITY OUTFALL SUCH AS AN UNDERDRAIN LOCATED IN THE UTILITY TRENCH IN THE STREET WITH A MIN. GRADE OF PIPE = 15%. IF A FREE GRAVITY OUTFALL CANNOT BE ACHIEVED, A SUMP PIT AND PUMP SHOULD BE PROVIDED.

One such system is an underslab drainage layer to help intercept groundwater before it enters the slab area should the groundwater levels rise. In general, if groundwater was encountered within 4 to 6 feet of the proposed basement slab elevation, an underslab drain should be anticipated. An Underslab Drain detail is presented in Figure 15. Another such system would consist of a subsurface drain and/or vertical drain board placed around the perimeter of the overexcavation to help intercept groundwater and allow for proper placement and compaction of the replacement structural fill. Careful attention should be paid to grade and discharge of the drain pipes of these systems.

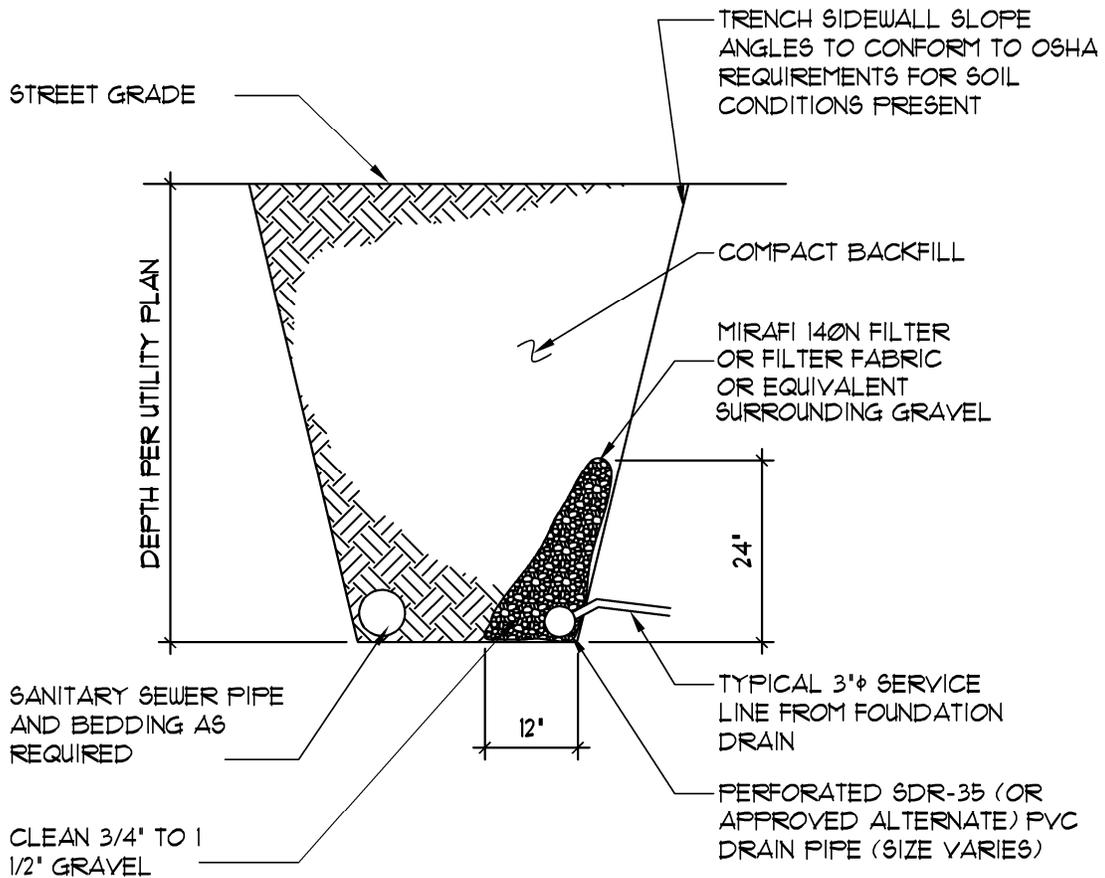
FIG No. 16

NOTE: TO BE USED IN CASES WHERE
GROUNDWATER IS FOUND DURING TRENCHING
OR WHERE SHALLOW GROUNDWATER IS KNOWN
TO EXIST

ACTIVE UNDERDRAIN IN
SANITARY SEWER TRENCH

In areas where basements are proposed, an underdrain placed at the bottom of sanitary sewer trenches within drive lanes may help reduce the impact of groundwater on basement feasibility. Underdrains placed in sanitary sewer trenches in areas where groundwater is anticipated will likely be the “active” type, which uses a perforated drain pipe. In areas where groundwater is not anticipated, “passive” type underdrains may be used. Typical underdrain details are presented in Figures 16 and 17

It is a common local practice for underdrains to be placed at the bottom of sanitary sewer trenches within drive lanes. Underdrains placed in the sanitary sewer trenches in areas where groundwater is anticipated will likely be the "active" type, which uses a perforated drain pipe. In areas where groundwater is not anticipated, "passive" type underdrains may be used. The outfall for the sanitary sewer trench underdrain was not known at the time of this investigation because the development plan and grading plan were not available for our review. Typical underdrain details are presented in Figures 16 and 17.

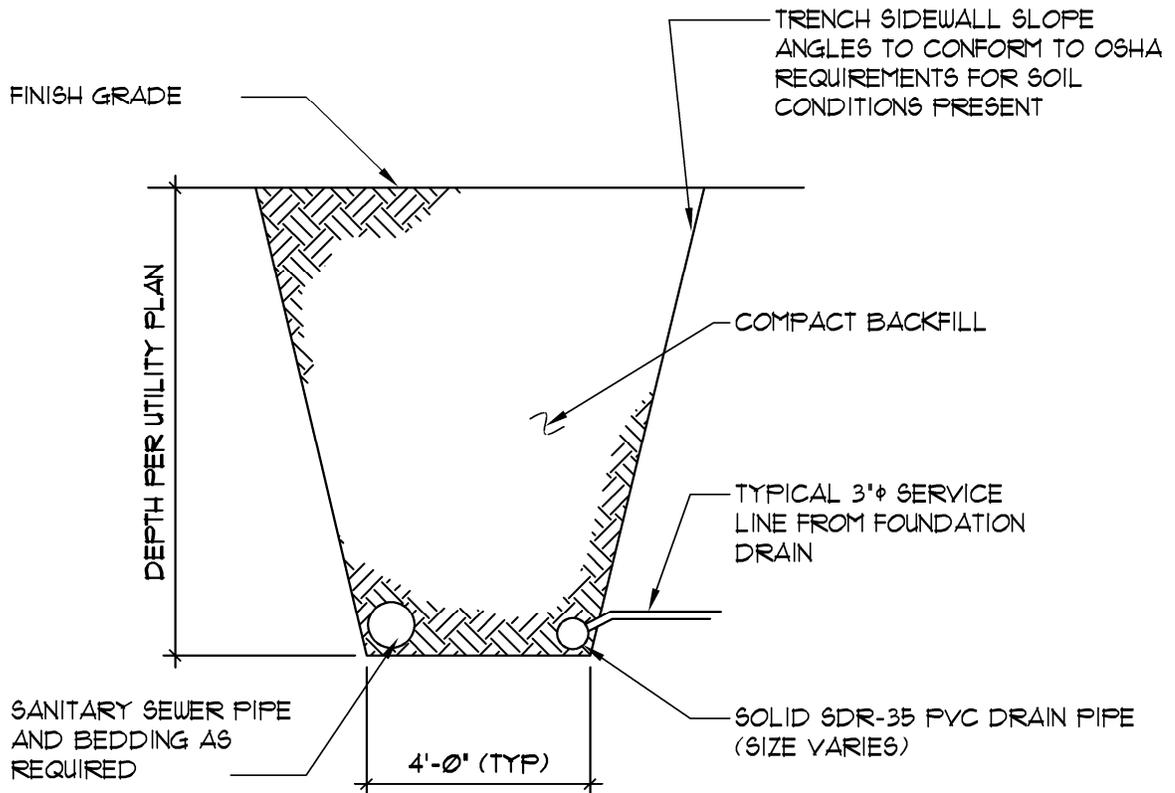
NOTE: TO BE USED WHERE NO SHALLOW
GROUNDWATER IS KNOWN TO EXIST

PASSIVE UNDERDRAIN IN
SANITARY SEWER TRENCH
