**SOIL, GEOLOGY, GEOLOGIC HAZARD,
AND WASTEWATER STUDY,
ABERT RANCH
STEPPLER ROAD AND HODGEN ROAD
EL PASO COUNTY, COLORADO**

Jerome Hannigan and Associates, Inc.
19360 Spring Valley Road
Monument, Colorado 80132

February 2, 2017

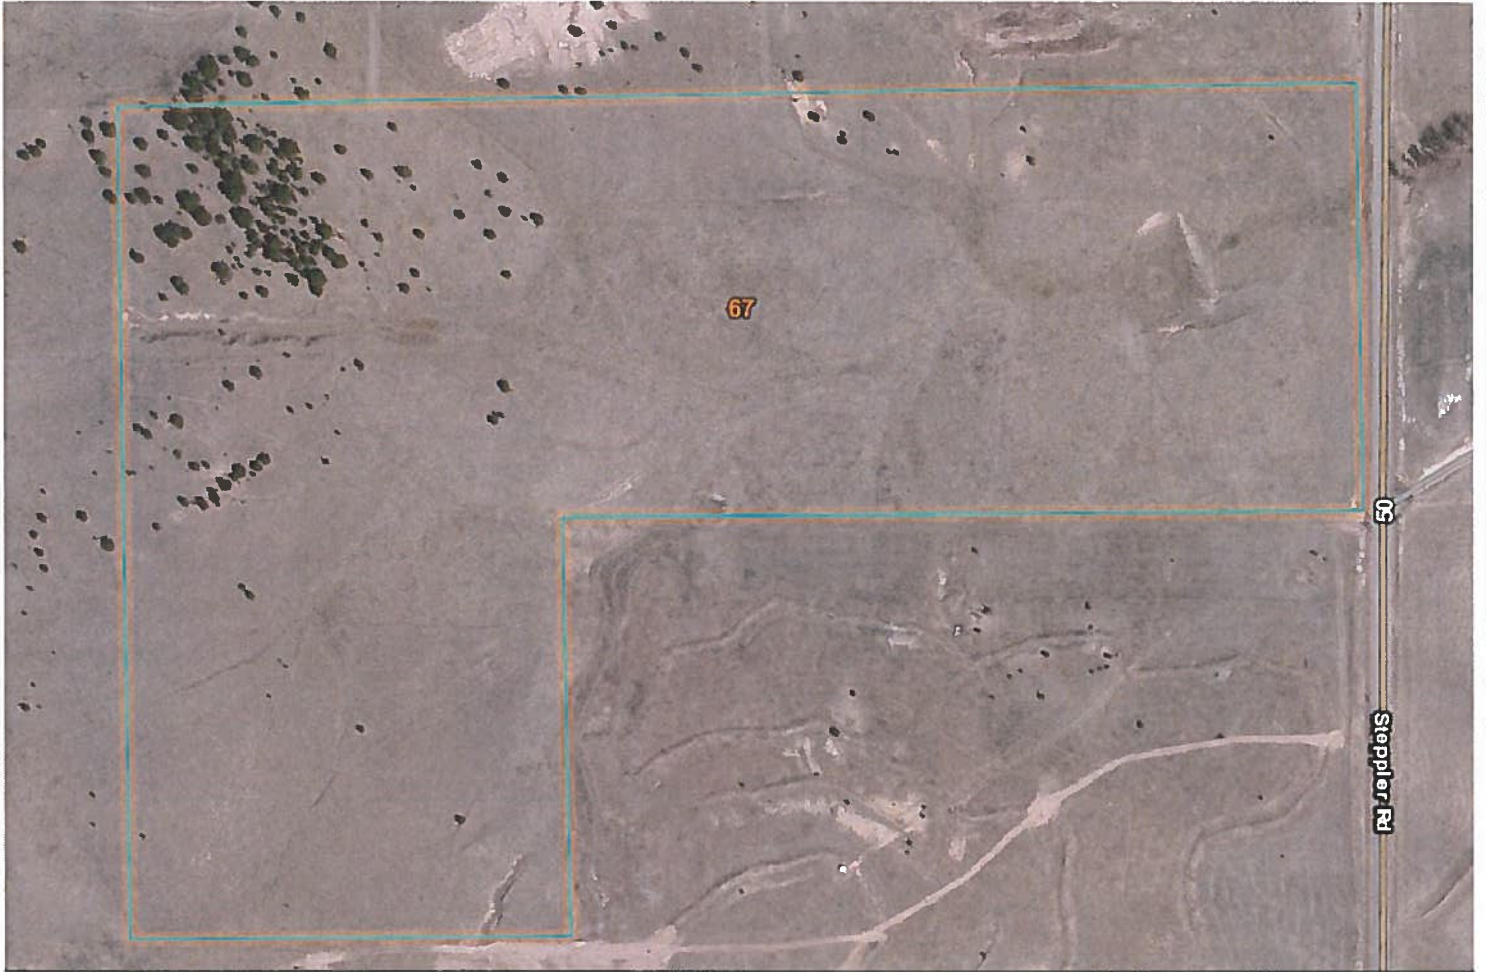
FIG NO.:
4

SOIL SURVEY MAP
ABERT RANCH
EL PASO COUNTY, CO.
FOR: JEROME HANNIGAN & ASSOCIATES, INC.

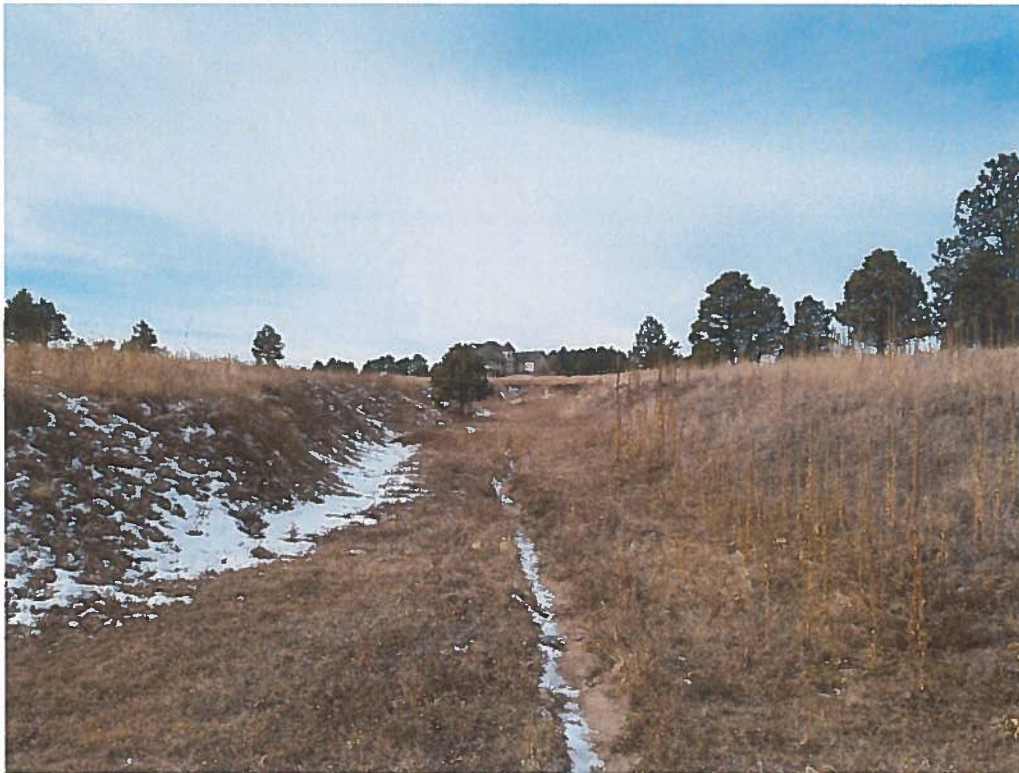
**Looking west up the
drainage and erosion
area in the western
portion of the site.**
