Re: Embankment Recommendations

Abert Ranch Subdivision El Paso County, Colorado

The project is to consist the construction of a detention pond/earthen embankment located on Lot 10 of Abert Ranch. The proposed detention pond will be constructed in the location of an existing stock pond.

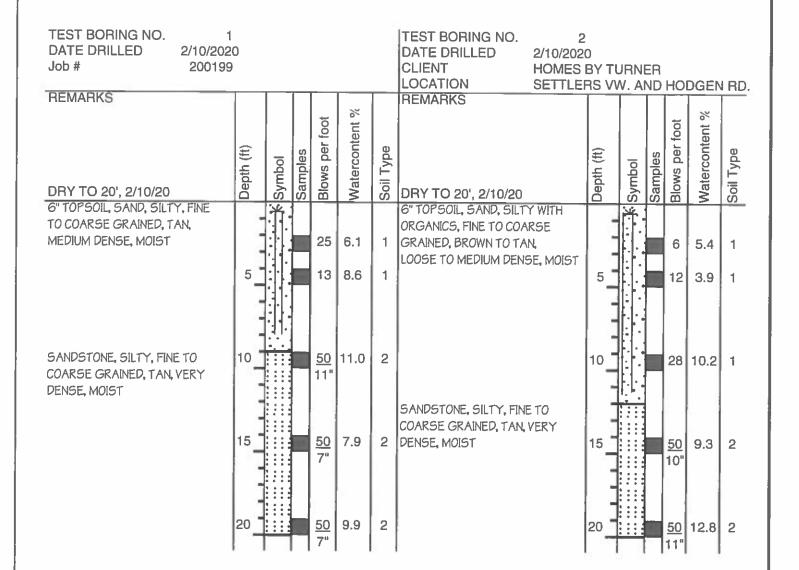
TEST BORING LOG				
DRAWN	DATE	CHECKED:	DATE: 2/15/20

TEST BORING NO. 3 TEST BORING NO. DATE DRILLED 2/10/2020 **DATE DRILLED** Job# 200199 CLIENT HOMES BY TURNER LOCATION SETTLERS VW. AND HODGEN RD. REMARKS REMARKS Watercontent % Blows per foot Blows per foot Watercontent **DRILLED WITH A 3"** Soil Type Depth (ft) Samples Samples Depth (ft) Symbol HAND AUGER Symbol DRY TO 5', 2/18/20 FILL, CLAY, SANDY, BROWN, FIRM, MOIST 6\* 7.9 1A 5 8\* 9.2 1A 5 \* - DRIVES TAKEN WITH A 351b HAMMER, BLOW COUNTS CONVERTED TO STANDARD 140b HAMMER 10 10 15 15 20 20

Soil Type 1A classified as sandy clay fill (CL). The sandy clay fill was encountered in Test Boring No. 3 at the existing ground surface and extending to termination of the boring 5 feet below the existing ground surface (bgs). Standard Penetration Testing conducted on the clay fill resulted in an N-value of 6 to 8 blows per foot (bpf) which indicates firm consistencies. Moisture content and grain size testing resulted in a moisture content of 8 to 9 percent with 68 percent of the soil size particles passing the No. 200 sieve.

Soil Type 1 classified as silty sand (SM). The sand was encountered in Test Boring Nos. 1 and 2 at the existing ground surface and extending to depths of 9 and 12 feet bgs. Standard Penetration Testing conducted on the sand resulted in N-values ranging between 6 and 25 bpf, which indicated loose to medium dense states. Moisture content and grain size testing resulted in moisture contents of 4 to 10 percent with 17 to 23 percent of the soil size particles passing the No. 200 sieve.

Soil Type 2 classified as silty sandstone (SM). The sandstone was encountered in Test Boring Nos. 1 and 2 underlying Soil Type 1 at depths of 9 and 12 feet and extending to the termination of the test borings, 20 feet bgs. Standard Penetration Testing conducted on the sandstone resulted in N-values of greater than 50 bpf which indicates very dense states. Moisture content and grain size testing resulted in moisture contents of 8 to 13 percent with 29 percent of the soil size particles passing the No. 200 sieve.

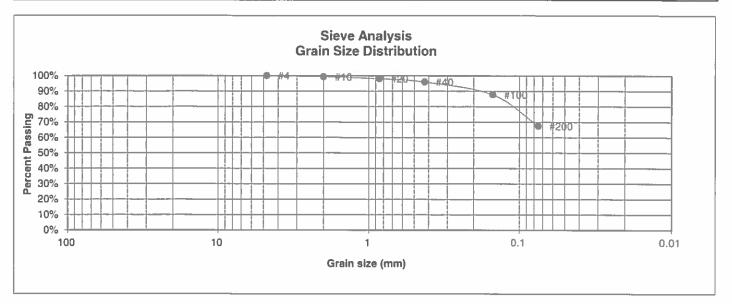
UNIFIED CLASSIFICATION	CL	CLIENT	HOMES BY TURNER
SOIL TYPE #	1A	PROJECT	SETTLERS VW. AND HODGEN RD.
TEST BORING #	3	JOB NO.	200199
DEPTH (FT)	2-3	TEST BY	BL

U.S. <u>Sieve #</u> 3" 1 1/2" 3/4" 1/2" 3/8"	Percent <u>Finer</u>	Atterberg <u>Limits</u> Plastic Limit Liquid Limit Plastic Index
4	100.0%	<u>Swell</u>
10	99.3%	Moisture at start
20	98.1%	Moisture at finish
40	95.9%	Moisture increase
100	87.8%	Initial dry density (pcf)
200	67.5%	Swell (psf)

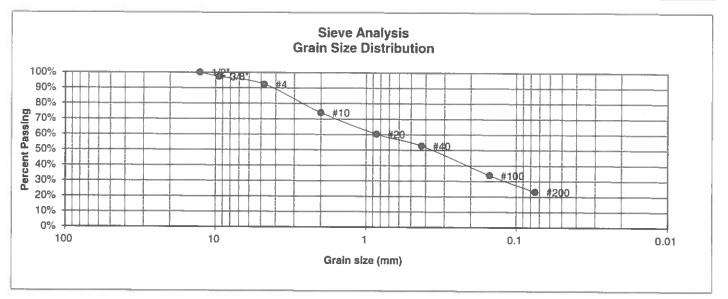
UNIFIED CLASSIFICATION	SM	CLIENT	HOMES BY TURNER
SOIL TYPE #	1	PROJECT	SETTLERS VW. AND HODGEN RD.
TEST BORING #	1	JOB NO.	200199
DEPTH (FT)	2-3	TEST BY	BL

U.S. <u>Sieve #</u> 3" 1 1/2" 3/4" 1/2" 3/8"	Percent <u>Finer</u> 100.0% 97.3%	Atterberg <u>Limits</u> Plastic Limit Liquid Limit Plastic Index
4	92.4%	<u>Swell</u>
10	74.1%	Moisture at start
20	60.3%	Moisture at finish
40	52.8%	Moisture increase
100	33.8%	Initial dry density (pcf)
200	23.2%	Swell (psf)

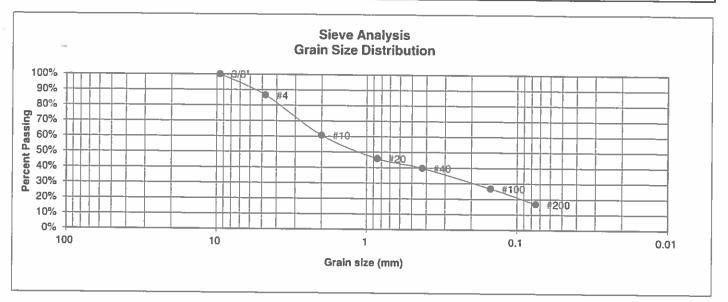
UNIFIED CLASSIFICATION	SM	CLIENT	HOMES BY TURNER
SOIL TYPE #	1	PROJECT	SETTLERS VW. AND HODGEN RD.
TEST BORING #	2	JOB NO.	200199
DEPTH (FT)	5	TEST BY	BL

U.S. <u>Sieve #</u> 3" 1 1/2" 3/4" 1/2" 3/8"	Percent <u>Finer</u> 100.0%	Atterberg <u>Limits</u> Plastic Limit Liquid Limit Plastic Index
4 10	86.5% 60.7%	Swell Moisture at start
20	45.8%	Moisture at finish
40	39.8%	Moisture increase
100	26.8%	Initial dry density (pcf)
200	16.8%	Swell (psf)

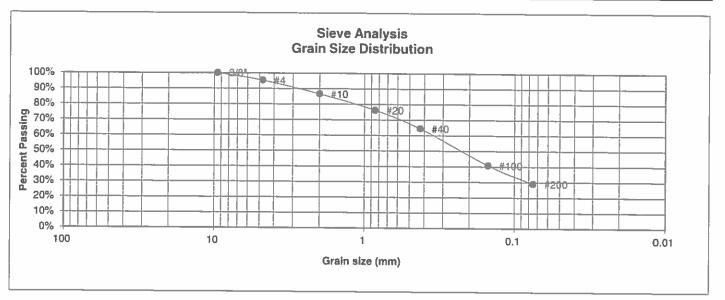
UNIFIED CLASSIFICATION	SM	CLIENT	HOMES BY TURNER
SOIL TYPE #	2	PROJECT	SETTLERS VW. AND HODGEN RD.
TEST BORING #	1	JOB NO.	200199
DEPTH (FT)	10	TEST BY	BL

U.S.	Percent	Atterberg
Sieve #	<u>Finer</u>	<u>Limits</u>
3"		Plastic Limit
1 1/2"		Liquid Limit
3/4"		Plastic Index
1/2"		
3/8"	100.0%	
4	95.3%	<u>Swell</u>
10	86.6%	Moisture at start 12.9%
20	76.3%	Moisture at finish 20.2%
40	64.5%	Moisture increase 7.2%
100	40.8%	Initial dry density (pcf) 100
200	29.0%	Swell (psf) 330
