PAVEMENT DESIGN REPORT

**Skyline at Lorson Ranch, Filing No. 1
El Paso County, Colorado**

JOB NO. 188710

**September 8, 2022
Revised September 27, 2022**

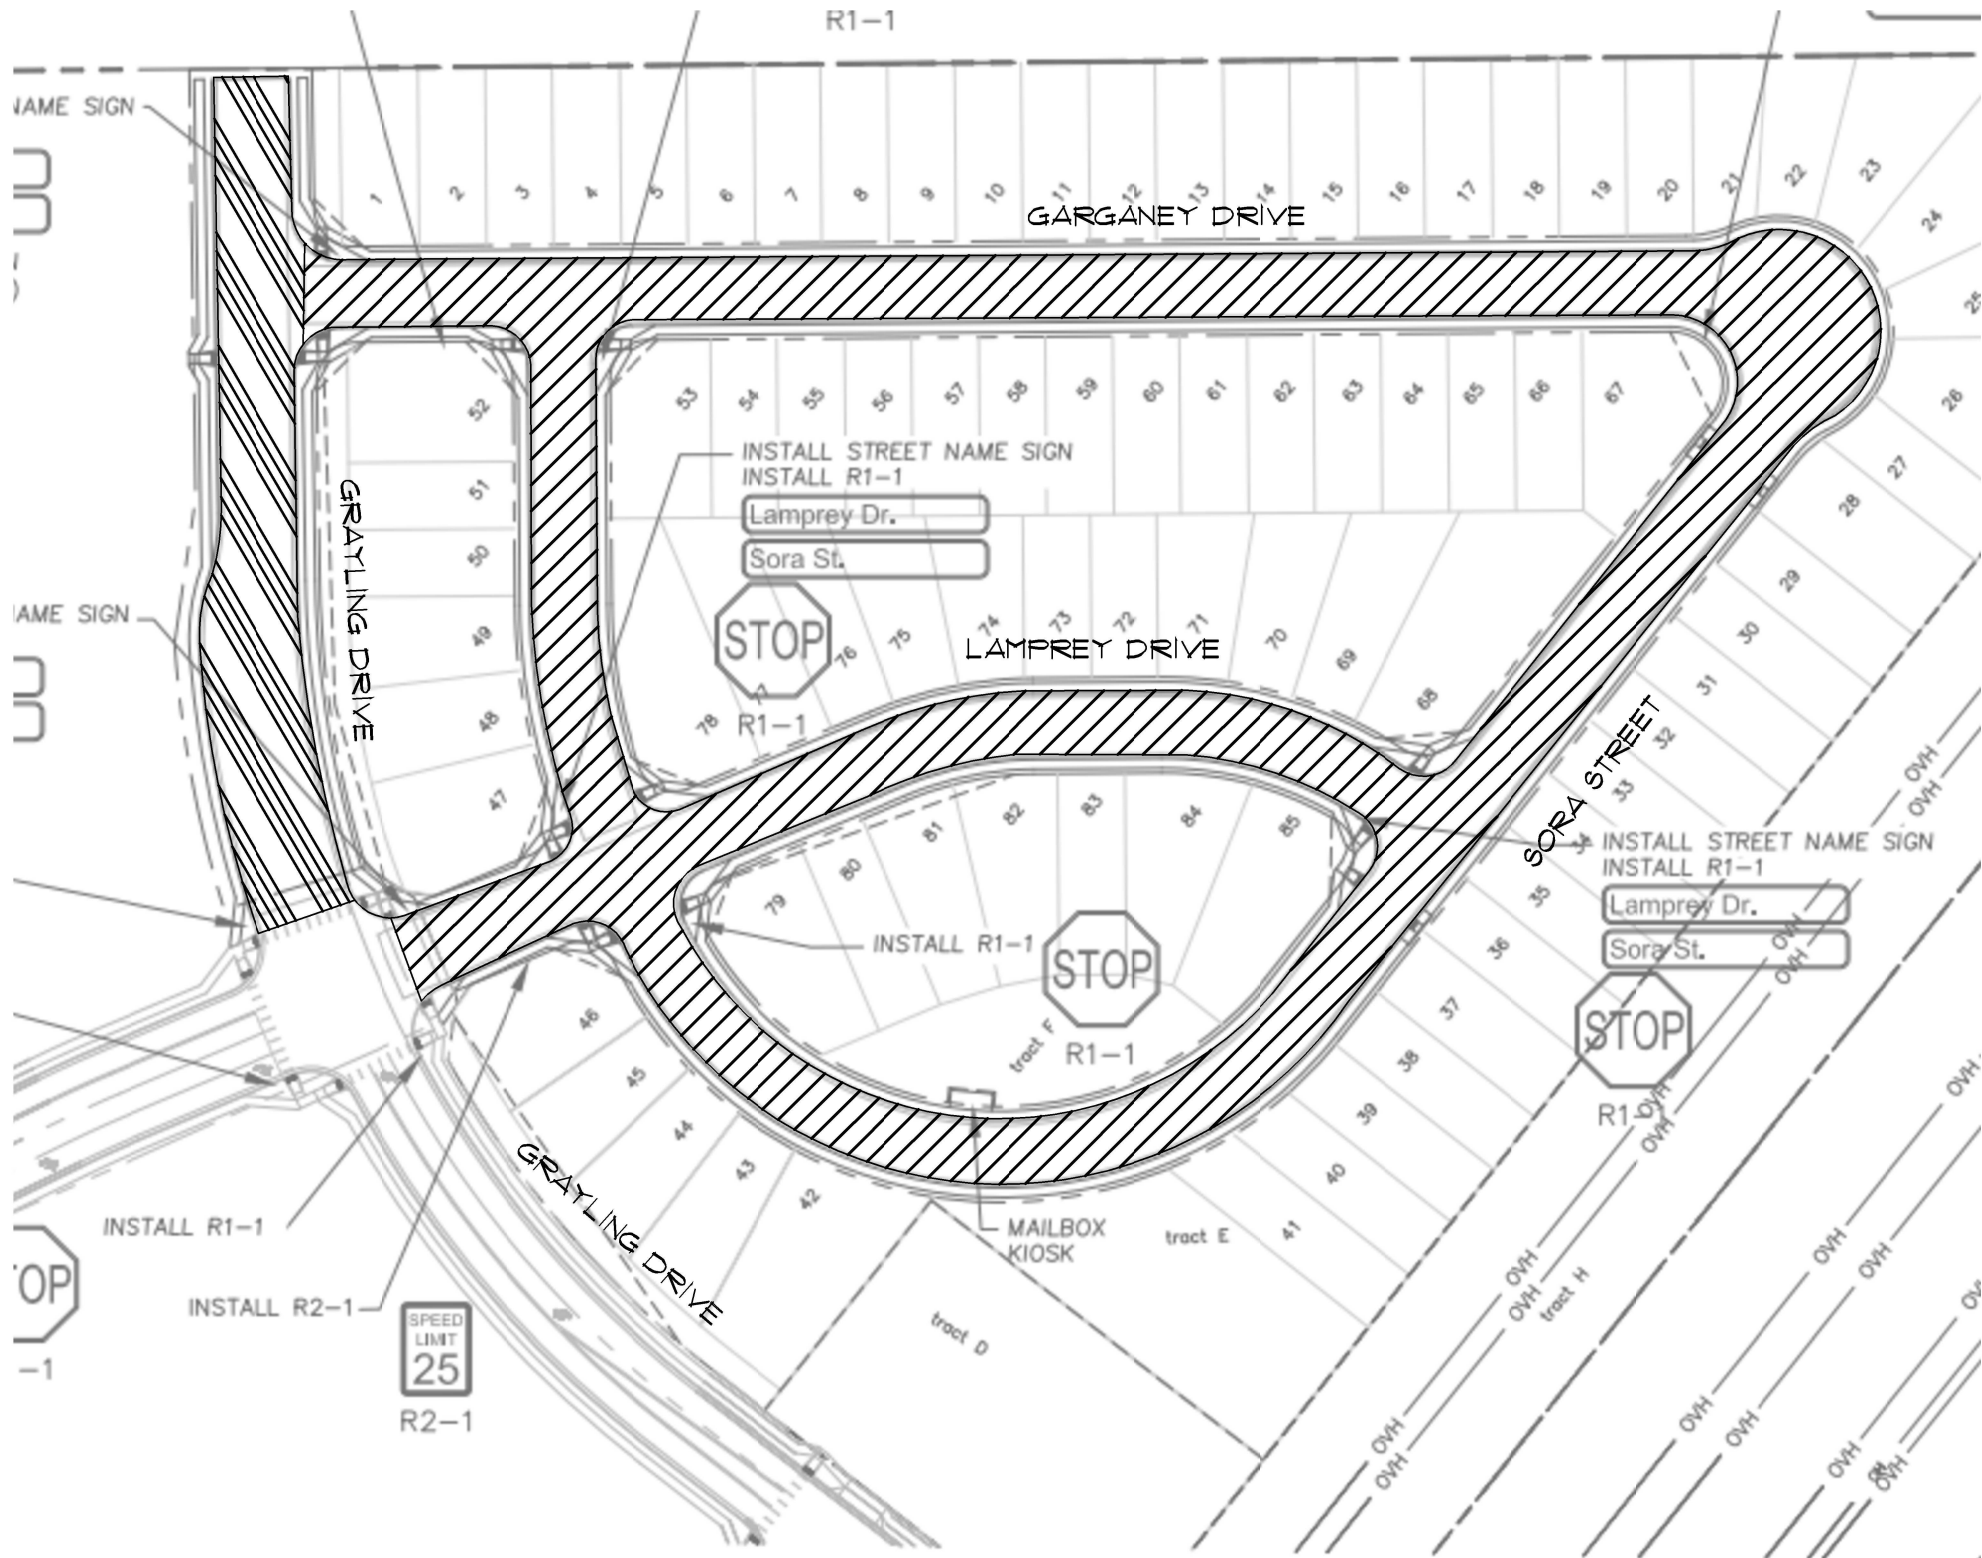
**PAVEMENT
RECOMMENDATIONS**

OPTION 1

5.25" HMA
OVER
12.5" ABC

EPC Planning & Community
Development Department
Condition: For the Local
Residential roads, only
Option 1 may be used.

Based on the design calculations, the recommended pavement sections are presented below and on Figure 2.2.

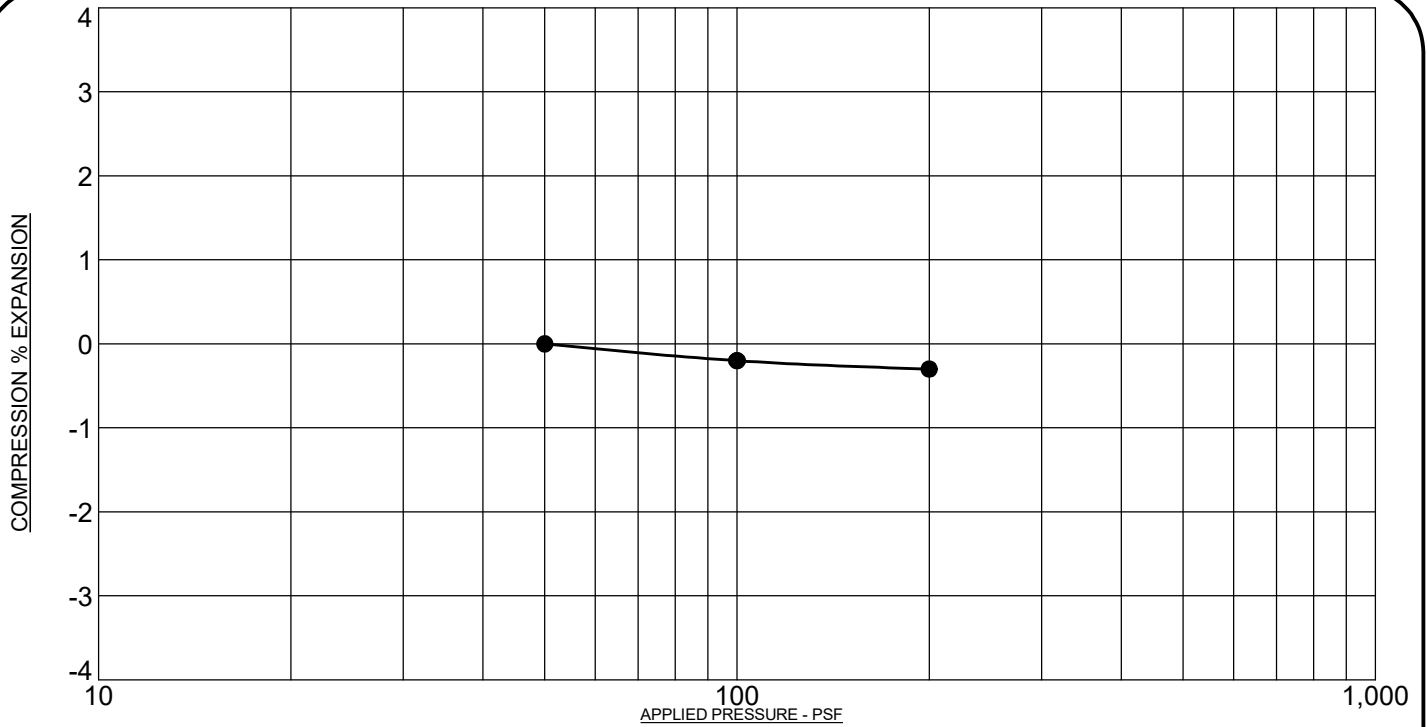
PROJECT: Grayling Dr El Paso County, Colorado
 RMG SOIL TYPE:
 SAMPLE DESCRIPTION: CLAY, SANDY
 NOTE: SAMPLE WAS INUNDATED WITH WATER AT 100 PSF

SAMPLE LOCATION: 1 @ 2 FT
 NATURAL DRY UNIT WEIGHT: 107.8 PCF
 NATURAL MOISTURE CONTENT: 12.2%
 PERCENT SWELL/COMPRESSION: 0.0

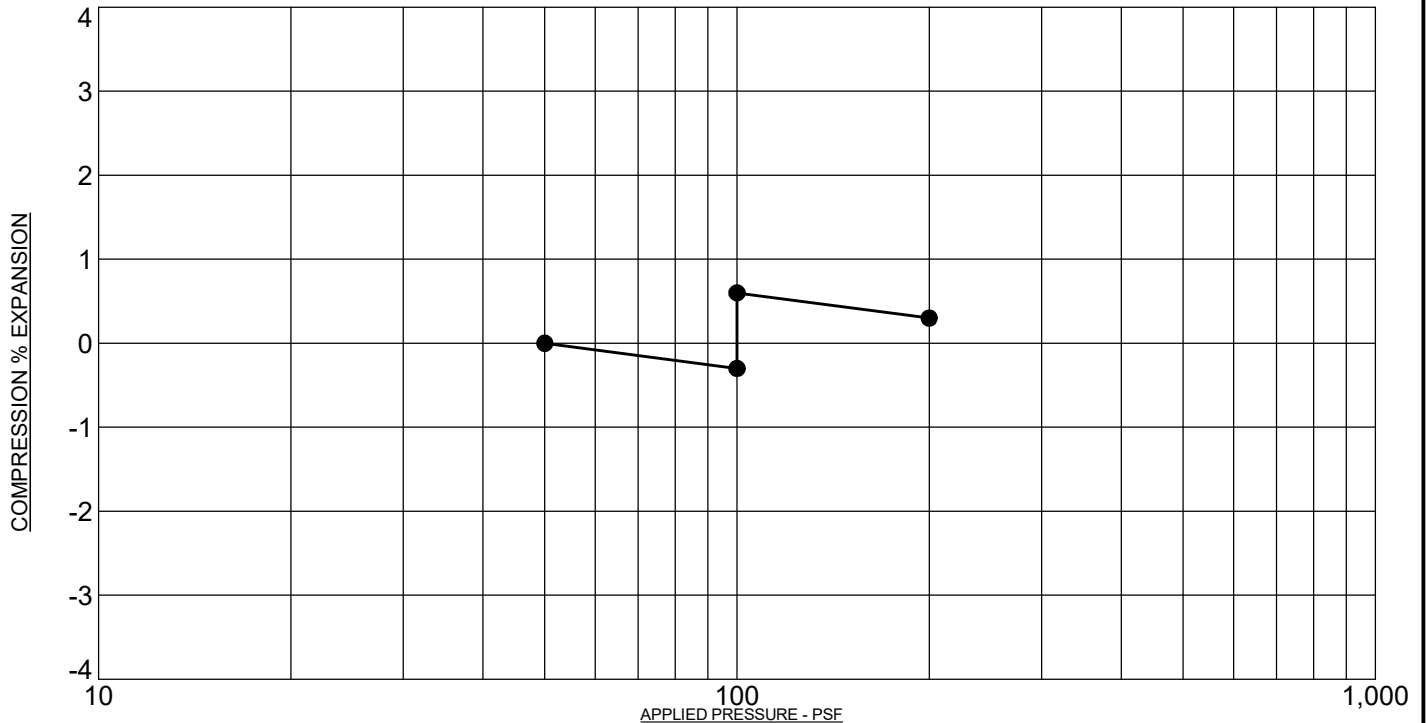
PROJECT: Grayling Dr El Paso County, Colorado
 RMG SOIL TYPE:
 SAMPLE DESCRIPTION: CLAYSTONE, SANDY
 NOTE: SAMPLE WAS INUNDATED WITH WATER AT 100 PSF

SAMPLE LOCATION: 2 @ 2 FT
 NATURAL DRY UNIT WEIGHT: 107.3 PCF
 NATURAL MOISTURE CONTENT: 16.9%
 PERCENT SWELL/COMPRESSION: 0.9

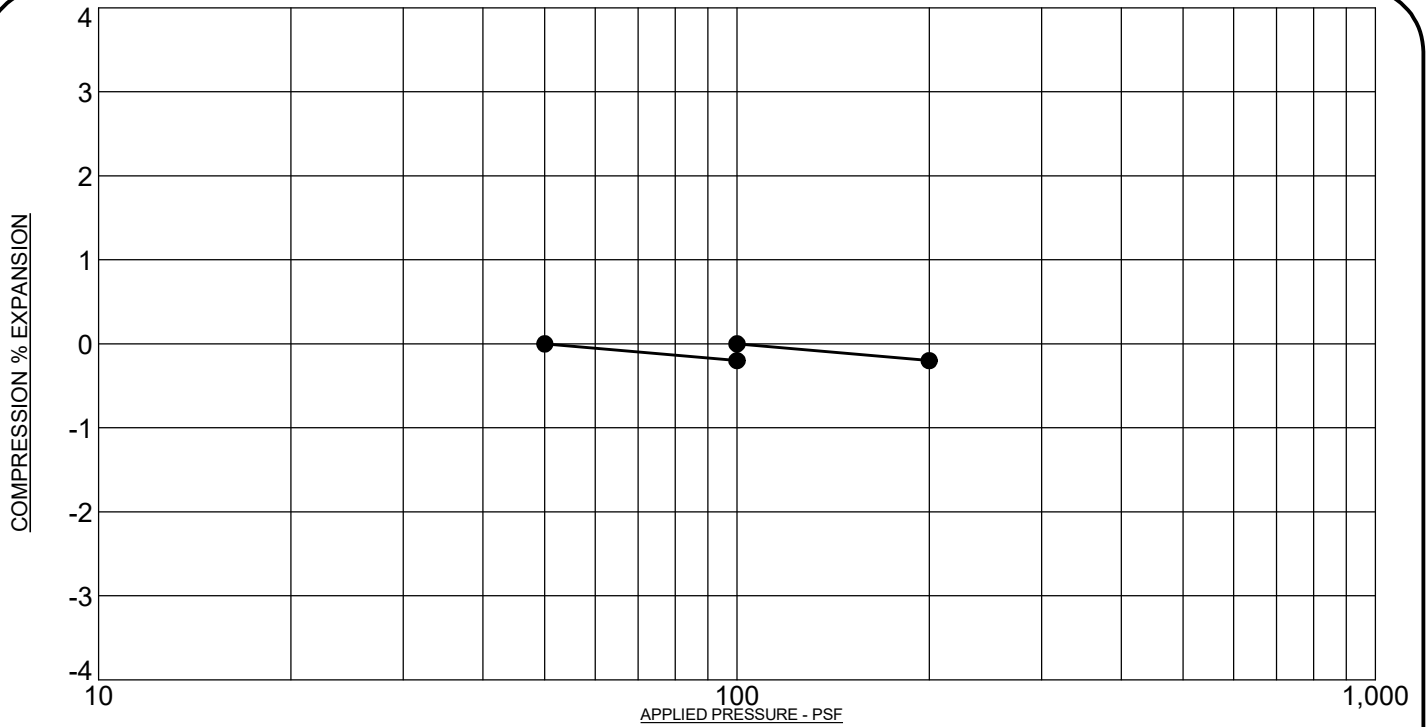
PROJECT: Grayling Dr El Paso County, Colorado
 RMG SOIL TYPE:
 SAMPLE DESCRIPTION: CLAYSTONE, SANDY
 NOTE: SAMPLE WAS INUNDATED WITH WATER AT 100 PSF

SAMPLE LOCATION: 3 @ 2 FT
 NATURAL DRY UNIT WEIGHT: 111.2 PCF
 NATURAL MOISTURE CONTENT: 12.7%
 PERCENT SWELL/COMPRESSION: 0.2

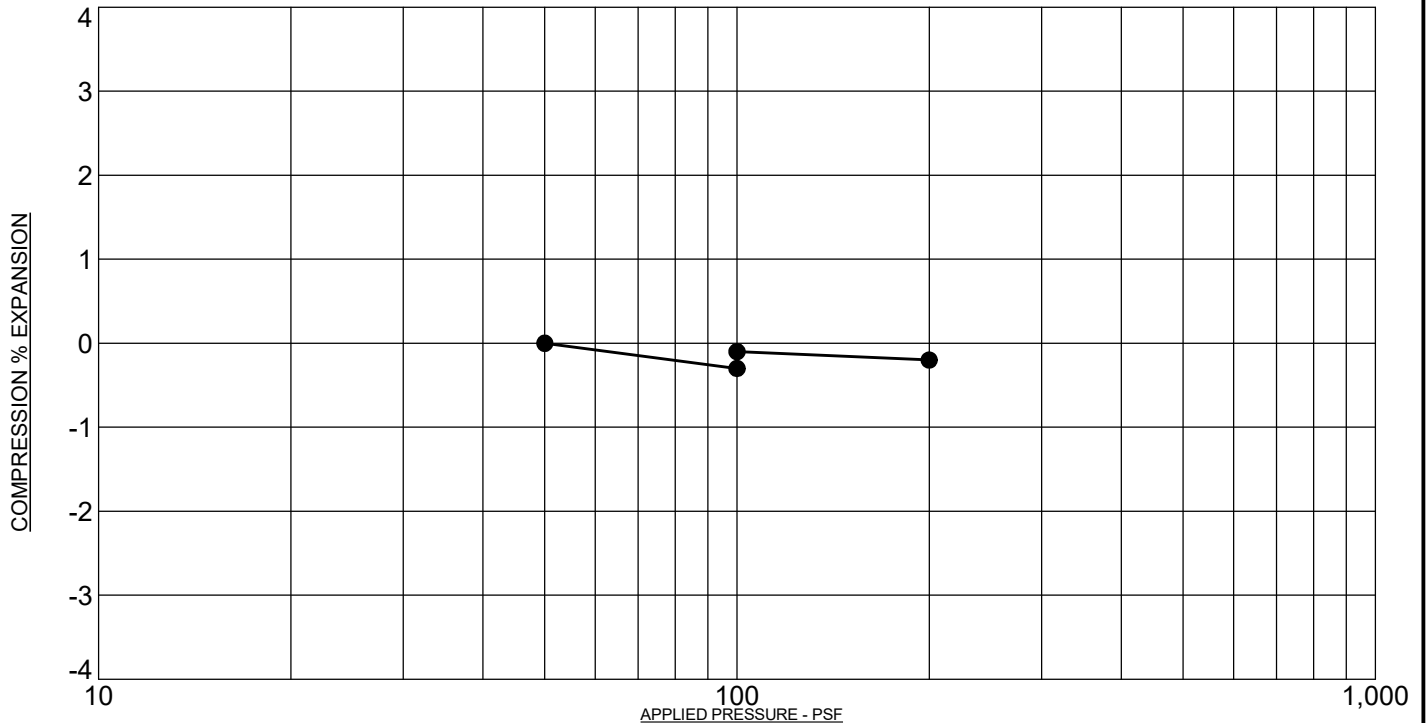
PROJECT: Grayling Dr El Paso County, Colorado
 RMG SOIL TYPE:
 SAMPLE DESCRIPTION: CLAY, SANDY
 NOTE: SAMPLE WAS INUNDATED WITH WATER AT 100 PSF

SAMPLE LOCATION: 4 @ 2 FT
 NATURAL DRY UNIT WEIGHT: 95.9 PCF
 NATURAL MOISTURE CONTENT: 16.8%
 PERCENT SWELL/COMPRESSION: 0.2

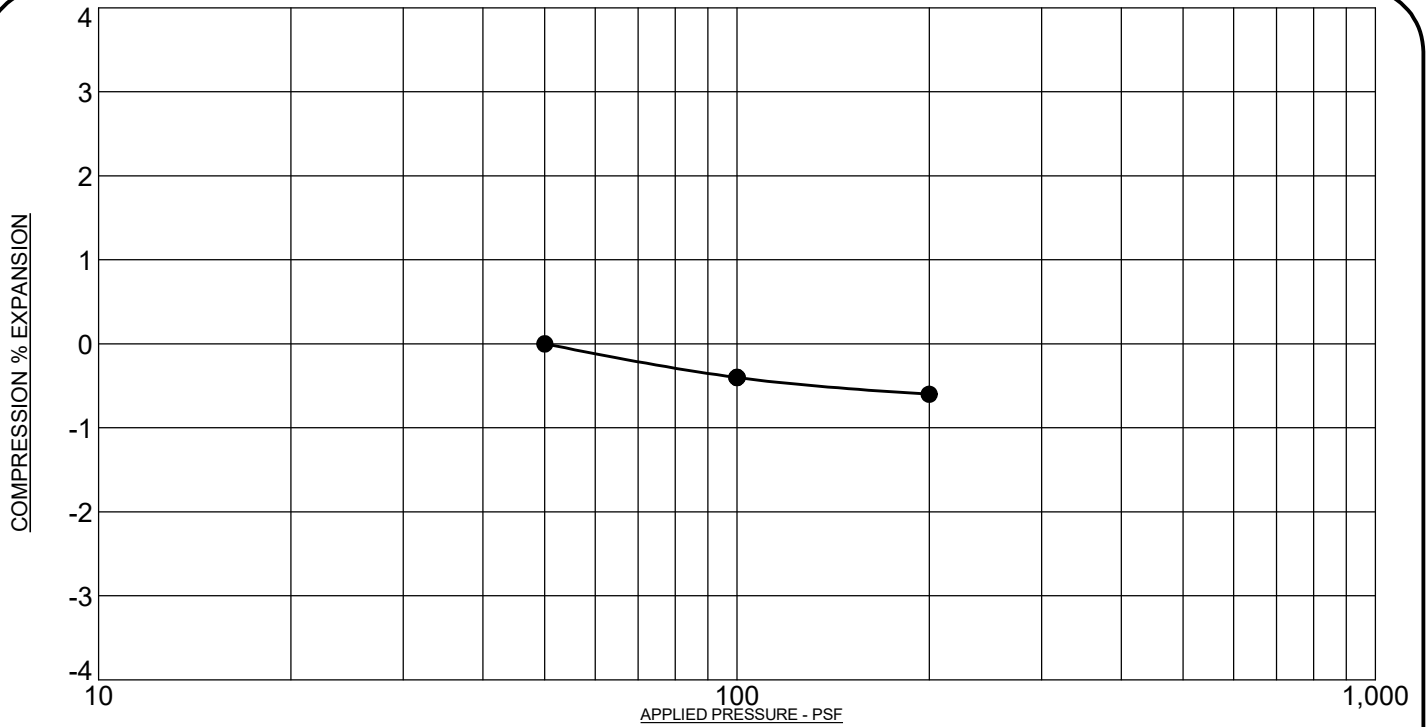
PROJECT: Grayling Dr El Paso County, Colorado
 RMG SOIL TYPE:
 SAMPLE DESCRIPTION: CLAY, SANDY
 NOTE: SAMPLE WAS INUNDATED WITH WATER AT 100 PSF

SAMPLE LOCATION: 5 @ 2 FT
 NATURAL DRY UNIT WEIGHT: 108.8 PCF
 NATURAL MOISTURE CONTENT: 15.2%
 PERCENT SWELL/COMPRESSION: 0.0

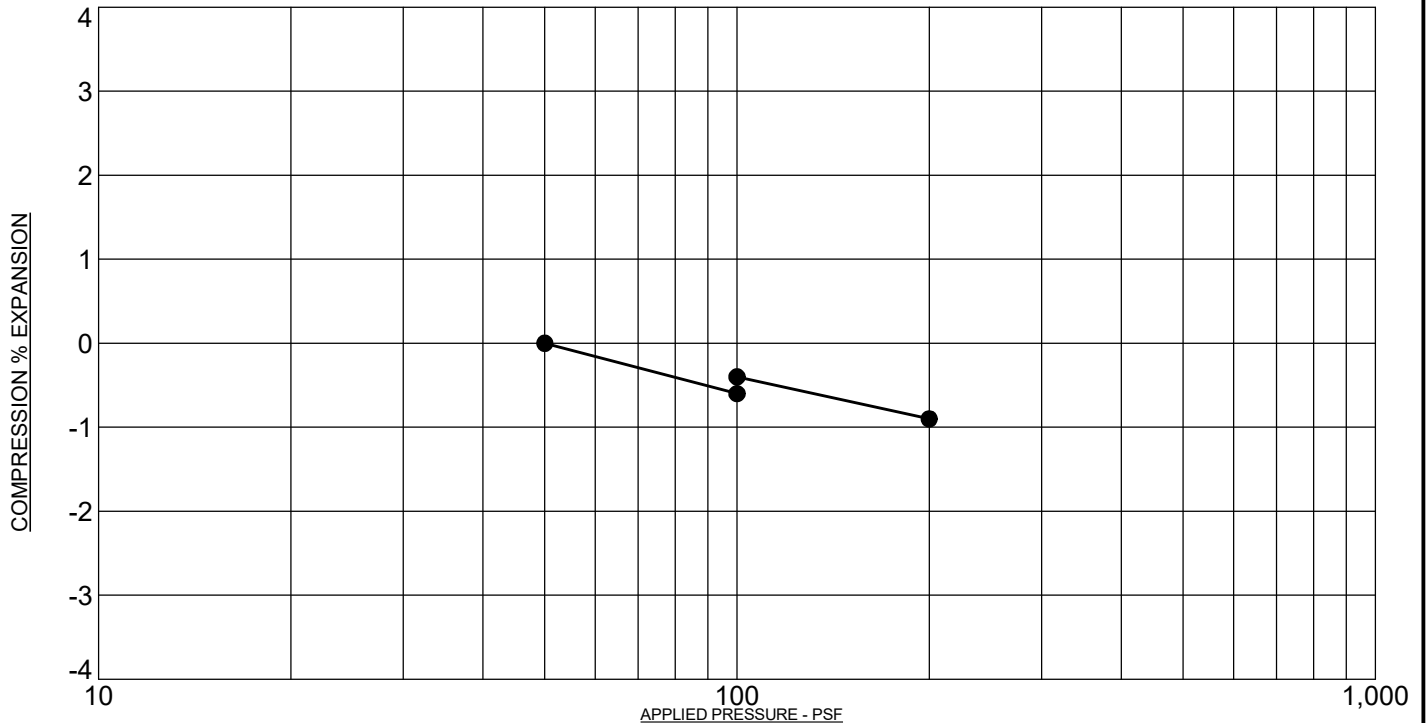
PROJECT: Grayling Dr El Paso County, Colorado
 RMG SOIL TYPE:
 SAMPLE DESCRIPTION: CLAY, SANDY
 NOTE: SAMPLE WAS INUNDATED WITH WATER AT 100 PSF

SAMPLE LOCATION: 6 @ 2 FT
 NATURAL DRY UNIT WEIGHT: 109.1 PCF
 NATURAL MOISTURE CONTENT: 14.9%
 PERCENT SWELL/COMPRESSION: 0.2

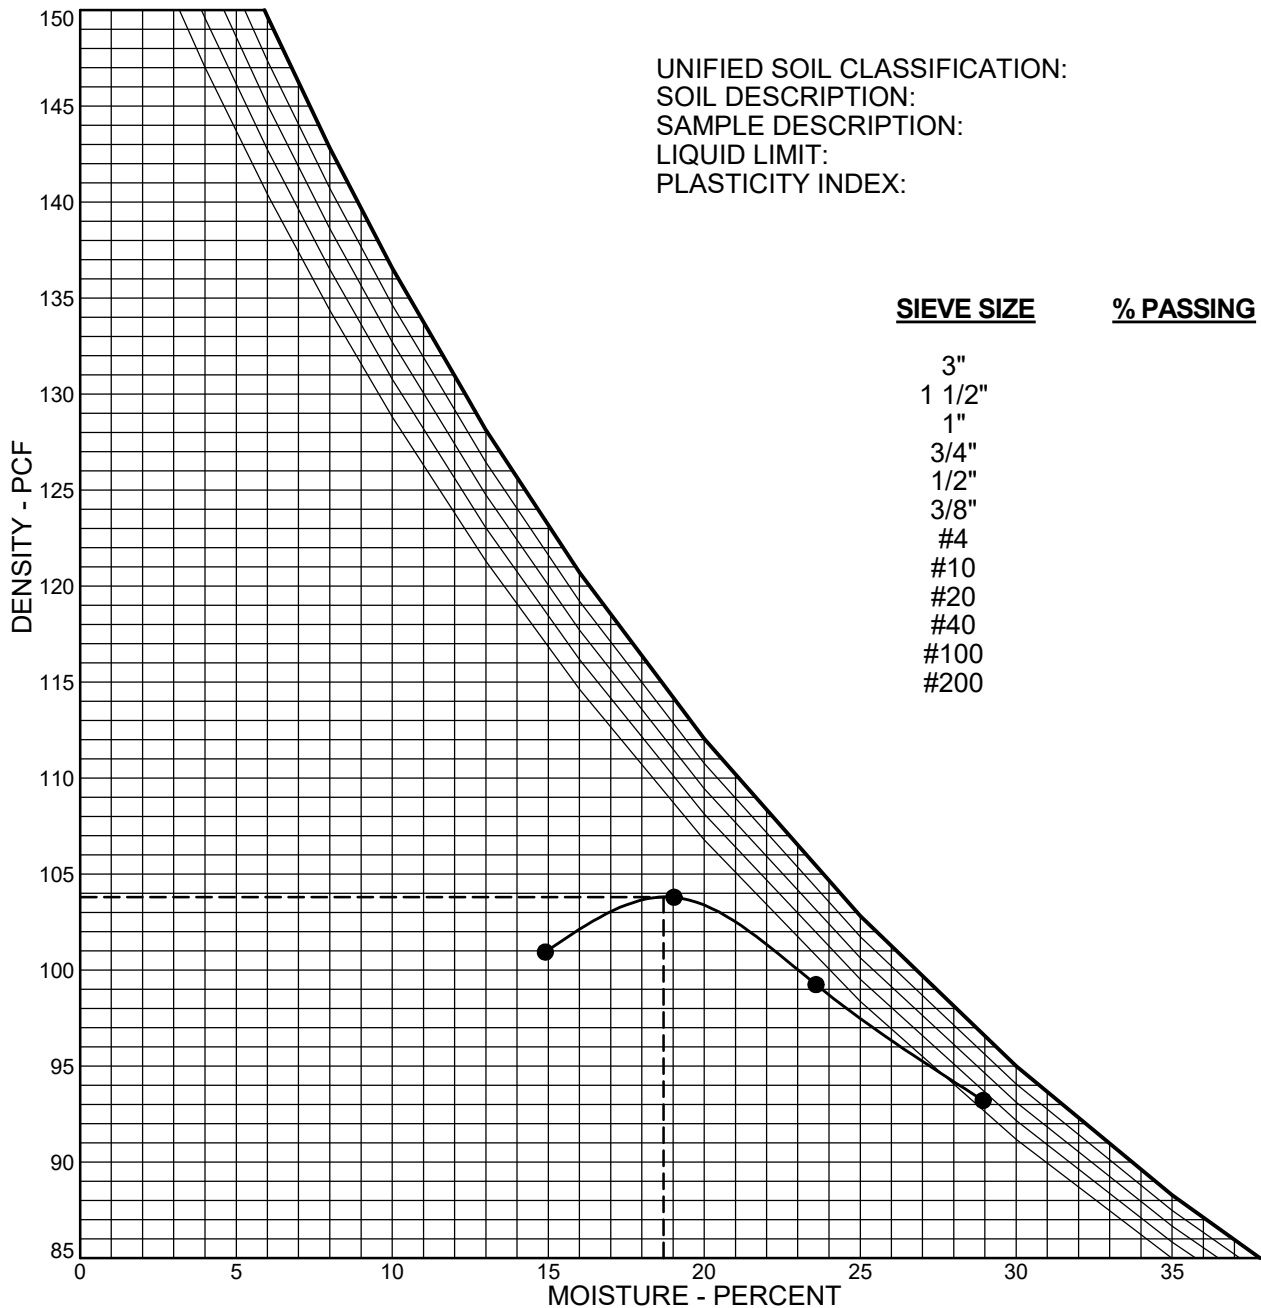
MOISTURE-DENSITY RELATION CURVE

DESIGNATION **ASTM D-698A**
MAX. DRY DENSITY **103.8 pcf**
OPTIMUM MOISTURE **18.7 %**
FRACTION USED **#4**
MOLD VOLUME **0.0333 cu.ft.**

NOTE: ZERO AIR VOIDS CURVES PLOTTED FOR:
Gs = 2.60
Gs = 2.65
Gs = 2.70
Gs = 2.75
Gs = 2.80

Grain-size analyses and Atterberg limits tests were performed on the combined samples obtained from the borings for purposes of classification and obtaining pertinent engineering parameters. A moisture-density relationship curve and a California Bearing Ratio (CBR) test were performed on a composite bulk sample obtained from all ten Test Borings, TB-1 through TB-6. A Summary of Laboratory Test Results is presented in Figure 7. Soil Classification Data are presented in Figures 8 and 9. Denver Swell/Consolidation Test results are presented in Figures 10 through 12. The Moisture Density Relationship Curve is presented in Figure 13. The CBR Test Results are presented in Figures 14 and 15.

A composite bulk sample from all of the Test Borings, A-7-6 soil, was tested to determine its moisture-density relationship curve in accordance with ASTM D698 (Standard Proctor compaction test). Maximum Dry Density proved to be 103.8 pcf at 18.7 percent moisture. A CBR test was performed in accordance with Appendix D.2.4 of the El Paso County Engineering Criteria Manual (EPCECM) at varying densities at moisture content near optimum. At 95% of the maximum Modified Proctor density, the CBR of the bulk sample was 1.7.

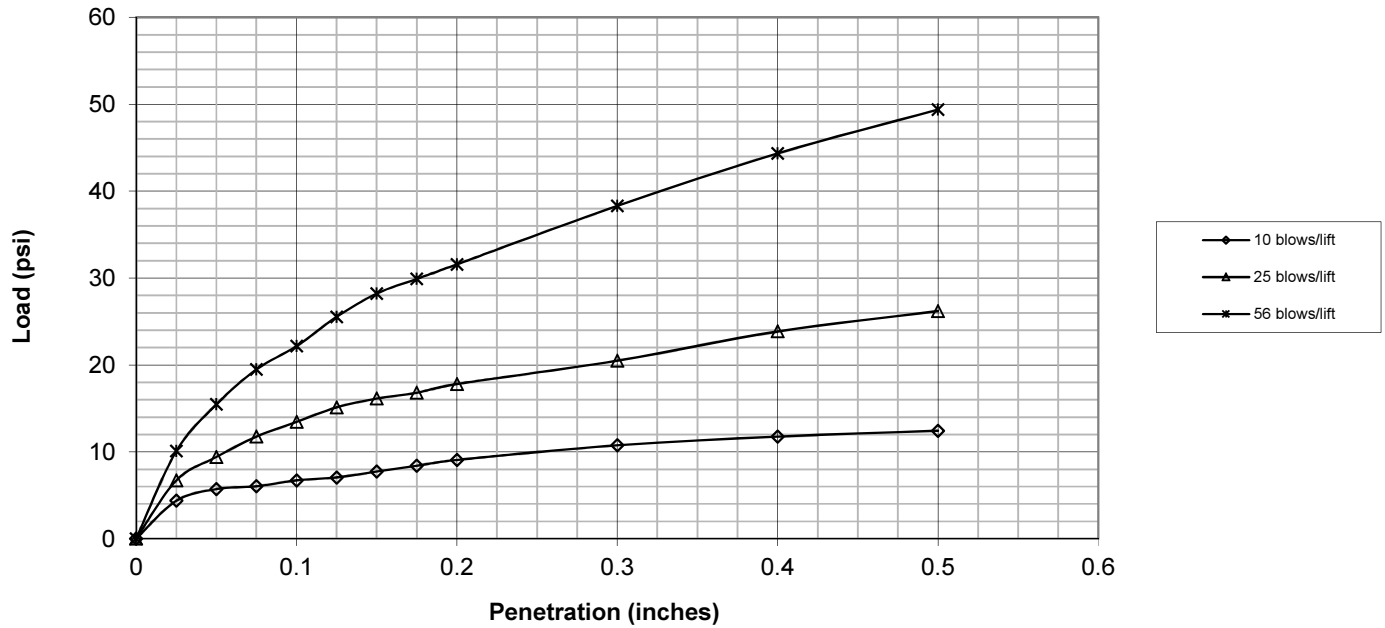
| | Corrected Penetration (in) | Corrected Load (psi) |
| 10 blows/lift | 0.100 | 0.7 |

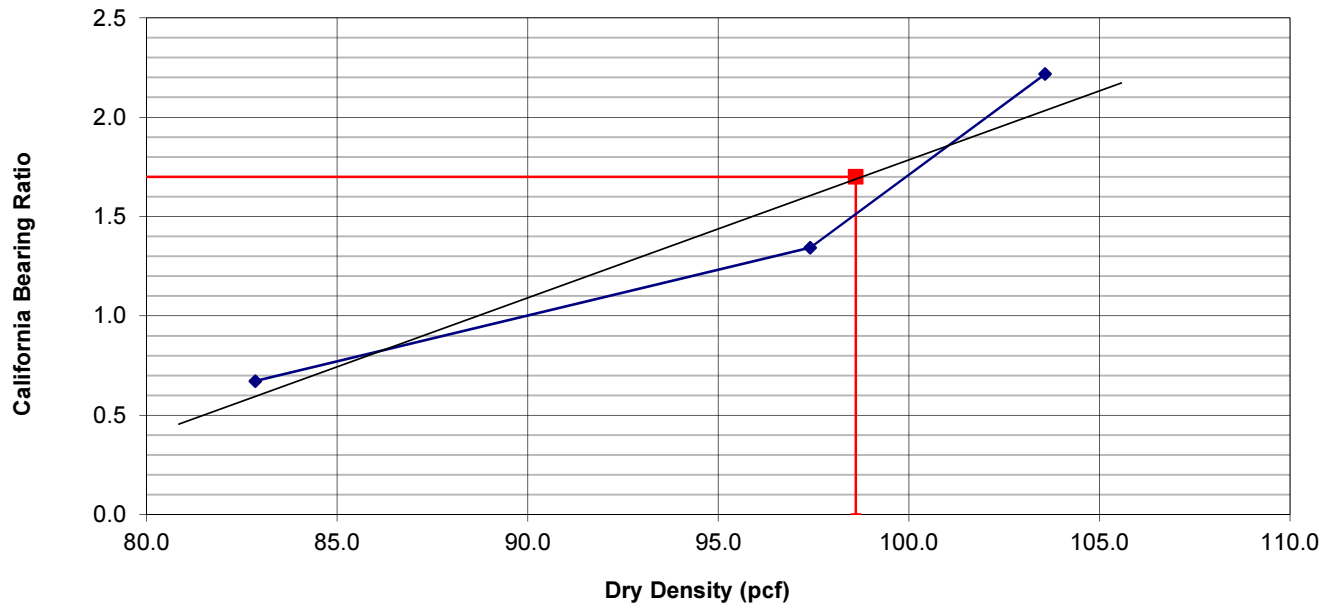
| California Bearing Ratio | 1.7 |
| Dry Density (pcf) | 103.8 |
| Condition of sample | Soaked |

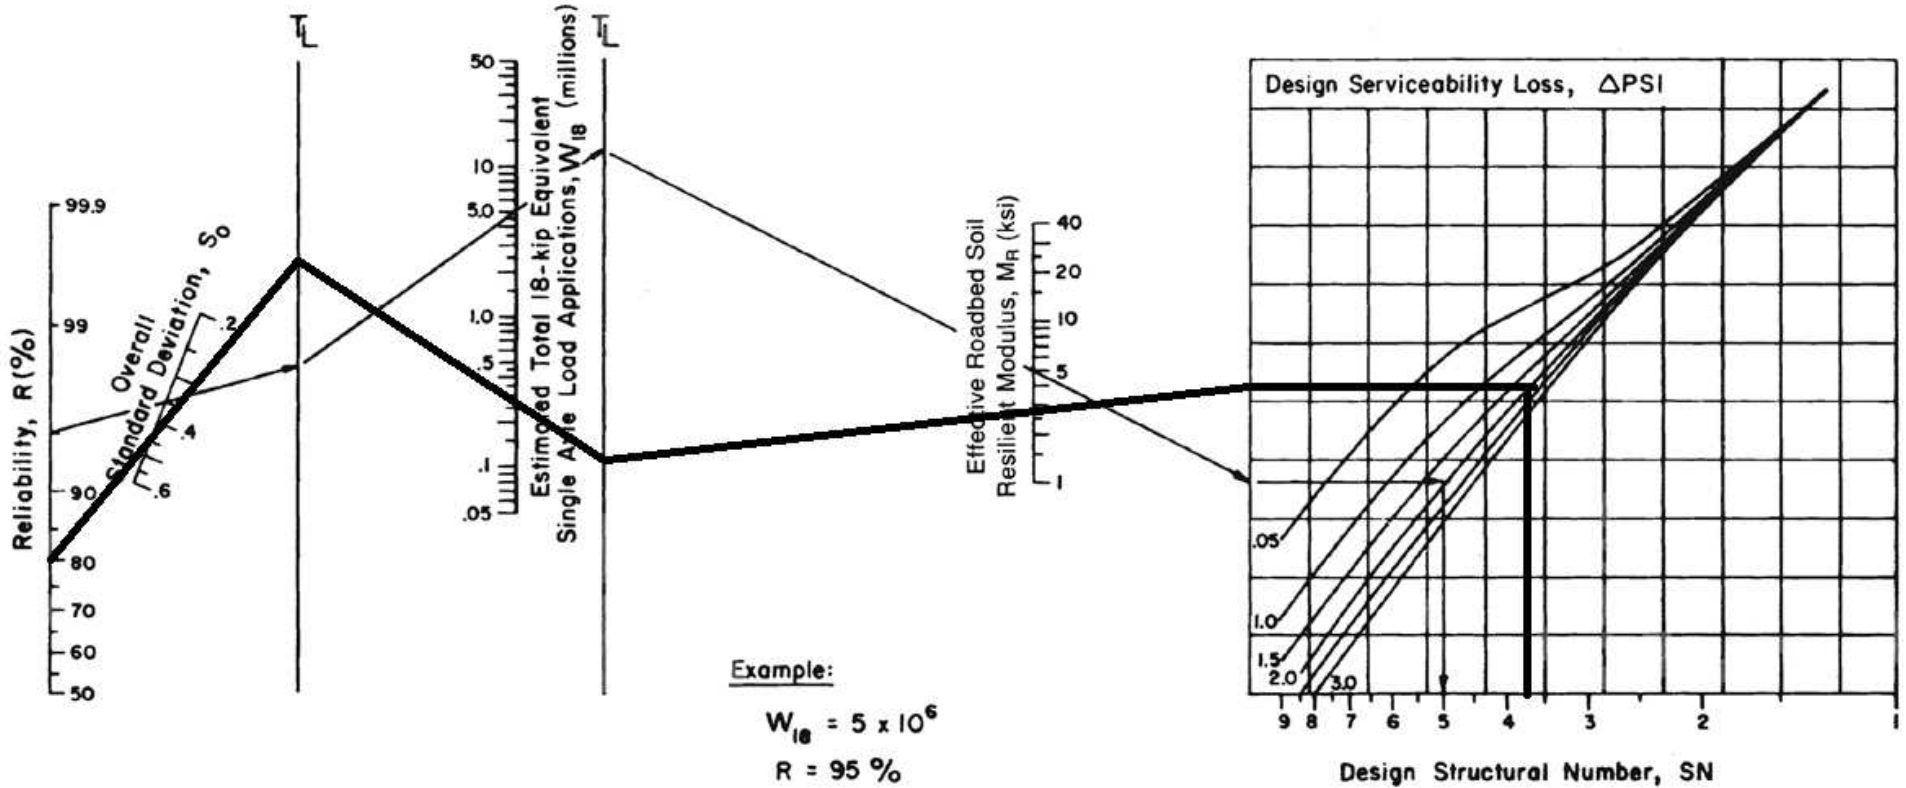
NOMOGRAPH SOLVES:

$$\log_{10} W_{18} = Z_R * S_o + 9.36 * \log_{10}(SN+1) - 0.20 + \frac{\log_{10} \left[\frac{\Delta PSI}{4.2 - 1.5} \right]}{0.40 + \frac{1094}{(SN+1)^{5.19}}} + 2.32 * \log_{10} M_R - 8.07$$

Example:

$W_{18} = 5 \times 10^6$

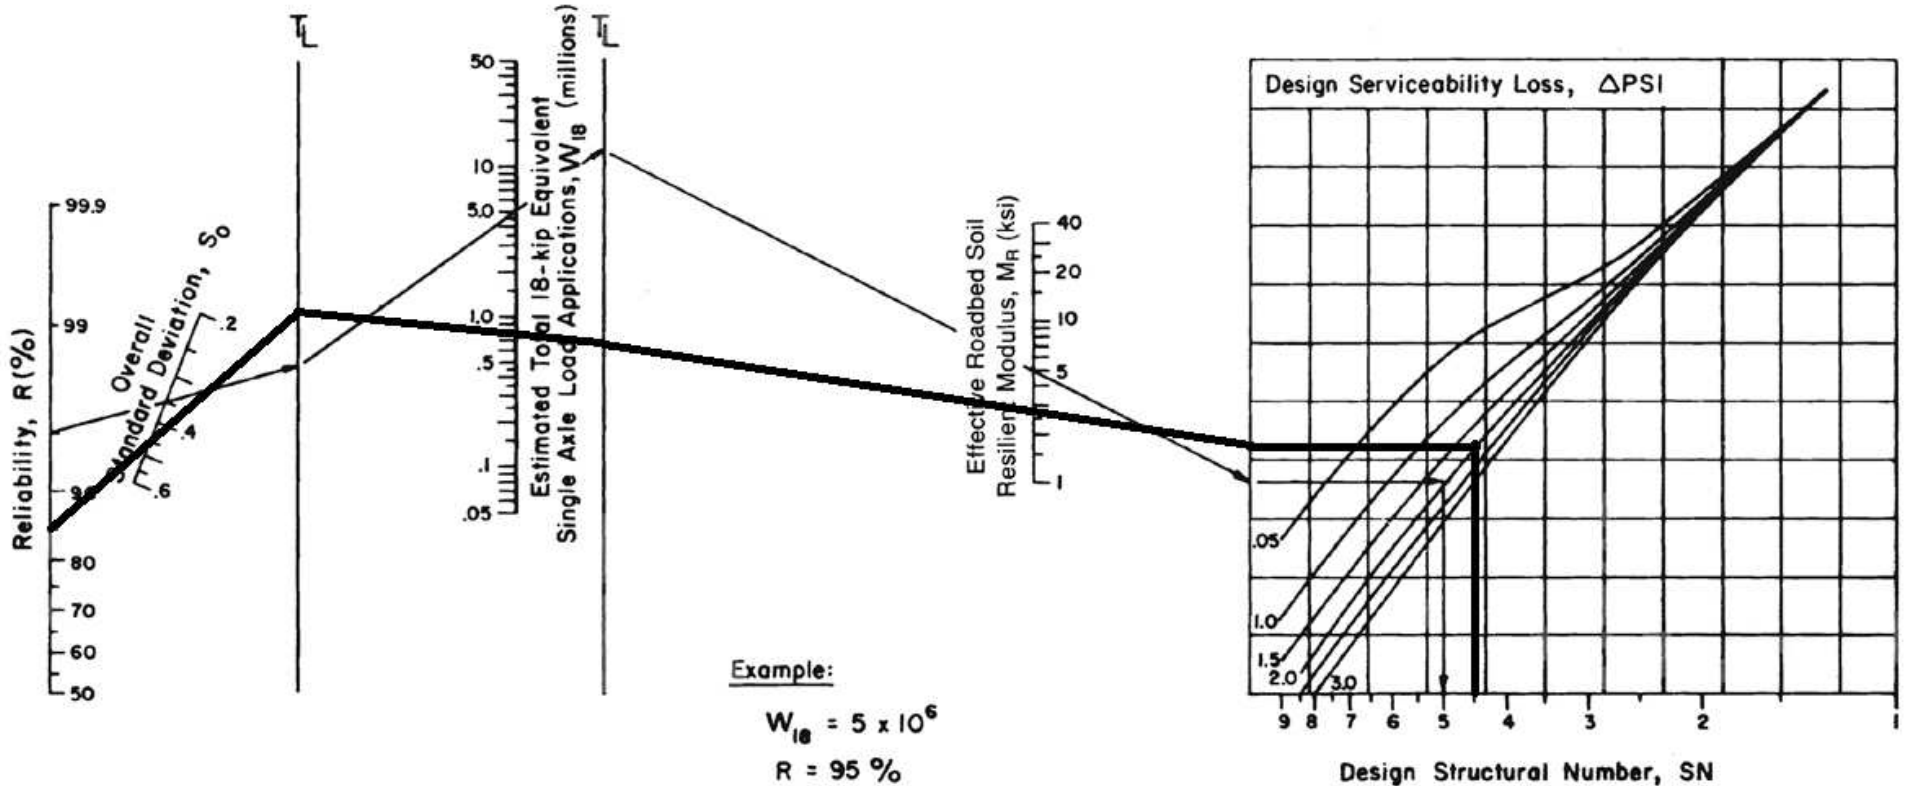
NOMOGRAPH SOLVES:

$$\log_{10} W_{18} = Z_R * S_o + 9.36 * \log_{10}(SN+1) - 0.20 + \frac{\log_{10} \left[\frac{\Delta \text{PSI}}{4.2 - 1.5} \right]}{0.40 + \frac{1094}{(SN+1)^{5.19}}} + 2.32 * \log_{10} M_R - 8.07$$

Example:

- $W_{18} = 5 \times 10^6$
- $R = 95 \%$
- $S_o = 0.35$
- $M_R = 5000 \text{ psi}$
- $\Delta \text{PSI} = 1.9$
- Solution: $SN = 5.0$**
