SOILS AND GEOLOGY STUDY

**Skyline at Lorson Ranch
El Paso County, Colorado**

JOB NO. 175809

January 15, 2021

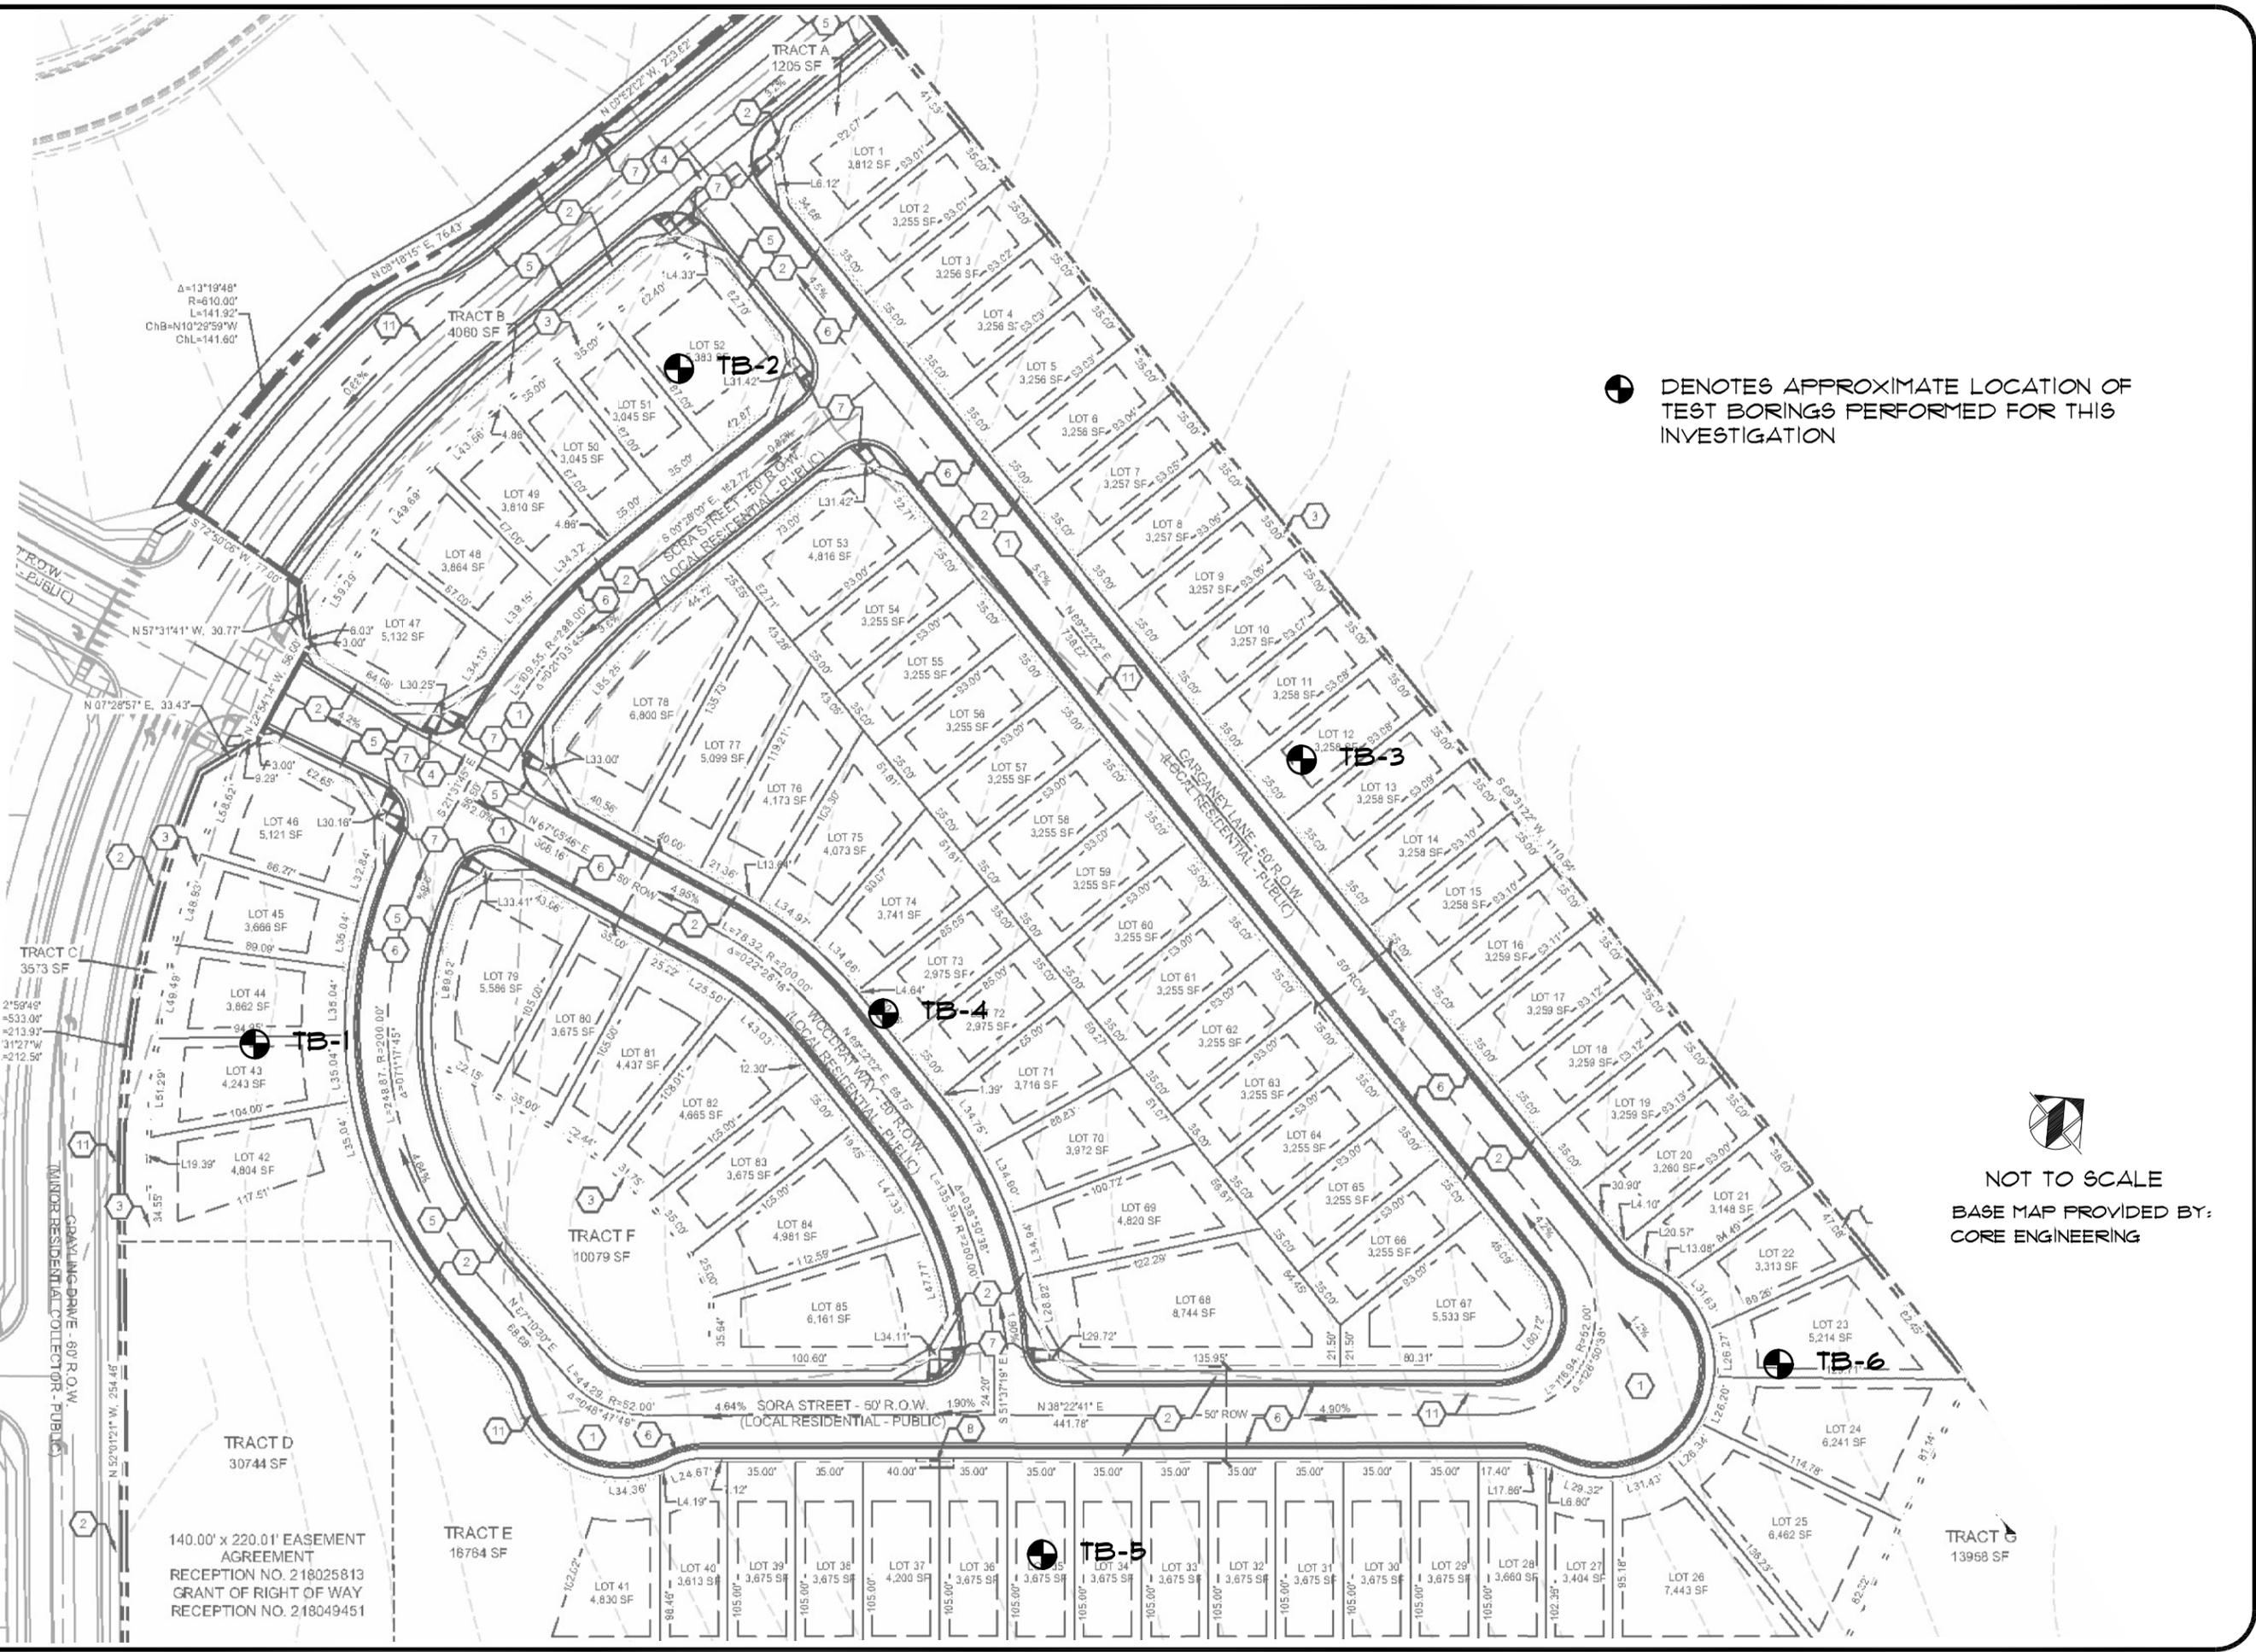
● DENOTES APPROXIMATE LOCATION OF TEST BORINGS PERFORMED FOR THIS INVESTIGATION

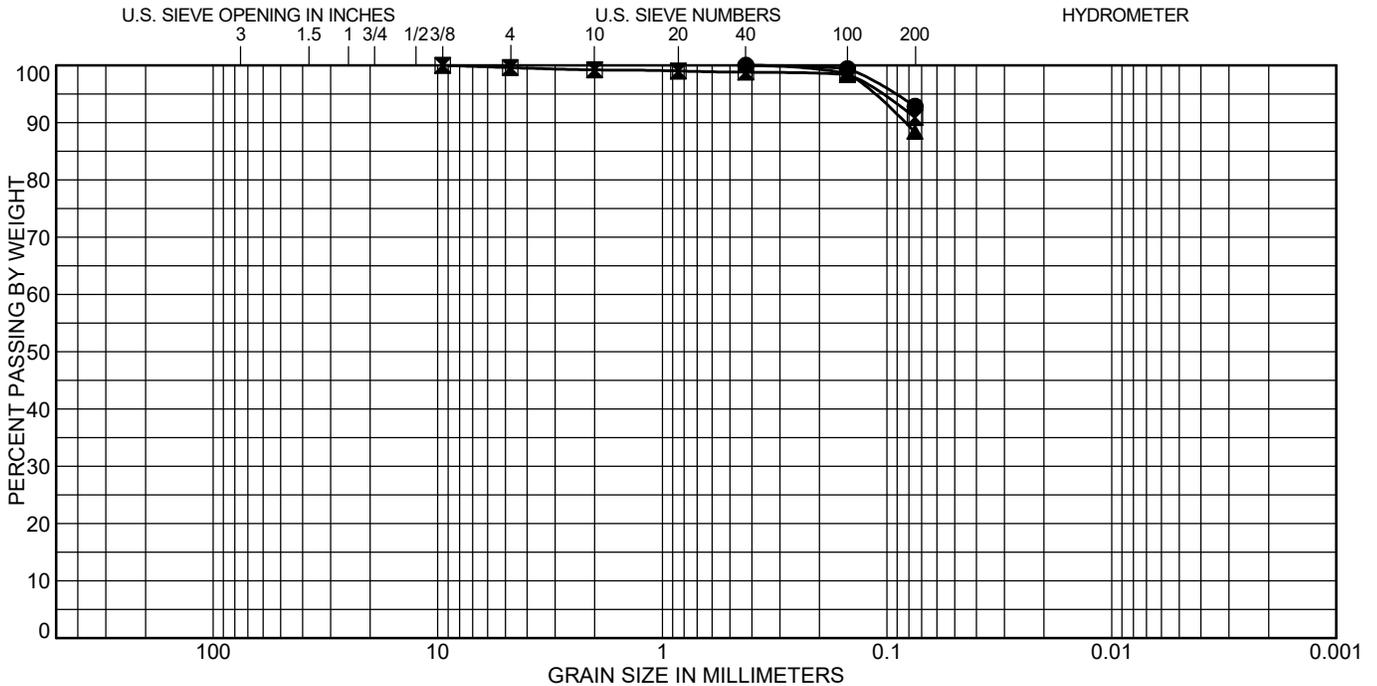
FIGURE No. 8

COBBLES	GRAVEL		SAND			SILT OR CLAY
	coarse	fine	coarse	medium	fine

Test Boring	Depth (ft)	Classification	LL	PL	PI
● 1	4.0	LEAN CLAY(CL)	48	16	32
☒ 2	9.0	LEAN CLAY(CL)	48	17	31
▲ 4	4.0	LEAN CLAY(CL)	41	15	26

Soil laboratory testing was performed as part of this investigation. The laboratory tests included moisture content, dry density, grain-size analyses, Atterberg Limits and Swell/Consolidation tests. A Summary of Laboratory Test Results is presented in Figure 7. Soils Classification Data is presented in Figure 8. Swell/Consolidation Test Results are presented in Figures 9 through 11.

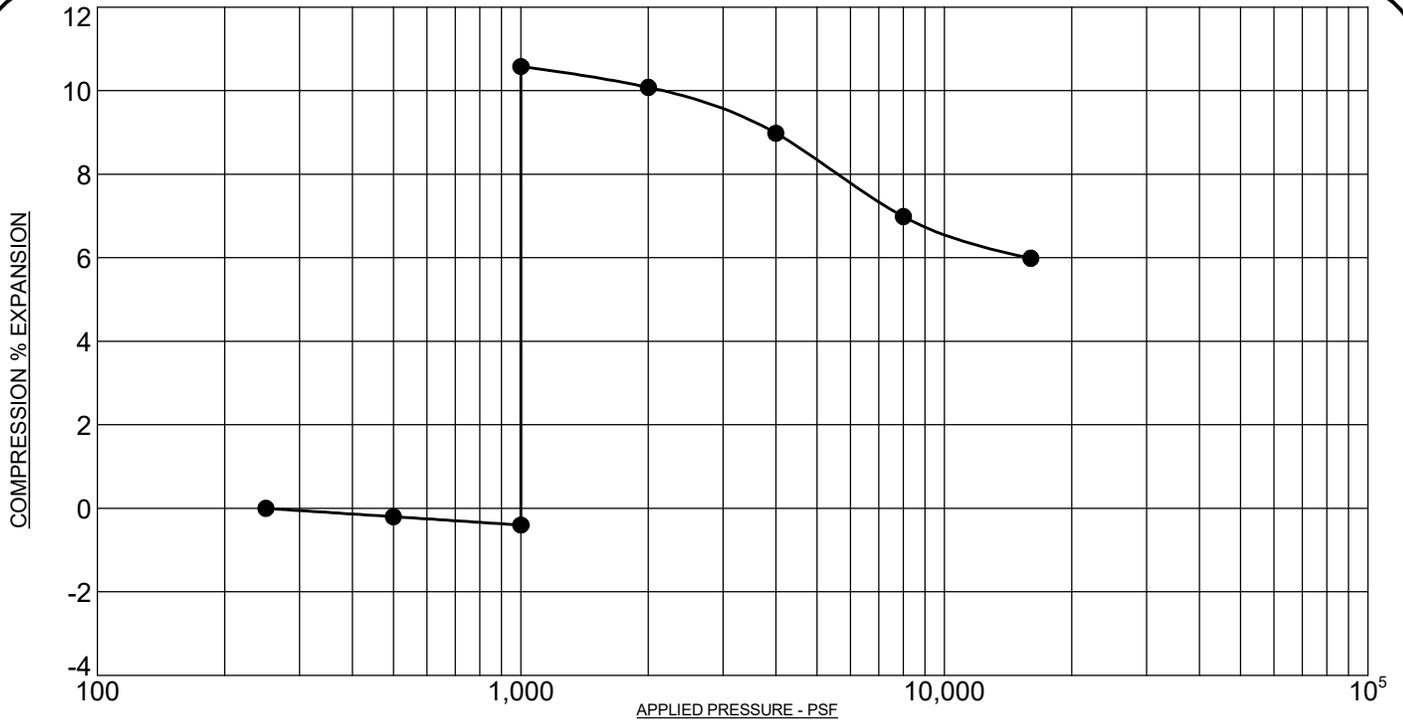
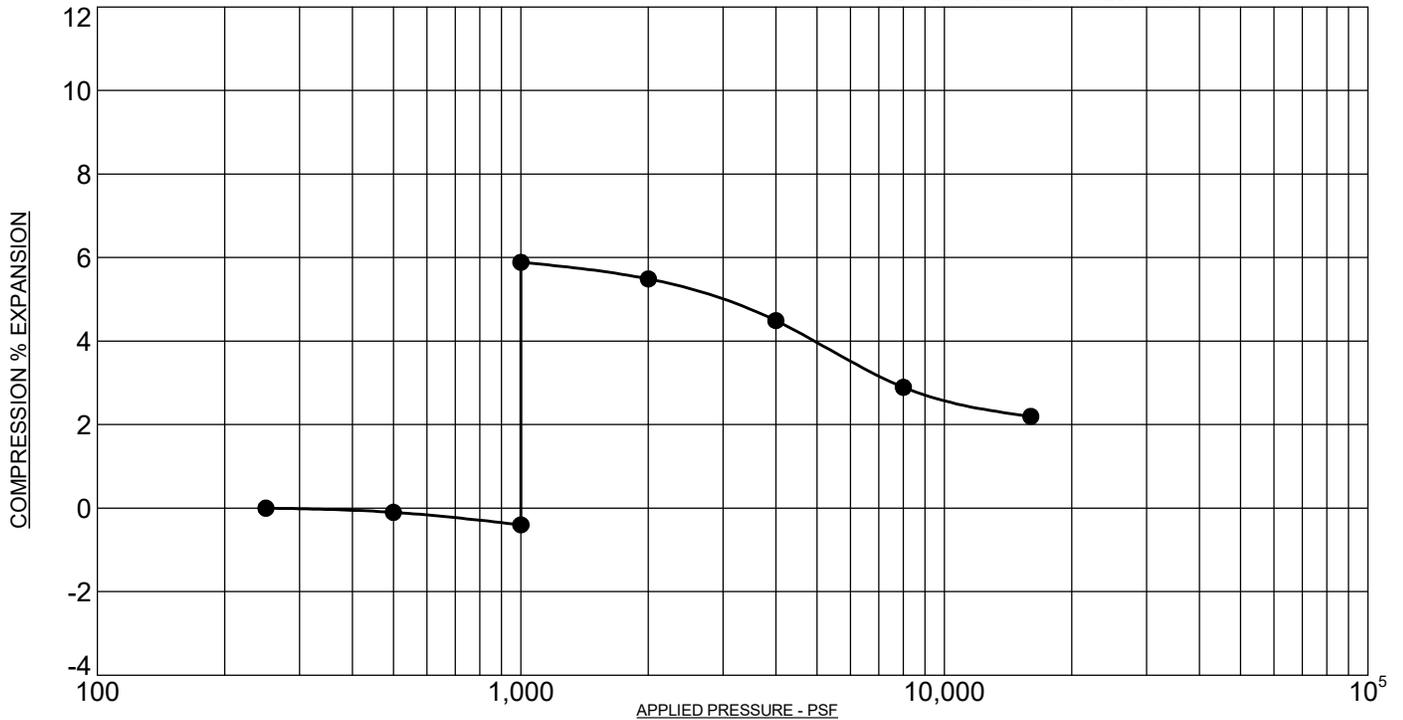
FIGURE No. 9

PROJECT: Skyline at Lorson Ranch El Paso County, Colorado
 SAMPLE DESCRIPTION: CLAYSTONE
 NOTE: SAMPLE WAS INUNDATED WITH WATER AT 1,000 PSF

SAMPLE LOCATION: 1 @ 4 FT
 NATURAL DRY UNIT WEIGHT: 123.2 PCF
 NATURAL MOISTURE CONTENT: 11.6%
 PERCENT SWELL/COMPRESSION: 11.0

PROJECT: Skyline at Lorson Ranch El Paso County, Colorado
 SAMPLE DESCRIPTION: CLAYSTONE, SANDY
 NOTE: SAMPLE WAS INUNDATED WITH WATER AT 1,000 PSF

SAMPLE LOCATION: 2 @ 9 FT
 NATURAL DRY UNIT WEIGHT: 121.0 PCF
 NATURAL MOISTURE CONTENT: 12.6%
 PERCENT SWELL/COMPRESSION: 6.3

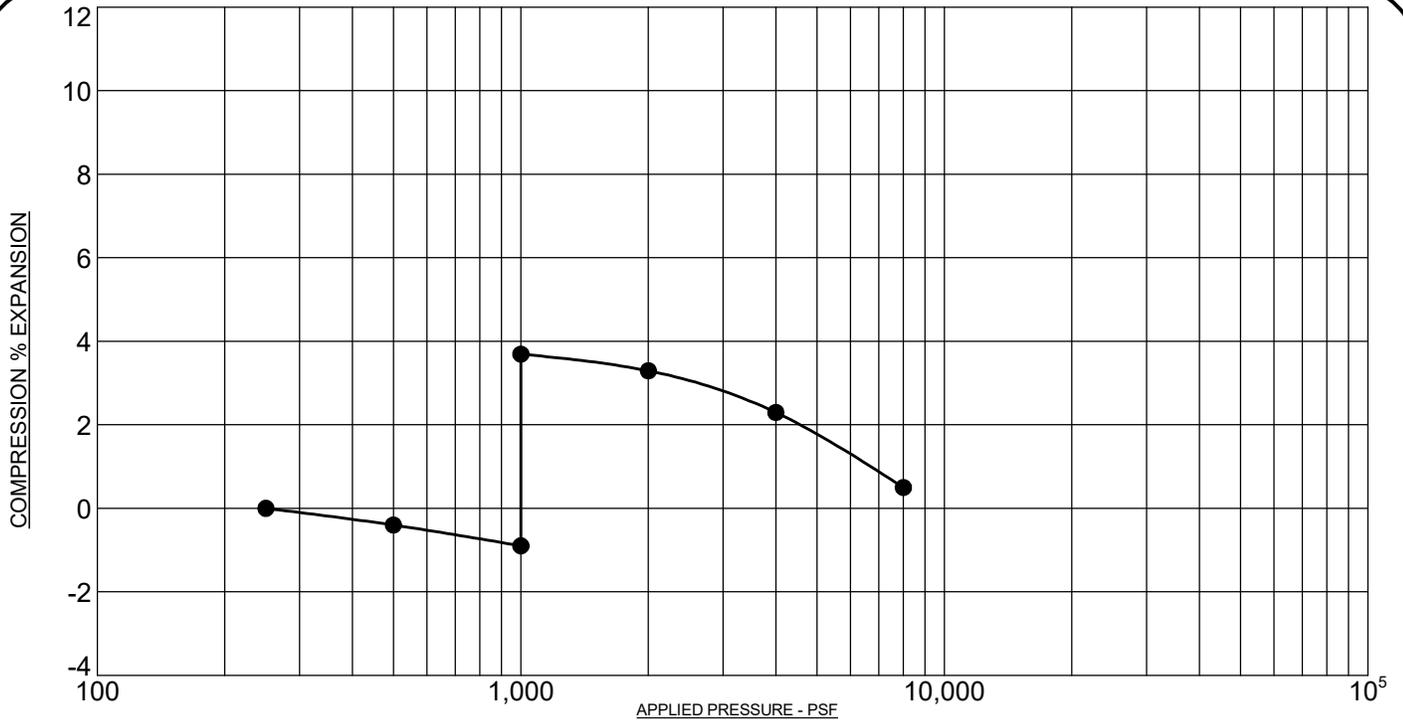
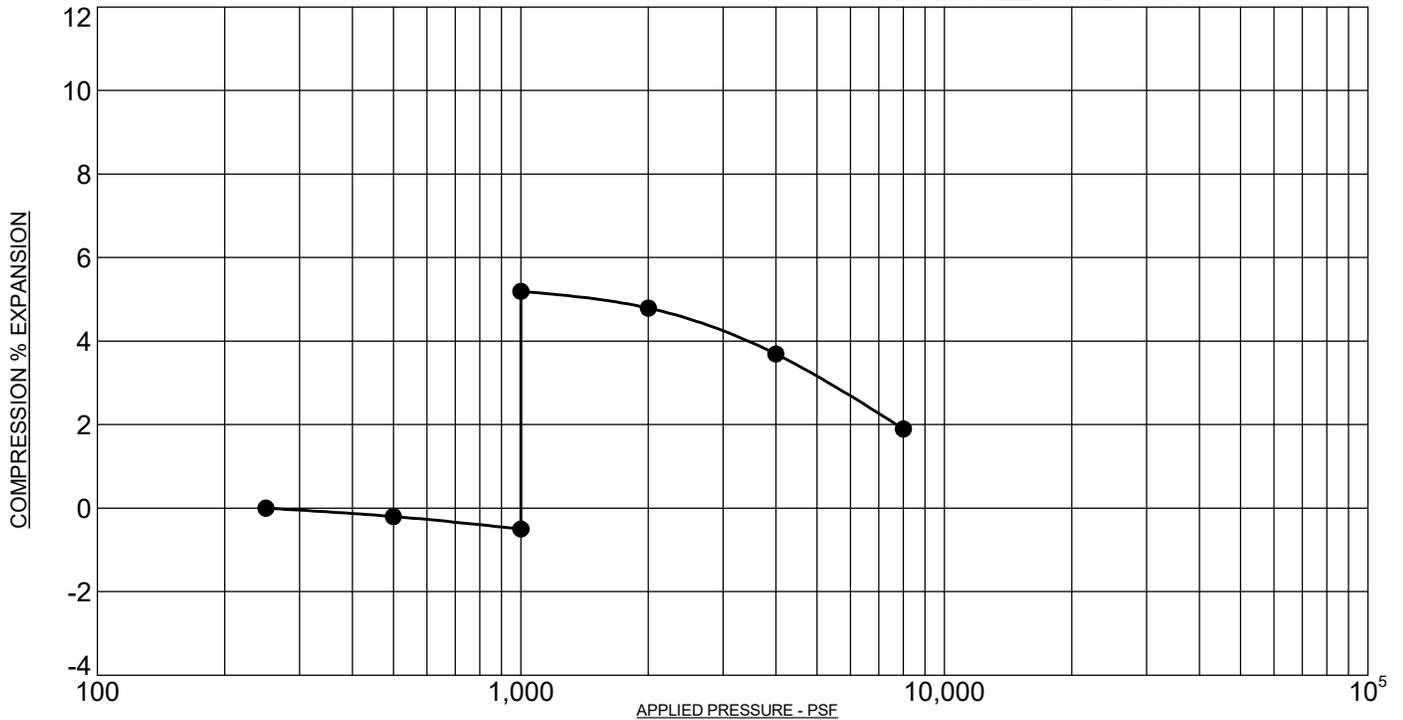
FIGURE No. 10

PROJECT: Skyline at Lorson Ranch El Paso County, Colorado
 SAMPLE DESCRIPTION: CLAYSTONE, SANDY
 NOTE: SAMPLE WAS INUNDATED WITH WATER AT 1,000 PSF

SAMPLE LOCATION: 3 @ 14 FT
 NATURAL DRY UNIT WEIGHT: 115.0 PCF
 NATURAL MOISTURE CONTENT: 15.3%
 PERCENT SWELL/COMPRESSION: 4.6

PROJECT: Skyline at Lorson Ranch El Paso County, Colorado
 SAMPLE DESCRIPTION: CLAY, SANDY
 NOTE: SAMPLE WAS INUNDATED WITH WATER AT 1,000 PSF

SAMPLE LOCATION: 5 @ 9 FT
 NATURAL DRY UNIT WEIGHT: 121.4 PCF
 NATURAL MOISTURE CONTENT: 10.1%
 PERCENT SWELL/COMPRESSION: 5.7

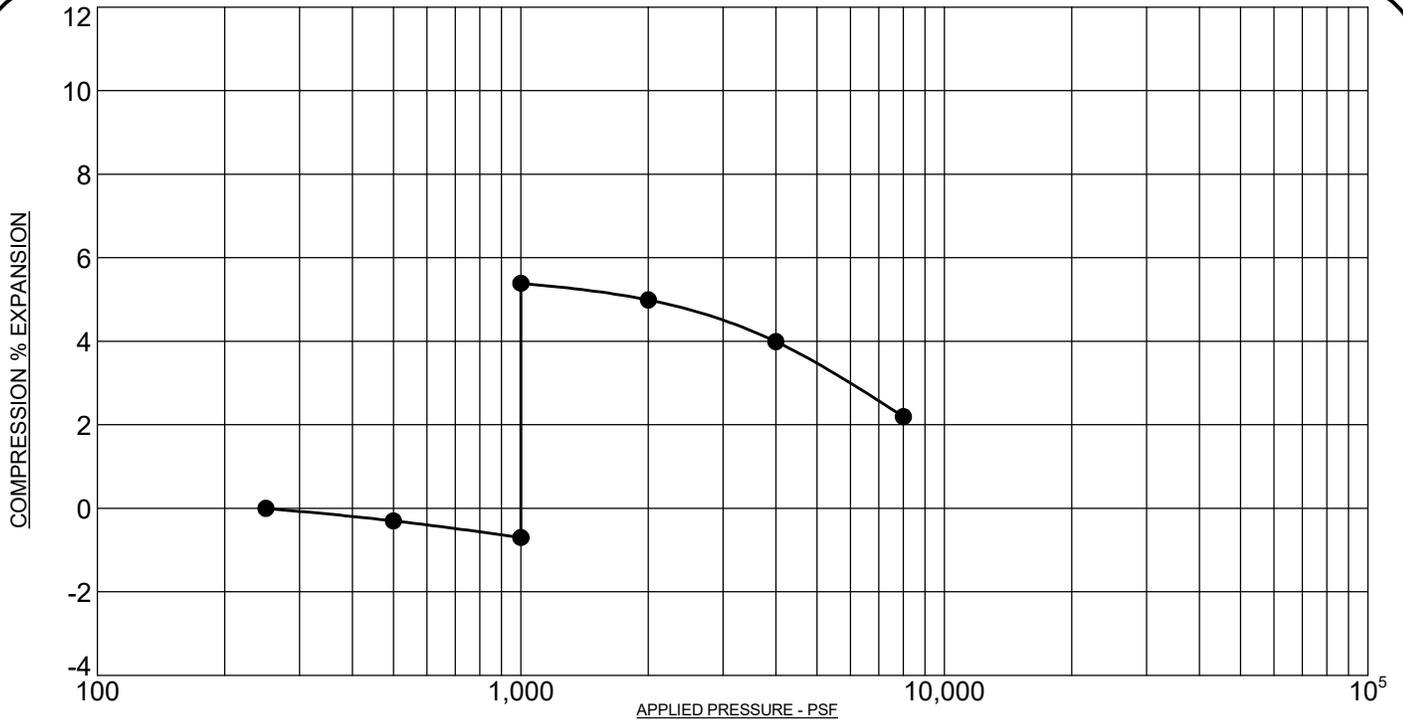
PROJECT: Skyline at Lorson Ranch El Paso County, Colorado
 SAMPLE DESCRIPTION: CLAYSTONE, SANDY
 NOTE: SAMPLE WAS INUNDATED WITH WATER AT 1,000 PSF

SAMPLE LOCATION: 6 @ 4 FT
 NATURAL DRY UNIT WEIGHT: 119.6 PCF
 NATURAL MOISTURE CONTENT: 14.5%
 PERCENT SWELL/COMPRESSION: 6.1

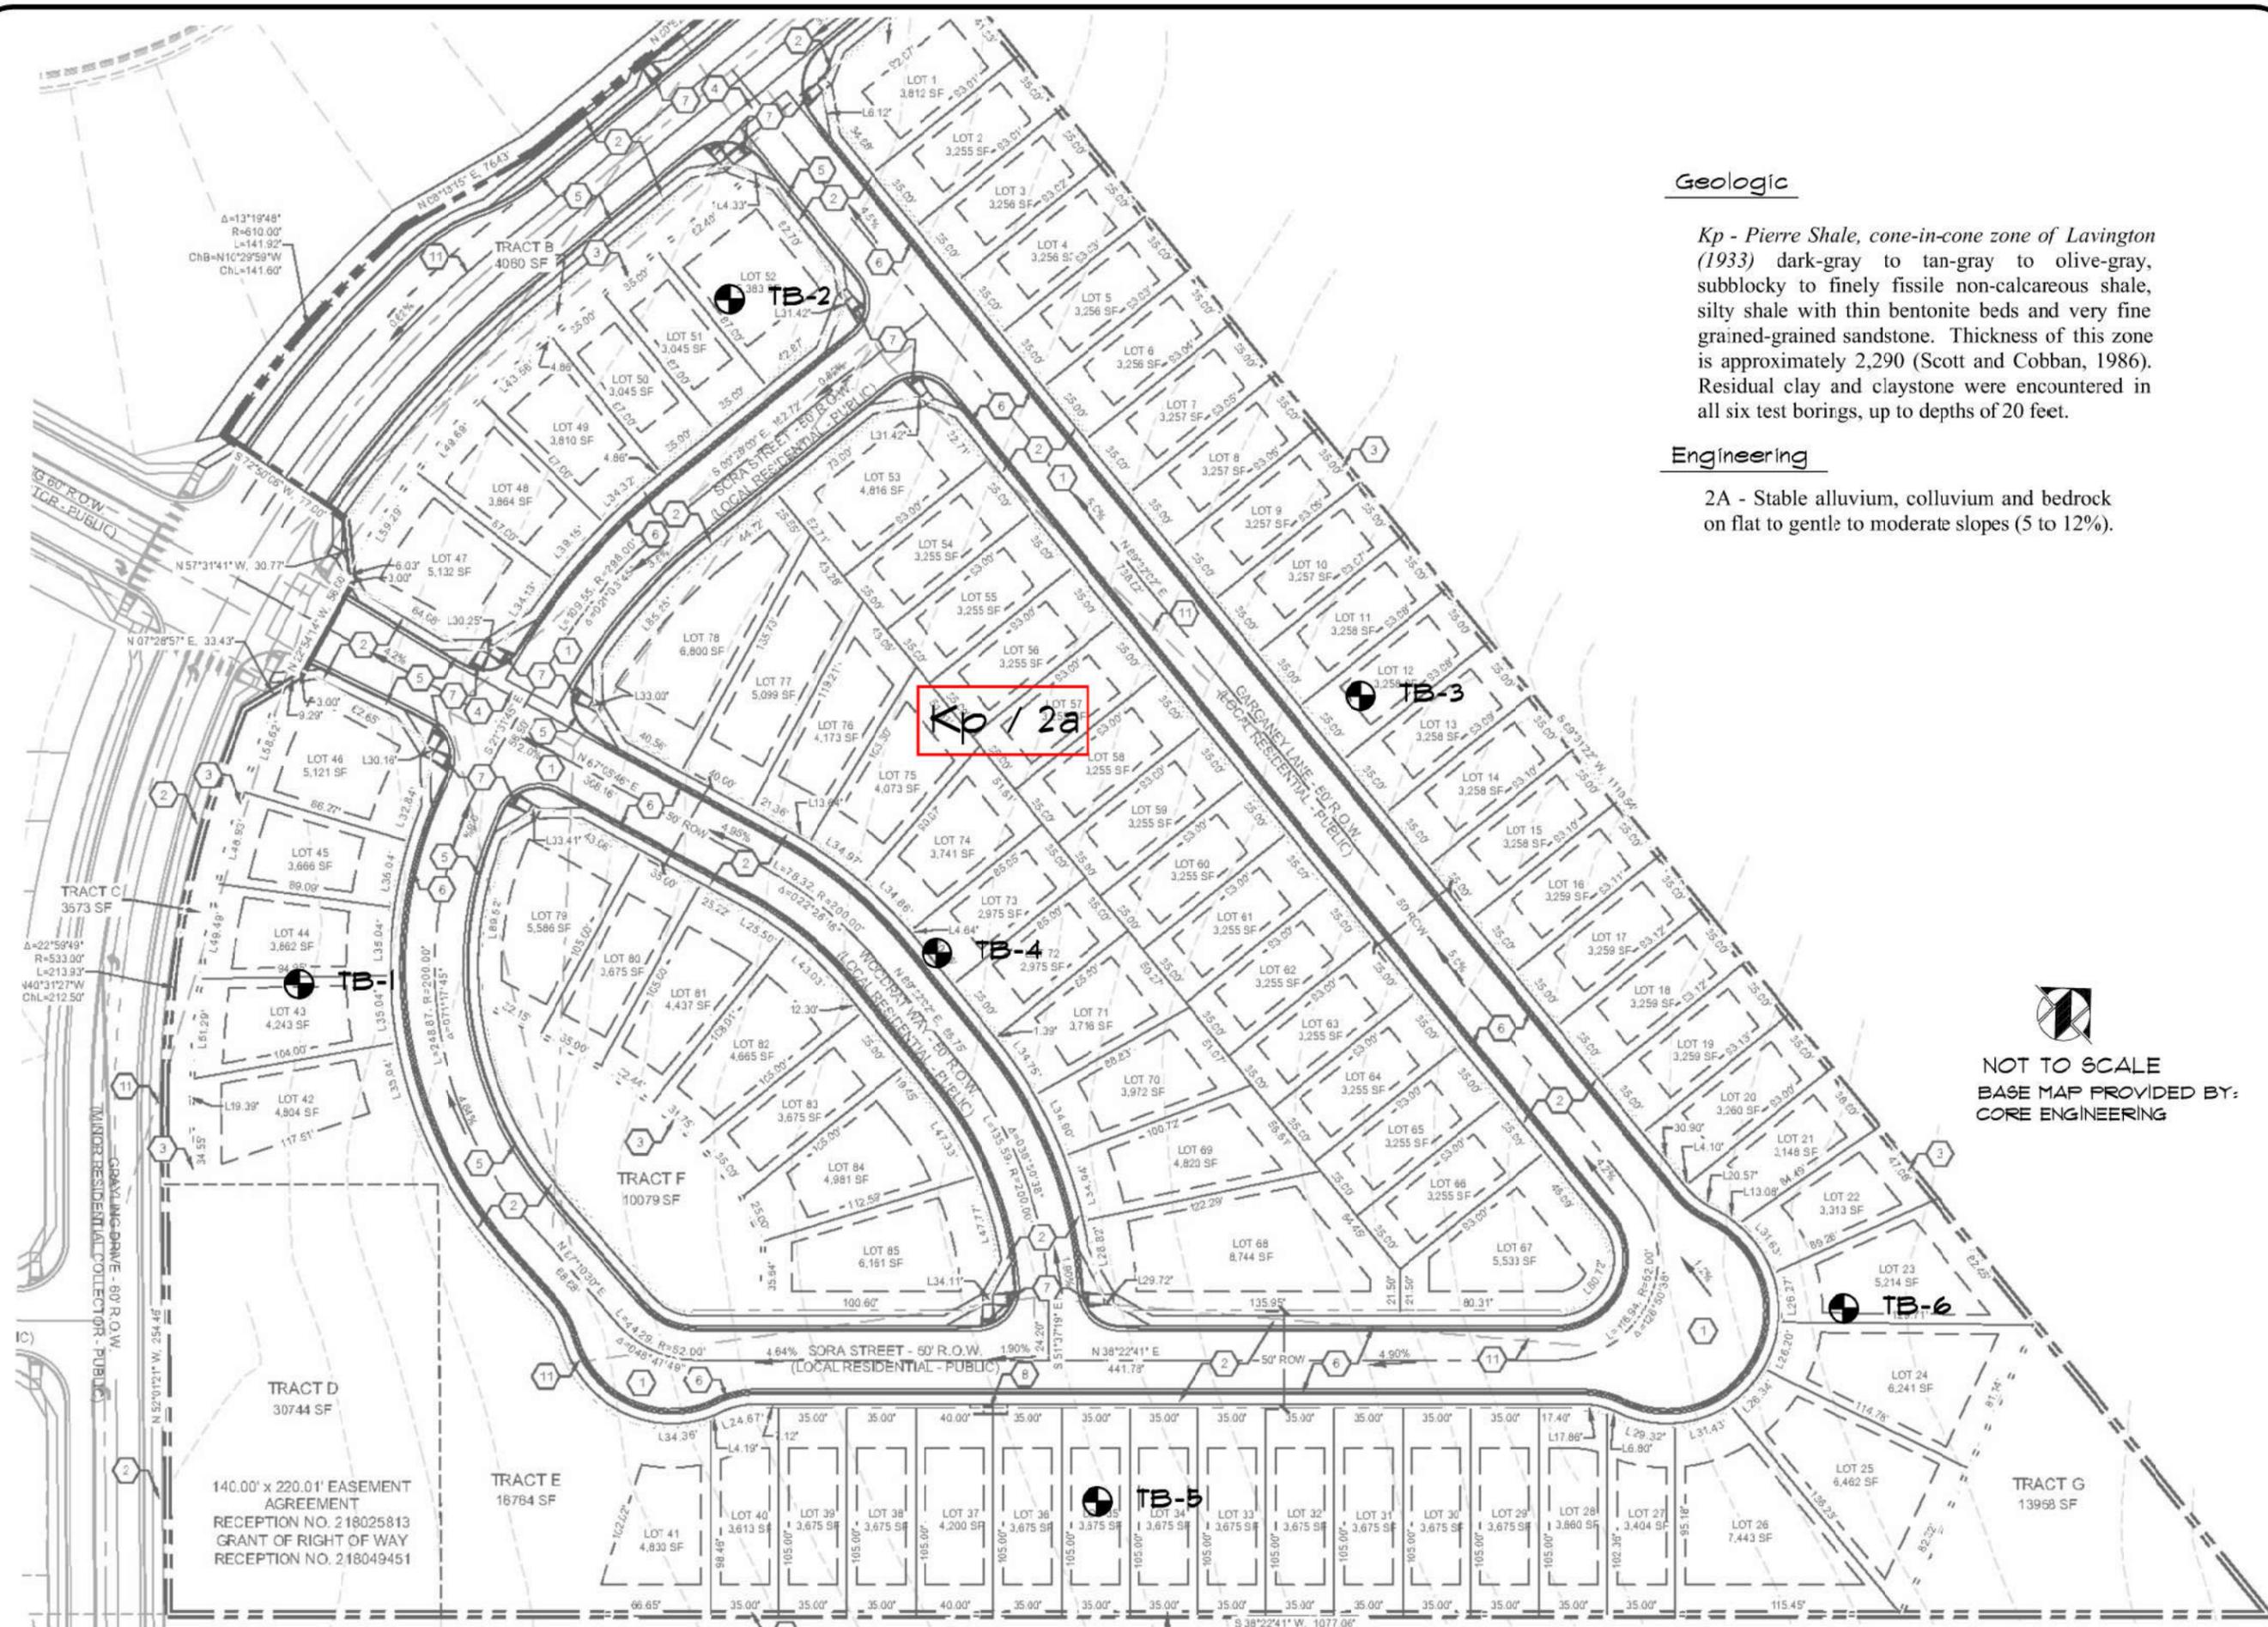
2A - Stable alluvium, colluvium and bedrock on flat to gentle to moderate slopes (5 to 12%).

NOT TO SCALE
BASE MAP PROVIDED BY:
CORE ENGINEERING

SKYLINE AT LORSON RANCH
EL PASO COUNTY, CO
LORSON RANCH METRO DISTRICT NO. 1

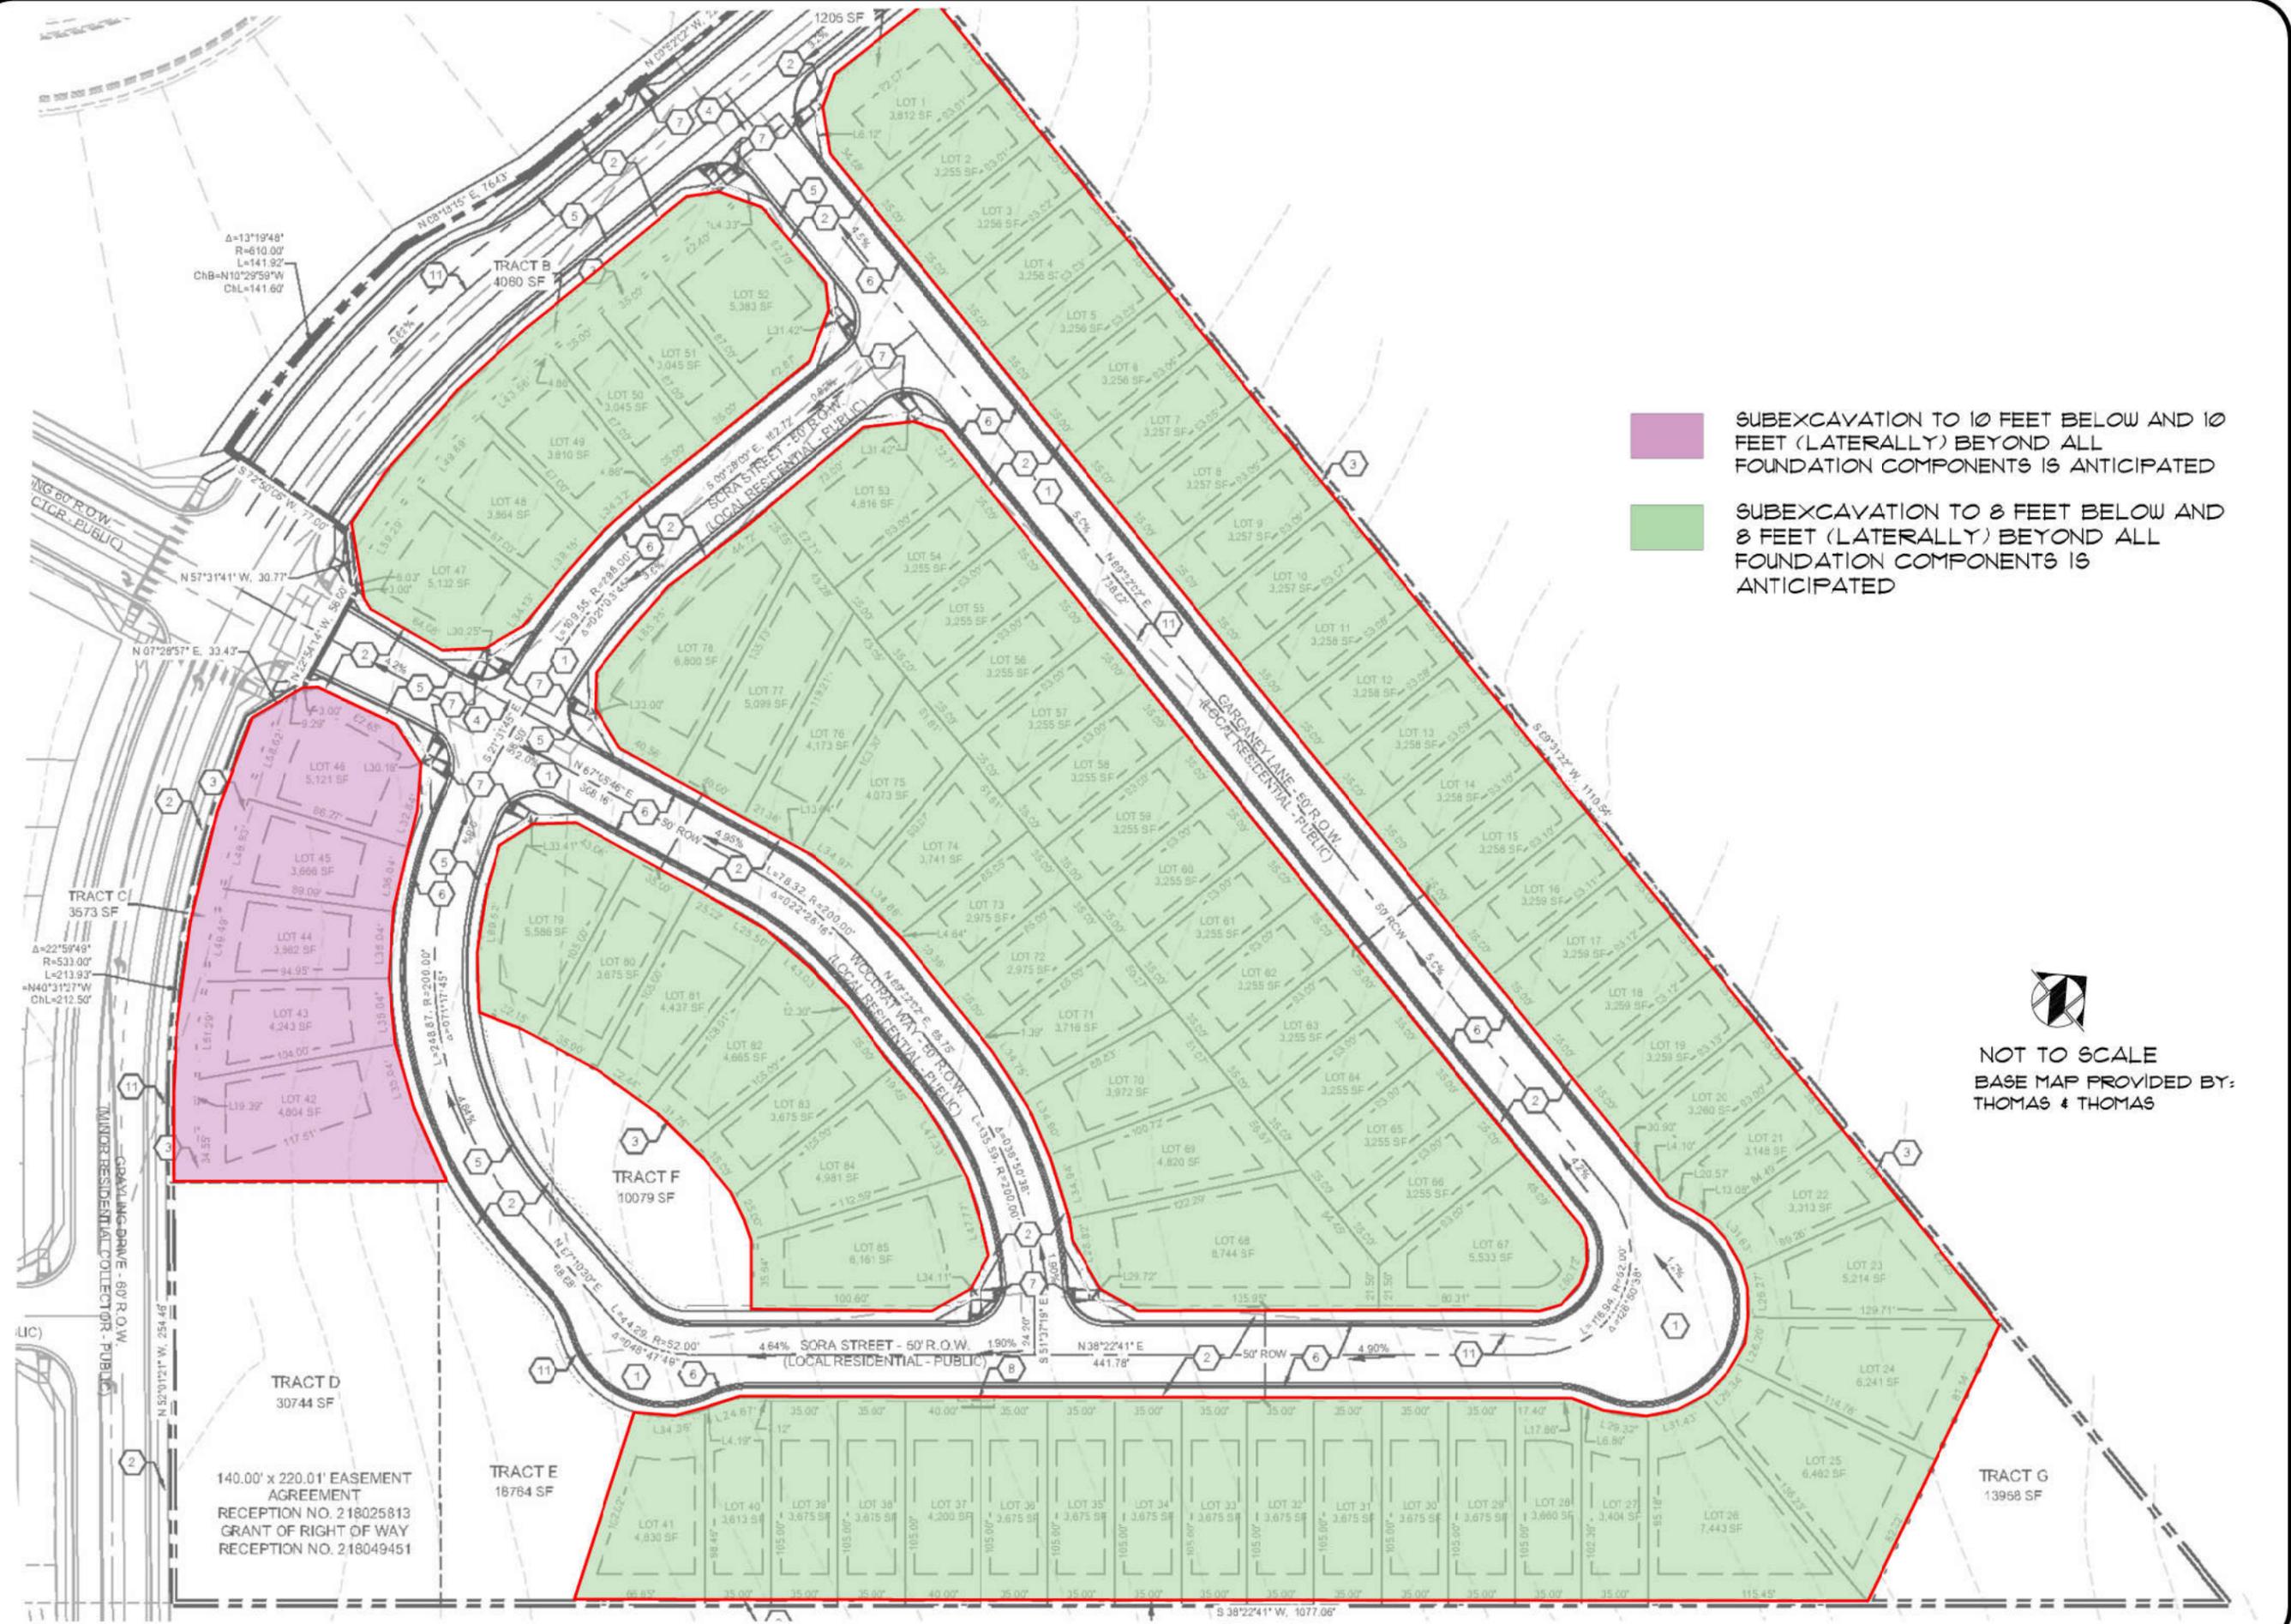
SHEET No.
FIG-13

SUBEXCAVATION TO 10 FEET BELOW AND 10 FEET (LATERALLY) BEYOND ALL FOUNDATION COMPONENTS IS ANTICIPATED

SUBEXCAVATION TO 8 FEET BELOW AND 8 FEET (LATERALLY) BEYOND ALL FOUNDATION COMPONENTS IS ANTICIPATED

SUBEXCAVATION
 RECOMMENDATIONS

Our subexcavation recommendations are presented in Section **13.0 Subexcavation and Replacement** of this report and the attached Figure 13.

Where subexcavation is to be performed, vegetation, organic materials and deleterious materials shall be cleared and disposed of in accordance with applicable requirements prior to performing excavation and/or filling operations. The sub-excavation should extend to minimum depths of 8 to 10 feet (as indicated on Figure 13, Subexcavation Recommendations) below the bottom of all proposed foundations components, and at least those same distances (laterally) beyond the proposed "buildable" area on each lot. Before the placement of structural fill, the underlying subgrade shall be scarified, moisture conditioned to within 2% of the optimum moisture content and compacted to the degree specified for the overlying fill material.

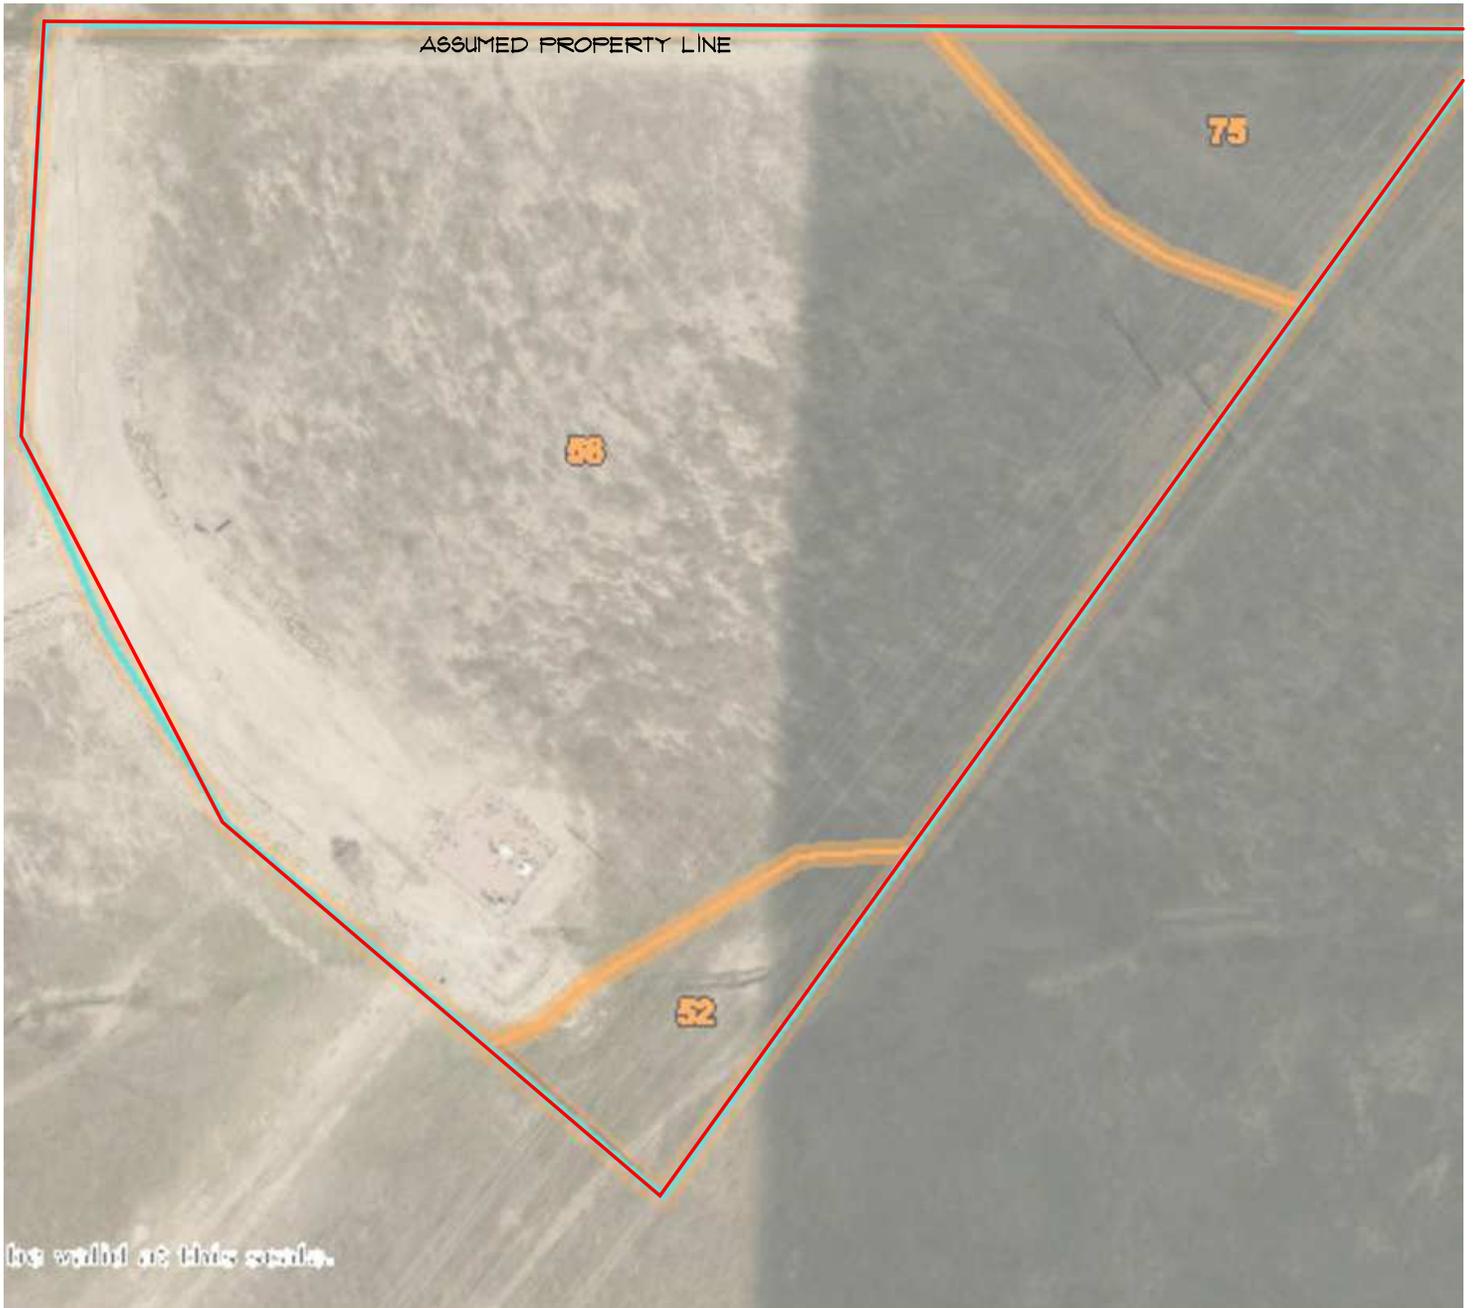
FIG No. 14

52 - Manzanst clay loam, 0 to 3 percent slopes.

The USDA Soil Survey Map is presented in Figure 14.
