SOILS AND GEOLOGY STUDY

Ivilo Heights
Currently addressed as: 6225 Vessey Road
El Paso County, Colorado

JOB NO. 191208

December 5, 2022

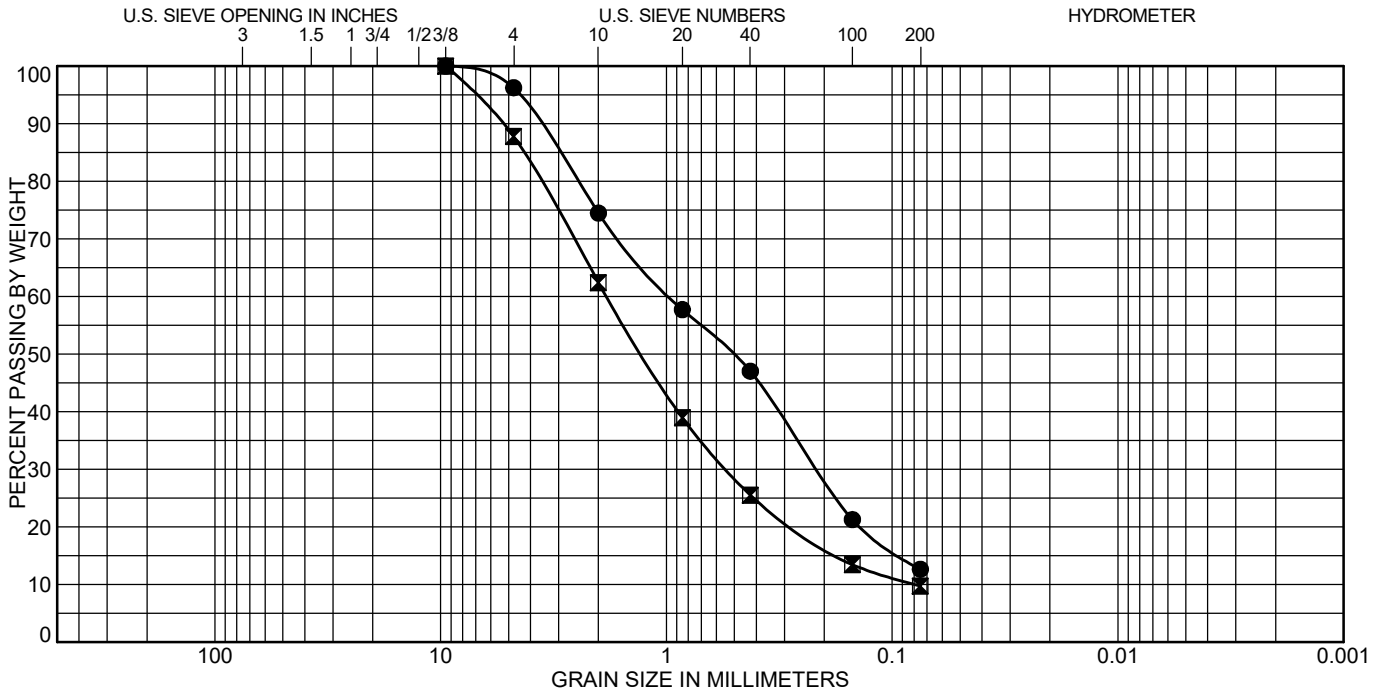
JOB No. 191208
 FIGURE No. 5
 PAGE 1 OF 1
 DATE Dec/05/2022

SUMMARY OF LABORATORY TEST RESULTS

Test Boring	Depth (ft)	Classification	LL	PL	PI
● 1	7.0	SILTY SAND(SM)	NP	NP	NP
☒ 2	4.0	WELL-GRADED SAND with SILT(SW-SM)	NP	NP	NP

Soil laboratory testing was performed as part of this investigation. The laboratory tests included moisture content, grain-size analyses, and Atterberg Limit tests. A Summary of Laboratory Test Results is presented in Figure 5. Soils Classification Data is presented in Figure 6.

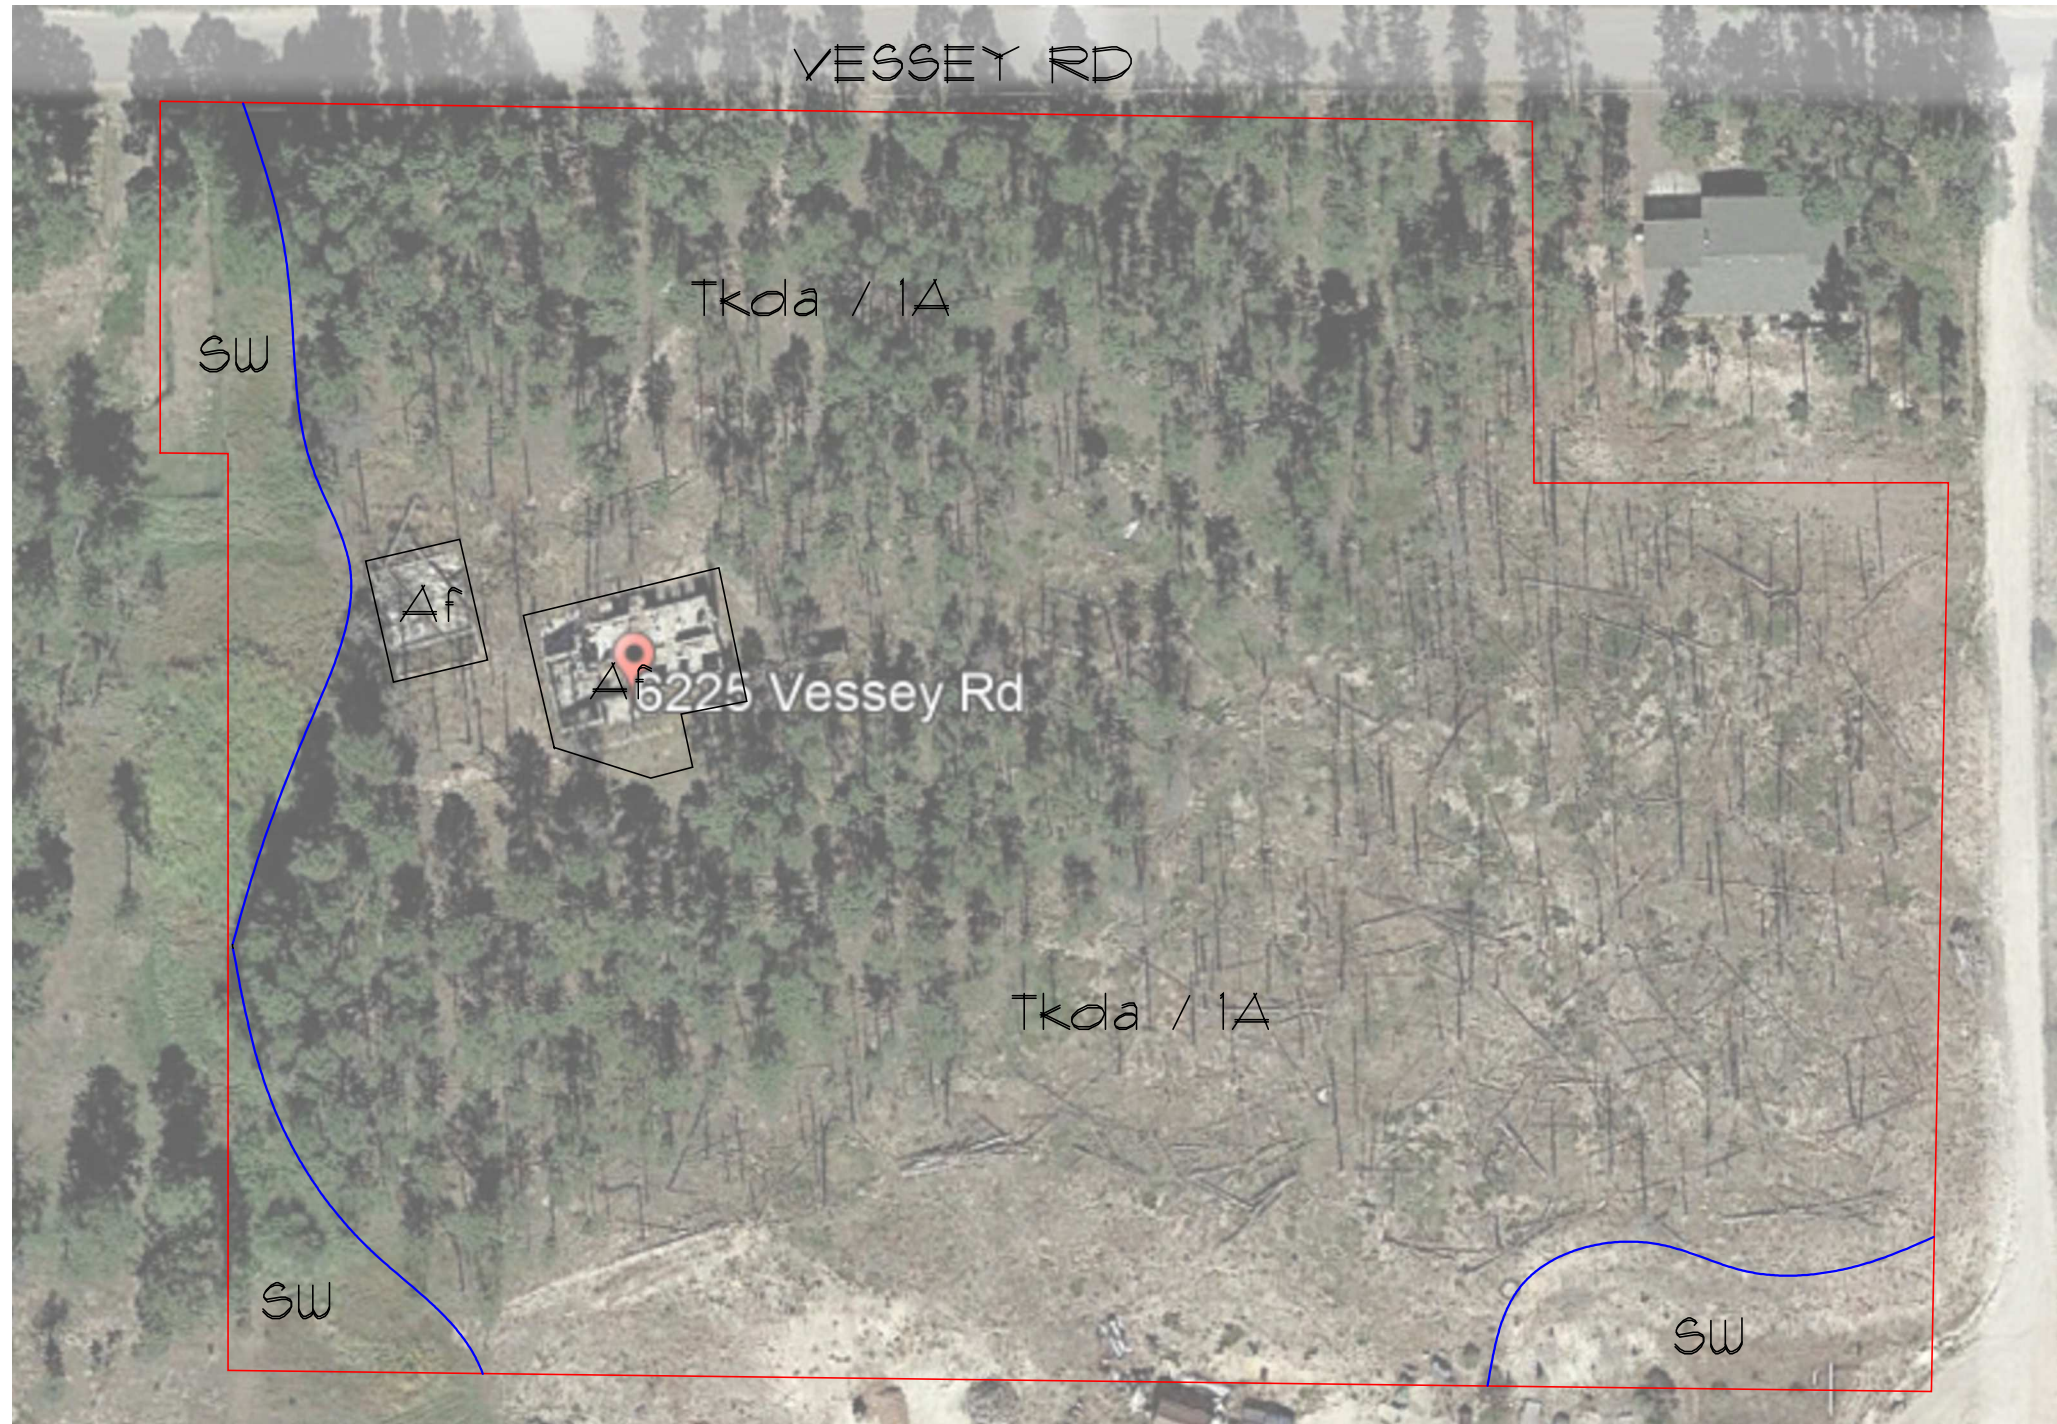
SHEET No.
FIG-7

General Geologic Conditions

- *Tkda₅* - Dawson Formation facies unite three (Eocene) - these sandstones are poorly sorted, have high clay contents, and are usually thin to medium bedded. The facies five is estimated to be about 500 feet thick. The unit is generally permeable, well drained, and has good foundation characteristics.
- *SW* -Seasonally Wet areas - areas that may contain low amounts of surface water during heavy rainstorms.
- *Af* - Artificial Fill - fill resulting from construction of the original structures and septic system.

ENGINEERING
GEOLOGY MAP

Based on our field observations and review of relevant geologic maps, we identified the geologic conditions (listed below) affecting the development, as shown on the Engineering Geology Map, Figure 7.

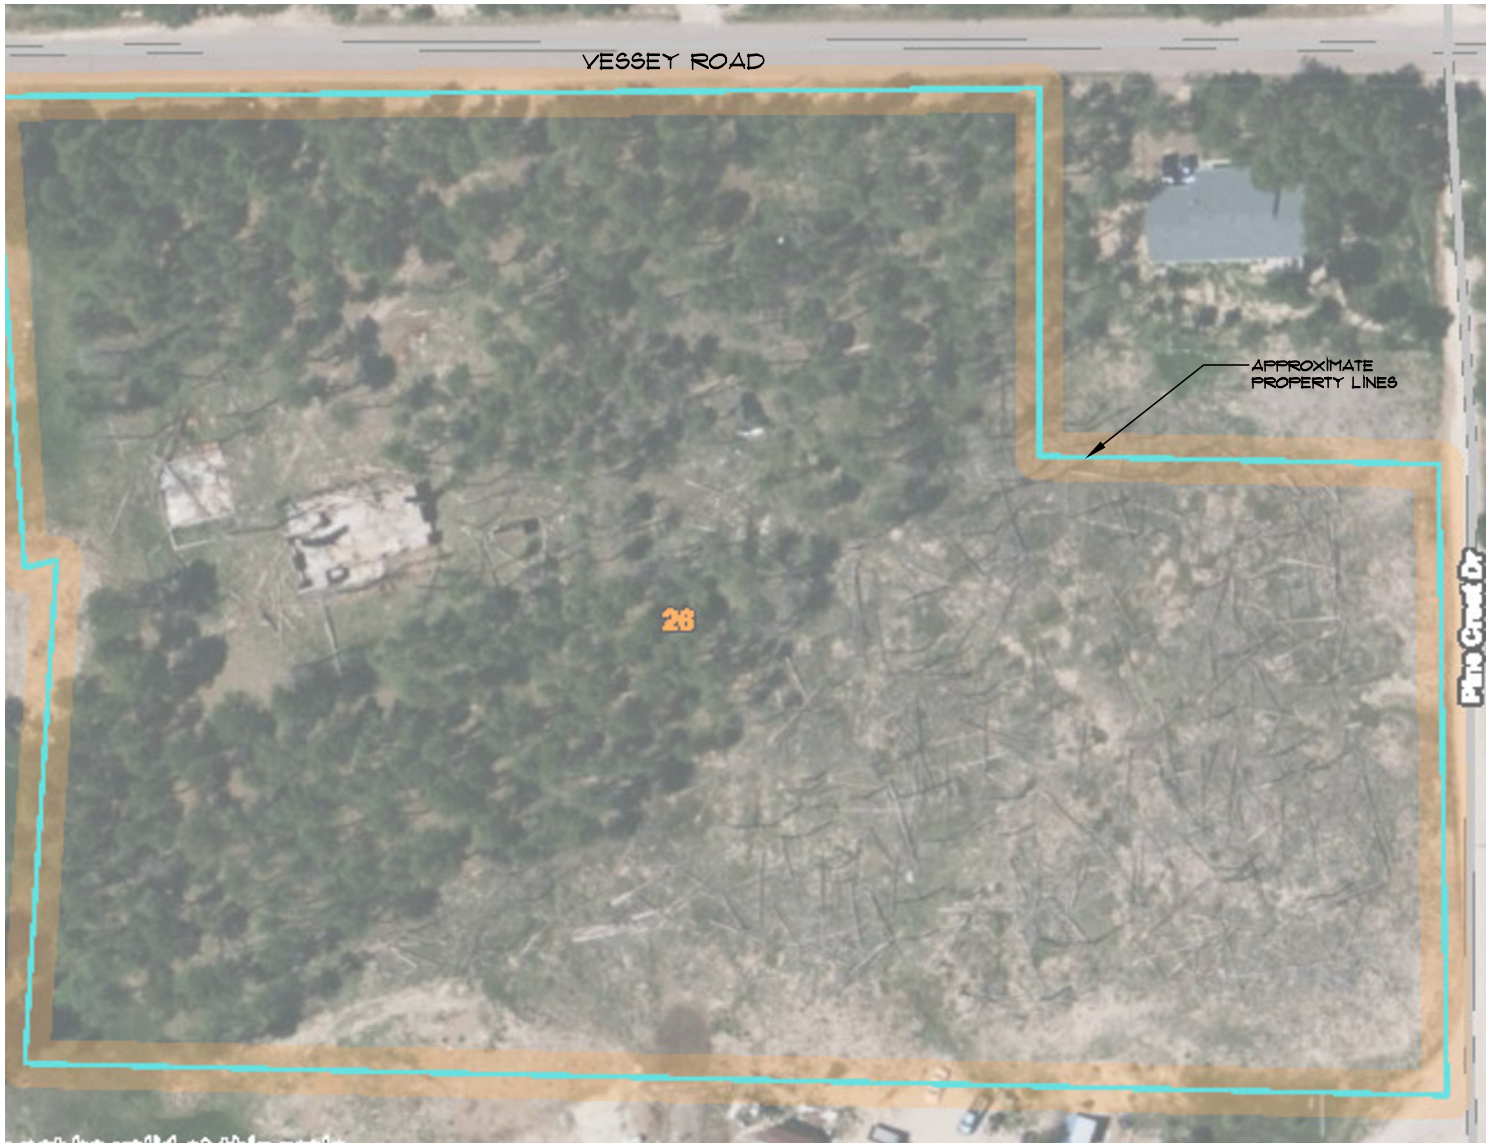
FIG No. 9

28 - Elbeth sandy loam, 8 to 15 percent slopes

The USDA Soil Survey Map is presented in Figure 9.

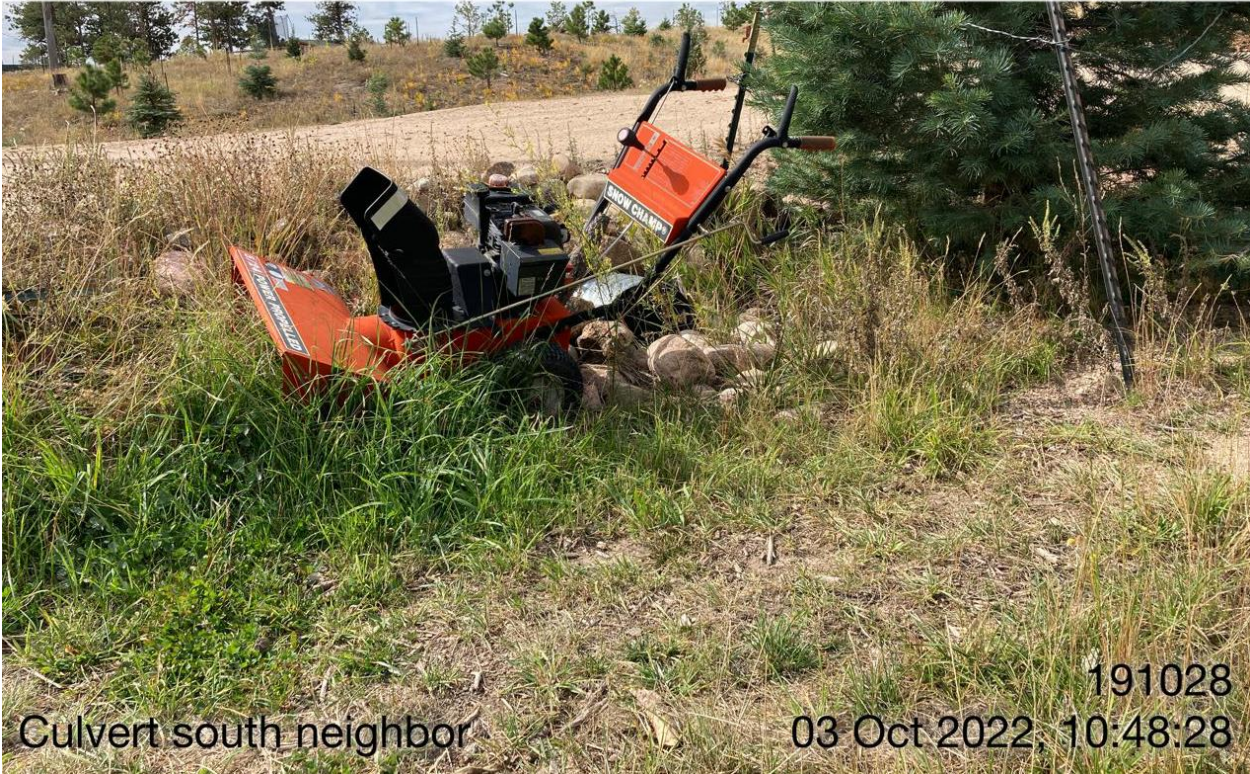
191028
Culvert south neighbor 03 Oct 2022, 10:48:28

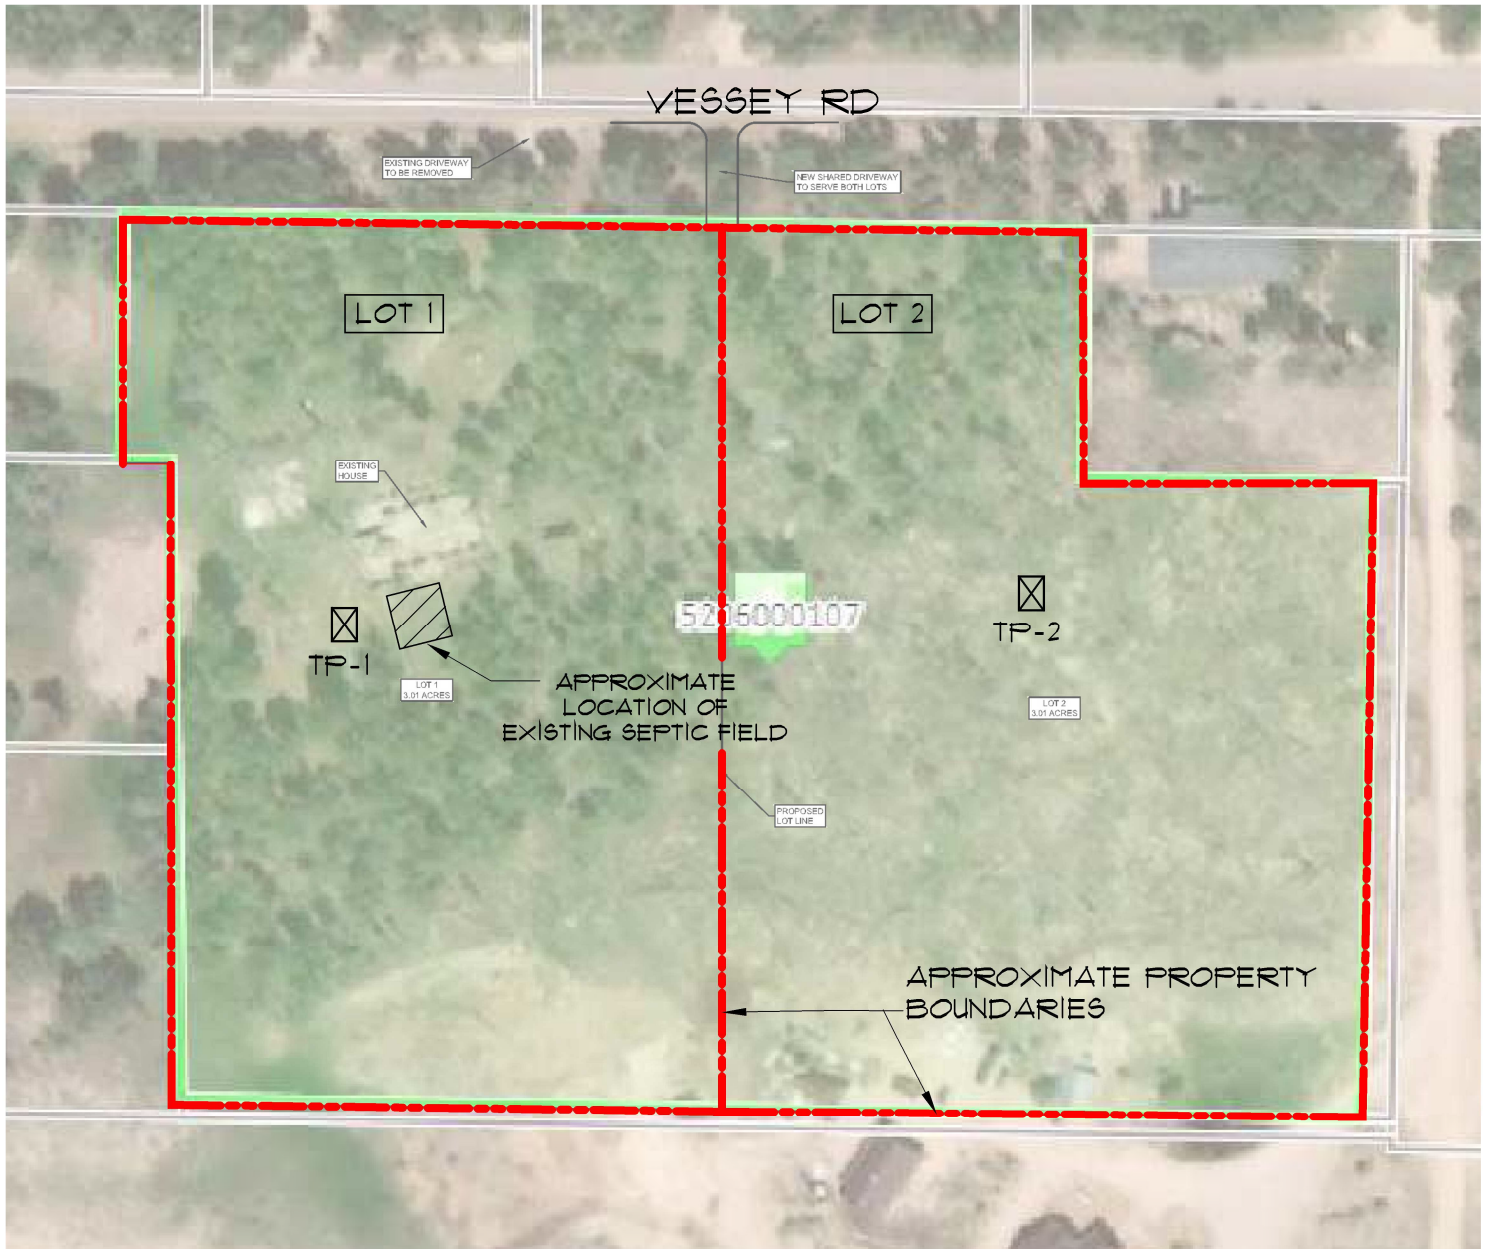
☒ DENOTES APPROXIMATE LOCATION OF TEST PITS

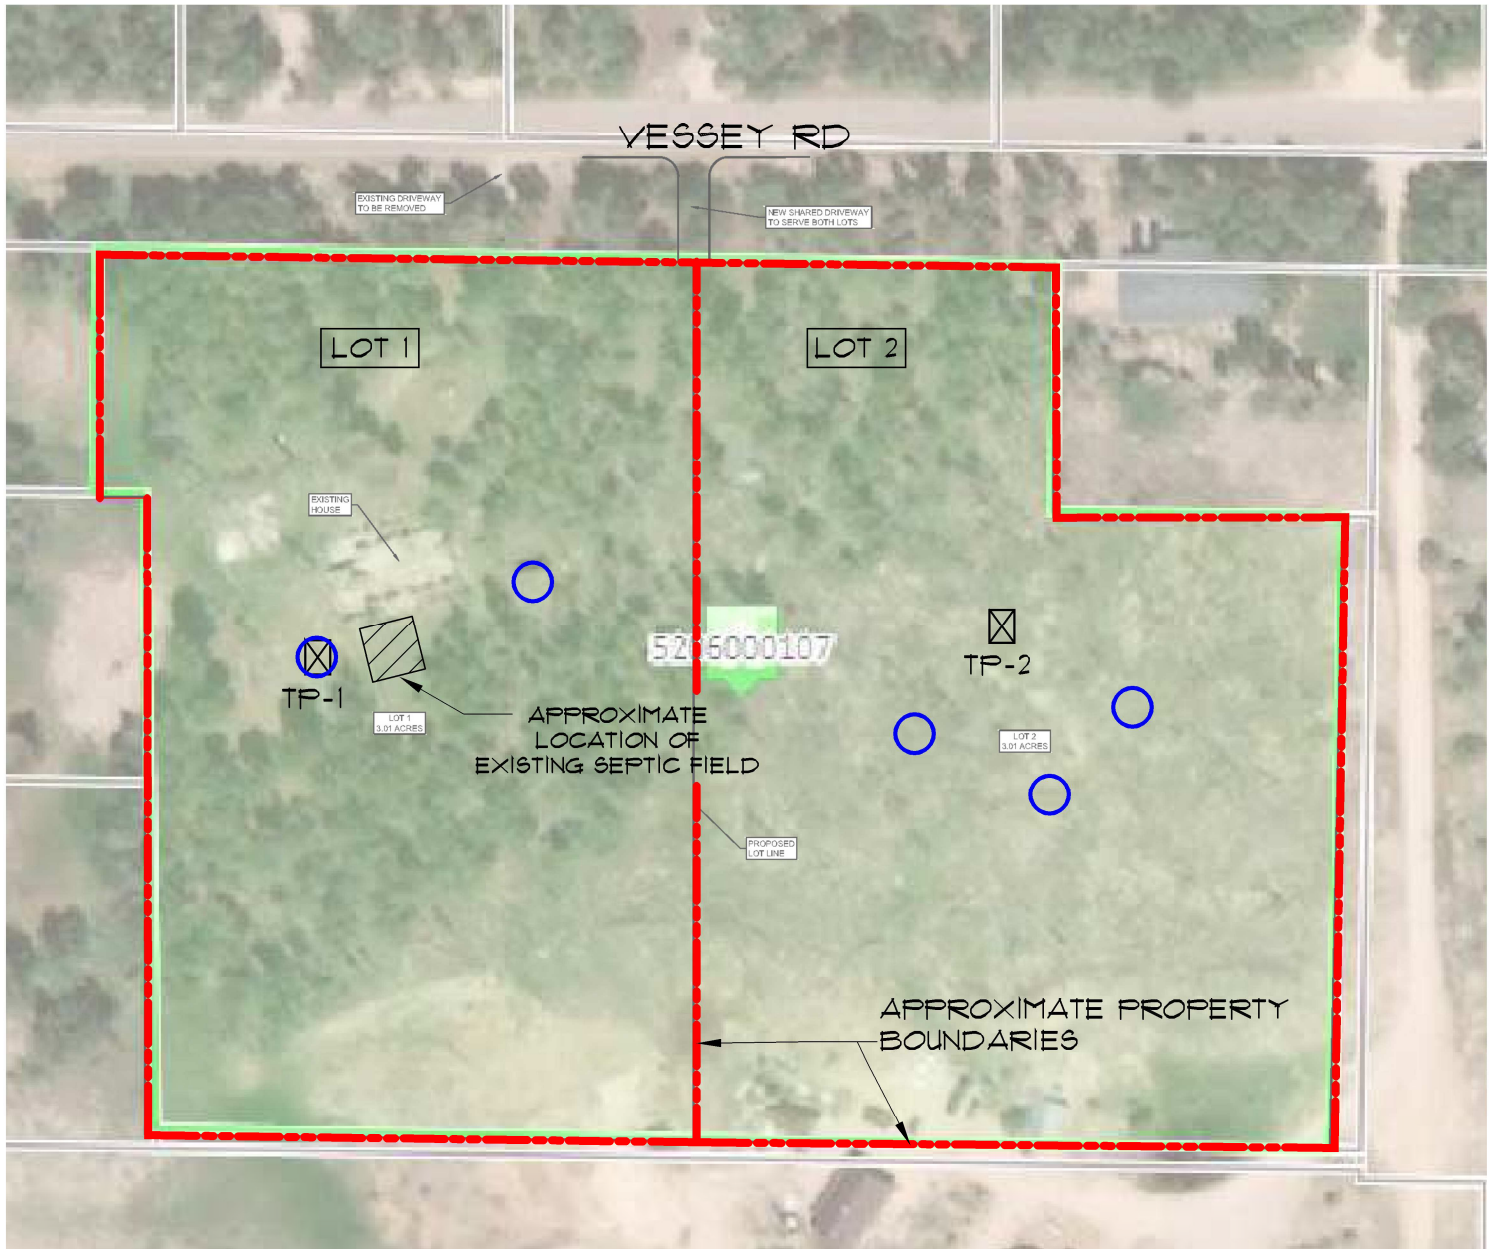
NOTE: The septic locations are for illustration only. If the El Paso County Health Department physical setback requirements are met for each lot, there are no restrictions on the placement of the individual OWTs
