Project: Entech Job #200100
PT Cloverleaf, LLC
Soil, Geology, and Geologic Hazard Study
Cloverleaf Development
El Paso County, Colorado

**SOIL, GEOLOGY AND
GEOLOGIC HAZARD STUDY
CLOVERLEAF DEVELOPMENT
EL PASO COUNTY, COLORADO**

April 7, 2020
Revised November 9, 2020

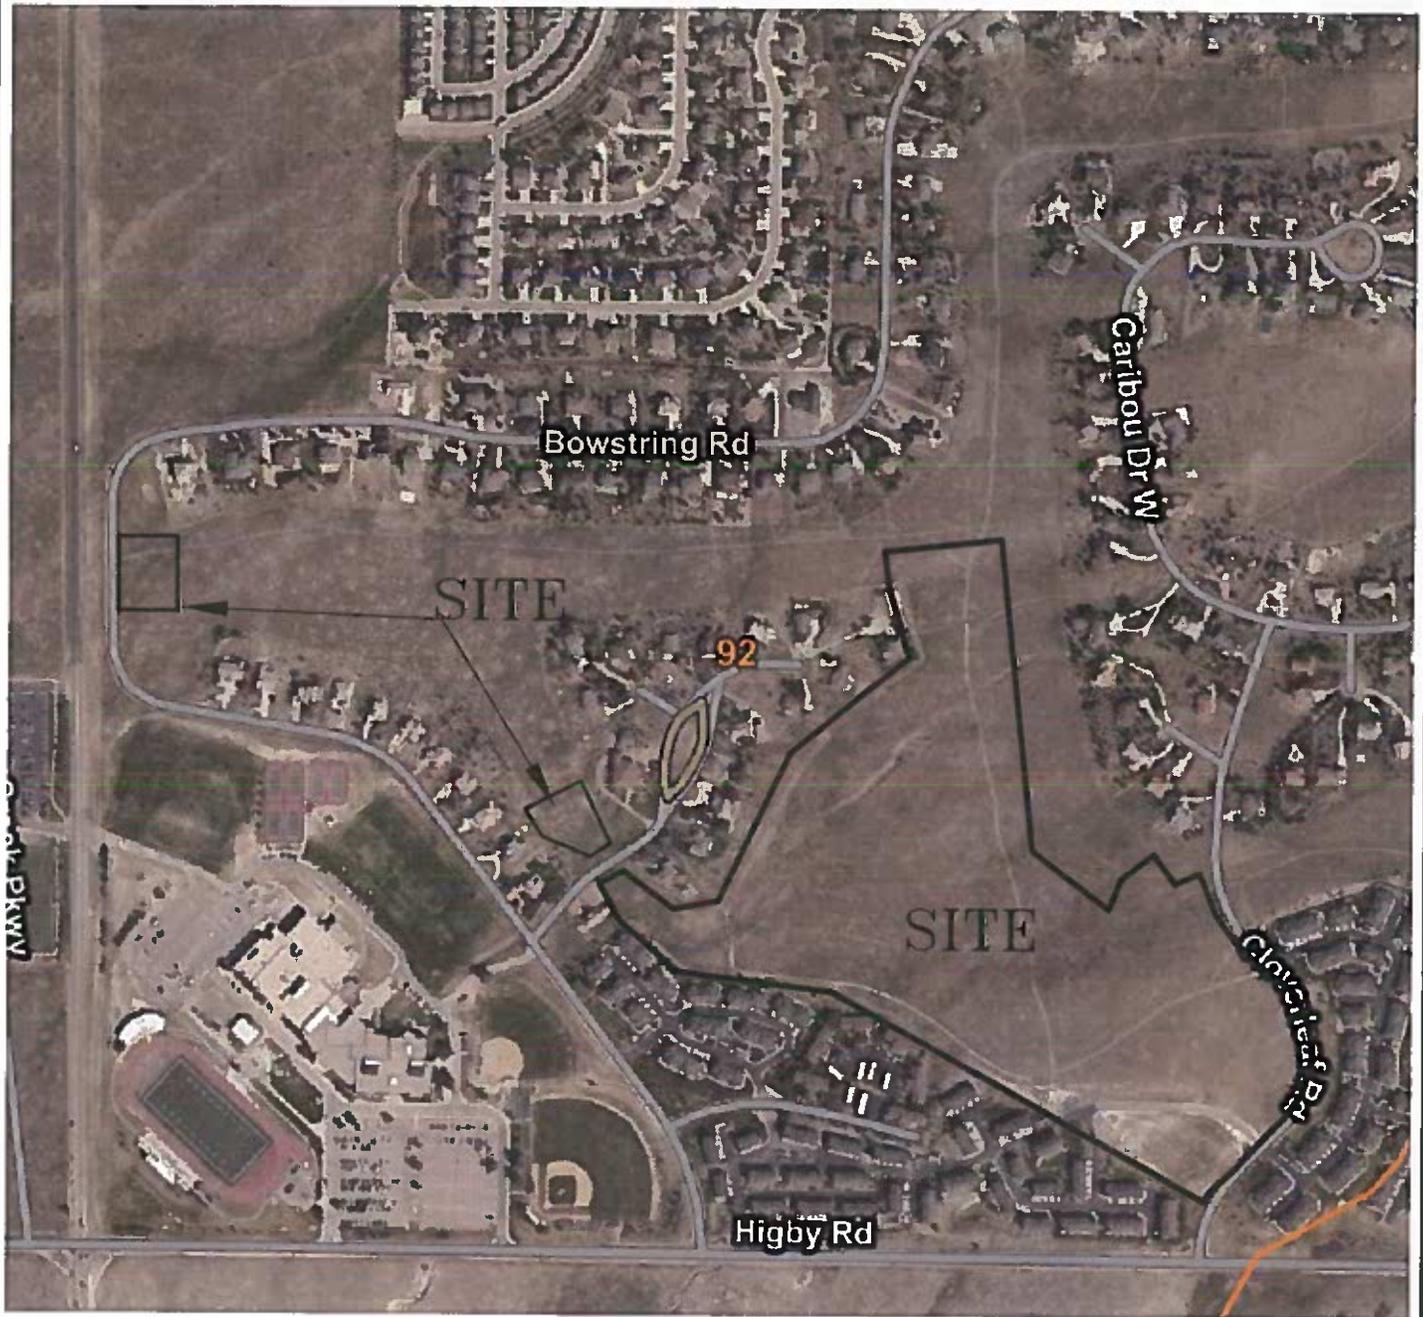
FIG NO.:
4

SOIL SURVEY MAP
CLOVERLEAF DEVELOPMENT
HIGBY ROAD & CLOVERLEAF ROAD
MONUMENT, CO
FOR: PT CLOVERLEAF, LLC

Complete descriptions of the soils are presented in Appendix C. The soils have generally been described to have rapid to very rapid permeabilities. The majority of the soils have been described by the Soil Conservation Service as good potential for urban development. Possible hazards with soil erosion are present on the site. The erosion potential can be controlled with vegetation. The majority of the soils have been described to have slight to moderate erosion hazards. The soil blowing hazard is severe if vegetation is removed.

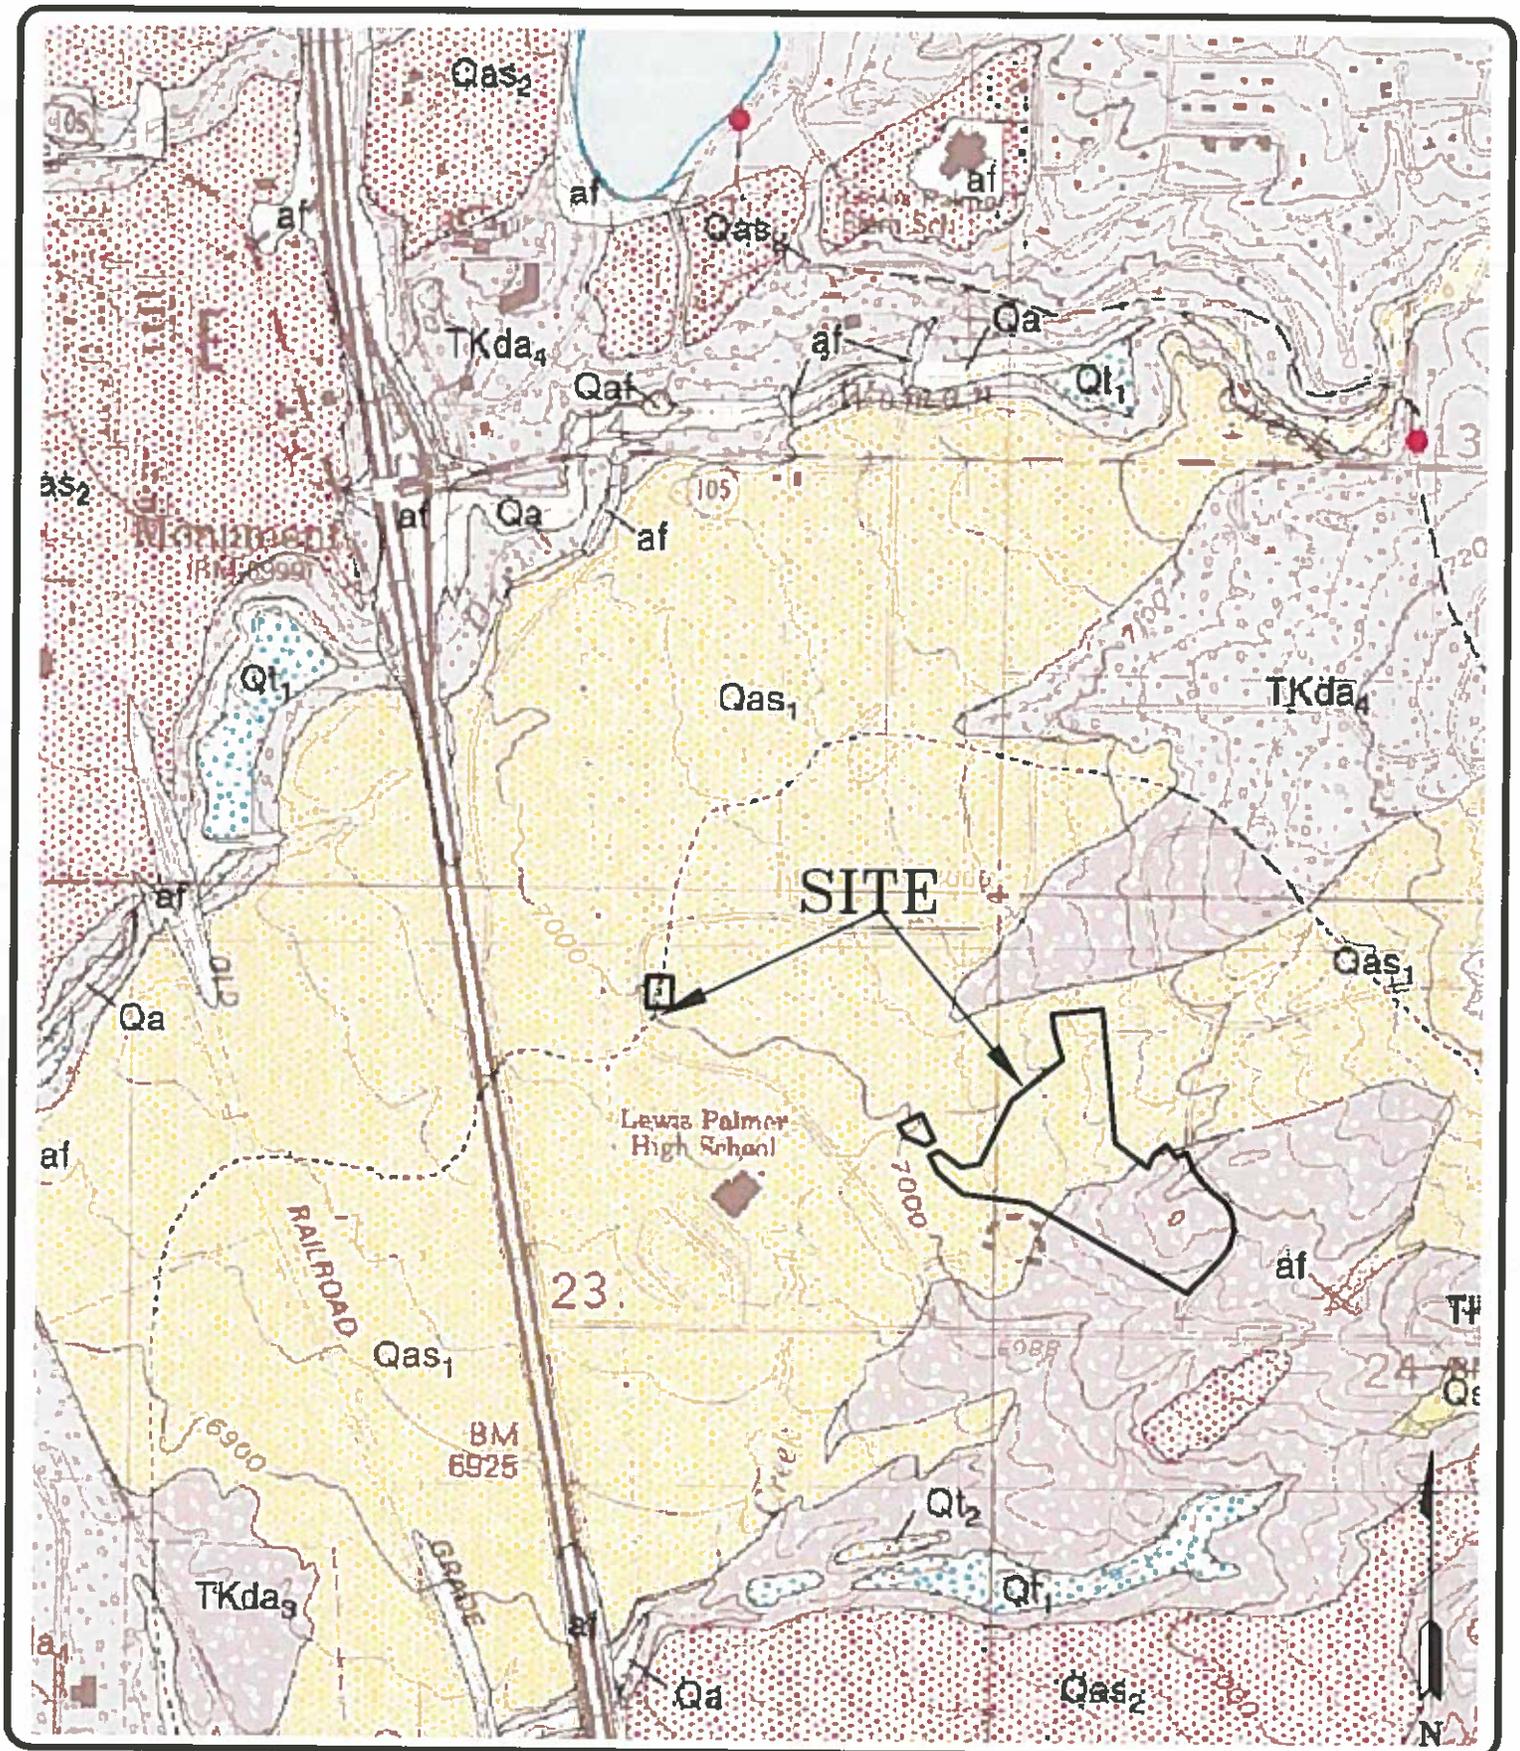
FIG NO:
5

MONUMENT QUADRANGLE GEOLOGY MAP
CLOVERLEAF DEVELOPMENT
HIGBY ROAD & CLOVERLEAF ROAD
MONUMENT, CO
FOR: PT CLOVERLEAF, LLC

The position of mappable units within the subject property are shown on the Geologic Map. Our mapping procedures involved field reconnaissance, measurements and interpretation. The same mapping procedures have also been utilized to produce the Engineering Geology Map which identifies pertinent geologic conditions affecting development.

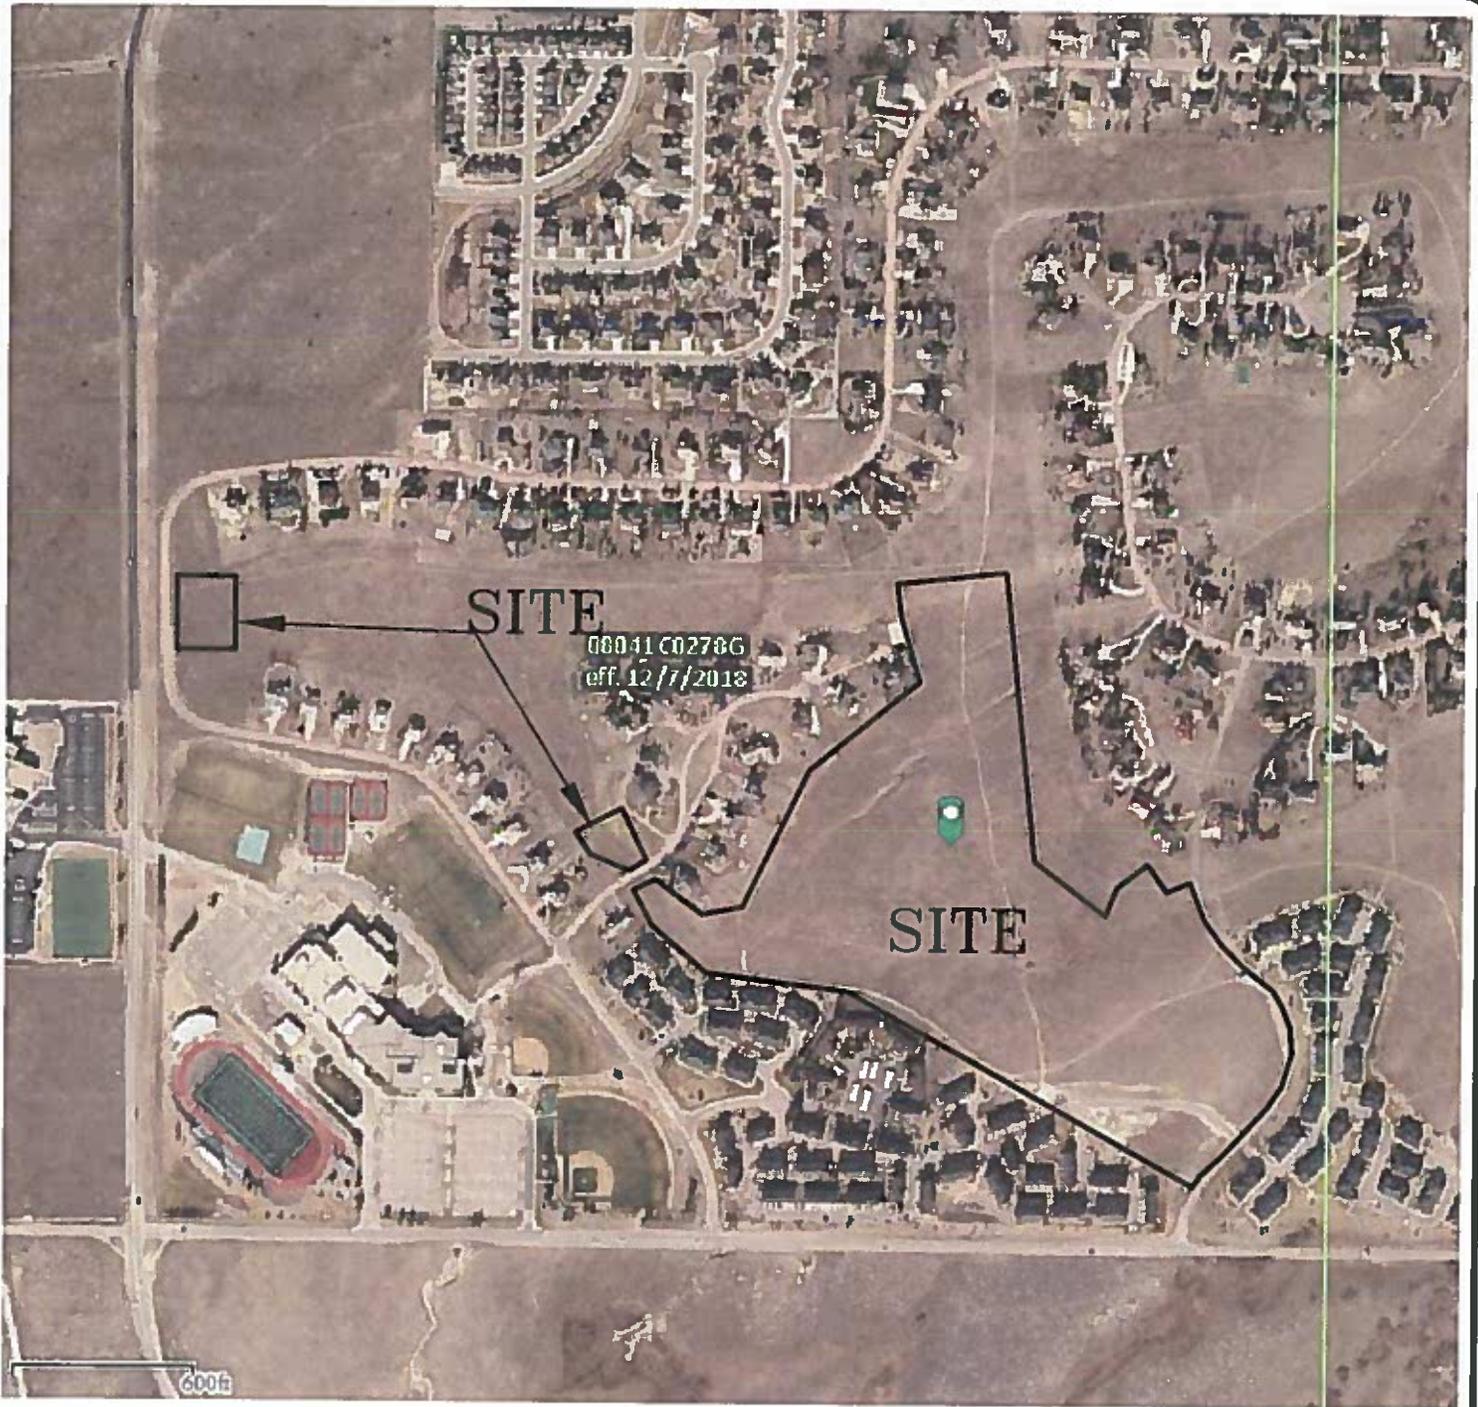
FIG NO.:
 7

FLOODPLAIN MAP
CLOVERLEAF DEVELOPMENT
HIGBY ROAD & CLOVERLEAF ROAD
MONUMENT, CO
FOR: PT CLOVERLEAF, LLC

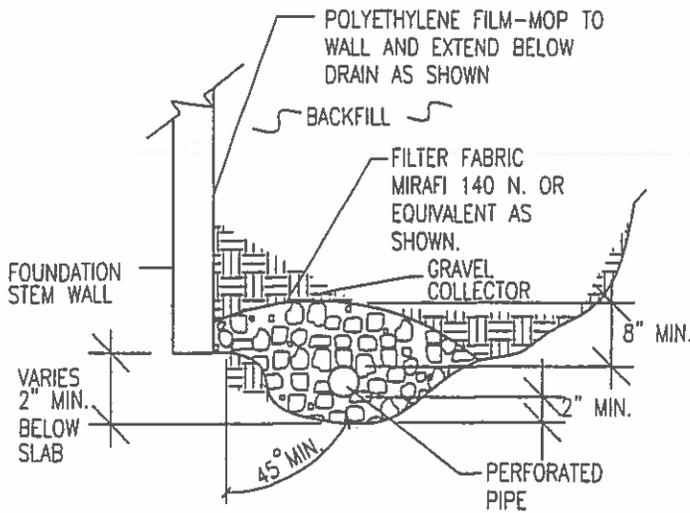
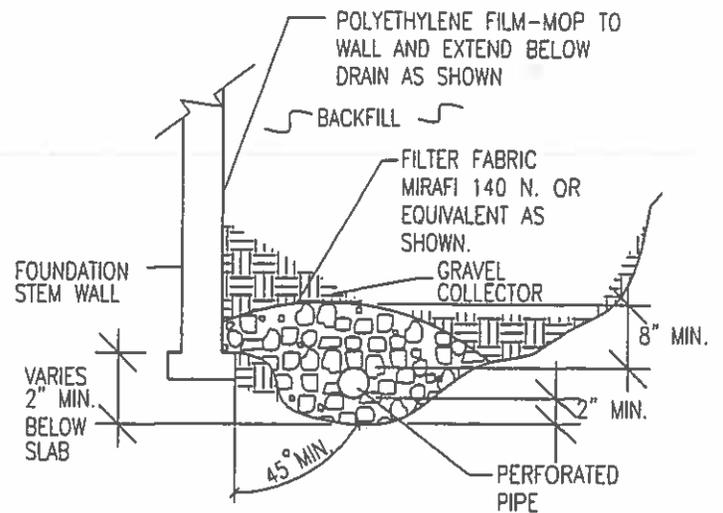
JOB NO.:
200100
FIG NO.:
8

-GRAVEL SIZE IS RELATED TO DIAMETER OF PIPE PERFORATIONS-85% GRAVEL GREATER THAN 2x PERFORATION DIAMETER.

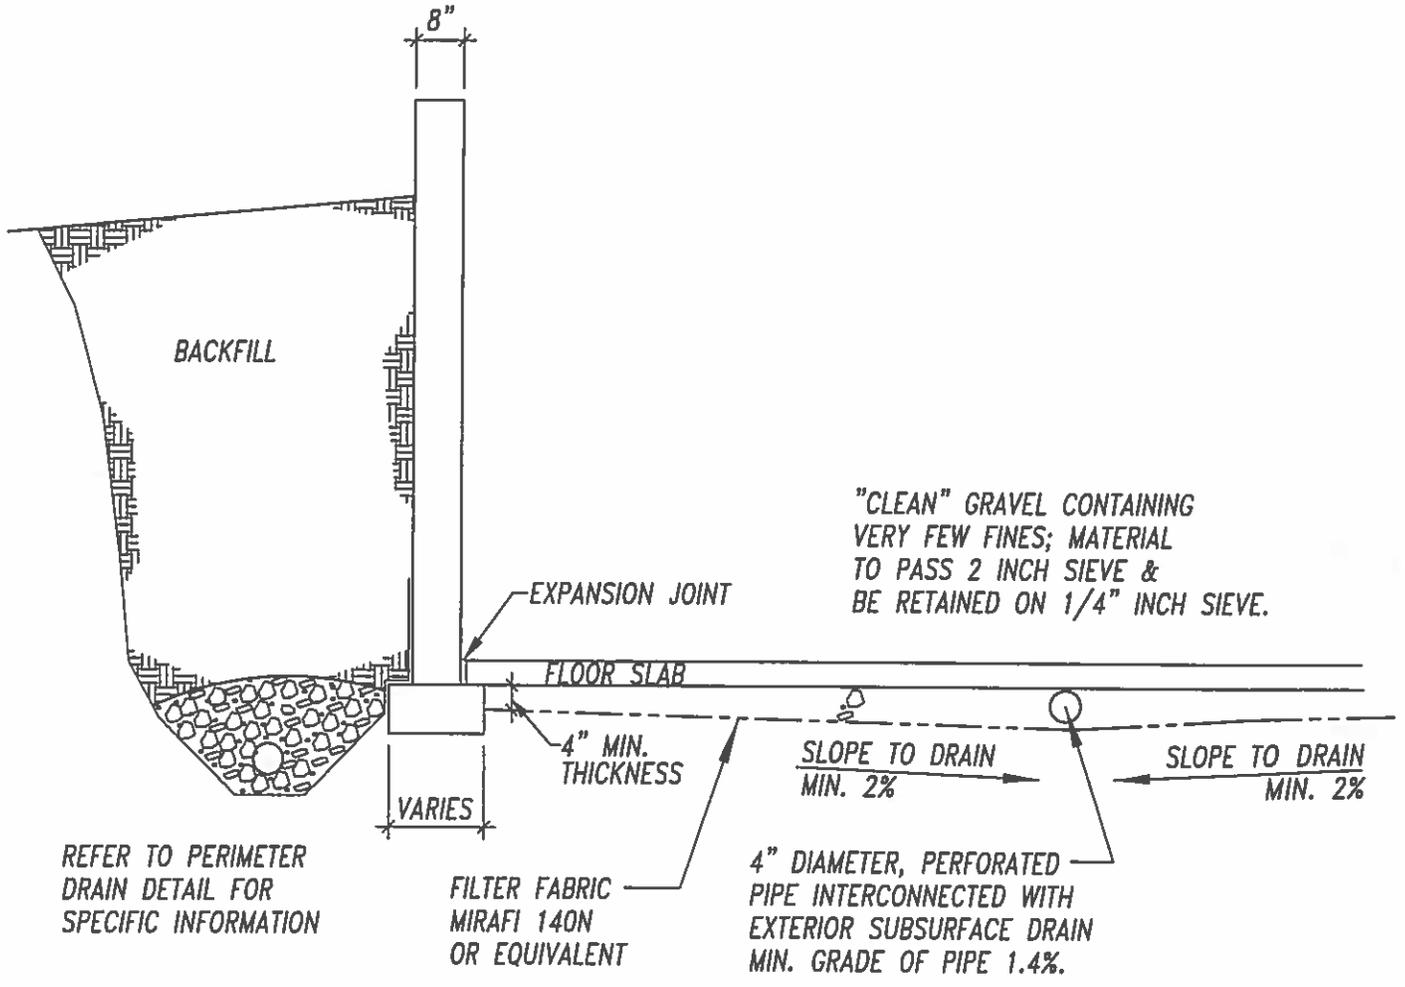
JOB NO.:
200100
FIG NO.:
9

A:\16 - Detail Room\Drawings\UNDERSLAB CAPILLARY BREAK DRAIN.dwg, Layer:1, 6/12/2007, 12:11:55 PM

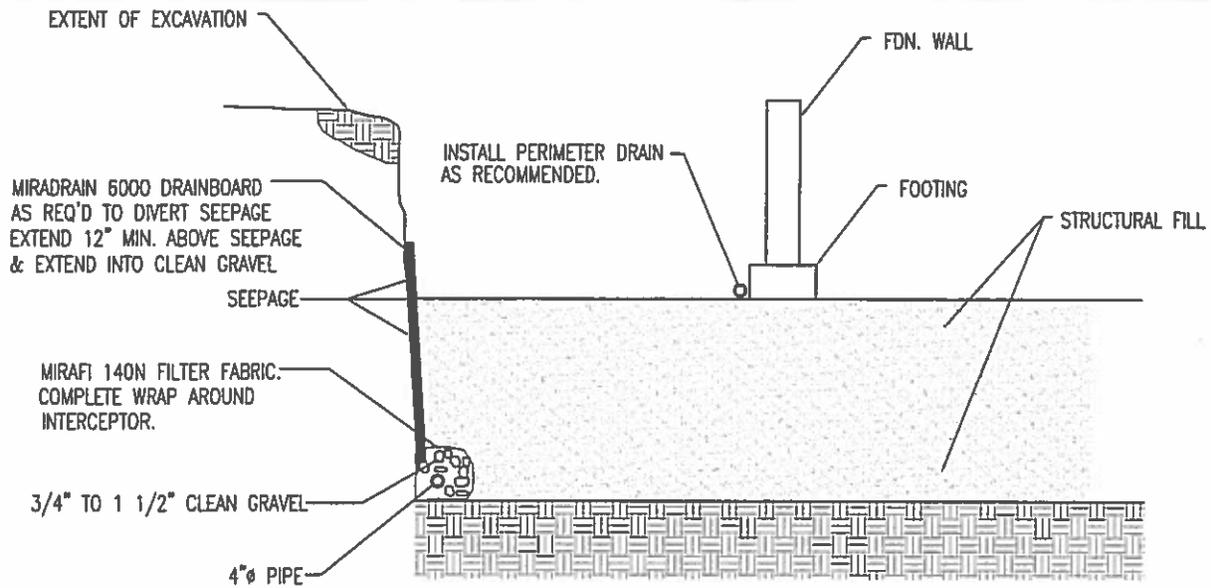
INTERCEPTOR DRAIN DETAIL
N.T.S.

NOTE:
EXTEND INTERCEPTOR DRAIN TO DAYLIGHT

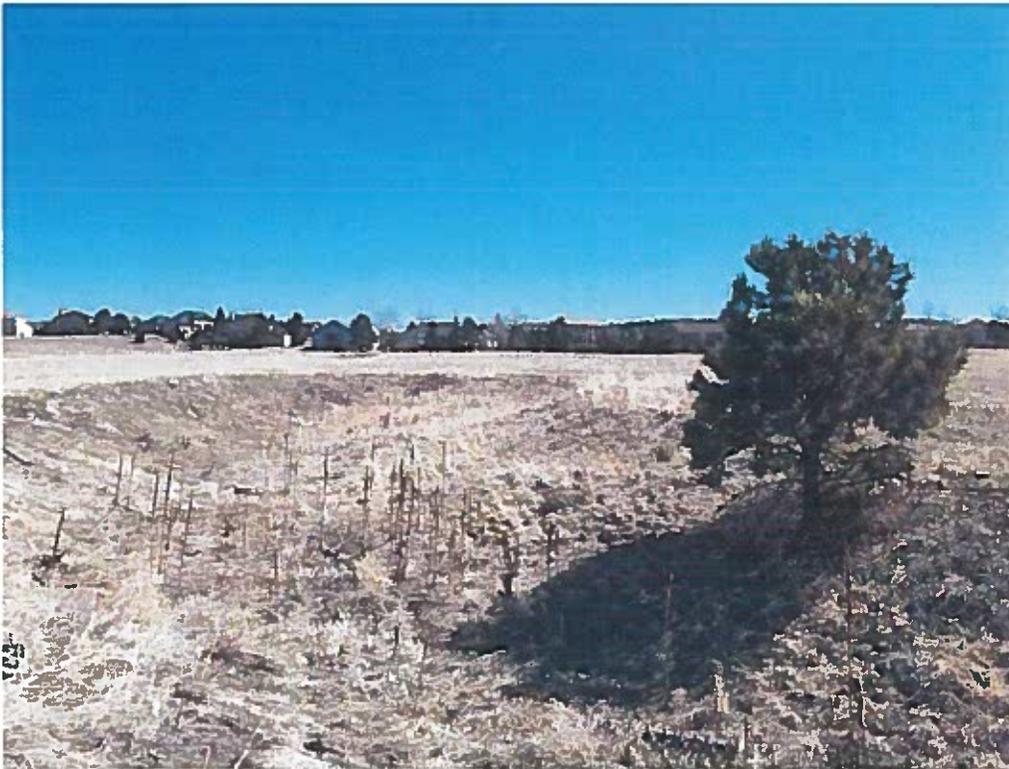
**Looking northeast
along Teachout Creek
in the northwestern
portion of the site.**

These are areas that are undergoing erosion by water and sheetwash producing gullies and rill erosion. Areas of erosion were observed in the Teachout Creek drainage in the northern portion of the site, and an area along eastern side of the site along Cloverleaf Road.

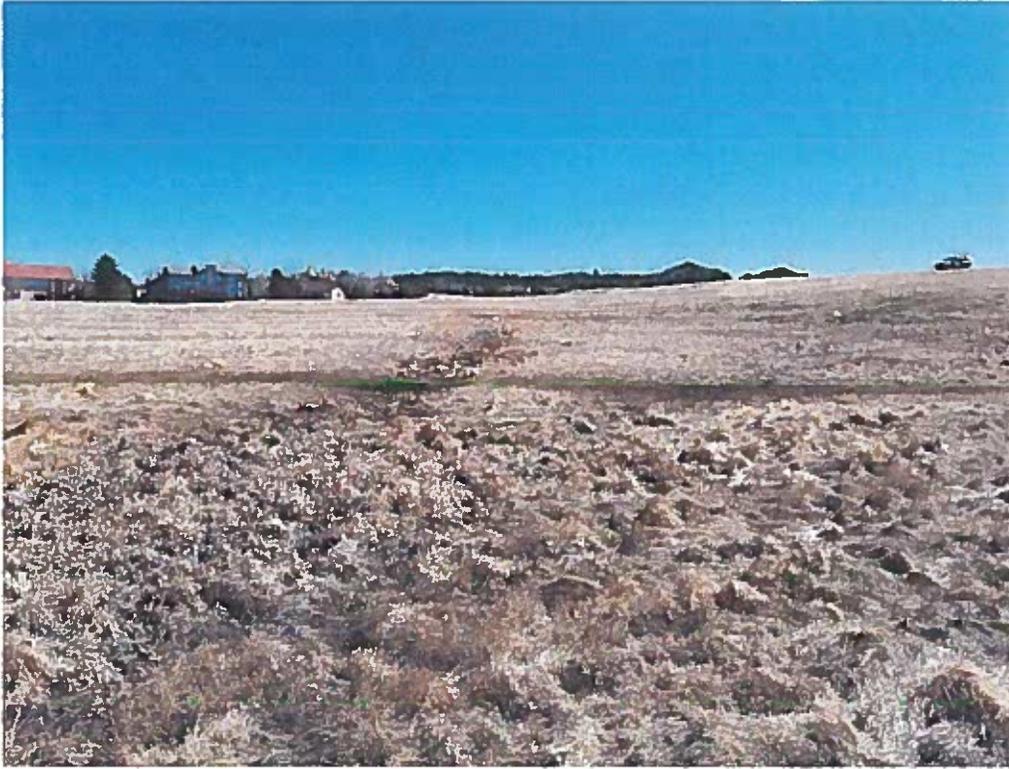
**Looking east along
seasonally wet area in
the central portion of
the site.**

In these areas, we would anticipate the potential for periodically high subsurface moisture conditions and possible frost heave potential, depending on the soil conditions. Areas within the drainages on-site have been identified as potentially seasonal shallow groundwater, and the seasonal shallow groundwater area is located in a minor drainage area in the south-central portion of the site, and is also identified as a wetland in the National Wetland Inventory. In this wetland area we would anticipate the potential for surface and near surface groundwater conditions depending on seasonal changes in precipitation and runoff. This area had saturated surface conditions and minor areas of standing water during our field mapping. The areas identified as potentially seasonal and seasonal shallow groundwater lie within drainages and low-lying areas that will be regraded during overlot grading. Where structures or utility trenches encroach on, or lie within these areas, the following mitigation is recommended:

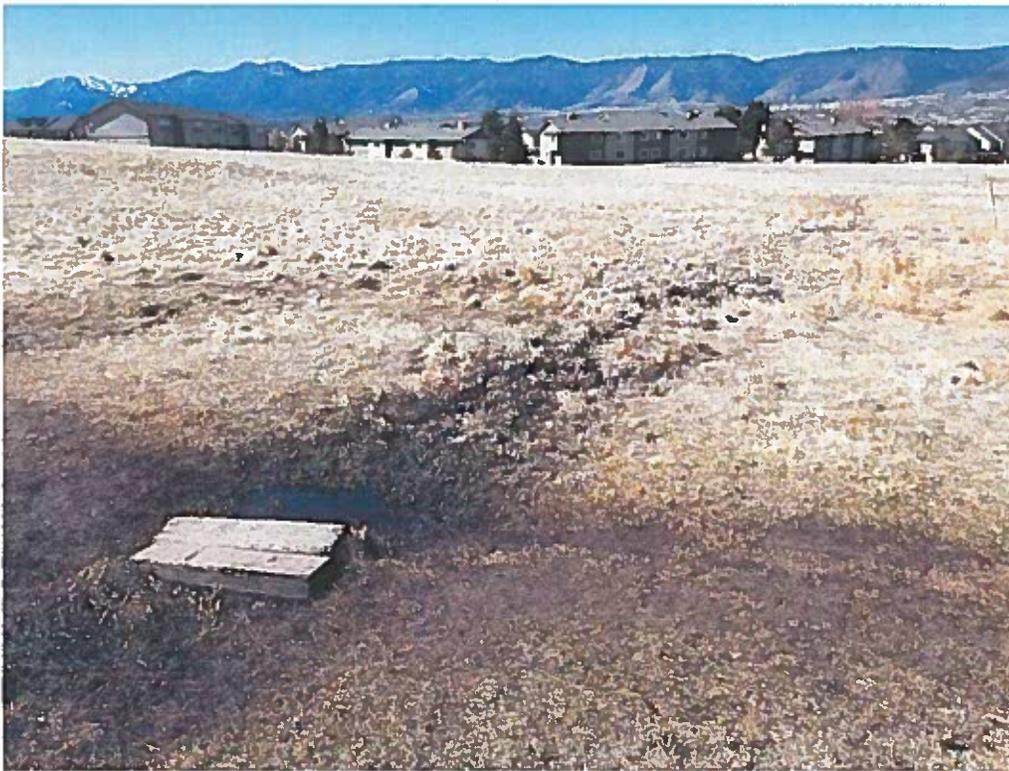
**Looking west along
seasonally wet area in
the central portion of
the site.**

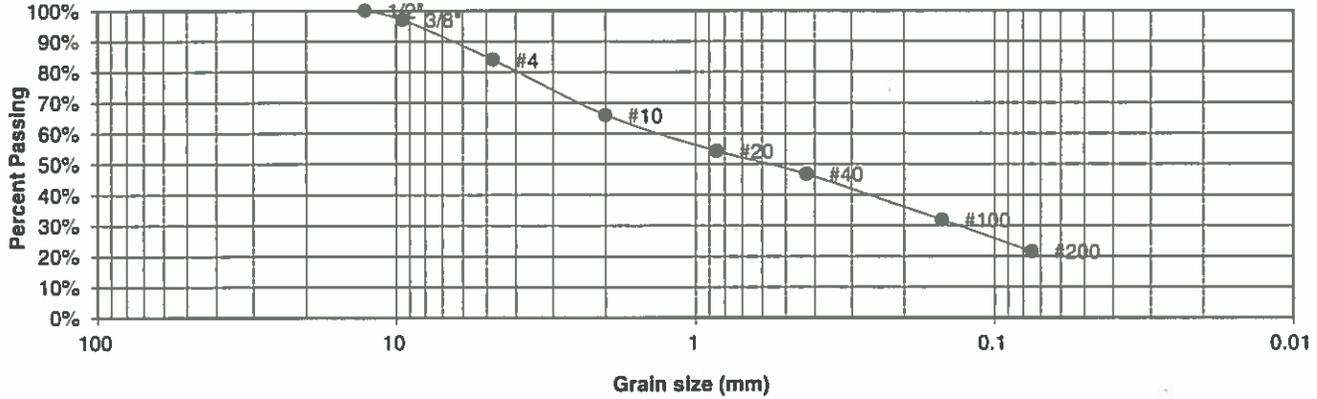
FIG NO:
C-1

<u>UNIFIED CLASSIFICATION</u>	SM	<u>CLIENT</u>	PT CLOVERLEAF, LLC
<u>SOIL TYPE #</u>	1	<u>PROJECT</u>	CLOVERLEAF SITE
<u>TEST BORING #</u>	1	<u>JOB NO.</u>	200100
<u>DEPTH (FT)</u>	2-3	<u>TEST BY</u>	BL

**Sieve Analysis
Grain Size Distribution**

U.S. Sieve #	Percent Finer
3"	
1 1/2"	
3/4"	
1/2"	100.0%
3/8"	97.0%
4	84.0%
10	66.0%
20	54.3%
40	46.8%
100	31.9%
200	21.5%

Atterberg Limits	
Plastic Limit	NP
Liquid Limit	NV
Plastic Index	NP

Soil Type 1 classified as a slightly silty to silty sand (SM, SM-SW). The sand was encountered in all the test borings from the existing ground surface to depths ranging from 7 to 24 feet below ground surface (bgs), and to the termination of Test Boring Nos. 1 and 6 (20 feet). Standard Penetration Testing of the sand resulted in N-values of 3 to 30 bpf indicating very loose to medium dense states. Water content and grain size analysis resulted in water contents of 2 to 17 percent and approximately 5 to 22 percent of the soil particles passing the No. 200 sieve. Atterberg Limits testing on samples of the sand resulted in liquid limits ranging from 35 to no value and plastic indexes ranging from 11 to non-plastic. Sulfate testing on the sand resulted in less than 0.01 percent soluble sulfate by weight, indicating negligible potential for below grade concrete degradation due to sulfate attack.

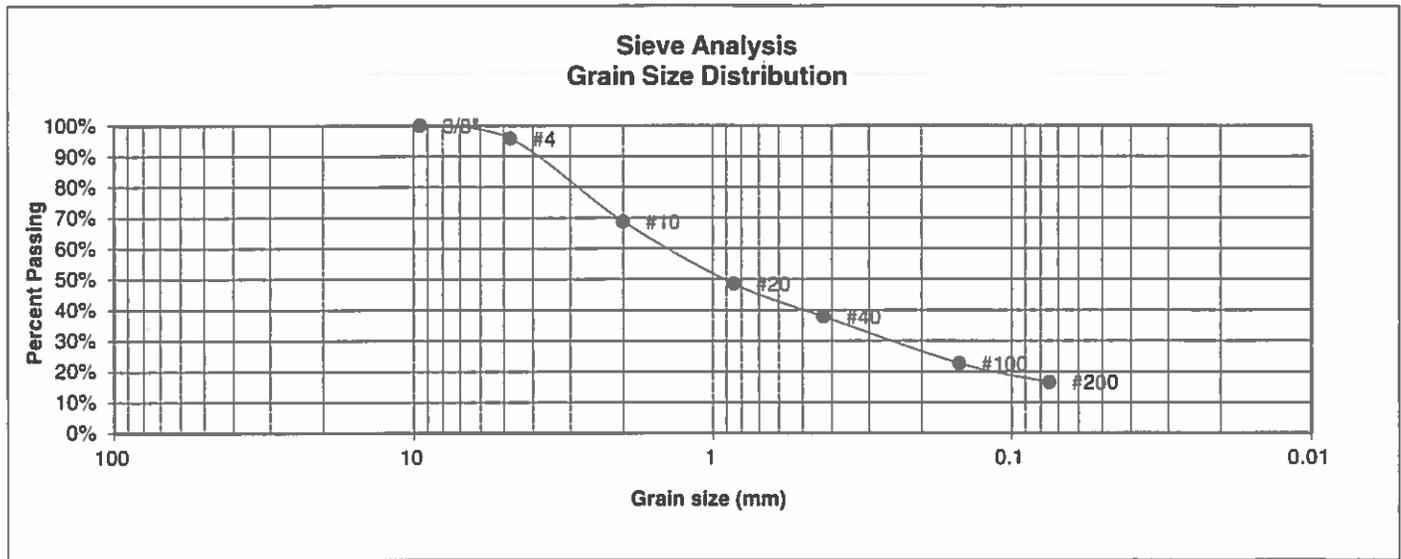
<u>UNIFIED CLASSIFICATION</u>	SM	<u>CLIENT</u>	PT CLOVERLEAF, LLC
<u>SOIL TYPE #</u>	1	<u>PROJECT</u>	CLOVERLEAF SITE
<u>TEST BORING #</u>	2	<u>JOB NO.</u>	200100
<u>DEPTH (FT)</u>	5	<u>TEST BY</u>	BL

U.S. Sieve #	Percent Finer
3"	
1 1/2"	
3/4"	
1/2"	
3/8"	100.0%
4	95.8%
10	68.7%
20	48.5%
40	37.8%
100	22.6%
200	16.5%

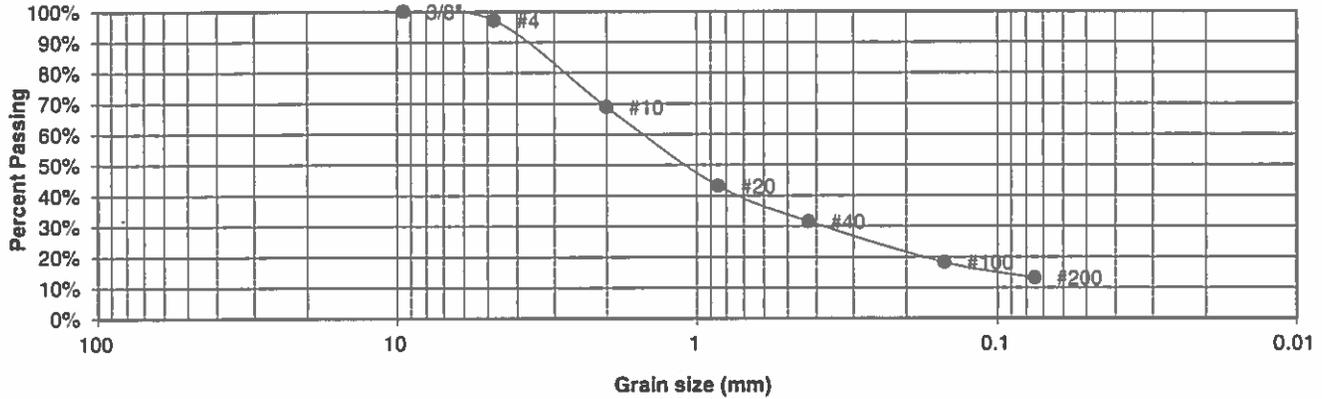
<u>UNIFIED CLASSIFICATION</u>	SM	<u>CLIENT</u>	PT CLOVERLEAF, LLC
<u>SOIL TYPE #</u>	1	<u>PROJECT</u>	CLOVERLEAF SITE
<u>TEST BORING #</u>	3	<u>JOB NO.</u>	200100
<u>DEPTH (FT)</u>	5	<u>TEST BY</u>	BL

**Sieve Analysis
Grain Size Distribution**

<u>U.S. Sieve #</u>	<u>Percent Finer</u>
3"	
1 1/2"	
3/4"	
1/2"	
3/8"	100.0%
4	97.1%
10	68.9%
20	43.1%
40	31.6%
100	18.2%
200	13.1%

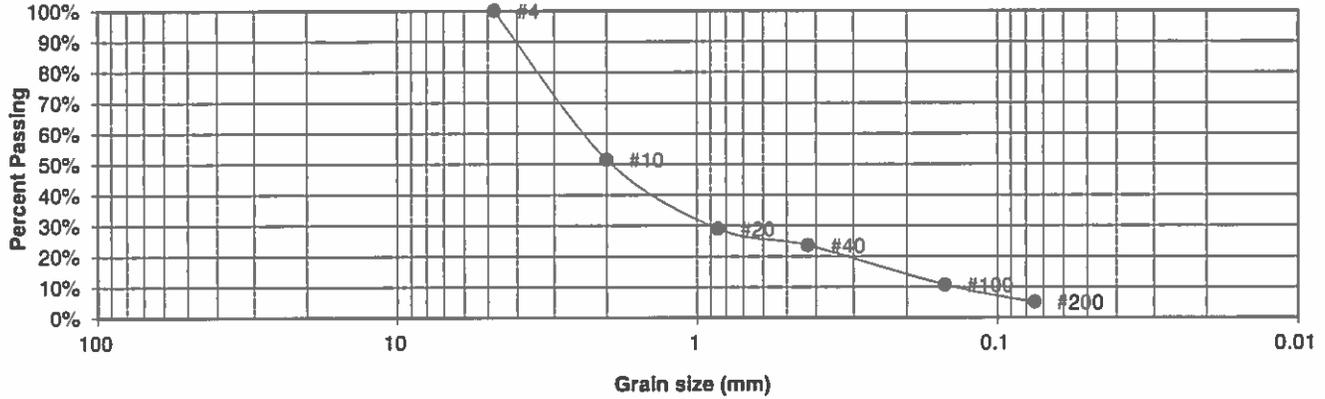
FIG NO.:
C-4

<u>UNIFIED CLASSIFICATION</u>	SM-SW	<u>CLIENT</u>	PT CLOVERLEAF, LLC
<u>SOIL TYPE #</u>	1	<u>PROJECT</u>	CLOVERLEAF SITE
<u>TEST BORING #</u>	4	<u>JOB NO.</u>	200100
<u>DEPTH (FT)</u>	5	<u>TEST BY</u>	BL

**Sieve Analysis
Grain Size Distribution**

U.S. Sieve #	Percent Finer
3"	
1 1/2"	
3/4"	
1/2"	
3/8"	
4	100.0%
10	51.4%
20	29.0%
40	23.6%
100	10.7%
200	5.0%

Atterberg Limits	
Plastic Limit	NP
Liquid Limit	NV
Plastic Index	NP

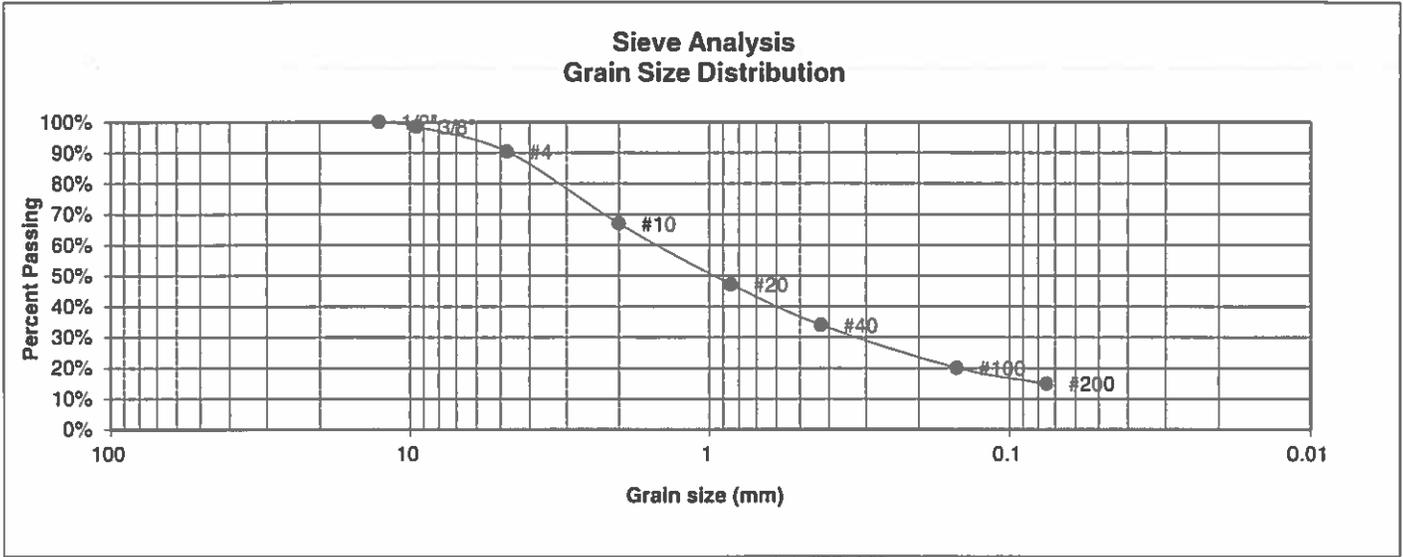
FIG NO:
C-5

<u>UNIFIED CLASSIFICATION</u>	SM	<u>CLIENT</u>	PT CLOVERLEAF, LLC
<u>SOIL TYPE #</u>	1	<u>PROJECT</u>	CLOVERLEAF SITE
<u>TEST BORING #</u>	5	<u>JOB NO.</u>	200100
<u>DEPTH (FT)</u>	10	<u>TEST BY</u>	BL

U.S. Sieve #	Percent Finer
3"	
1 1/2"	
3/4"	
1/2"	100.0%
3/8"	98.5%
4	90.4%
10	67.0%
20	47.2%
40	34.0%
100	20.1%
200	14.9%

Atterberg Limits	
Plastic Limit	24
Liquid Limit	35
Plastic Index	11

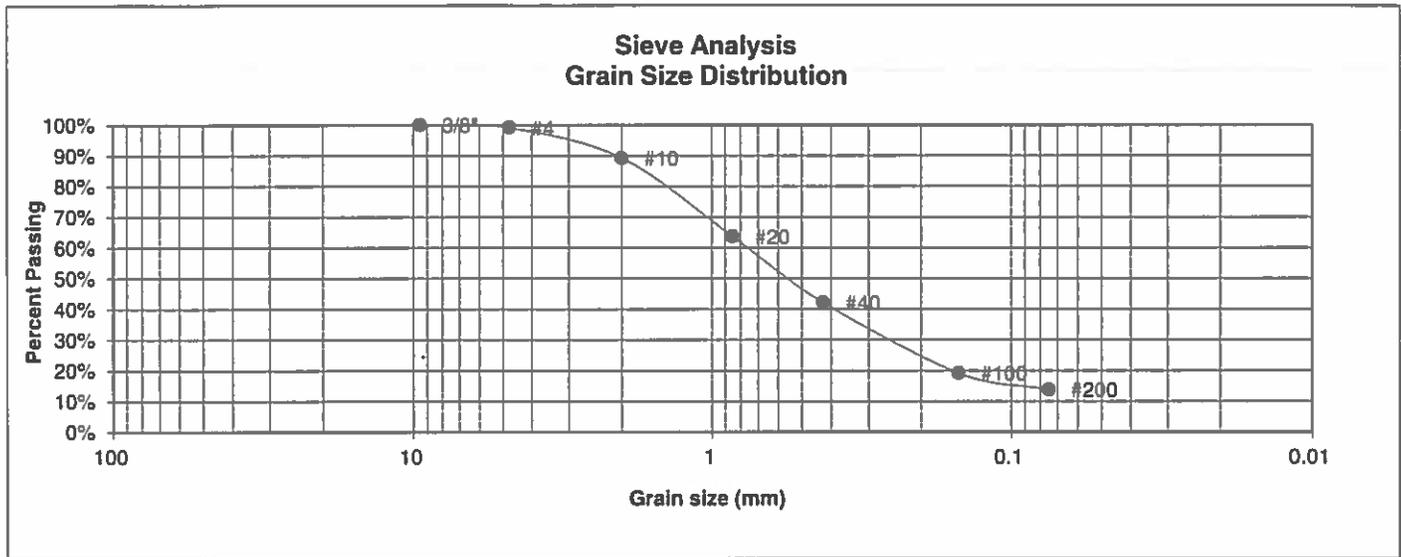
FIG NO.:
C-6

<u>UNIFIED CLASSIFICATION</u>	SM	<u>CLIENT</u>	PT CLOVERLEAF, LLC
<u>SOIL TYPE #</u>	1	<u>PROJECT</u>	CLOVERLEAF SITE
<u>TEST BORING #</u>	6	<u>JOB NO.</u>	200100
<u>DEPTH (FT)</u>	15	<u>TEST BY</u>	BL

U.S. Sieve #	Percent Finer
3"	
1 1/2"	
3/4"	
1/2"	
3/8"	100.0%
4	99.1%
10	89.2%
20	63.6%
40	42.1%
100	19.1%
200	13.8%

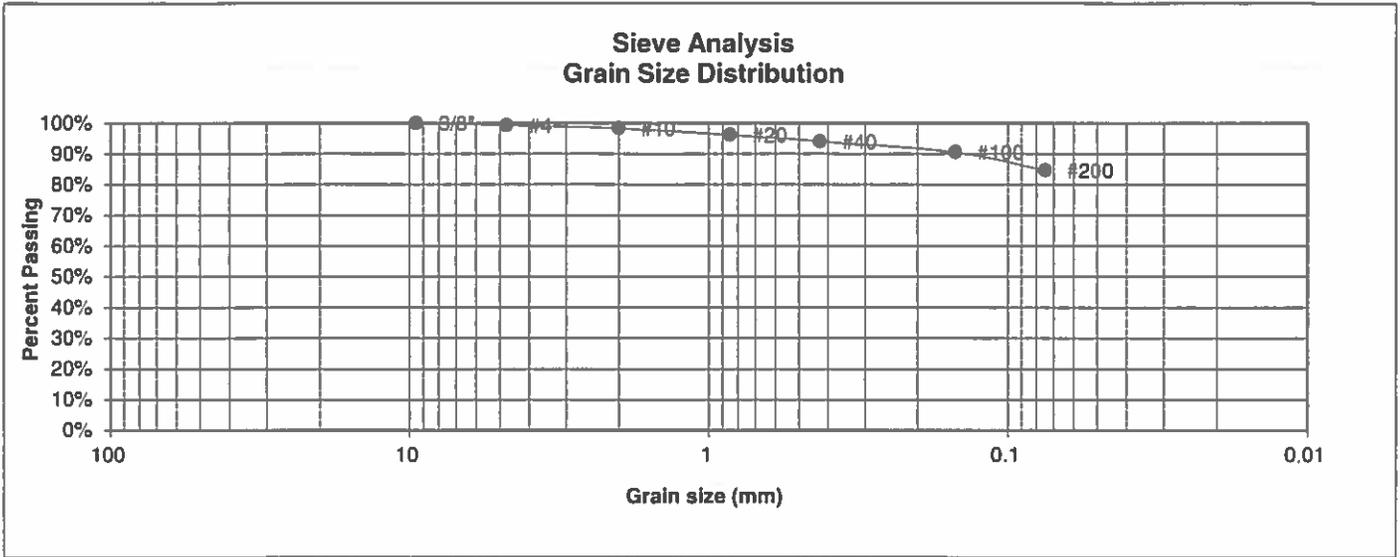
FIG NO:
C-7

<u>UNIFIED CLASSIFICATION</u>	ML	<u>CLIENT</u>	PT CLOVERLEAF, LLC
<u>SOIL TYPE #</u>	1A	<u>PROJECT</u>	CLOVERLEAF SITE
<u>TEST BORING #</u>	6	<u>JOB NO.</u>	200100
<u>DEPTH (FT)</u>	2-3	<u>TEST BY</u>	BL

U.S. Sieve #	Percent Finer
3"	
1 1/2"	
3/4"	
1/2"	
3/8"	100.0%
4	99.2%
10	98.3%
20	96.2%
40	94.0%
100	90.6%
200	84.6%

- Atterberg Limits
 Plastic Limit
 Liquid Limit
 Plastic Index
- Swell
 Moisture at start
 Moisture at finish
 Moisture increase
 Initial dry density (pcf)
 Swell (psf)

The soils encountered in the test borings can be grouped into two general soil types. Three soil types were observed during drilling and consisted of Type 1A: sandy silt (ML), Type 1: slightly silty to silty sand (SM, SM-SW), and Type 2: clayey to very clayey and silty sandstone (SC, SM). Each soil type was classified in accordance with the Unified Soil Classification System (USCS) using the laboratory testing results and the observations made during drilling.

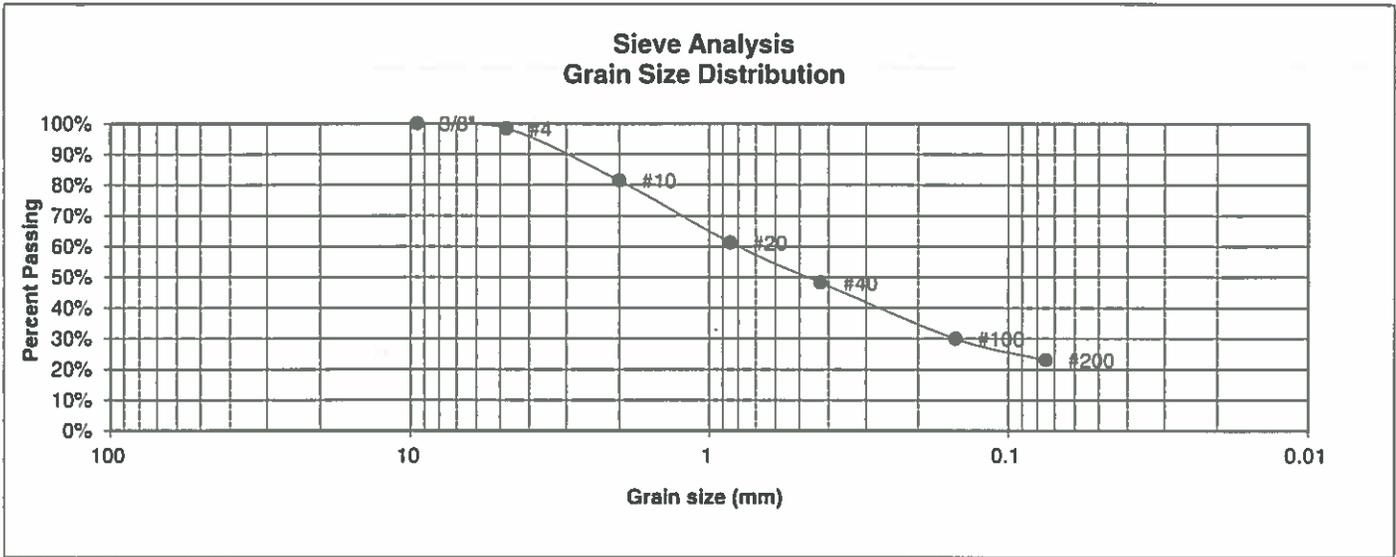
<u>UNIFIED CLASSIFICATION</u>	SC	<u>CLIENT</u>	PT CLOVERLEAF, LLC
<u>SOIL TYPE #</u>	2	<u>PROJECT</u>	CLOVERLEAF SITE
<u>TEST BORING #</u>	2	<u>JOB NO.</u>	200100
<u>DEPTH (FT)</u>	15	<u>TEST BY</u>	BL

<u>U.S. Sieve #</u>	<u>Percent Finer</u>
3"	
1 1/2"	
3/4"	
1/2"	
3/8"	100.0%
4	98.4%
10	81.4%
20	61.2%
40	48.2%
100	30.0%
200	23.0%

<u>Atterberg Limits</u>	
Plastic Limit	22
Liquid Limit	39
Plastic Index	17

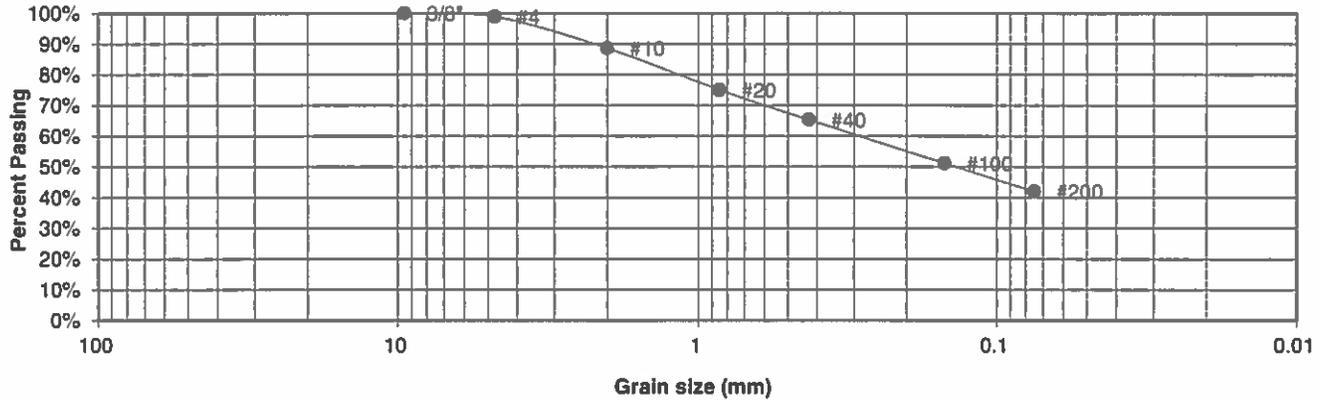
<u>UNIFIED CLASSIFICATION</u>	SC	<u>CLIENT</u>	PT CLOVERLEAF, LLC
<u>SOIL TYPE #</u>	2	<u>PROJECT</u>	CLOVERLEAF SITE
<u>TEST BORING #</u>	3	<u>JOB NO.</u>	200100
<u>DEPTH (FT)</u>	10	<u>TEST BY</u>	BL

**Sieve Analysis
Grain Size Distribution**

U.S. Sieve #	Percent Finer
3"	
1 1/2"	
3/4"	
1/2"	
3/8"	100.0%
4	98.9%
10	88.6%
20	75.0%
40	65.3%
100	51.2%
200	42.0%

Atterberg Limits	
Plastic Limit	26
Liquid Limit	48
Plastic Index	22

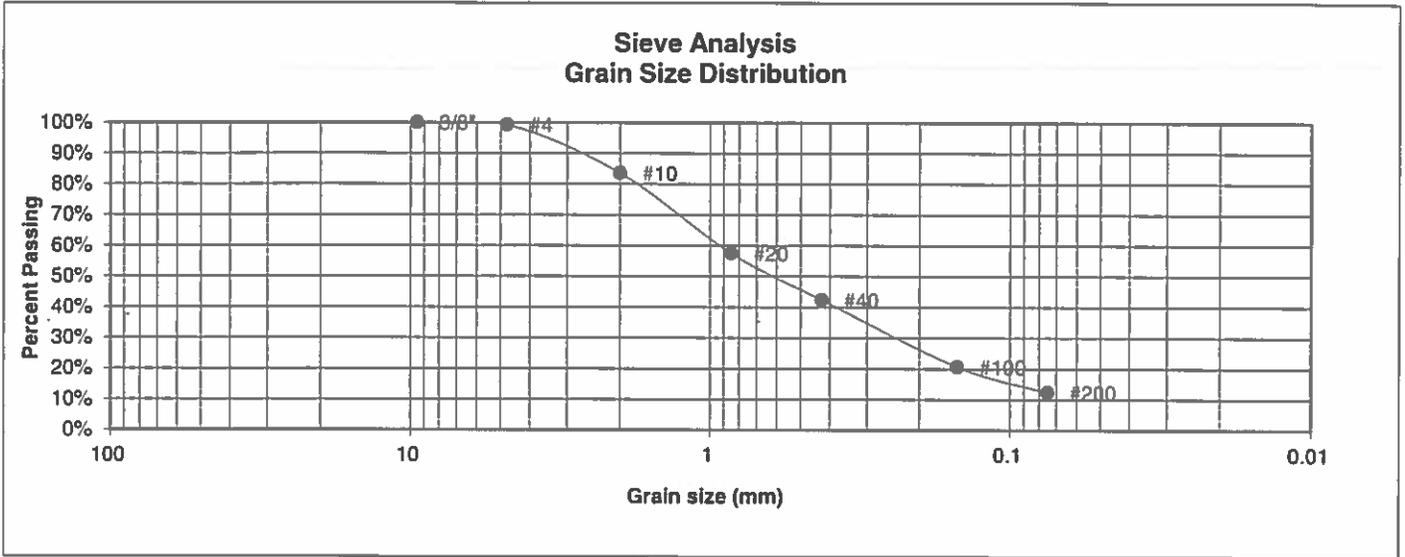
FIG NO.:
C-9

<u>UNIFIED CLASSIFICATION</u>	SM	<u>CLIENT</u>	PT CLOVERLEAF, LLC
<u>SOIL TYPE #</u>	2	<u>PROJECT</u>	CLOVERLEAF SITE
<u>TEST BORING #</u>	4	<u>JOB NO.</u>	200100
<u>DEPTH (FT)</u>	30	<u>TEST BY</u>	BL

<u>U.S. Sieve #</u>	<u>Percent Finer</u>
3"	
1 1/2"	
3/4"	
1/2"	
3/8"	100.0%
4	99.3%
10	83.6%
20	57.5%
40	42.4%
100	20.7%
200	12.3%

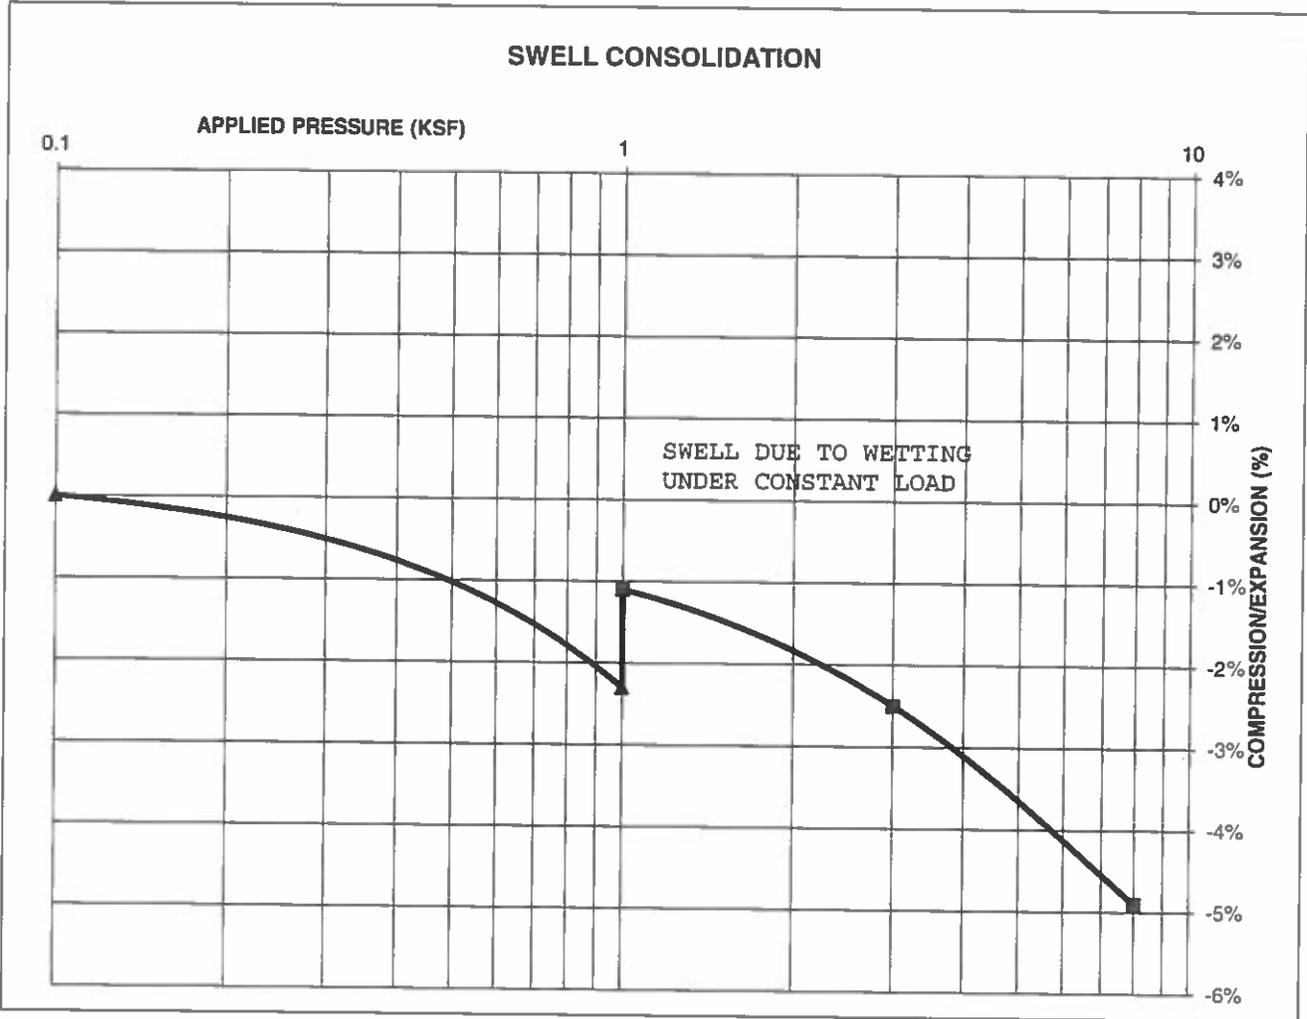
SWELL CONSOLIDATION TEST RESULTS

TEST BORING #	3	DEPTH(ft)	10
DESCRIPTION	SC	SOIL TYPE	2
NATURAL UNIT DRY WEIGHT (PCF)			107
NATURAL MOISTURE CONTENT			16.1%
SWELL/CONSOLIDATION (%)			1.2%

JOB NO. 200100
 CLIENT PT CLOVERLEAF, LLC
 PROJECT CLOVERLEAF SITE
