SOILS AND GEOLOGY STUDY

**Skyline at Lorson Ranch
El Paso County, Colorado**

JOB NO. 175809

January 15, 2021

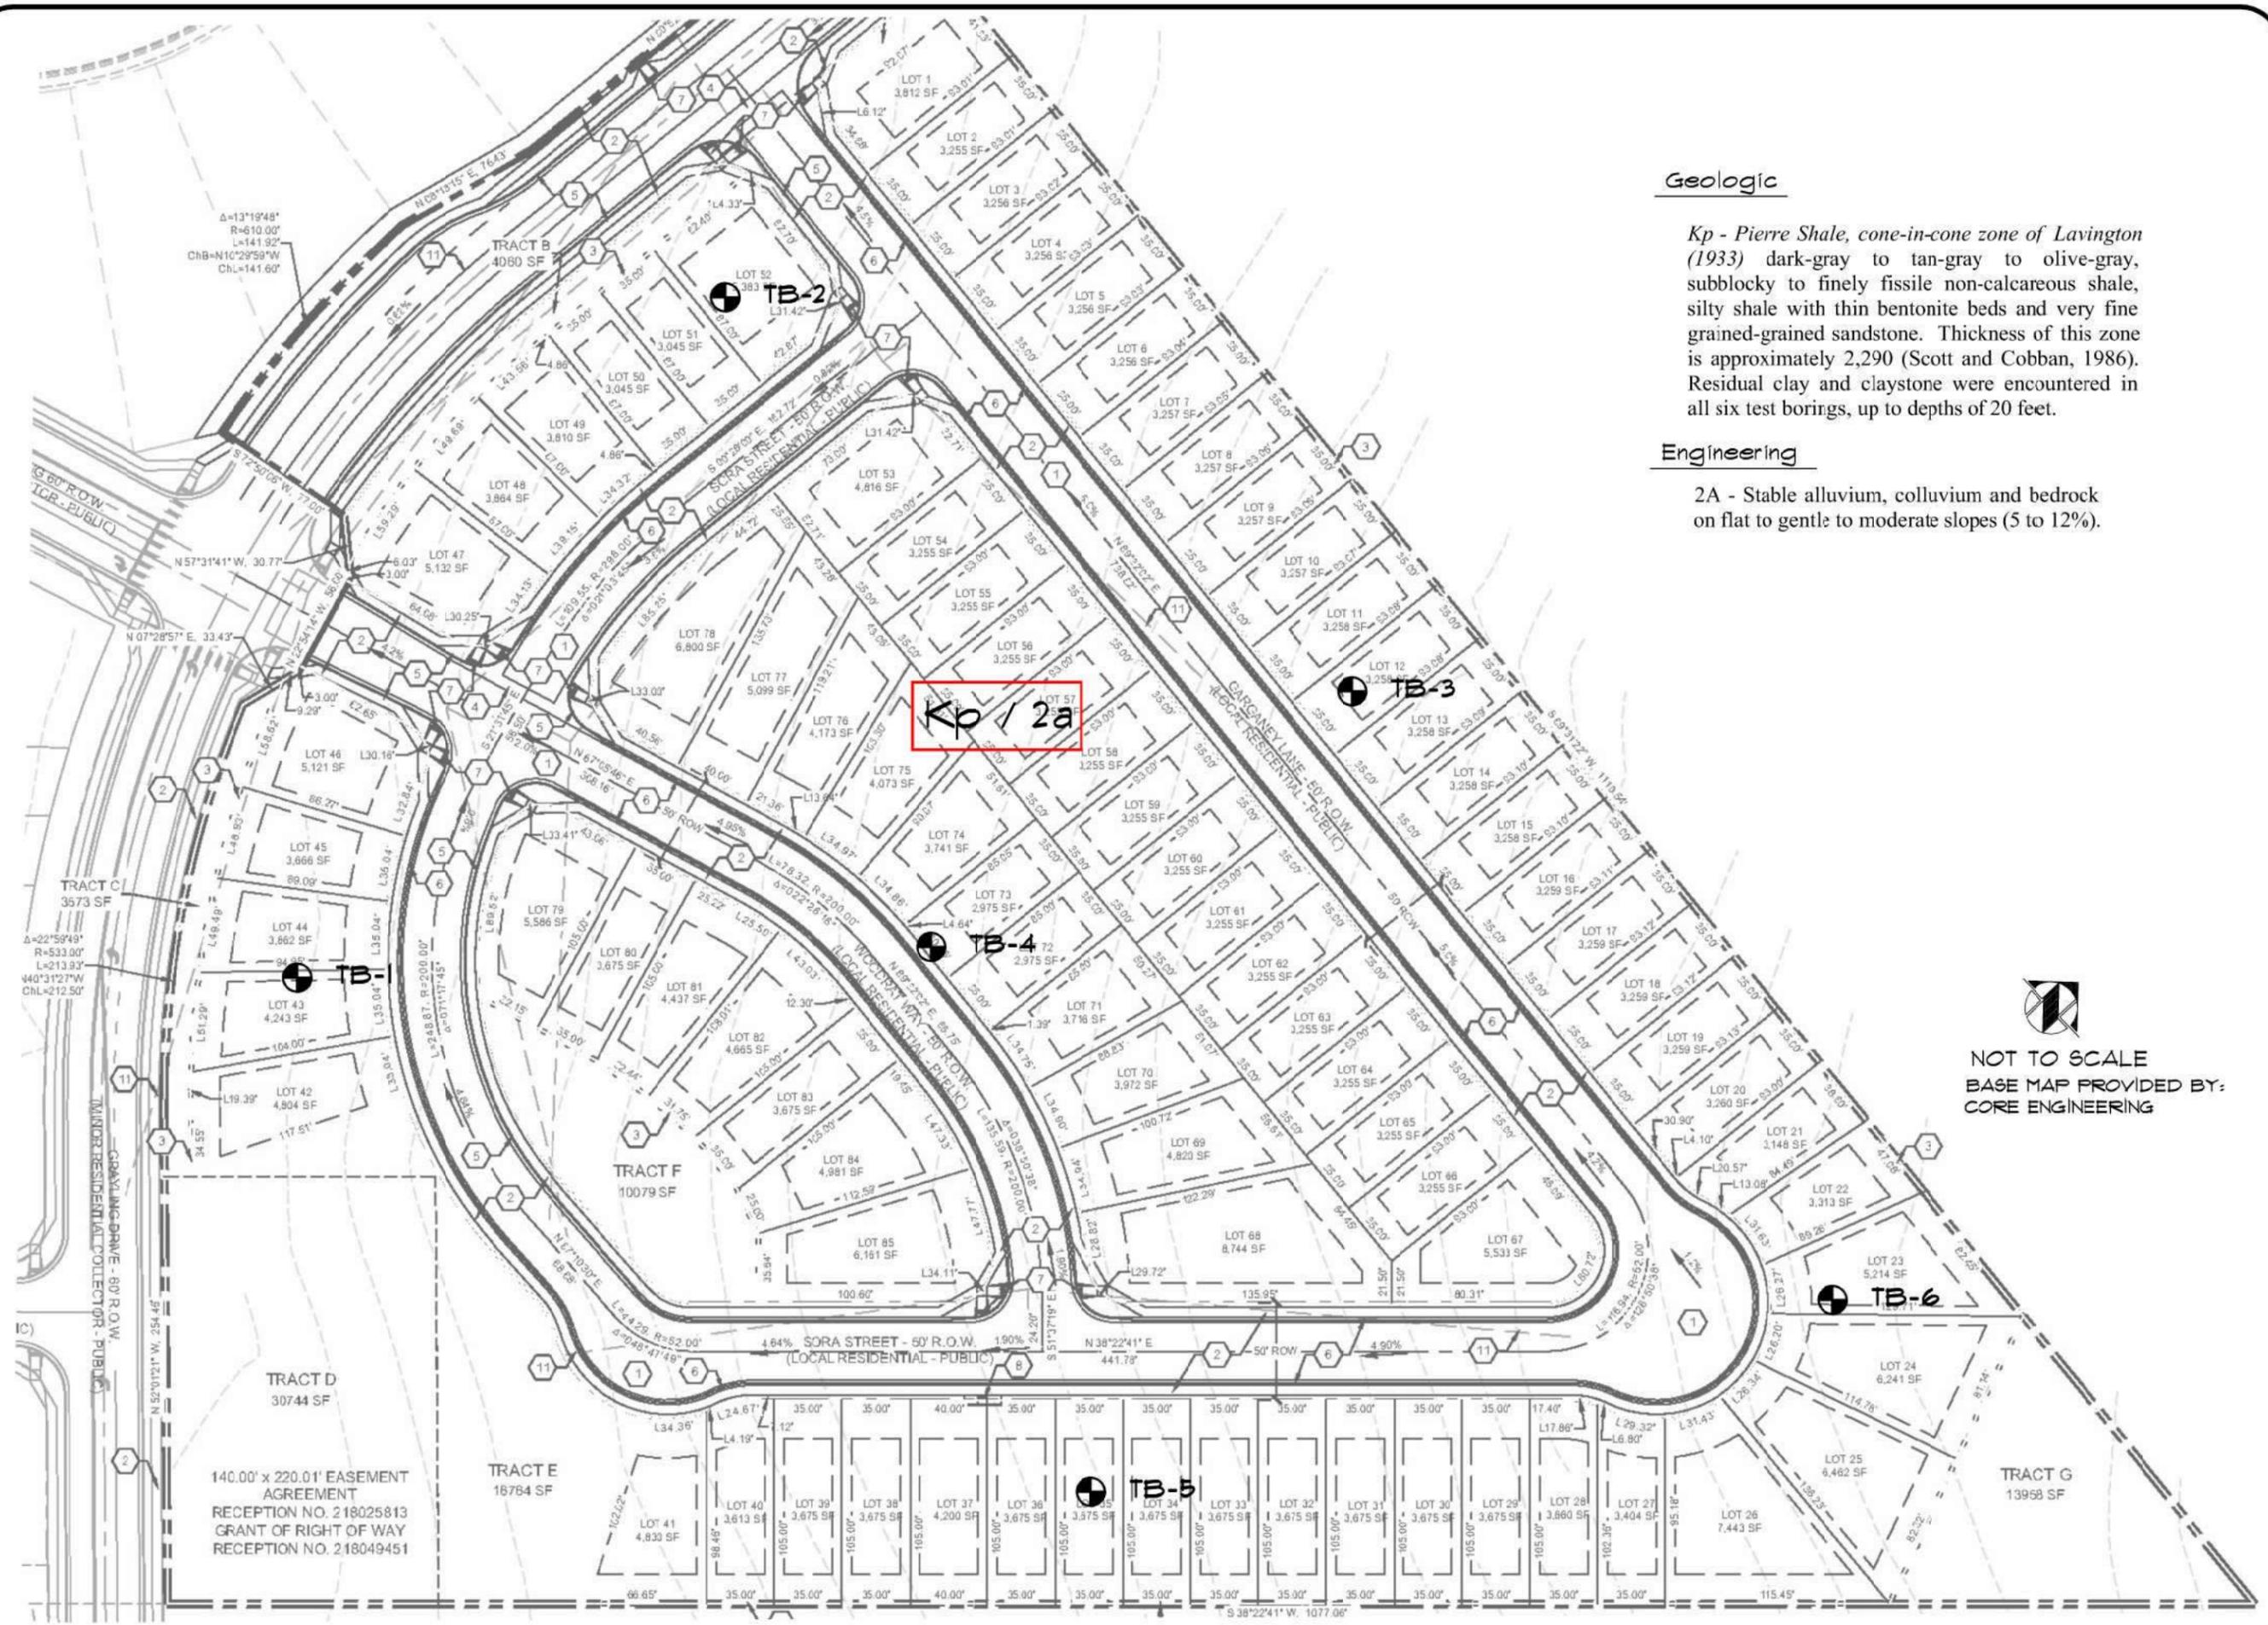
Engineering

2A - Stable alluvium, colluvium and bedrock on flat to gentle to moderate slopes (5 to 12%).

NOT TO SCALE
 BASE MAP PROVIDED BY:
 CORE ENGINEERING

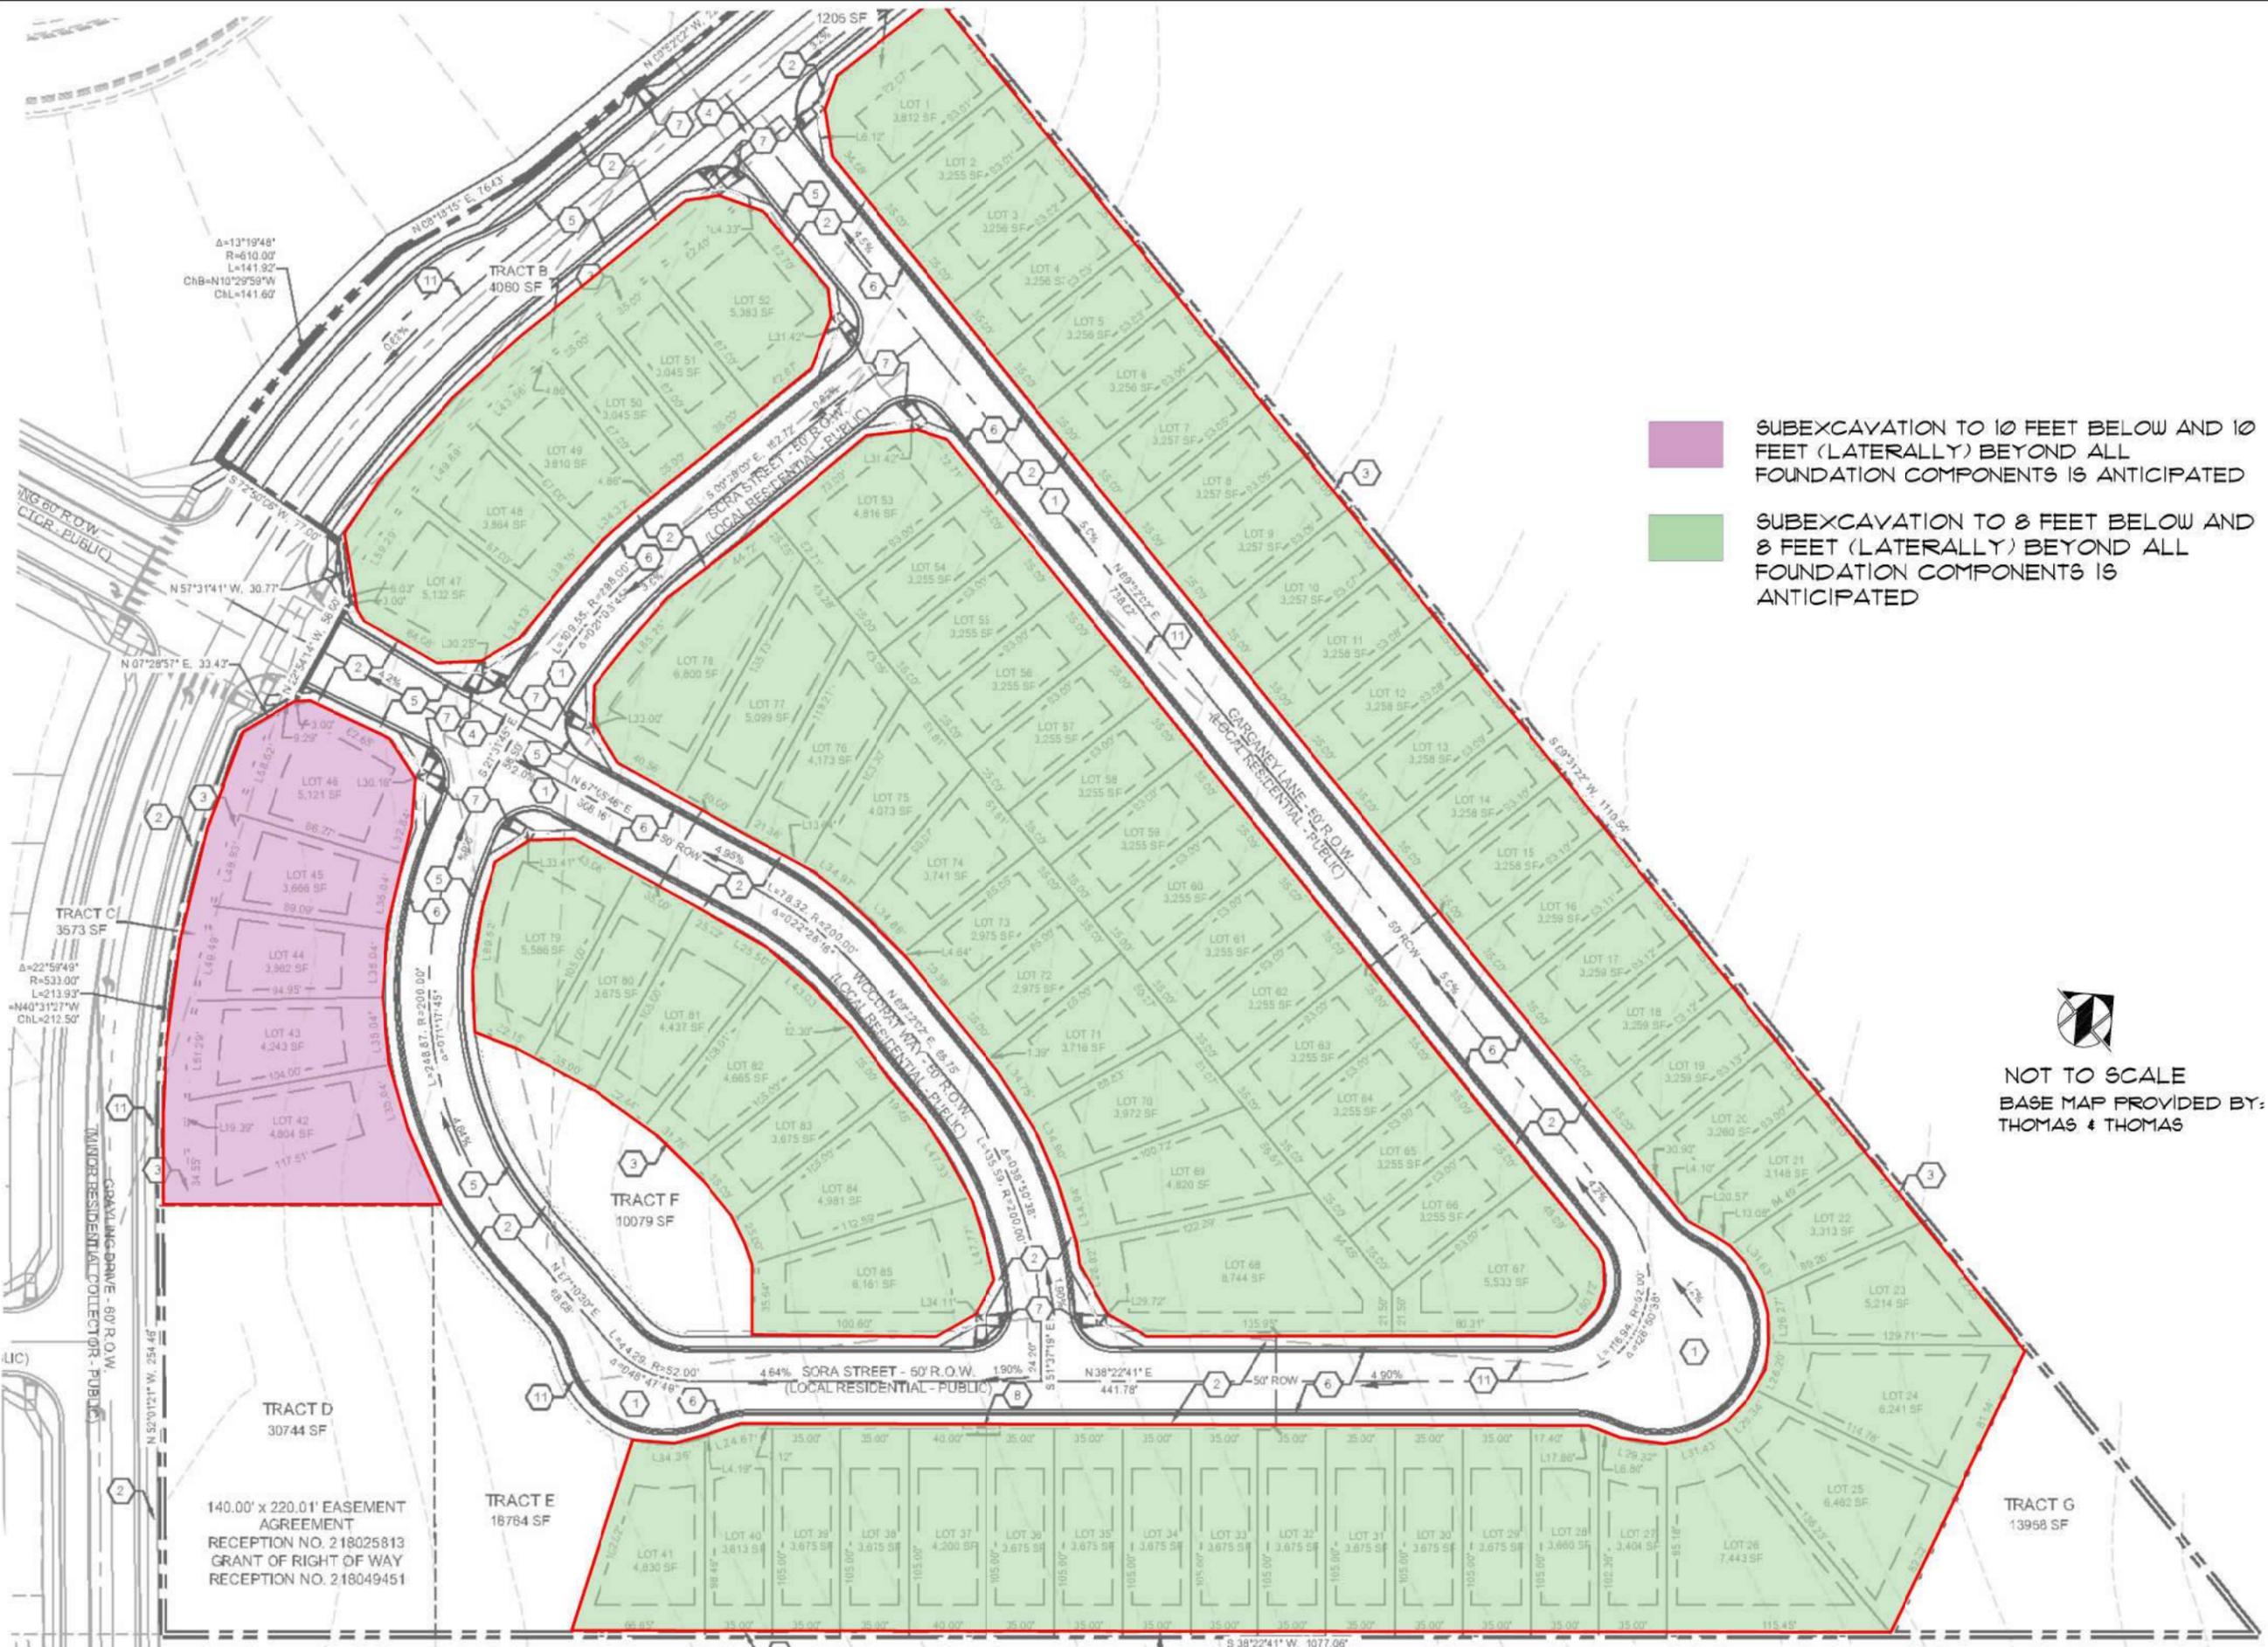
SHEET No.
FIG-13

SUBEXCAVATION TO 10 FEET BELOW AND 10 FEET (LATERALLY) BEYOND ALL FOUNDATION COMPONENTS IS ANTICIPATED

SUBEXCAVATION
RECOMMENDATIONS

Our subexcavation recommendations are presented in Section **13.0 Subexcavation and Replacement** of this report and the attached Figure 13.

Where subexcavation is to be performed, vegetation, organic materials and deleterious materials shall be cleared and disposed of in accordance with applicable requirements prior to performing excavation and/or filling operations. The sub-excavation should extend to minimum depths of 8 to 10 feet (as indicated on Figure 13, Subexcavation Recommendations) below the bottom of all proposed foundations components, and at least those same distances (laterally) beyond the proposed "buildable" area on each lot. Before the placement of structural fill, the underlying subgrade shall be scarified, moisture conditioned to within 2% of the optimum moisture content and compacted to the degree specified for the overlying fill material.
