Re: Geology and Surface Soils Evaluation Update
Eagle Forest Subdivision
El Paso County, CO 80908

Reference 1: The Original *Preliminary Geology and Surface Soils Evaluation* for Eagle Heights Subdivision, El Paso County, Colorado, by John Himmelreich & Associates, Project No. 05-100, dated January 24, 2005.

EAGLE FOREST SUBDIVISION
PRELIM / PUD DEVELOPMENT PLAN
EAGLE FOREST DEVELOPMENT, LLC
EL PASO COUNTY, CO

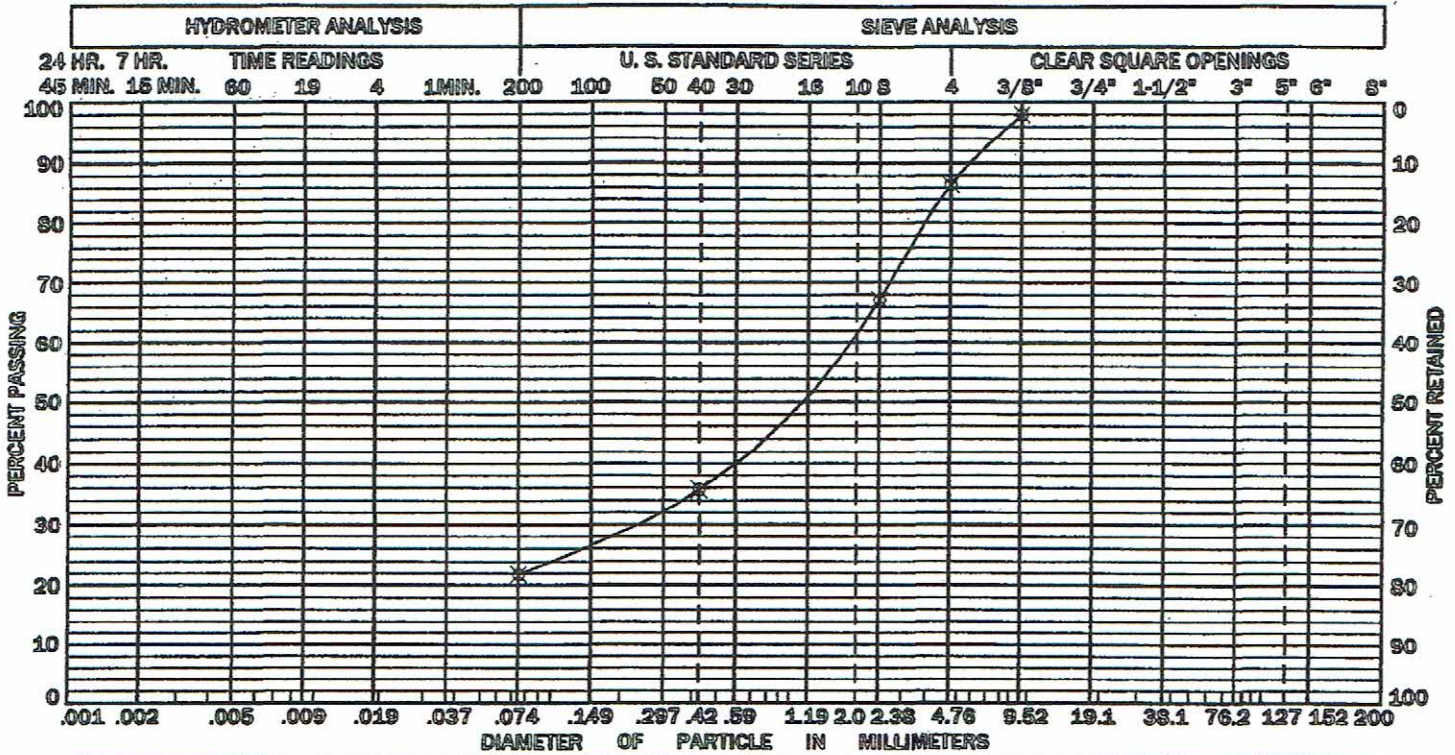
GRADATION TEST RESULTS

CLAY TO SILT	SAND			GRAVEL		COBBLES
	FINE	MEDIUM	COARSE	FINE	COARSE	
CLASSIFICATION	SC					
GRAVEL	13.5 %					
SAND	64.7 %					
FINES	21.8 %					
SAMPLE#	1	HOLES	P-1	DEPTH	4	FEET

NOTES:	6.9 % Moisture content
	LL = 32.8 %
	PL = 20.0 %
	PI = 12.8 %

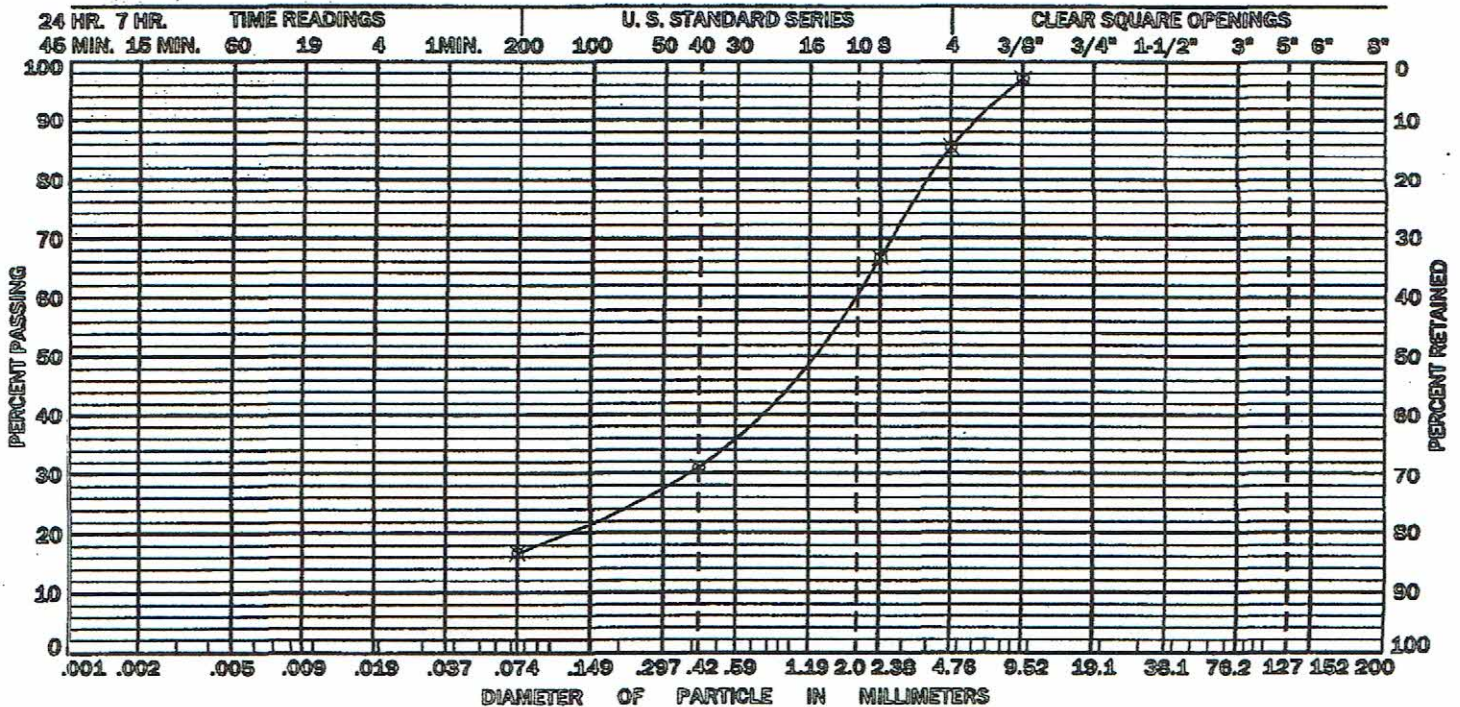
CLAY TO SILT		SAND			GRAVEL		COBBLES		
		FINE	MEDIUM	COARSE	FINE	COARSE			
CLASSIFICATION	SM	NOTES: 4.1 % Moisture content							
GRAVEL	14.4 %	LL = could not be determined							
SAND	69.1 %	PL = non-plastic							
FINES	16.5 %								
SAMPLE#	1	MOLE#	P-2	DEPTH	4	FEET	Job #: 13470	By: KO	1/12/2005

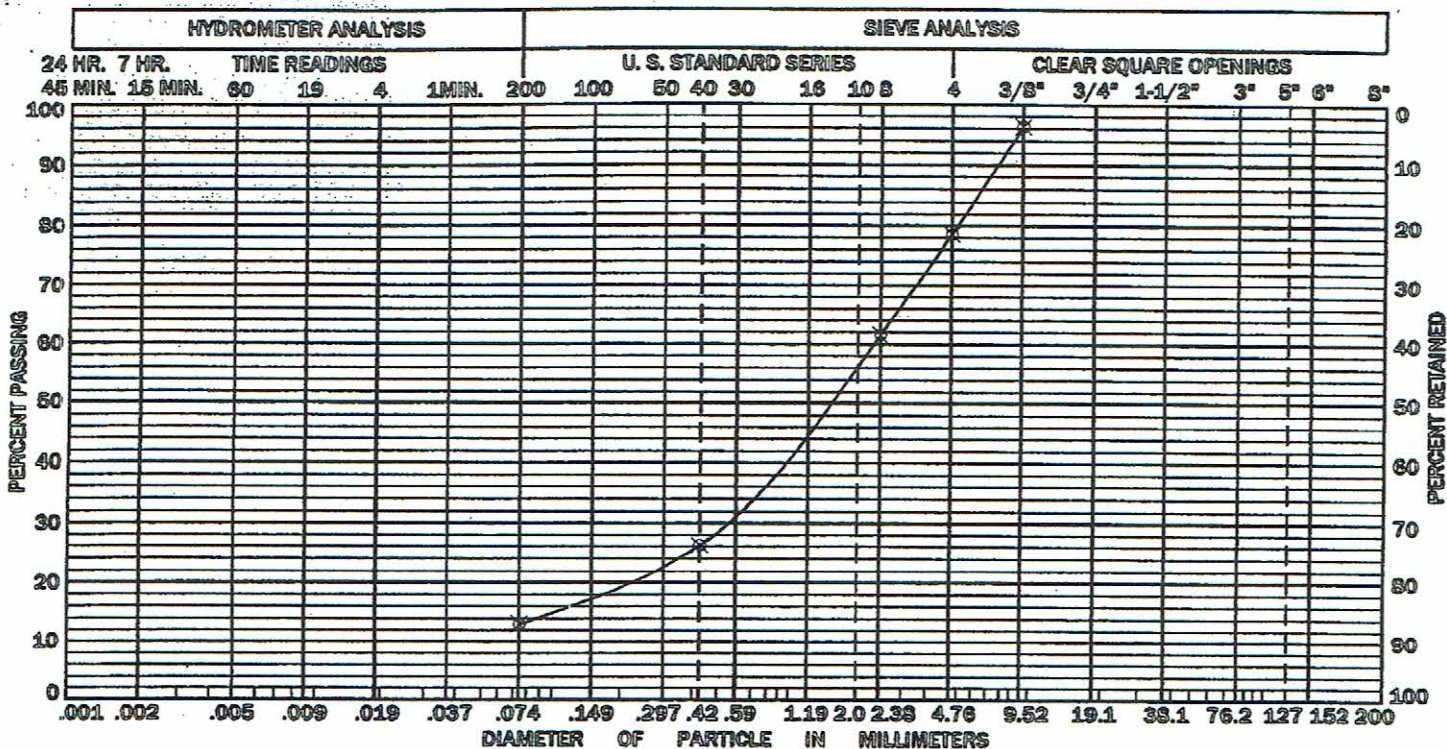
GRADATION TEST RESULTS

CLAY TO SILT		SAND			GRAVEL		COBBLES
		FINE	MEDIUM	COARSE	FINE	COARSE	
CLASSIFICATION	SM	NOTES: 3.6 % Moisture content					
GRAVEL	21.4 %	LL = could not be determined					
SAND	65.6 %	PL = non-plastic					
FINES	13.0 %						
SAMPLE#	1						
MOLES	P-3						
DEPTH	4						
FEET

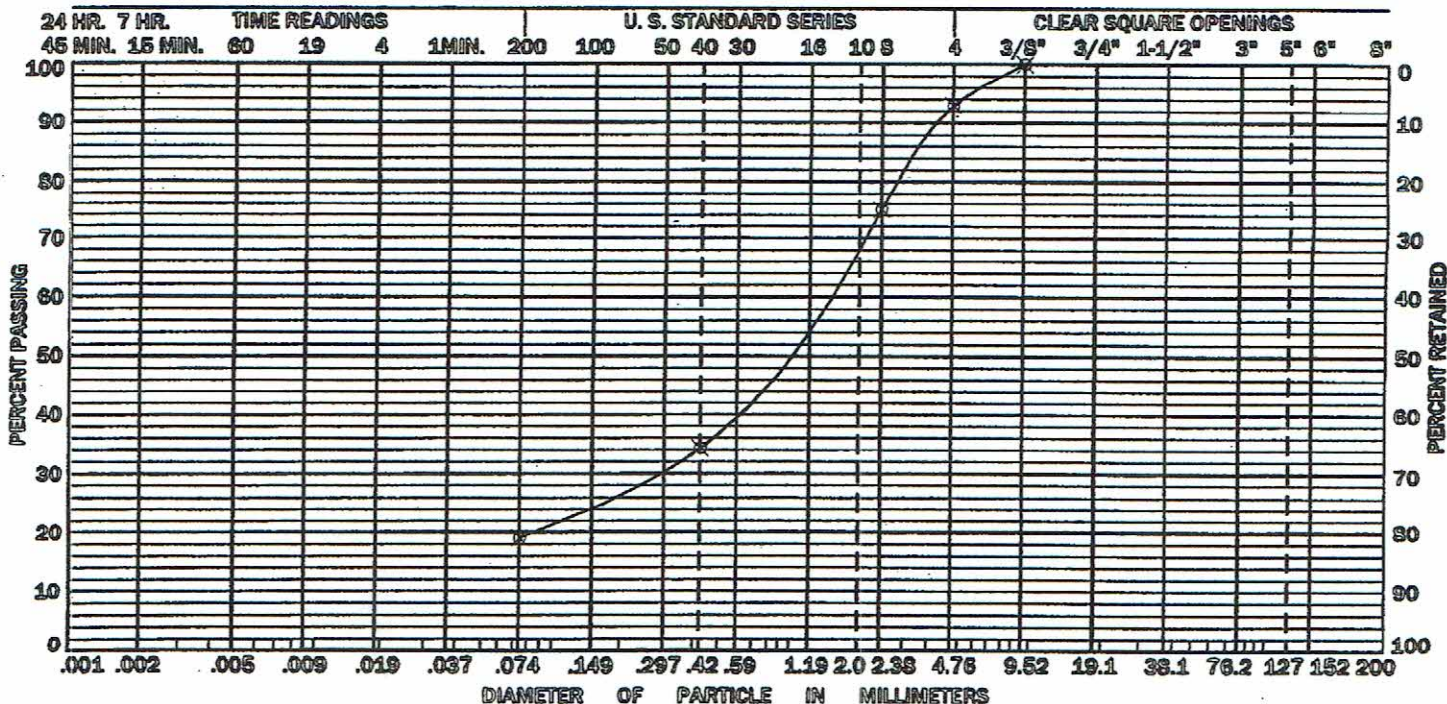
CLAY TO SILT		SAND			GRAVEL		COBBLES	
		FINE	MEDIUM	COARSE	FINE	COARSE		
CLASSIFICATION	SM	NOTES: 6.2 % Moisture content						
GRAVEL	7.0 %	LL = 34.1 %						
SAND	73.7 %	PL = 24.6 %						
FINES	19.3 %	PI = 9.5 %						
SAMPLE#	1	Job #: 13470 By: KO 1/12/2005						
HOLE#	P-4							
DEPTH	4							
FEET

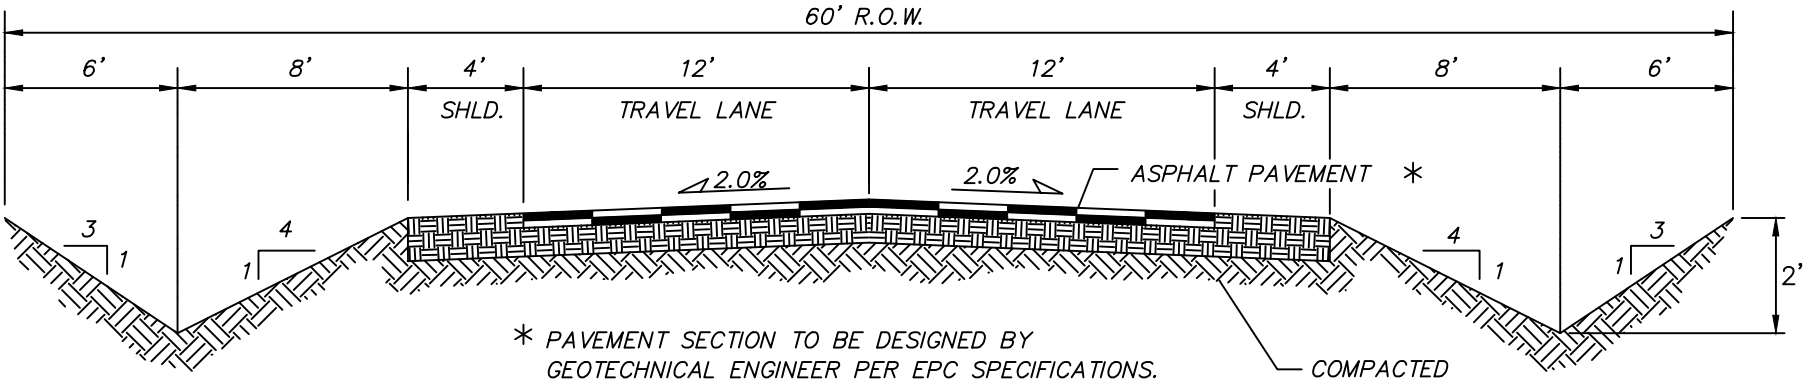
RURAL RESIDENTIAL
TYPICAL SECTION (A)
NOT TO SCALE

ROAD SURFACE DESIGN / TO BE MAINTAINED BY H.O.A.
