**PRELIMINARY GEOTECHNICAL INVESTIGATION  
GRANDVIEW RESERVE, FILING 1  
EASTONVILLE ROAD AND U.S. HIGHWAY 24  
FALCON, COLORADO**

D.R. HORTON  
9555 S. Kingston Court  
Englewood, Colorado

Project No. CS19345-115-R2

January 6, 2022  
Revised March 14, 2022  
Revised May 9, 2022

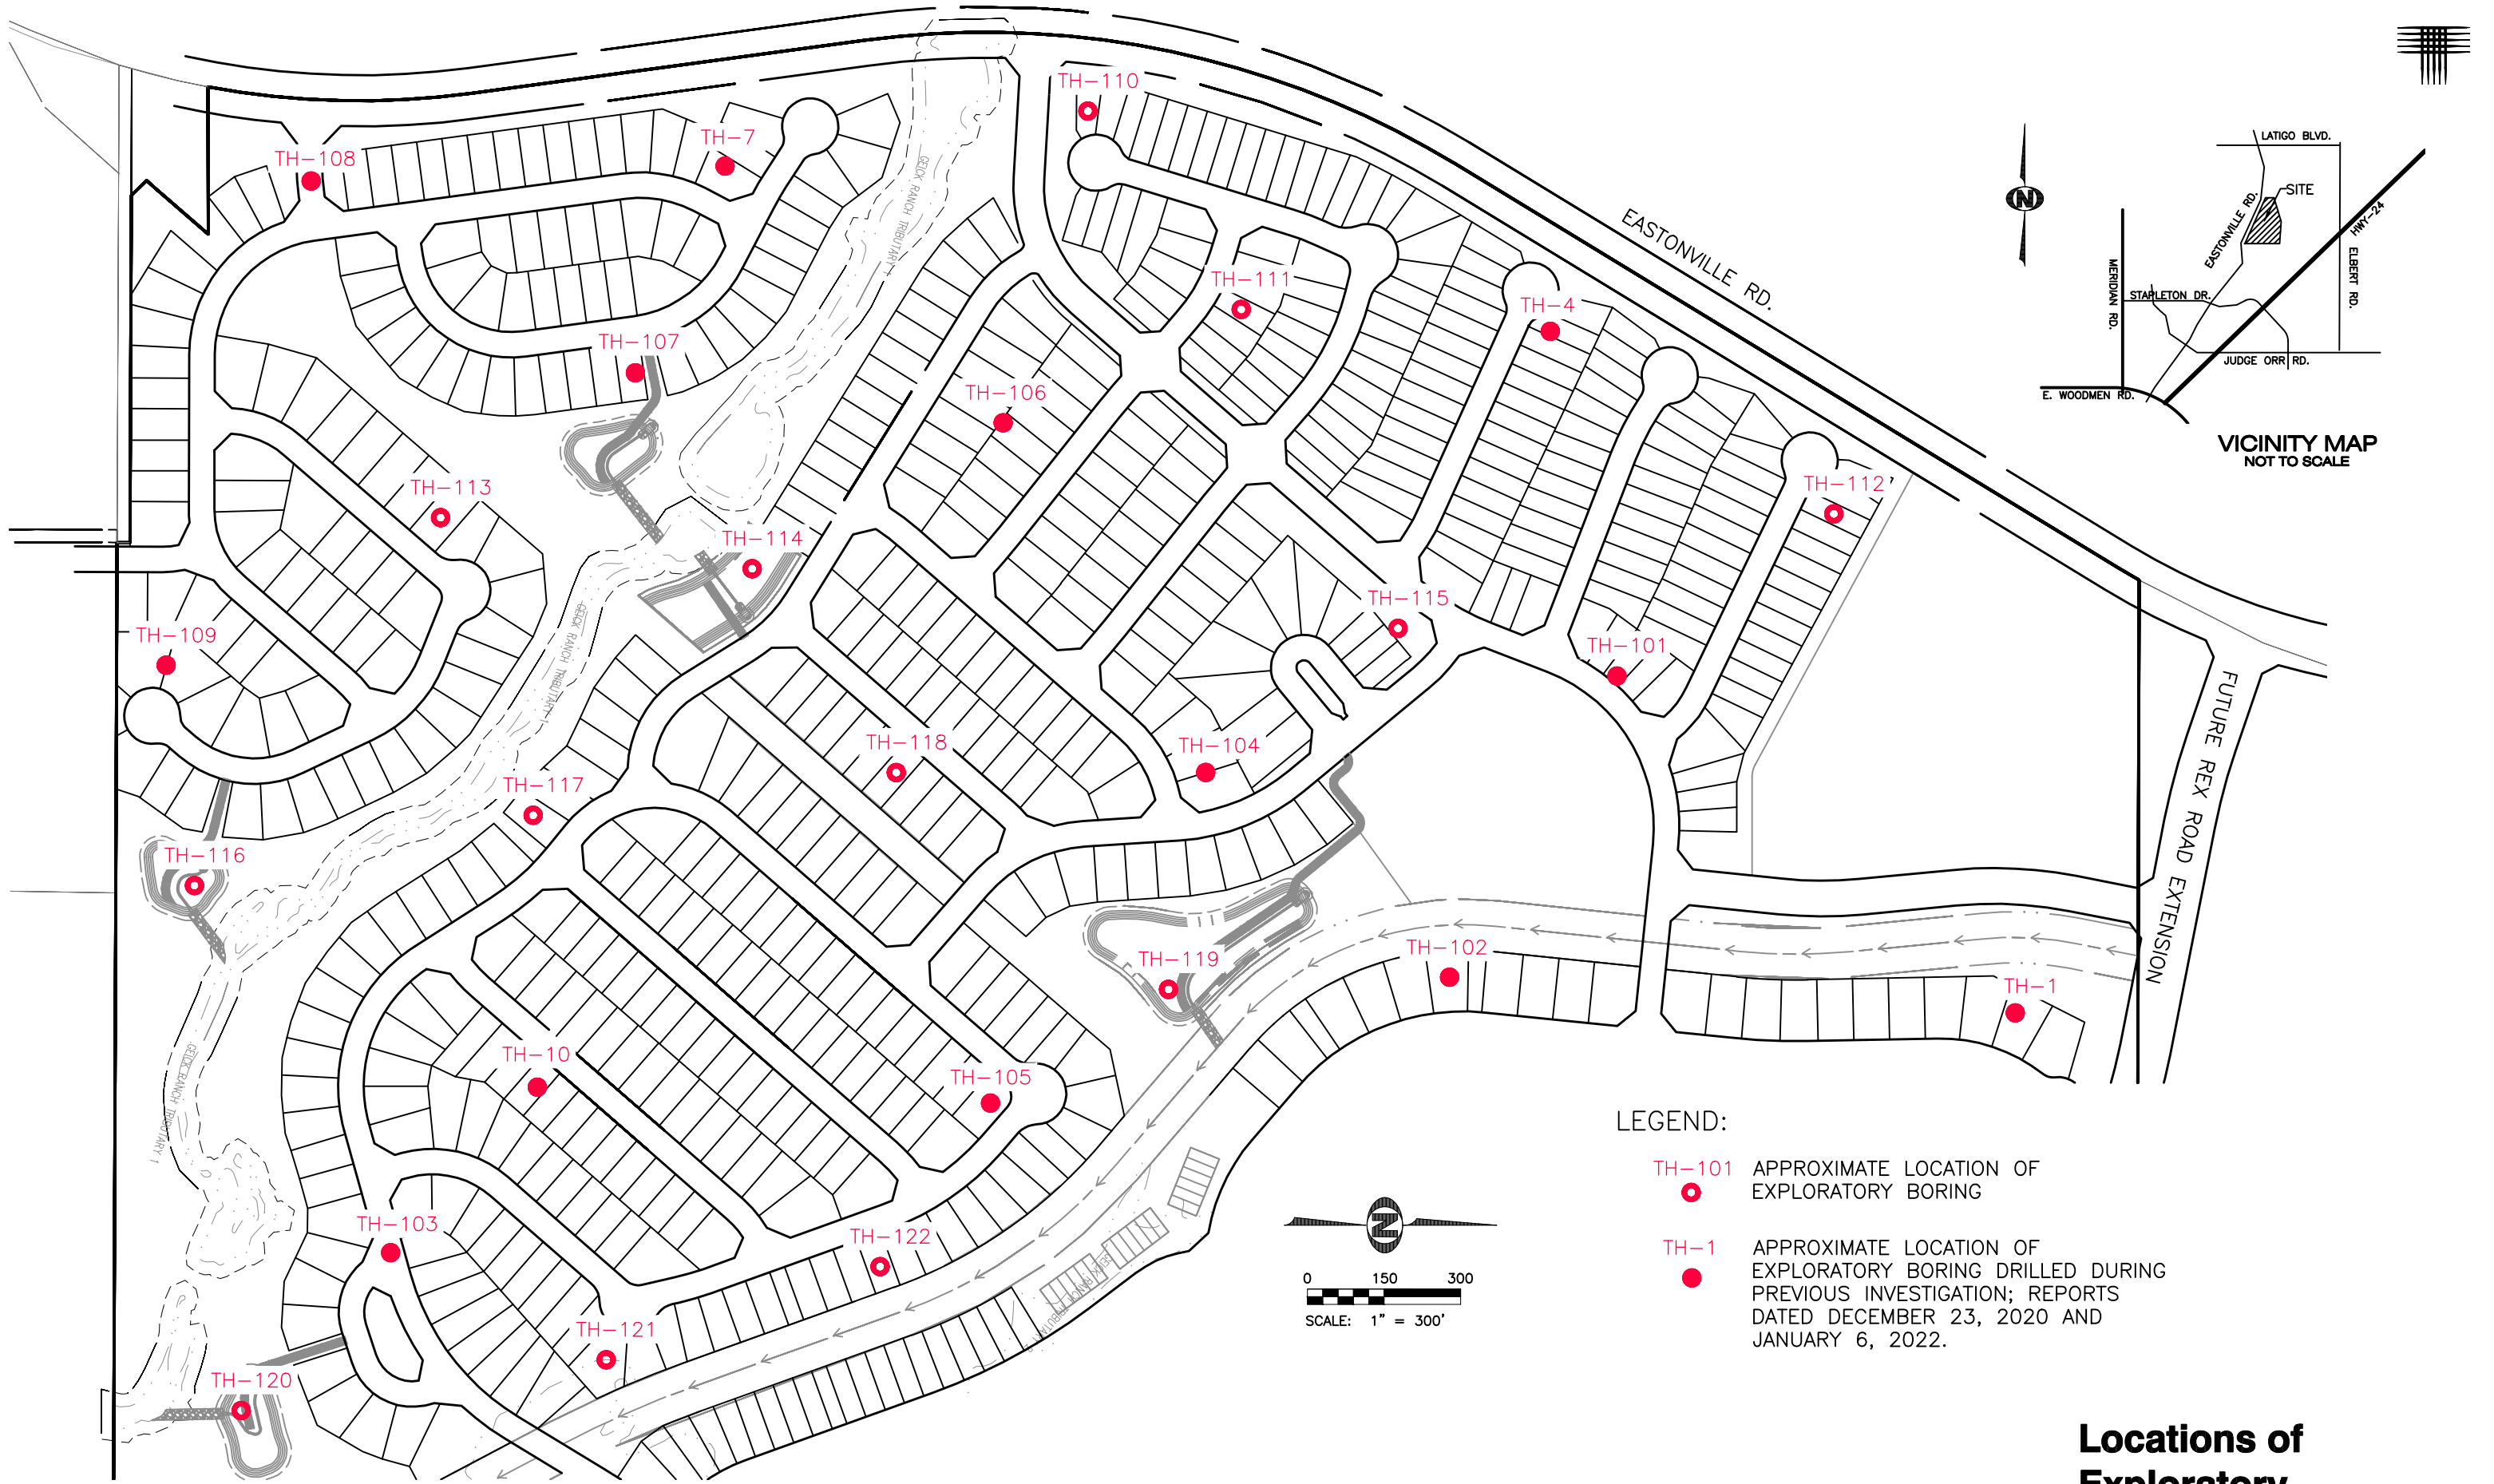
- LEGEND:**
- TH-101 APPROXIMATE LOCATION OF EXPLORATORY BORING
  - TH-1 APPROXIMATE LOCATION OF EXPLORATORY BORING DRILLED DURING PREVIOUS INVESTIGATION; REPORTS DATED DECEMBER 23, 2020 AND JANUARY 6, 2022.

FIG. 1 – LOCATIONS OF EXPLORATORY BORINGS

Subsurface conditions at the site were investigated by our firm by drilling a total of twenty-five widely spaced exploratory borings. Four exploratory borings (TH-1, TH-4, TH-7, and TH-10) were drilled during a previous study completed in December 2020, and an additional twenty-two exploratory borings (TH-101 through TH-122) were recently advanced within the subject 190-acre site, to depths between 20 and 30 feet. The boring locations were established by the client's surveyor. The approximate locations of the borings are shown in Fig. 1. Our representative observed the drilling operations, logged the subsurface conditions found in the borings, and obtained samples for laboratory testing. Graphical logs of the borings, including the results of field penetration resistance tests, and some laboratory test data are presented in Appendix A. Soil samples obtained during drilling were visually classified and laboratory testing was assigned to representative samples. Swell-consolidation and gradation test results are presented in Appendix B. Laboratory test data are summarized in Table B-1.
