**PRELIMINARY GEOTECHNICAL INVESTIGATION
GRANDVIEW RESERVE, FILING 1
EASTONVILLE ROAD AND U.S. HIGHWAY 24
FALCON, COLORADO**

Project No. CS19345-115-R2

January 6, 2022
Revised March 14, 2022
Revised May 9, 2022

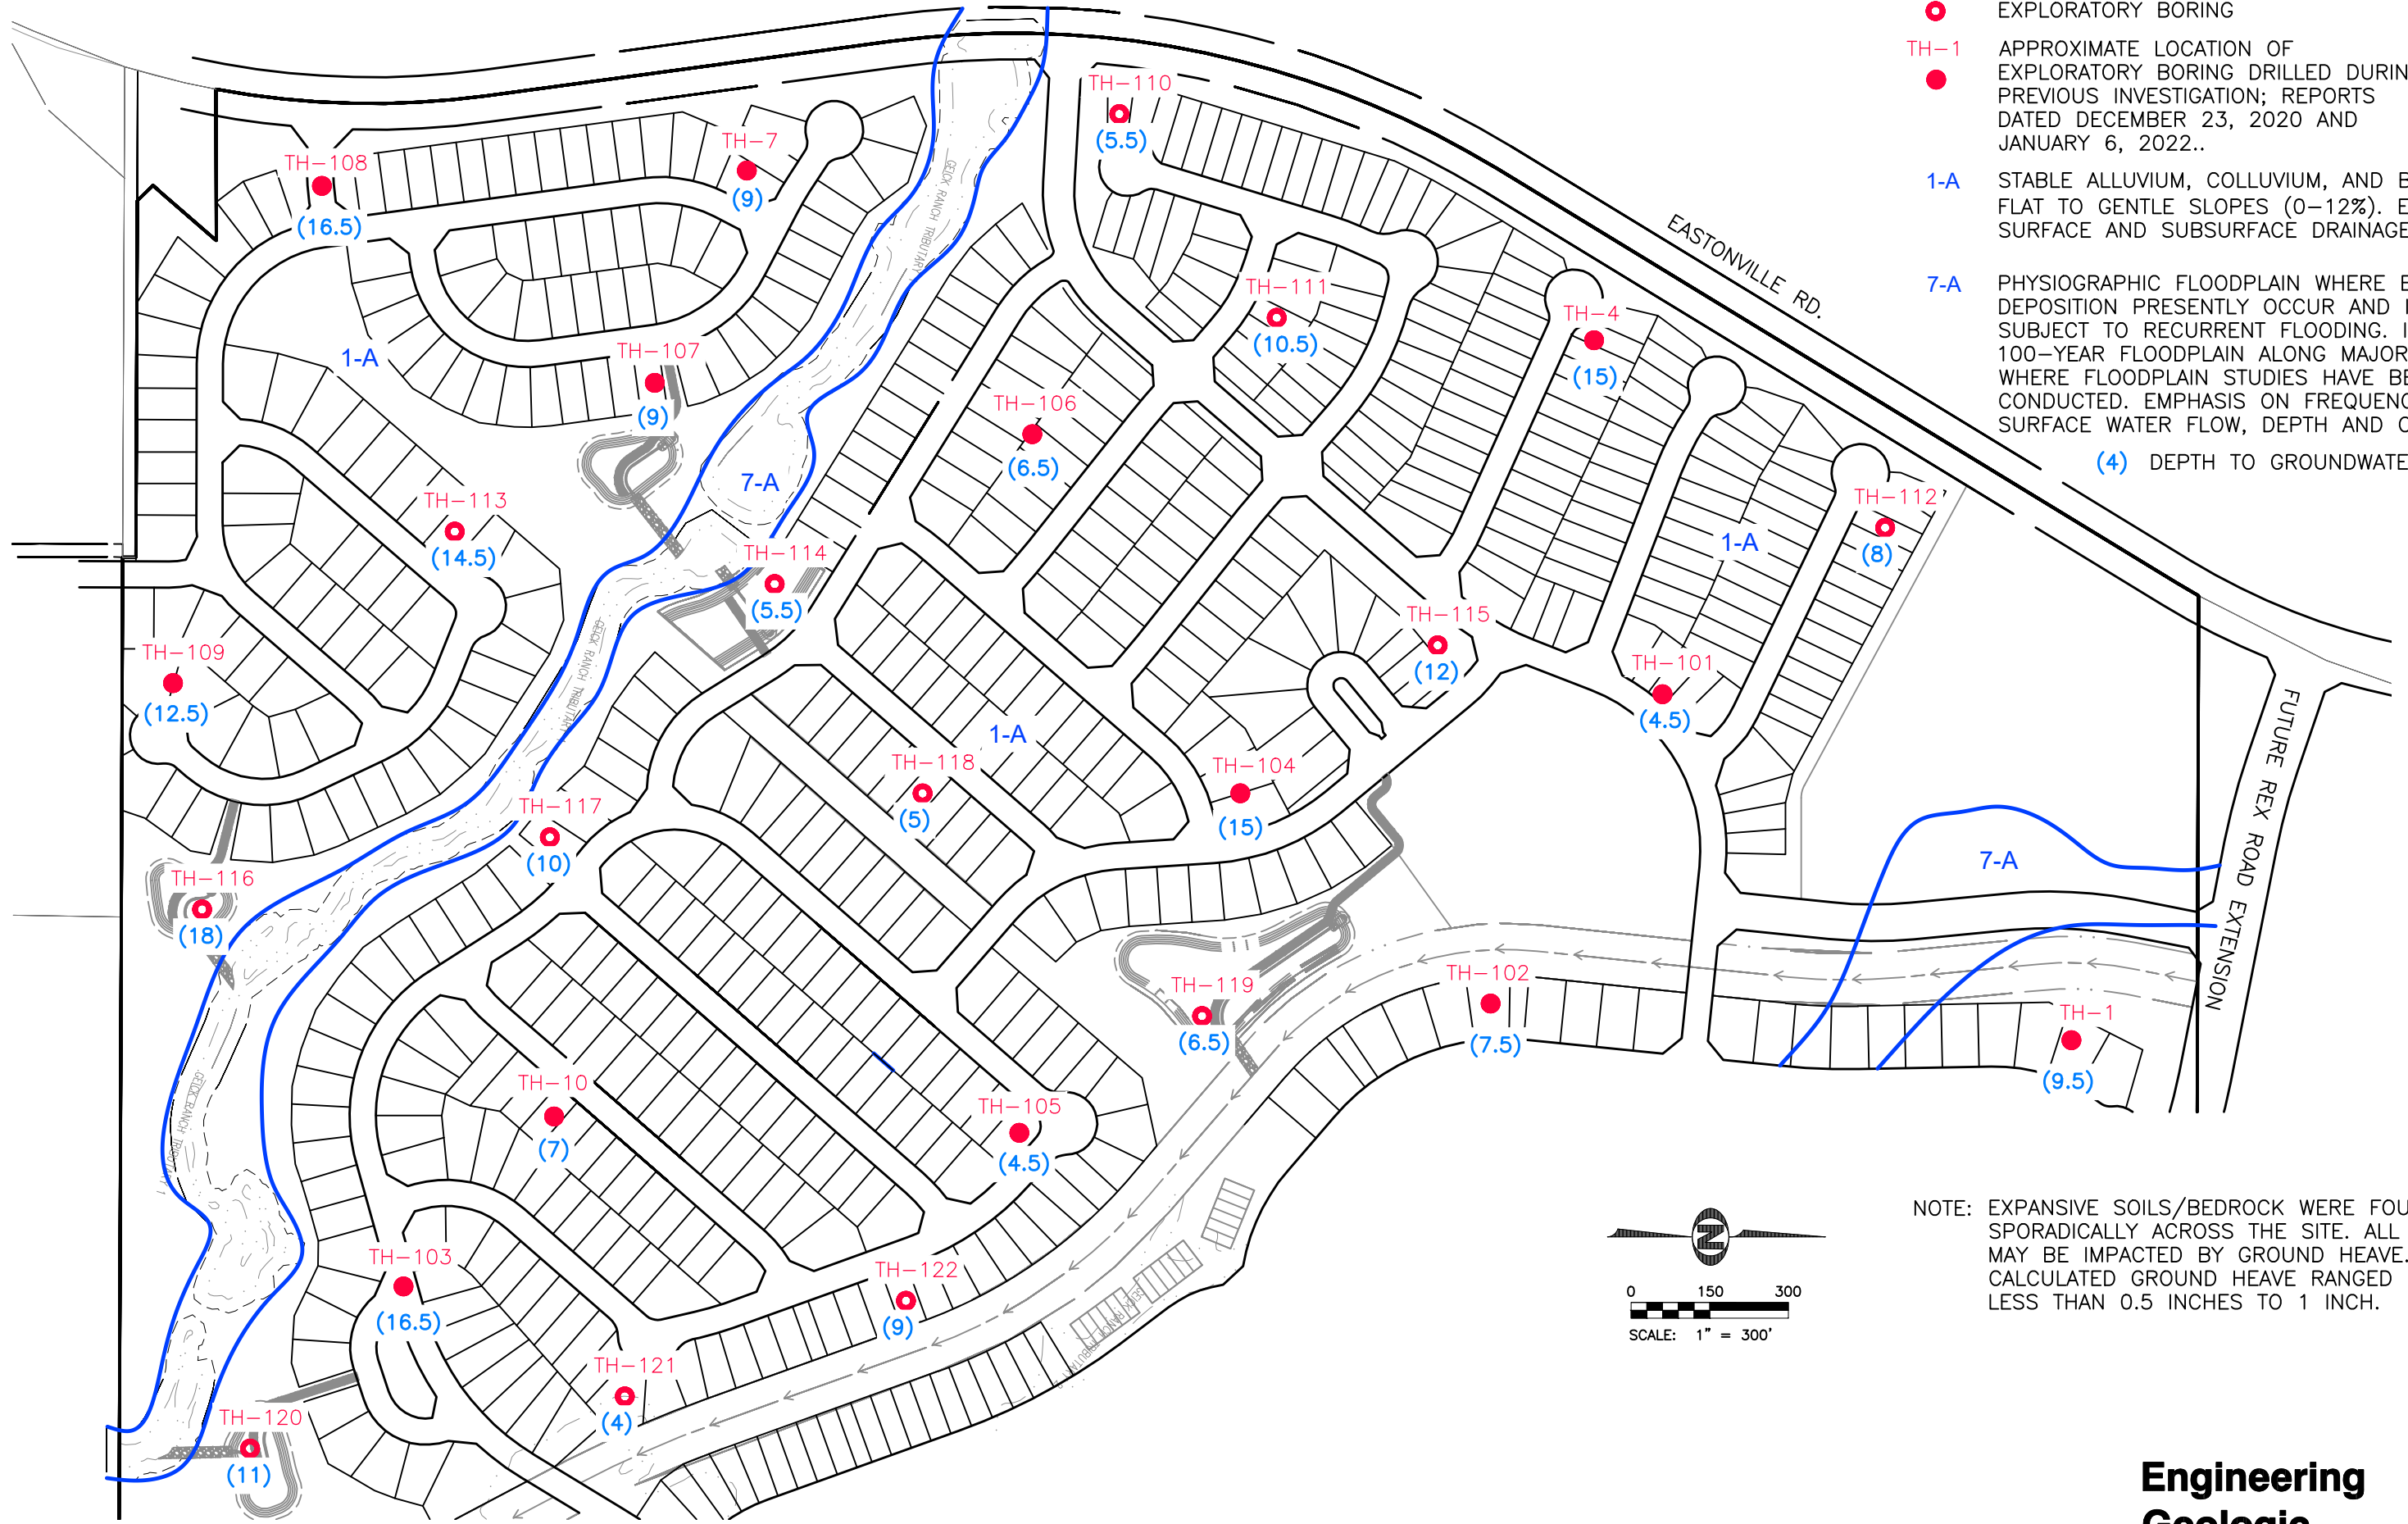
FIG. 2 – ENGINEERING GEOLOGIC CONDITIONS

- TH-101 APPROXIMATE LOCATION OF EXPLORATORY BORING
- TH-1 APPROXIMATE LOCATION OF EXPLORATORY BORING DRILLED DURING PREVIOUS INVESTIGATION; REPORTS DATED DECEMBER 23, 2020 AND JANUARY 6, 2022..
- 1-A STABLE ALLUVIUM, COLLUVIUM, AND BEDROCK ON FLAT TO GENTLE SLOPES (0-12%). EMPHASIS ON SURFACE AND SUBSURFACE DRAINAGE.
- 7-A PHYSIOGRAPHIC FLOODPLAIN WHERE EROSION AND DEPOSITION PRESENTLY OCCUR AND IS GENERALLY SUBJECT TO RECURRENT FLOODING. INCLUDES 100-YEAR FLOODPLAIN ALONG MAJOR STREAMS WHERE FLOODPLAIN STUDIES HAVE BEEN CONDUCTED. EMPHASIS ON FREQUENCY OF SURFACE WATER FLOW, DEPTH AND CONTROL.
- (4) DEPTH TO GROUNDWATER (FEET)

NOTE: EXPANSIVE SOILS/BEDROCK WERE FOUND SPORADICALLY ACROSS THE SITE. ALL LOTS MAY BE IMPACTED BY GROUND HEAVE. TOTAL CALCULATED GROUND HEAVE RANGED FROM LESS THAN 0.5 INCHES TO 1 INCH.

Geologic hazards we identified at the site include expansive soils, hard bedrock, and shallow groundwater. No geologic hazards were noted that we believe preclude the proposed development. We believe potential hazards can be mitigated with proper engineering, design, and construction practices, as discussed in this report. Figure 2 shows our interpretation of the engineering geology modified from the system used by Charles Robinson & Associates (1977).

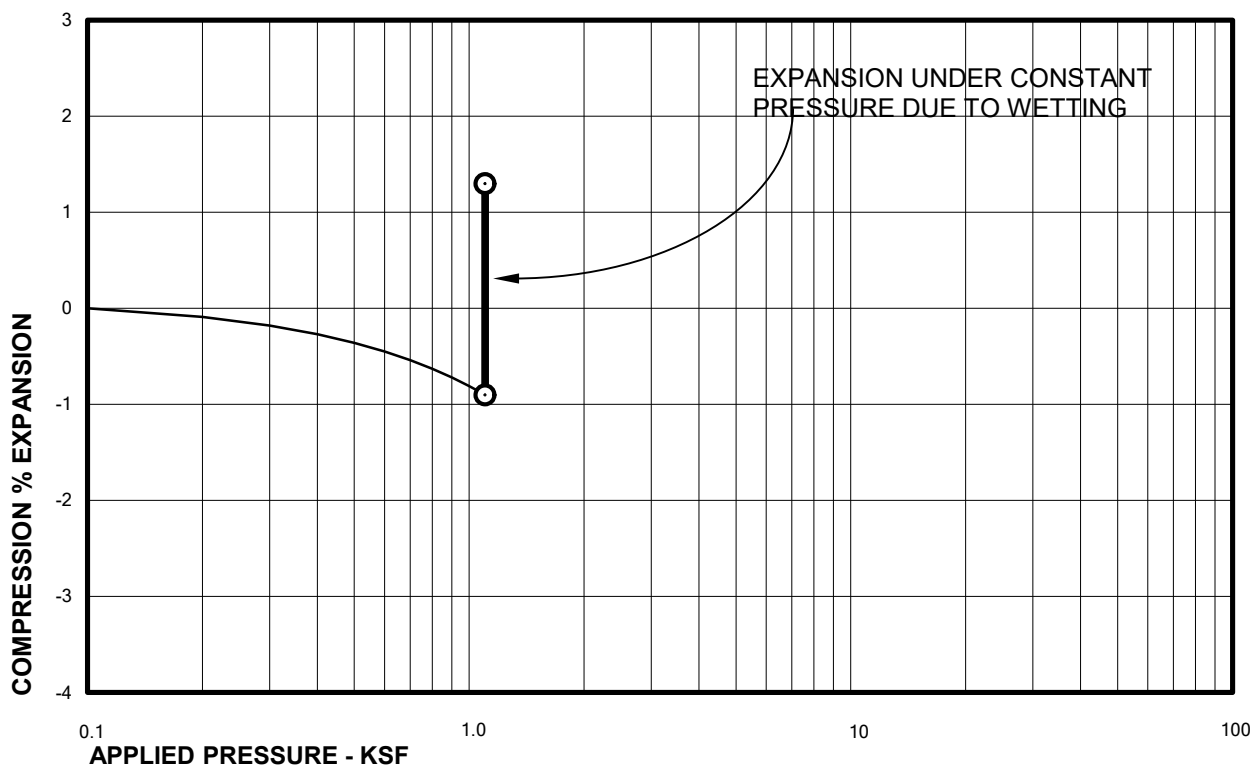
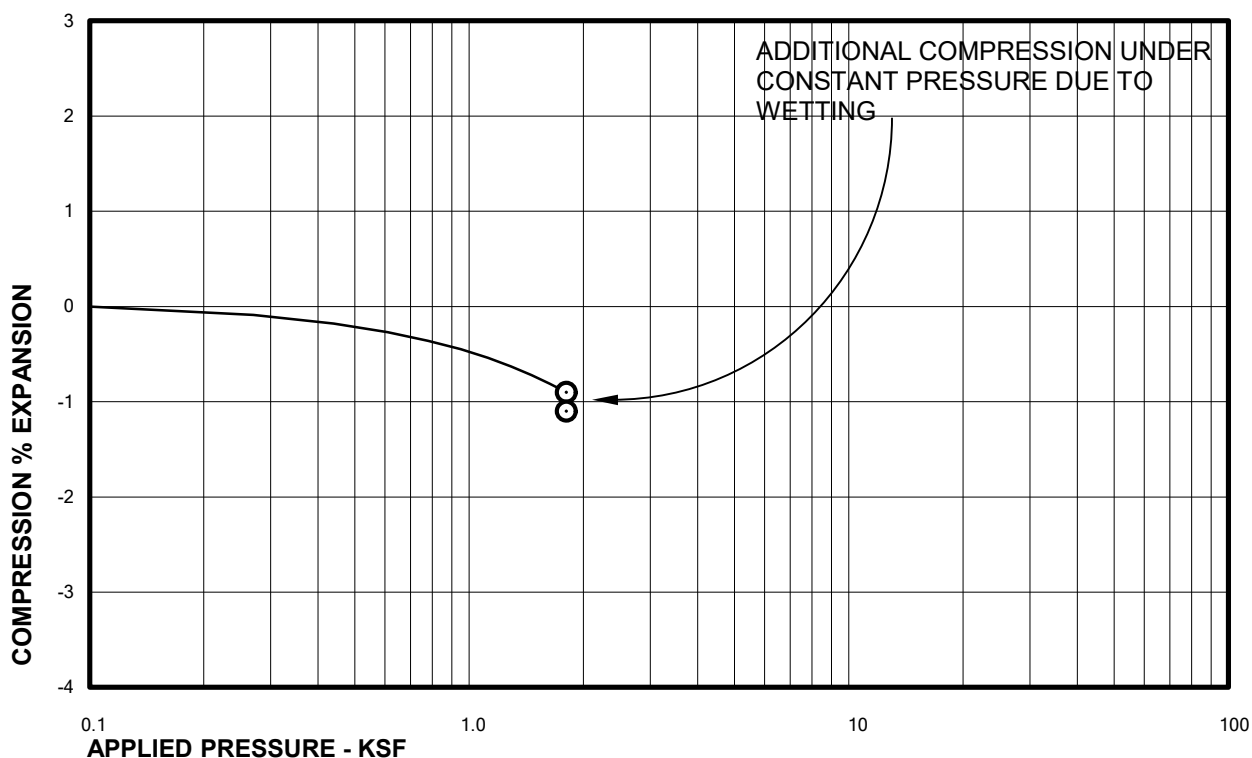
FIG. B-2

Sample of CLAYSTONE, VERY SANDY
From TH-107 AT 9 FEET

DRY UNIT WEIGHT= 121 PCF
MOISTURE CONTENT= 11.8 %

Sample of SANDSTONE, CLAYEY
From TH-107 AT 14 FEET

DRY UNIT WEIGHT= 121 PCF
MOISTURE CONTENT= 8.3 %

Swell Consolidation Test Results
