## SOIL AND GEOLOGY STUDY

**Andon Heights**  
**Currently addressed as: 19225 Elliott View**  
**EPC Schedule No. 3208000002**  
**El Paso County, Colorado**

**JOB NO. 197651**

**March 27, 2026**

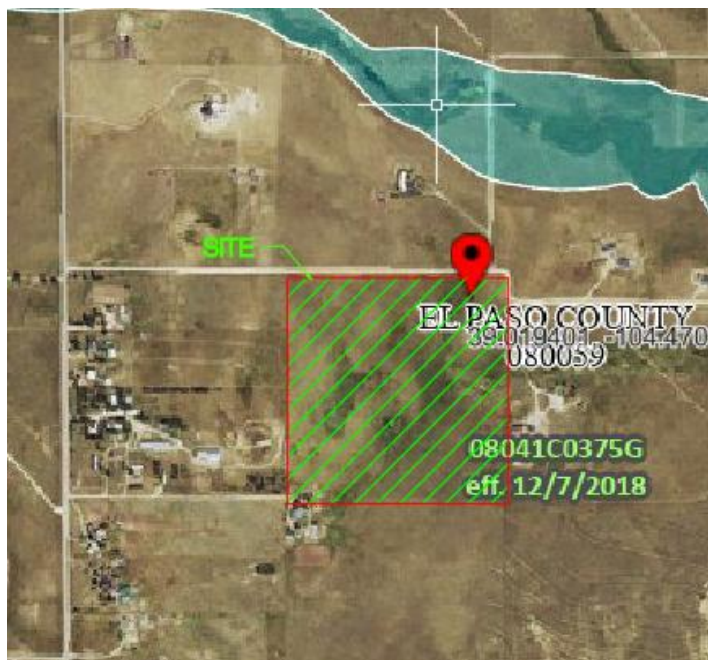
Based on our review of the Federal Emergency Management Agency (FEMA) Community Panel No. 08041C0375G and the online ArcGIS El Paso County Risk Map, the majority of the site lies outside of a 100-year floodplain. The site is within the boundaries of Zone X.

Zone X is defined by FEMA as an area of minimal flood hazard that is determined to be outside the Special Flood Hazard Area and higher than the elevation of the 0.2-percent-annual-chance (or 500-year) flood. The FEMA Map is presented below.
