## **SOIL AND GEOLOGY STUDY**

**Andon Heights**  
**Currently addressed as: 19225 Elliott View**  
**EPC Schedule No. 3208000002**  
**El Paso County, Colorado**

**JOB NO. 197651**

**March 27, 2026**

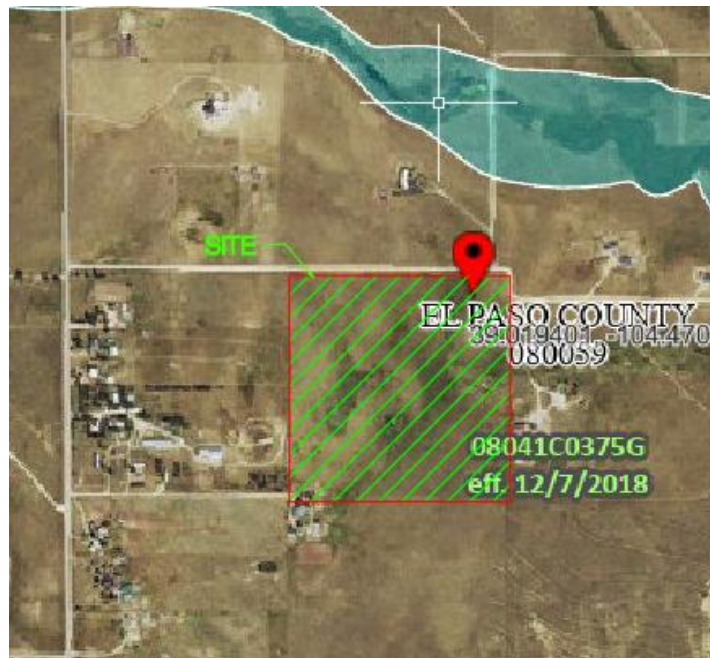
Based on our review of the Federal Emergency Management Agency (FEMA) Community Panel No. 08041C0375G and the online ArcGIS El Paso County Risk Map, the majority of the site lies outside of a 100-year floodplain. The site is within the boundaries of Zone X.

Zone X is defined by FEMA as an area of minimal flood hazard that is determined to be outside the Special Flood Hazard Area and higher than the elevation of the 0.2-percent-annual-chance (or 500-year) flood. The FEMA Map is presented below.
