**GEOLOGIC HAZARDS EVALUATION AND
PRELIMINARY GEOTECHNICAL INVESTIGATION
THE COVE AT WOODMOOR
DEER CREEK WAY AND BURNING OAK WAY
WOODMOOR, COLORADO**

CTL|T Project No. CS18589-115

PUDSP-22-008

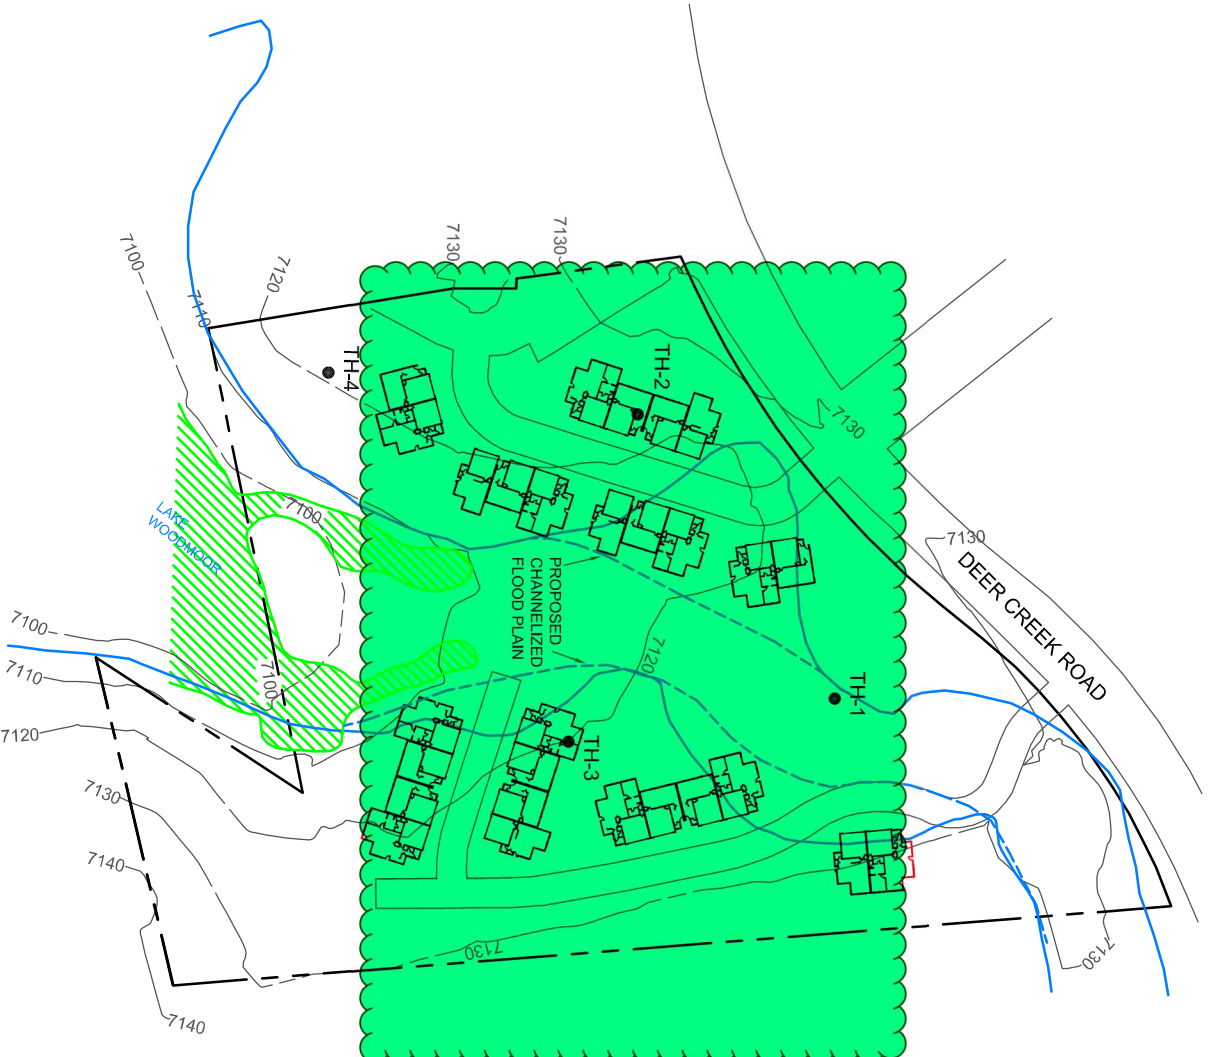
**Location of
 Exploratory
 Borings**

- LEGEND:
- APPROXIMATE LOCATION OF EXPLORATORY BORING.
 - PROJECT BOUNDARY
 - - - EXISTING TOPOGRAPHY
 - 7120 EXISTING CONTOUR ELEVATIONS
 - LOCATION OF EXISTING 100 YEAR FLOODPLAIN.
 - LOCATION OF PROPOSED BUILDING FOOTPRINT.
 - ▨ LOCATION OF WATER STORAGE EASEMENT.

Not the current proposal. please update

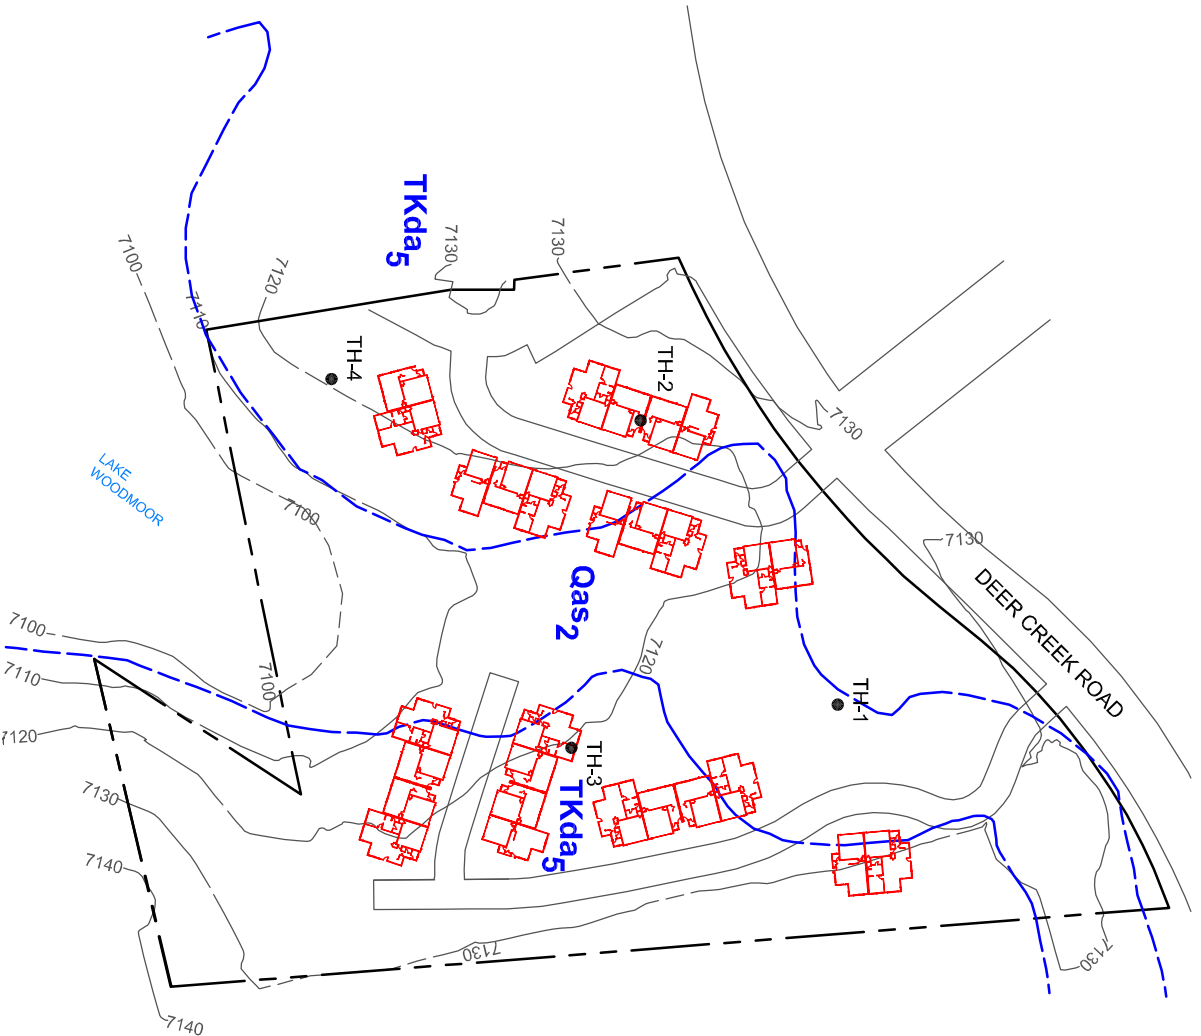
**Surficial
Geologic
Conditions**

- LEGEND:**
- TH-1 APPROXIMATE LOCATION OF EXPLORATORY BORING.
 - - - PROJECT BOUNDARY
 - - - EXISTING TOPOGRAPHY
 - 7120 EXISTING CONTOUR ELEVATIONS
 - - - LOCATION OF PROPOSED BUILDING FOOTPRINT.

- NOTES:**
1. BASE DRAWING WAS PROVIDED BY N.E.S., INC.
 2. ALL BOUNDARIES SHOWN SHOULD BE CONSIDERED APPROXIMATE. THEY ARE BASED UPON A SUBJECTIVE INTERPRETATION OF PUBLISHED MAPS, AERIAL PHOTOGRAPHS AND AN INITIAL FIELD RECONNAISSANCE. CHANGES IN THE MAPPED BOUNDARIES SHOWN ARE POSSIBLE AND SHOULD BE EXPECTED WITH MORE DETAILED WORK AND FURTHER INFORMATION. ALL INTERPRETATIONS AND CONDITIONS SHOWN ARE PRELIMINARY AND FOR LAND-USE PLANNING ONLY.

Our interpretation of the surficial geology and geologic hazards is presented in Fig. 2 and is described above. Our interpretation of the engineering geologic conditions is presented in Fig. 3. The site is shown as containing Map Units 2A, 3B, and 7A per the classification system described in Robinson's "El Paso County, Colorado - Potential Geologic Hazards and Surficial Deposits, Environmental and Engineering Geologic Maps and Tables for Land Use," 1977.

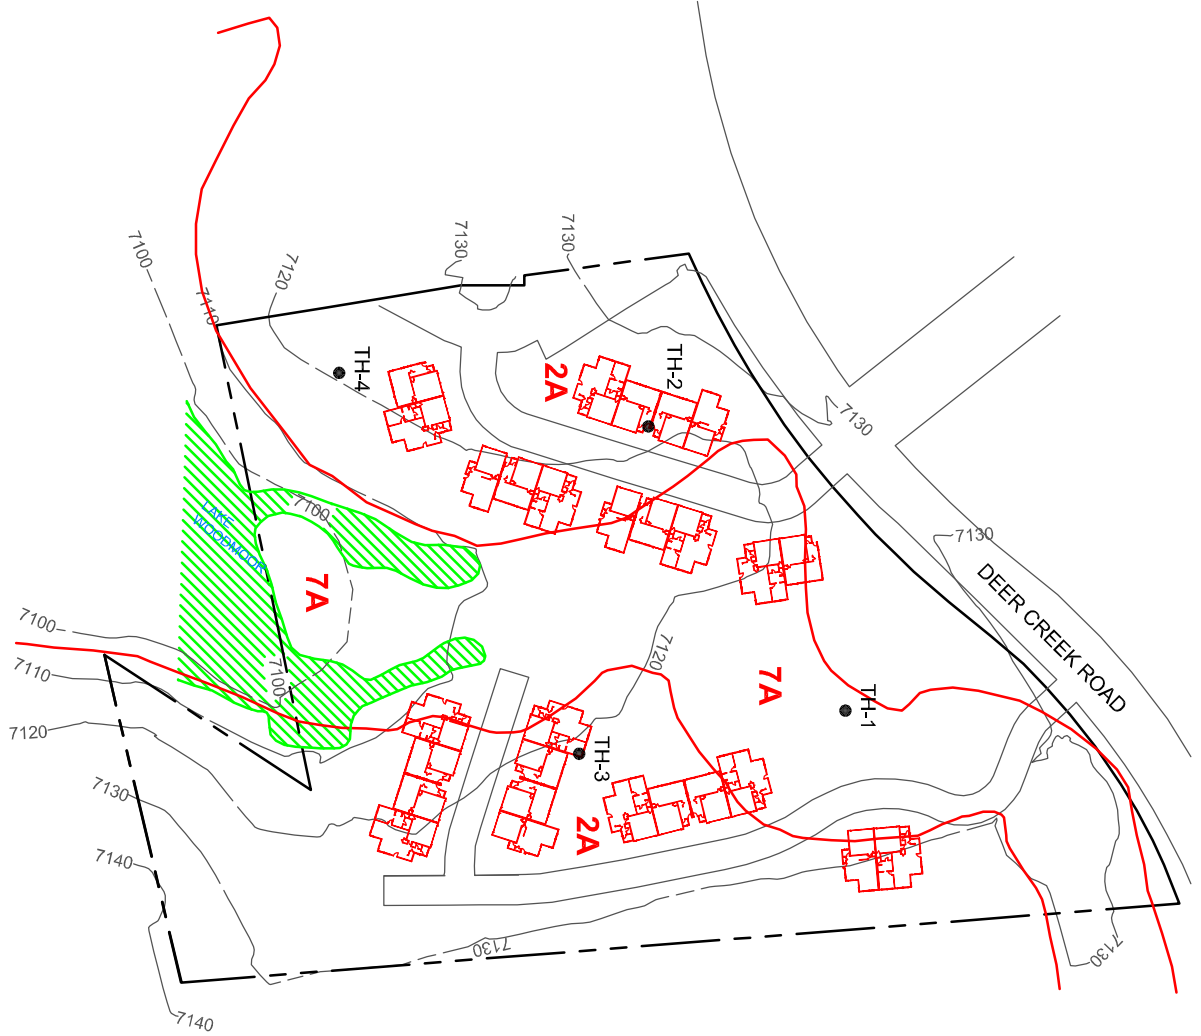
**Engineering
 Conditions**

- TH-1 APPROXIMATE LOCATION OF EXPLORATORY BORING.
- PROJECT BOUNDARY
- - - EXISTING TOPOGRAPHY
- 7120 EXISTING CONTOUR ELEVATIONS
- ▨ LOCATION OF WATER STORAGE EASEMENT.
- ▭ LOCATION OF PROPOSED BUILDING FOOTPRINT.
