**GEOLOGIC HAZARDS EVALUATION AND
PRELIMINARY GEOTECHNICAL INVESTIGATION
THE COVE AT WOODMOOR
DEER CREEK WAY AND BURNING OAK WAY
WOODMOOR, COLORADO**

CTL|T Project No. CS18589-115

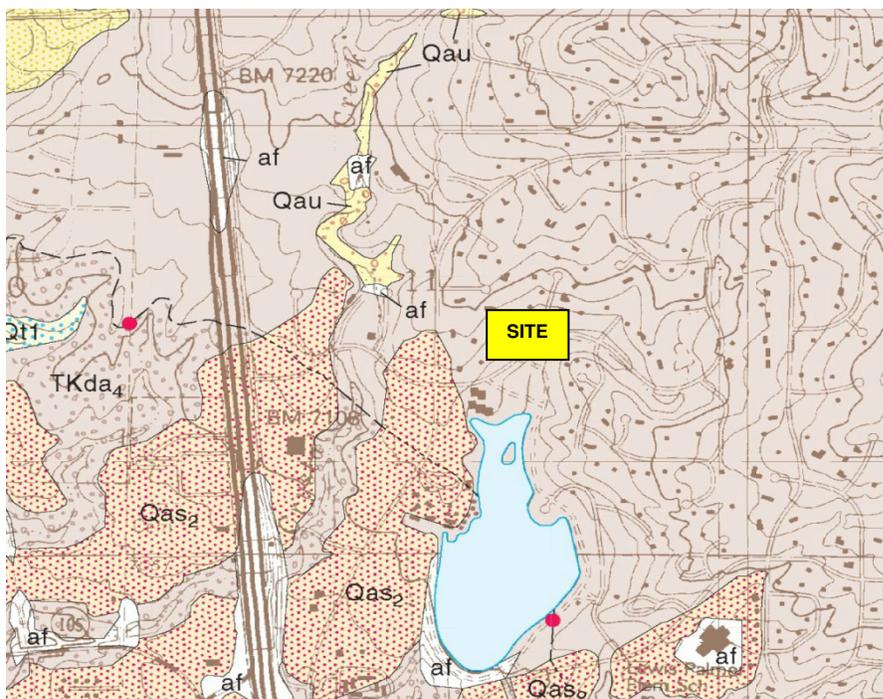
Excerpt from CGS 2004 Geologic Map of the Monument Quadrangle

Surficial Deposits

found in the flood plain to also consist of an alluvial deposit. A list of references is included at the end of the text of this report. The following sections discuss the mapped units.

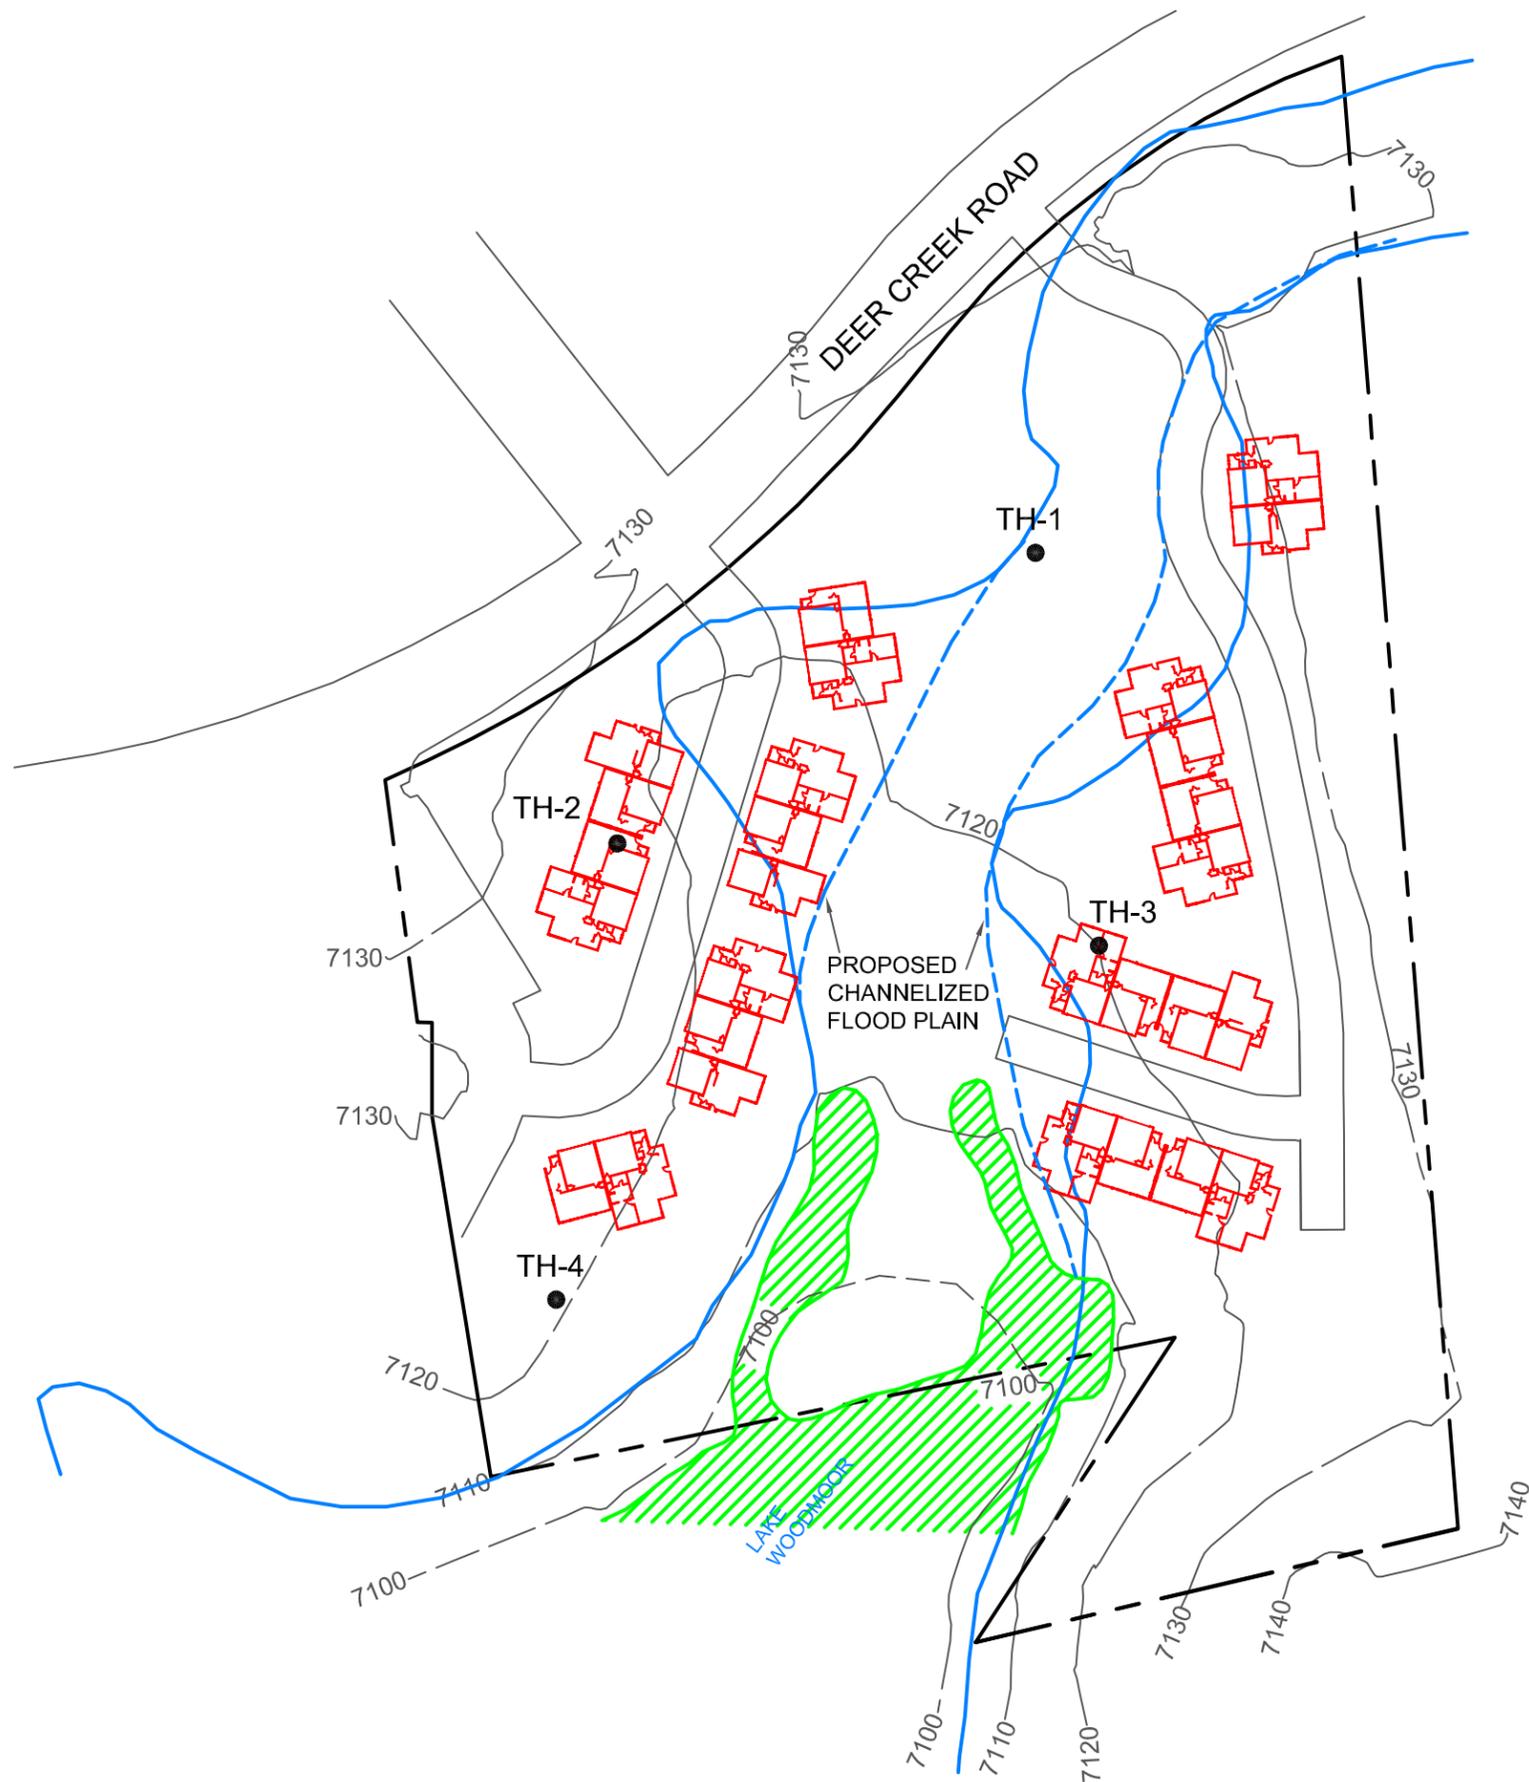
- — — SURFICIAL GEOLOGIC CONTACTS
- TKda₅** DAWSON FORMATION, SANDSTONE, FINE TO MEDIUM GRAINED POORLY SORTED WITH HIGH CLAY CONTENTS. CONTAINS THIN TO VERY THIN BEDDED GRAY CLAYSTONE AND SANDY CLAYSTONE.
- Qas₂** ALLUVIAL DEPOSITS. MIDDLE ALLUVIAL SLOPE DEPOSITS. SHEETWASH AND STREAM DEPOSITS OF ALLUVIUM.

Our interpretation of the surficial geology and geologic hazards is presented in Fig. 2 and is described above. Our interpretation of the engineering geologic conditions is presented in Fig. 3. The site is shown as containing Map Units 2A, 3B, and 7A per the classification system described in Robinson's "El Paso County, Colorado - Potential Geologic Hazards and Surficial Deposits, Environmental and Engineering Geologic Maps and Tables for Land Use," 1977.

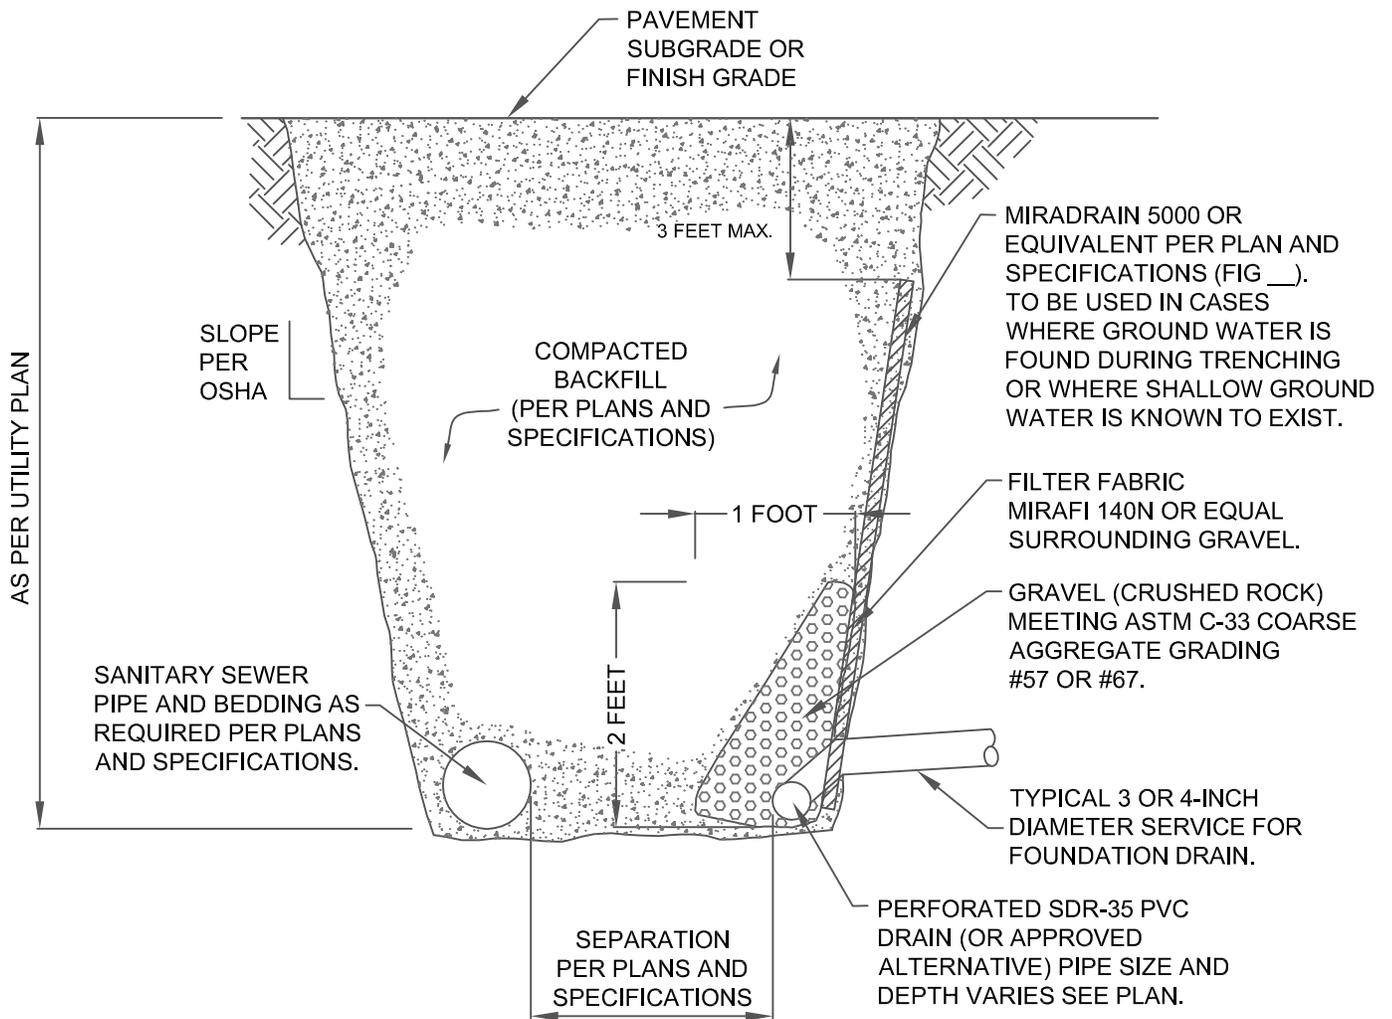
NOTE:
TO BE USED IN CASES WHERE GROUND WATER IS FOUND DURING TRENCHING OR WHERE SHALLOW GROUND WATER IS KNOWN TO EXIST, AND UPSTREAM OF MANHOLES.

If wet conditions or free water are encountered in the sanitary sewer trenches, we recommend an active underdrain system with perforated or slotted pipe for these

areas. A conceptual drain detail is shown in Fig. 4. A cutoff collar should be constructed around the sewer pipe and underdrain pipe immediately downstream of the point the underdrain pipe exits the sewer trench or changes from active to passive. Solid pipe should be used down gradient of this cutoff collar to the point of discharge. The underdrain should be maintained at least 3 to 5 feet below the lowest nearby foundation elevation. Where no groundwater is encountered in sanitary sewer excavations, passive underdrains may be used as presented on Fig. 5.

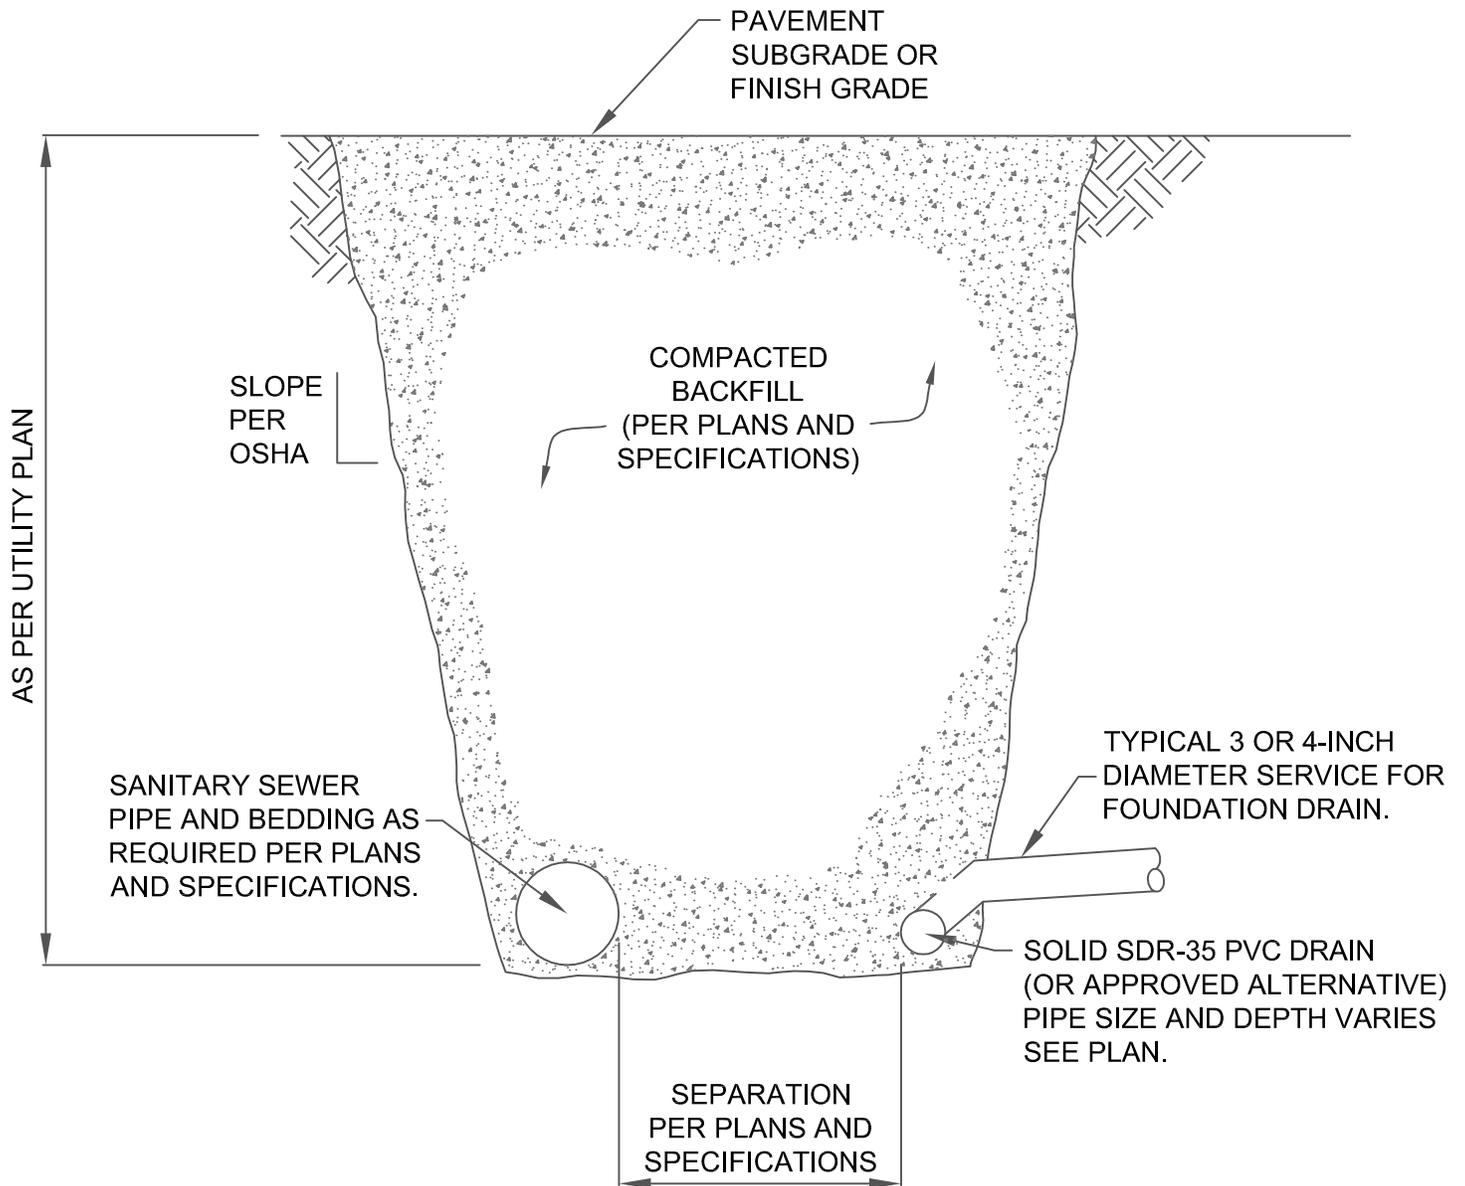
NOTE:
TO BE USED IN CASES WHERE NO
GROUND WATER IS KNOWN TO EXIST.

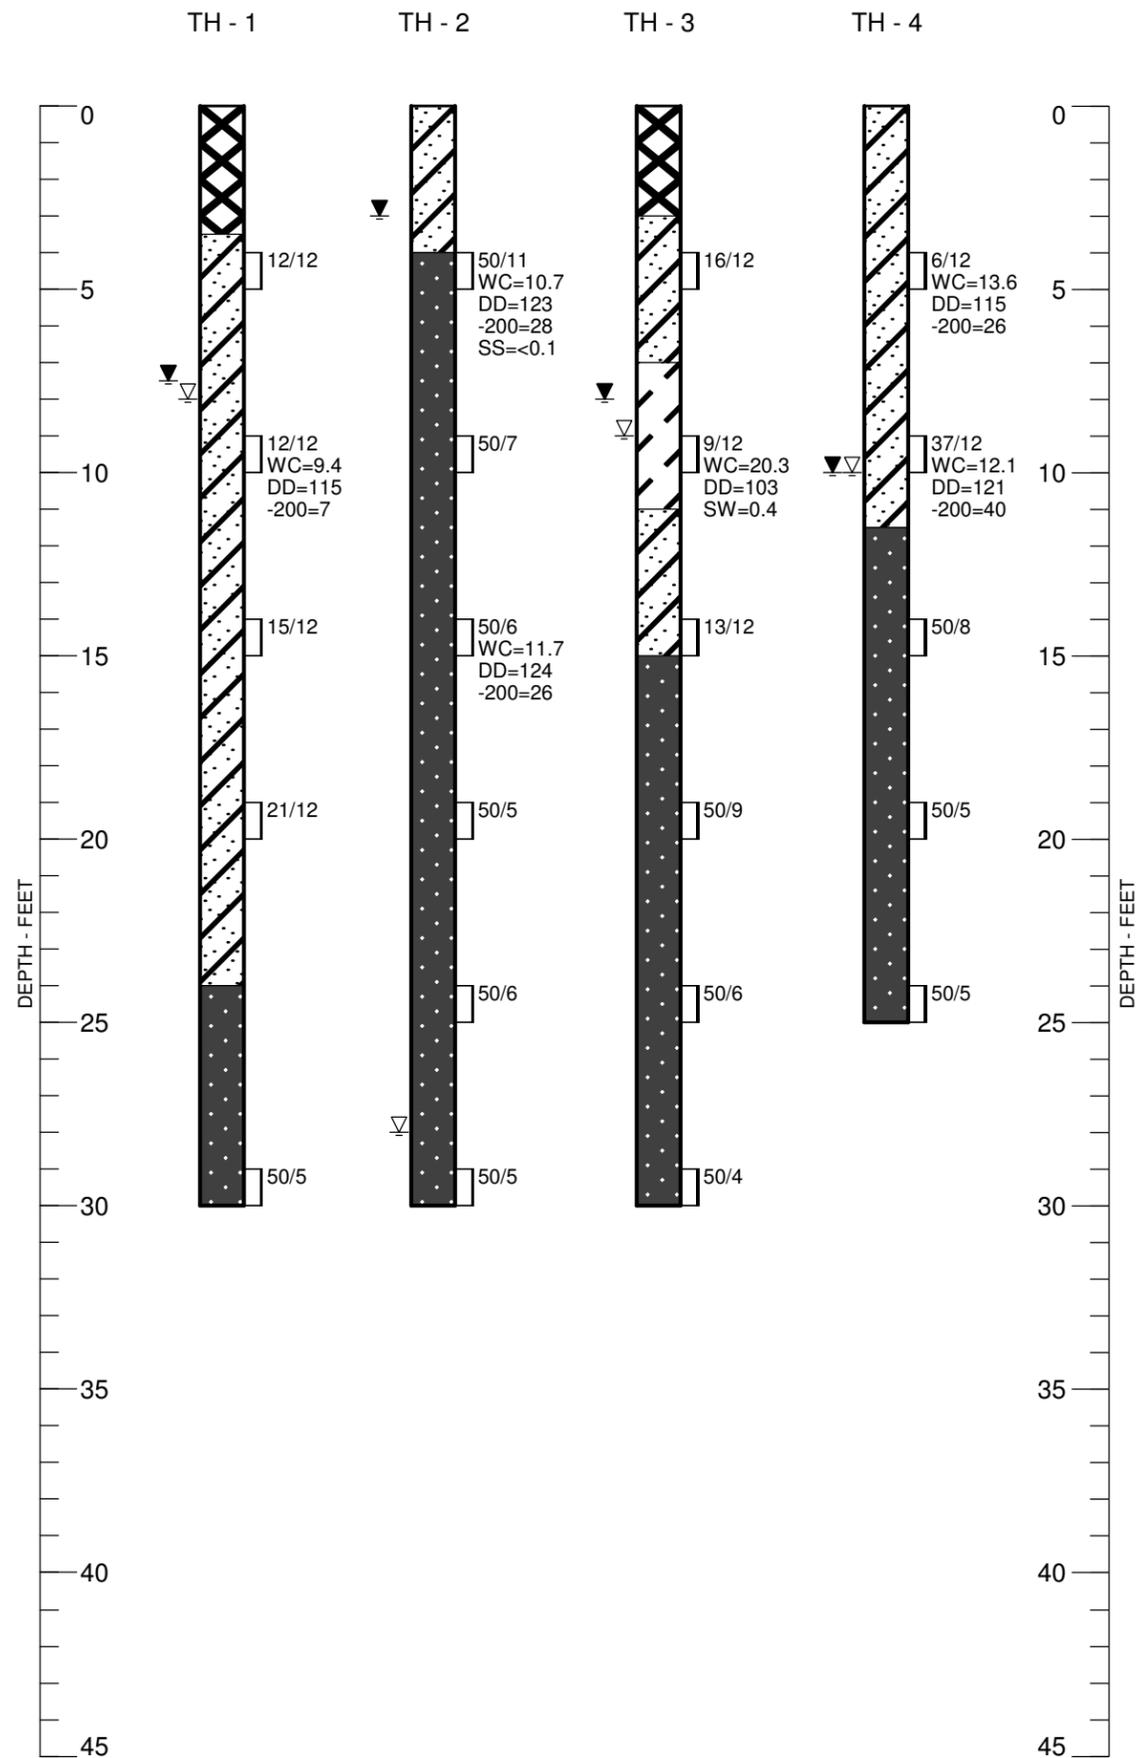
APPENDIX A
SUMMARY LOGS OF EXPLORATORY BORINGS

1. THE BORINGS WERE DRILLED MAY 19, 2016 USING A 4-INCH DIAMETER, CONTINUOUS-FLIGHT AUGER AND A CME-55, TRUCK-MOUNTED DRILL RIG.
2. THESE LOGS ARE SUBJECT TO THE EXPLANATIONS, LIMITATIONS, AND CONCLUSIONS AS CONTAINED IN THIS REPORT.
3. WC - INDICATES MOISTURE CONTENT. (%)
 DD - INDICATES DRY DENSITY. (PCF)
 SW - INDICATES SWELL WHEN WETTED UNDER ESTIMATED OVERBURDEN PRESSURE. (%)
 -200 - INDICATES PASSING NO. 200 SIEVE. (%)
 SS - INDICATES WATER-SOLUBLE SULFATE CONTENT. (%)

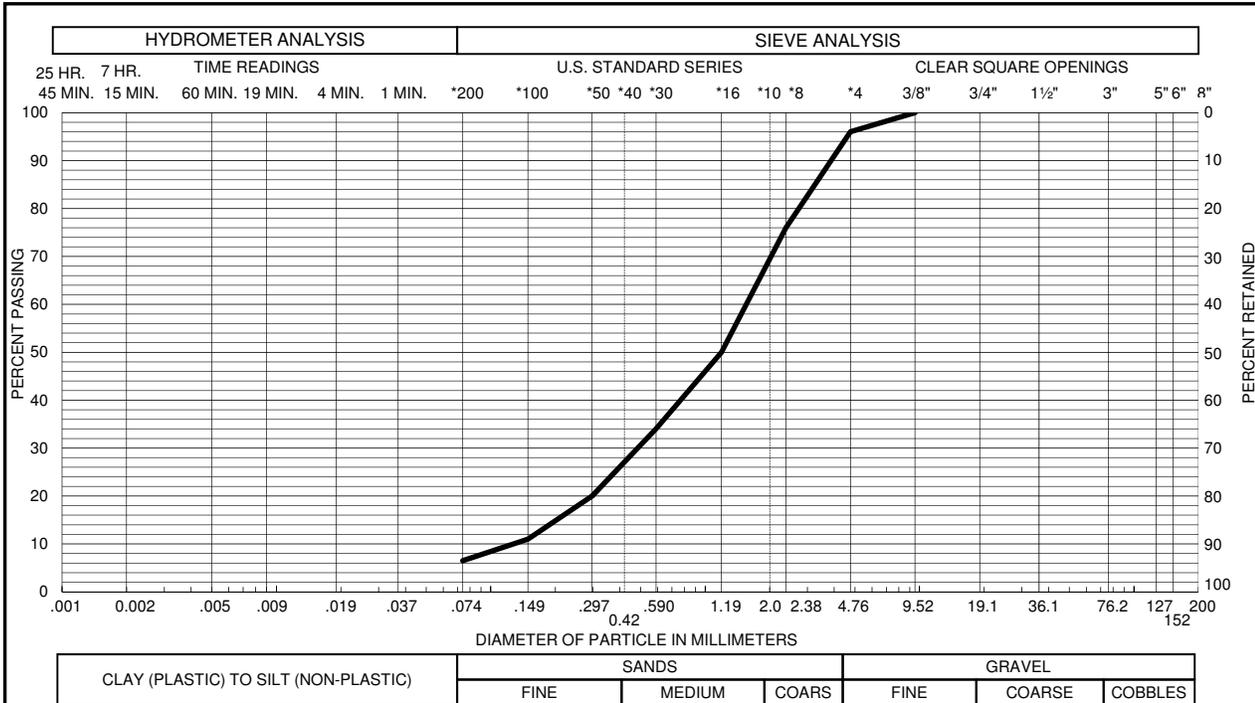
Sample of SAND, SLIGHTLY SILTY (SP-SM) GRAVEL 4 % SAND 89 %
 From TH - 1 AT 9 FEET SILT & CLAY 7 % LIQUID LIMIT %
 PLASTICITY INDEX %

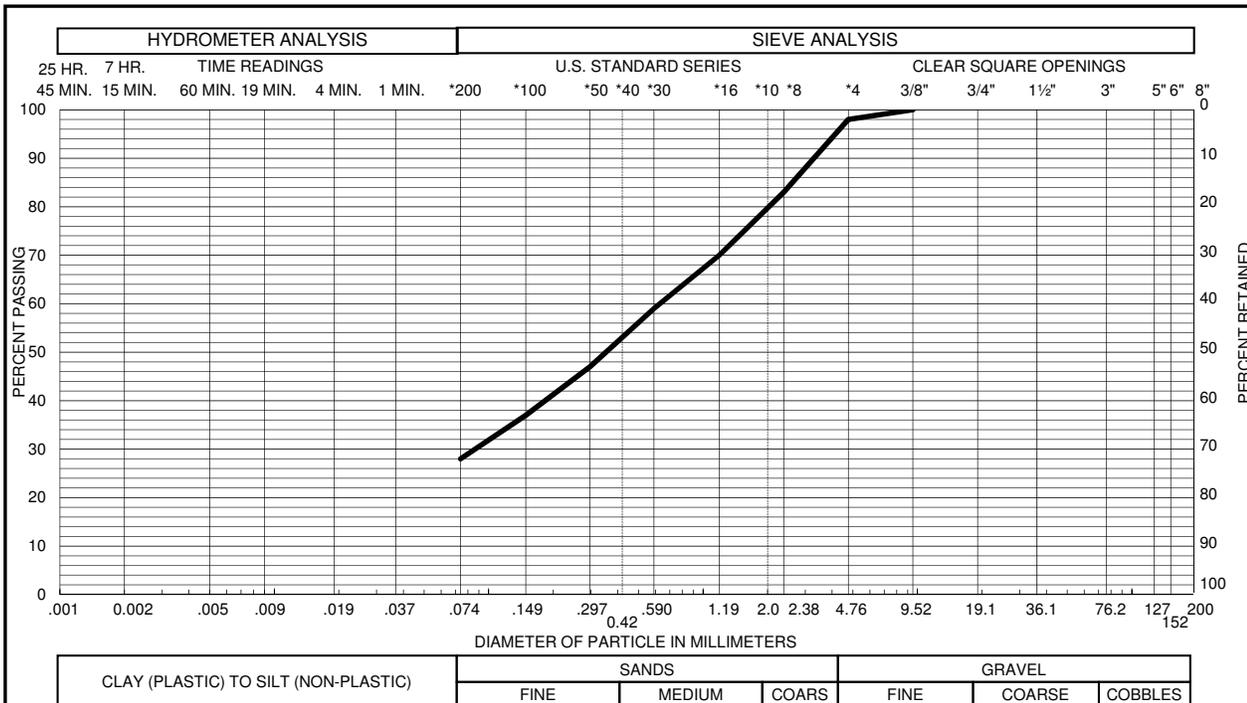
Sample of SANDSTONE, SILTY GRAVEL 2 % SAND 70 %
 From TH - 2 AT 4 FEET SILT & CLAY 28 % LIQUID LIMIT %
 PLASTICITY INDEX %

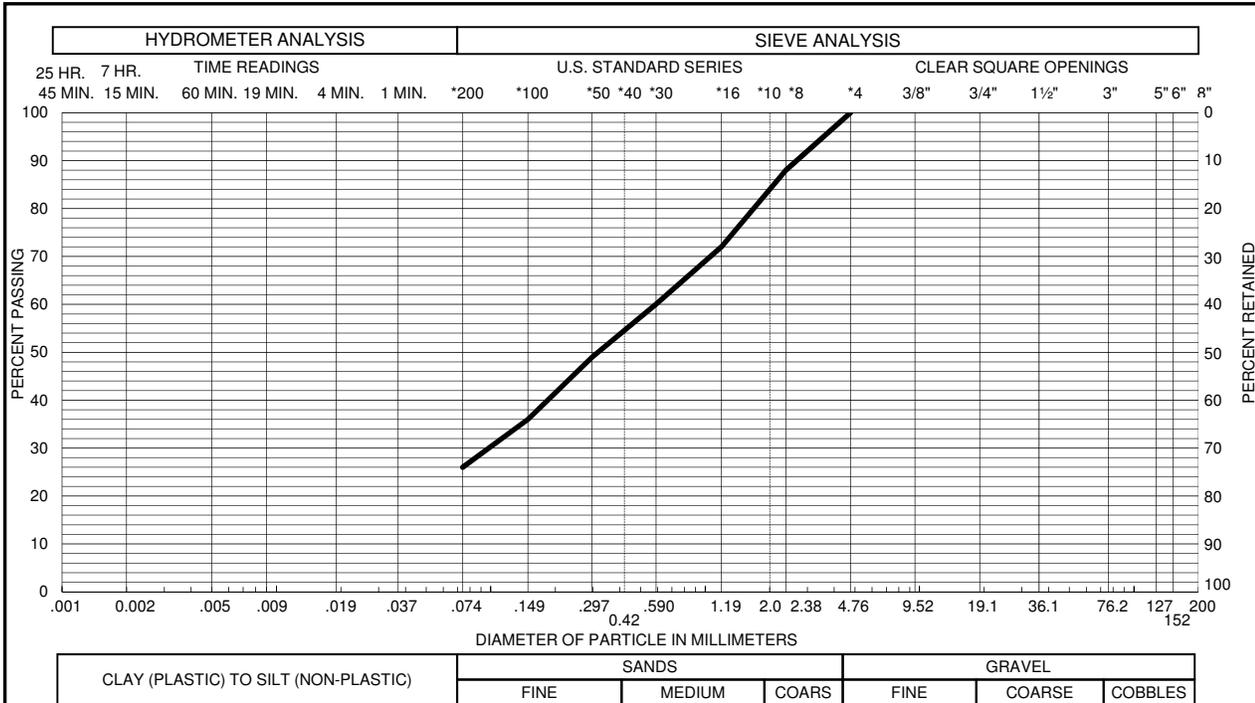
Sample of SANDSTONE, SILTY GRAVEL 0 % SAND 74 %
 From TH - 2 AT 14 FEET SILT & CLAY 26 % LIQUID LIMIT %
 PLASTICITY INDEX %

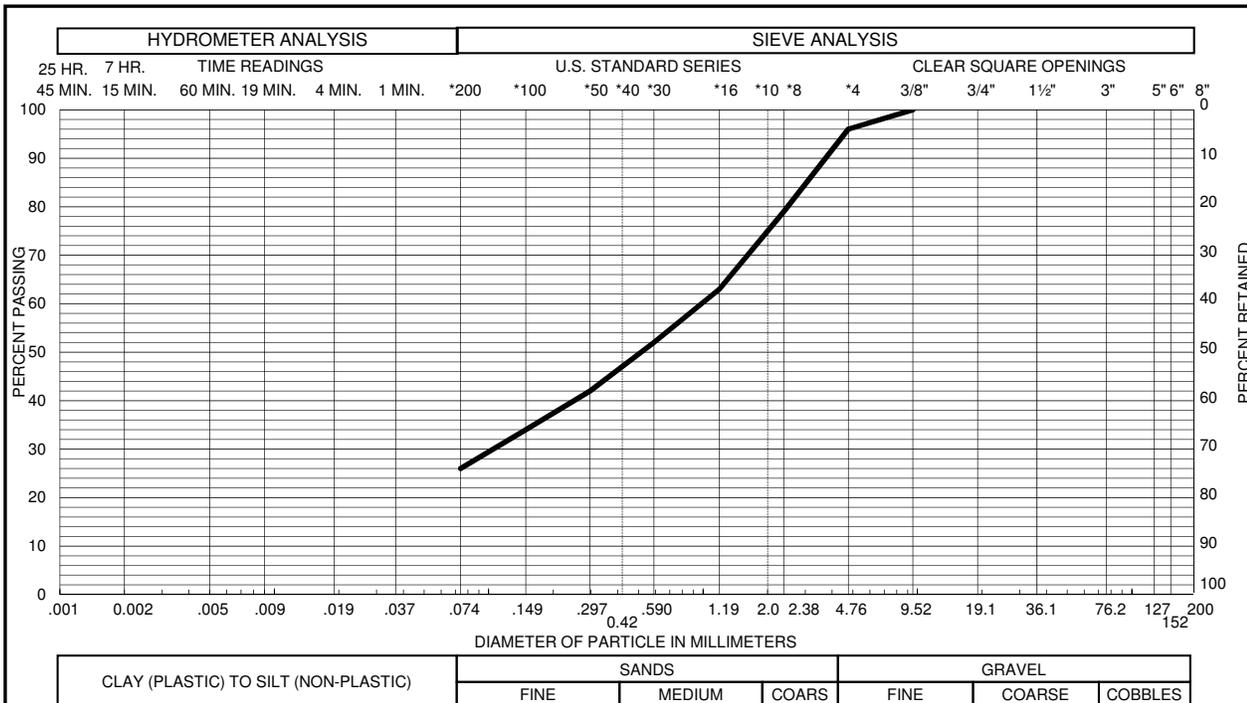
Sample of SAND, CLAYEY (SC) GRAVEL 4 % SAND 70 %
 From TH - 4 AT 4 FEET SILT & CLAY 26 % LIQUID LIMIT %
 PLASTICITY INDEX %

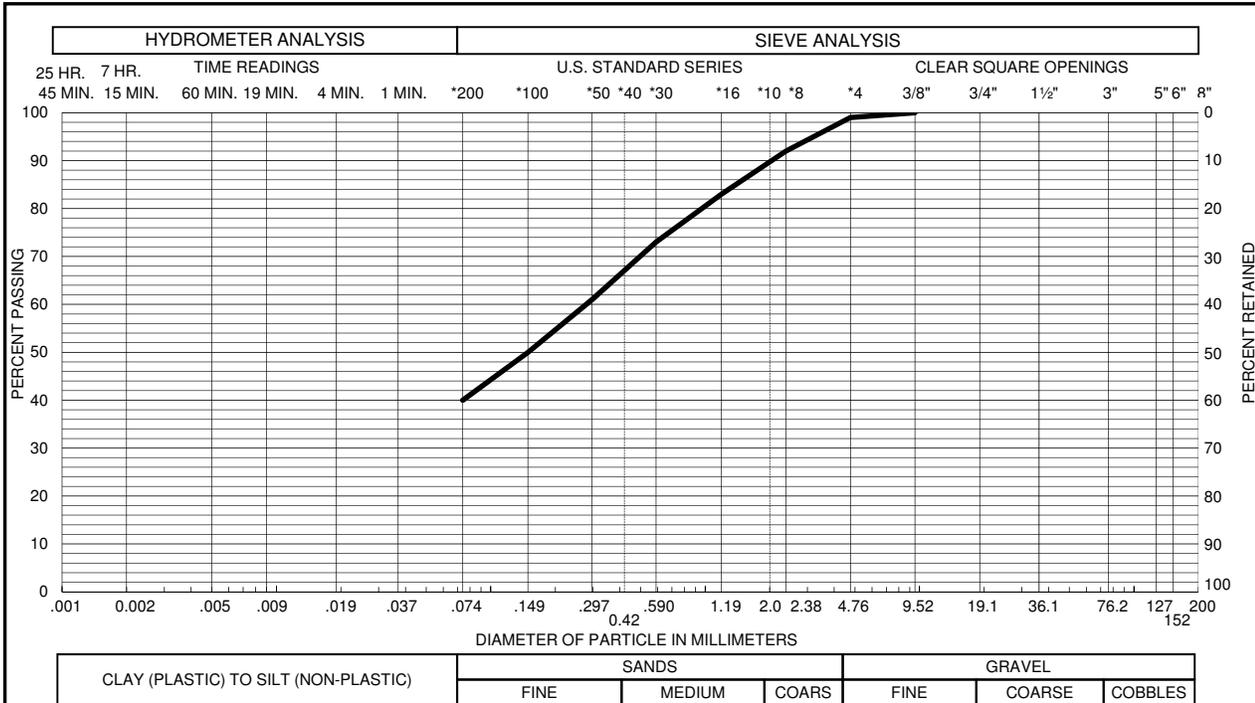
Sample of SAND, VERY CLAYEY (SC) GRAVEL 1 % SAND 59 %
 From TH - 4 AT 9 FEET SILT & CLAY 40 % LIQUID LIMIT _____ %
 PLASTICITY INDEX _____ %
