ENTECH
ENGINEERING, INC.

**SOILS AND GEOLOGY STUDY
URBAN LANDING
STRUTHERS ROAD AND SPANISH BIT DRIVE
EL PASO COUNTY, COLORADO**

July 12, 2024
Revised September 13, 2024

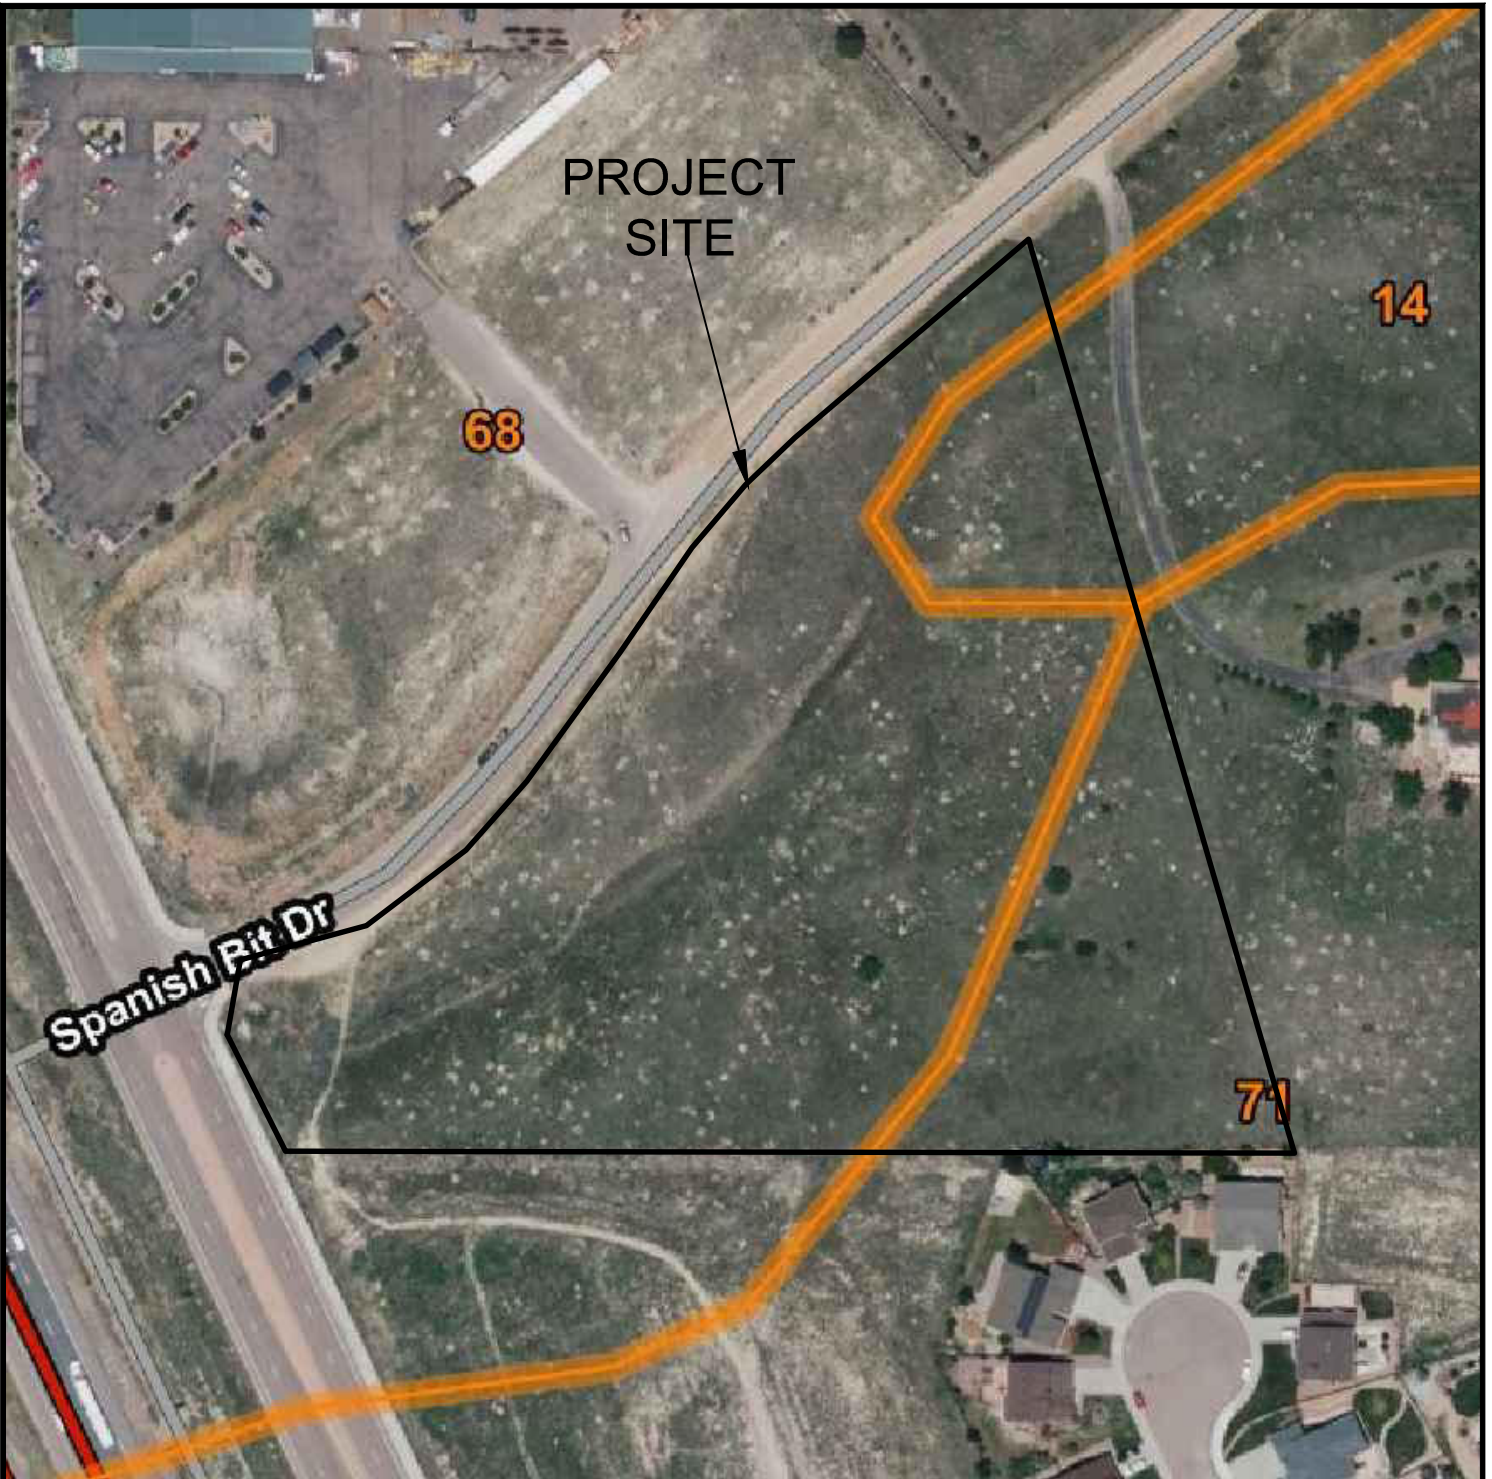
FIG. 4

USDA SOIL MAP
URBAN LANDING
ELITE PROPERTIES OF AMERICA, INC.

The Natural Resource Conservation Service (Reference 3), previously the Soil Conservation Service (Reference 4) has mapped one soil types on the site Figure 4. In general, the soils are classified as sandy loams. The soils are described as follows:

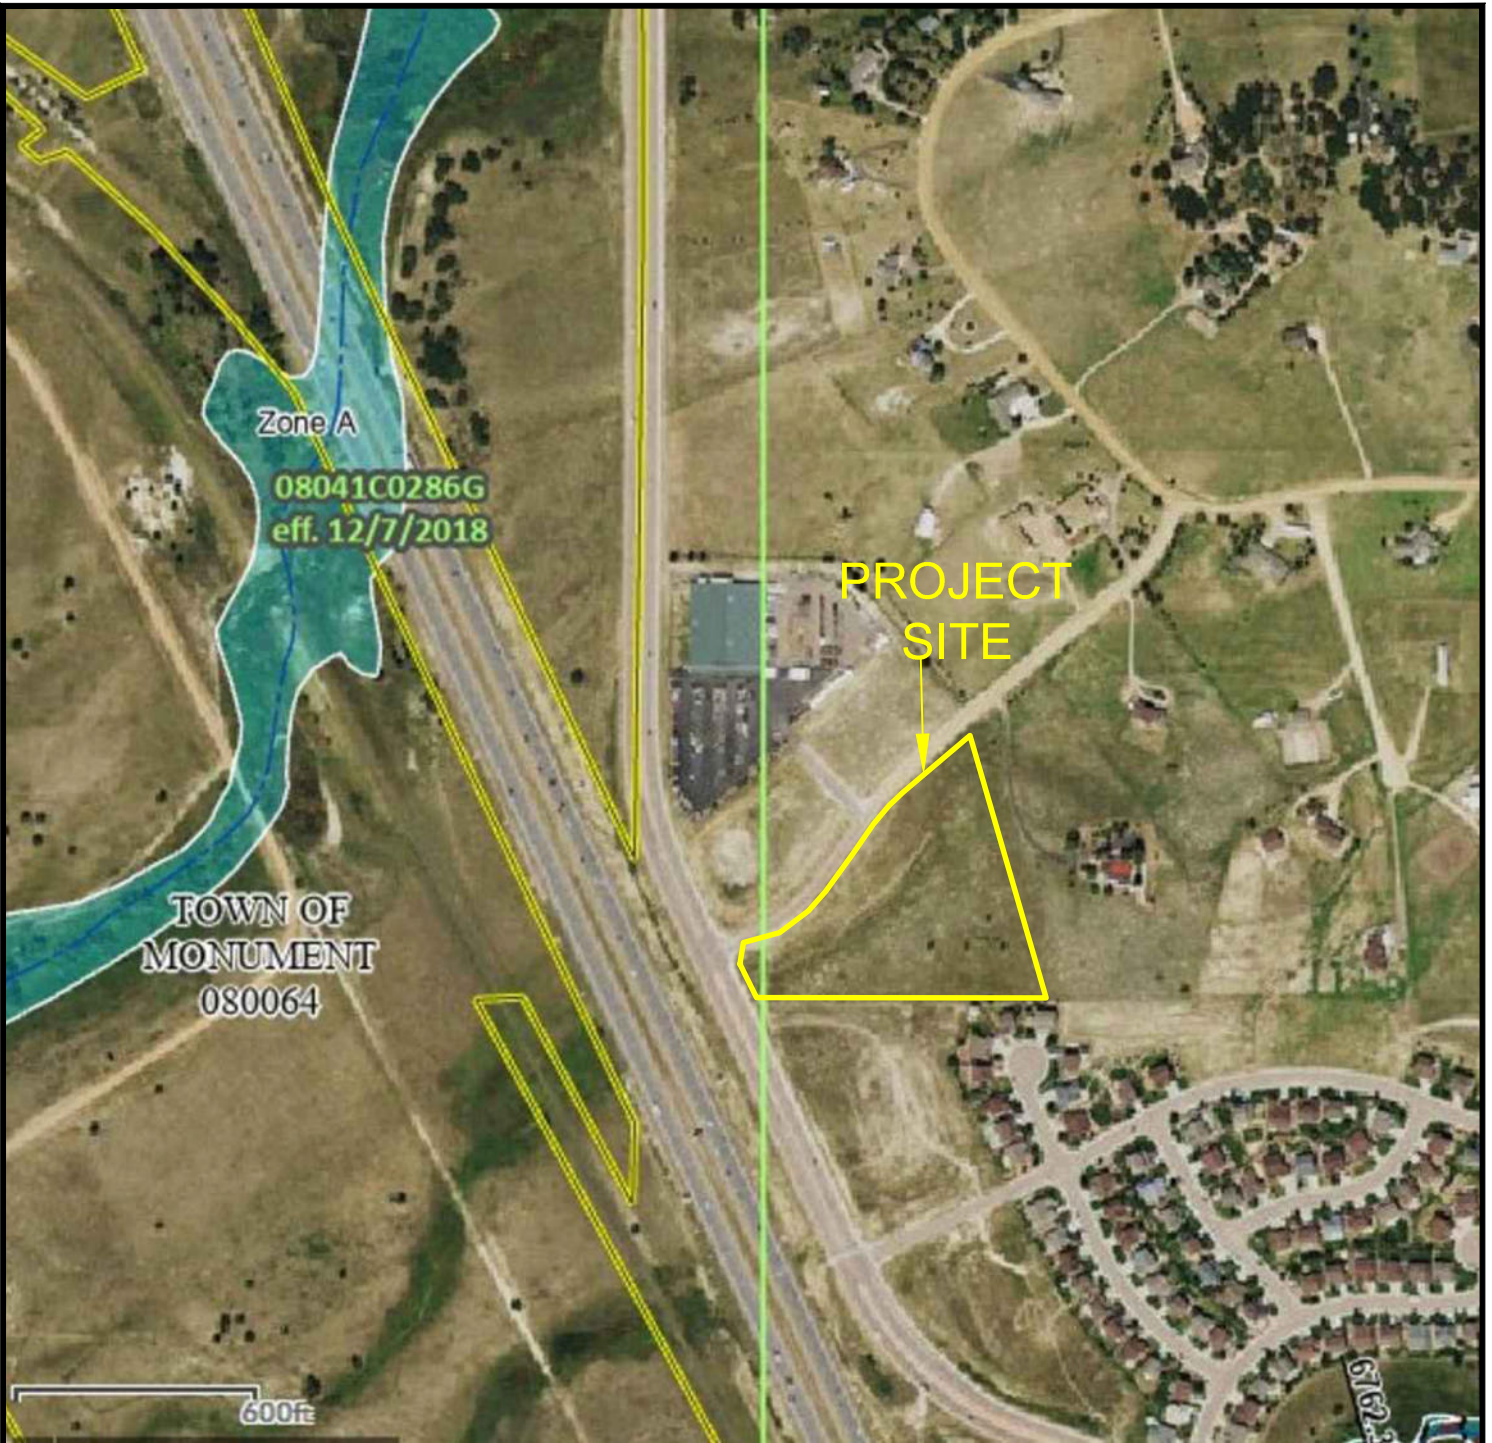
FIG. 7

FEMA FLOODPLAIN MAP

A minor drainage swale is located in the southwestern portion of the site south of Spanish Bit Drive. These areas have been potential seasonally shallow groundwater areas. Groundwater was encountered in two test borings at depths of 14 and 15.5 feet. The site is not mapped within floodplain zones according to the FEMA Map No. 08041CO286G and 08041CO287G, (Figure 7, Reference 10). **Exact floodplain locations and drainage studies are beyond the scope of this report.**

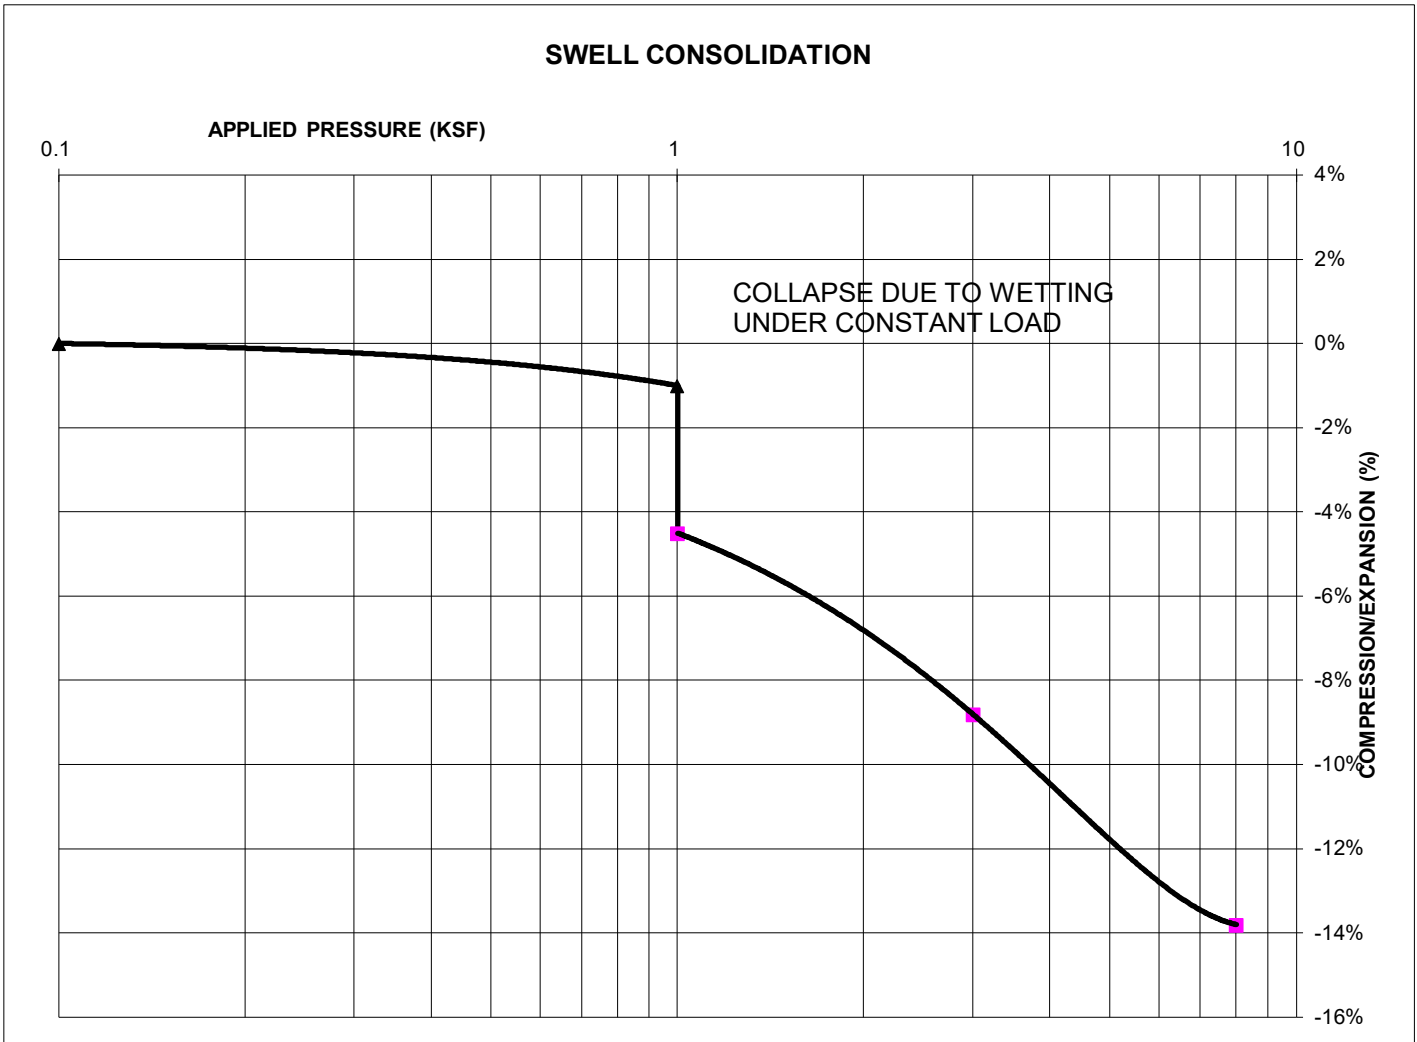
TEST BORING 1
DEPTH (FT) 10

SOIL DESCRIPTION CLAY, WITH SAND
SOIL TYPE 2

SWELL/COLLAPSE TEST RESULTS

NATURAL UNIT DRY WEIGHT (PCF): 99
NATURAL MOISTURE CONTENT: 13.5%
SWELL/COLLAPSE (%): -3.5%
