ENTECH
ENGINEERING, INC.

**SOILS AND GEOLOGY STUDY
URBAN LANDING
STRUTHERS ROAD AND SPANISH BIT DRIVE
EL PASO COUNTY, COLORADO**

July 12, 2024

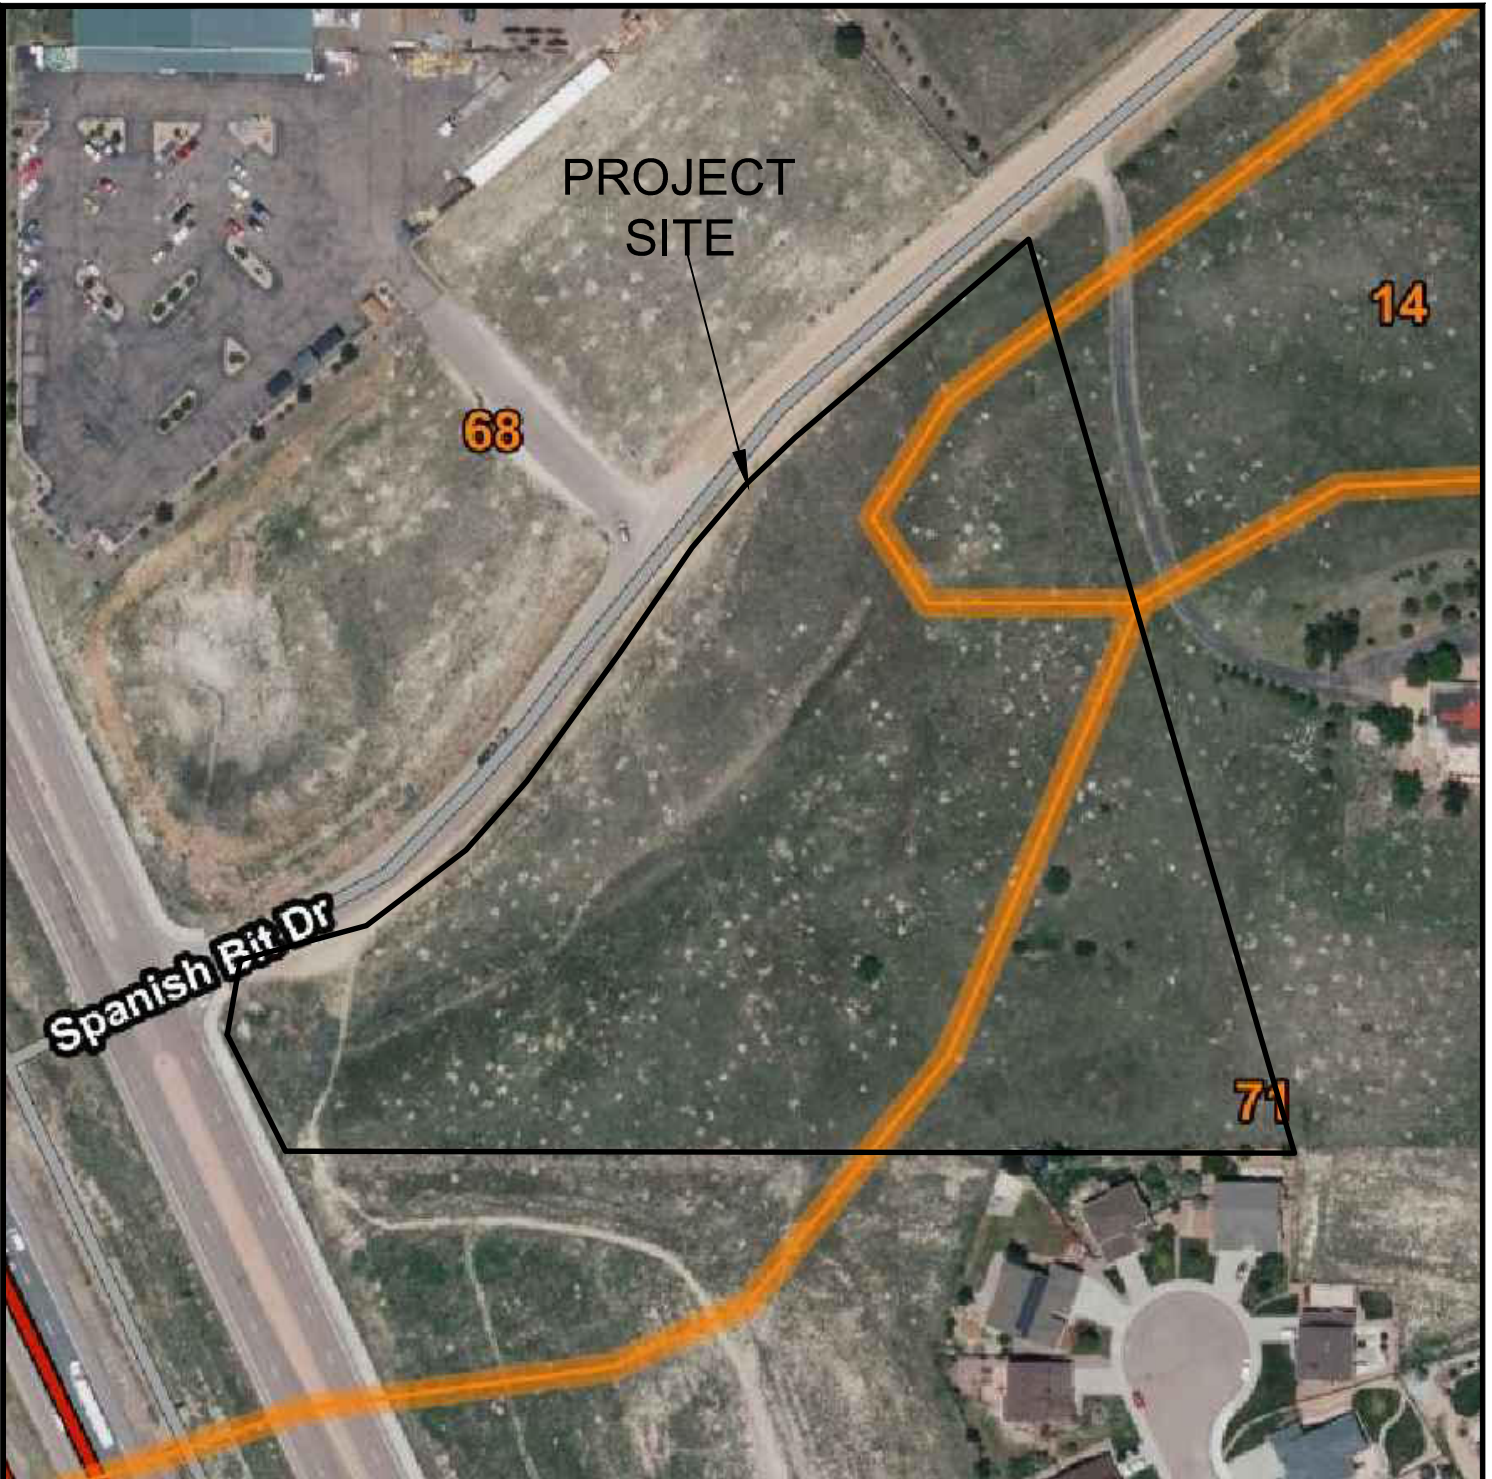
FIG. 4

USDA SOIL MAP
URBAN LANDING
ELITE PROPERTIES OF AMERICA, INC.

The Natural Resource Conservation Service (Reference 3), previously the Soil Conservation Service (Reference 4) has mapped one soil types on the site Figure 4. In general, the soils are classified as sandy loams. The soils are described as follows:

Complete descriptions of each soil type are presented in Appendix C. The soils have generally been described to have rapid to moderate permeabilities. Possible hazards with soil erosion are present on the site. The erosion potential can be controlled with vegetation. The soils have been described to have moderate erosion hazards.

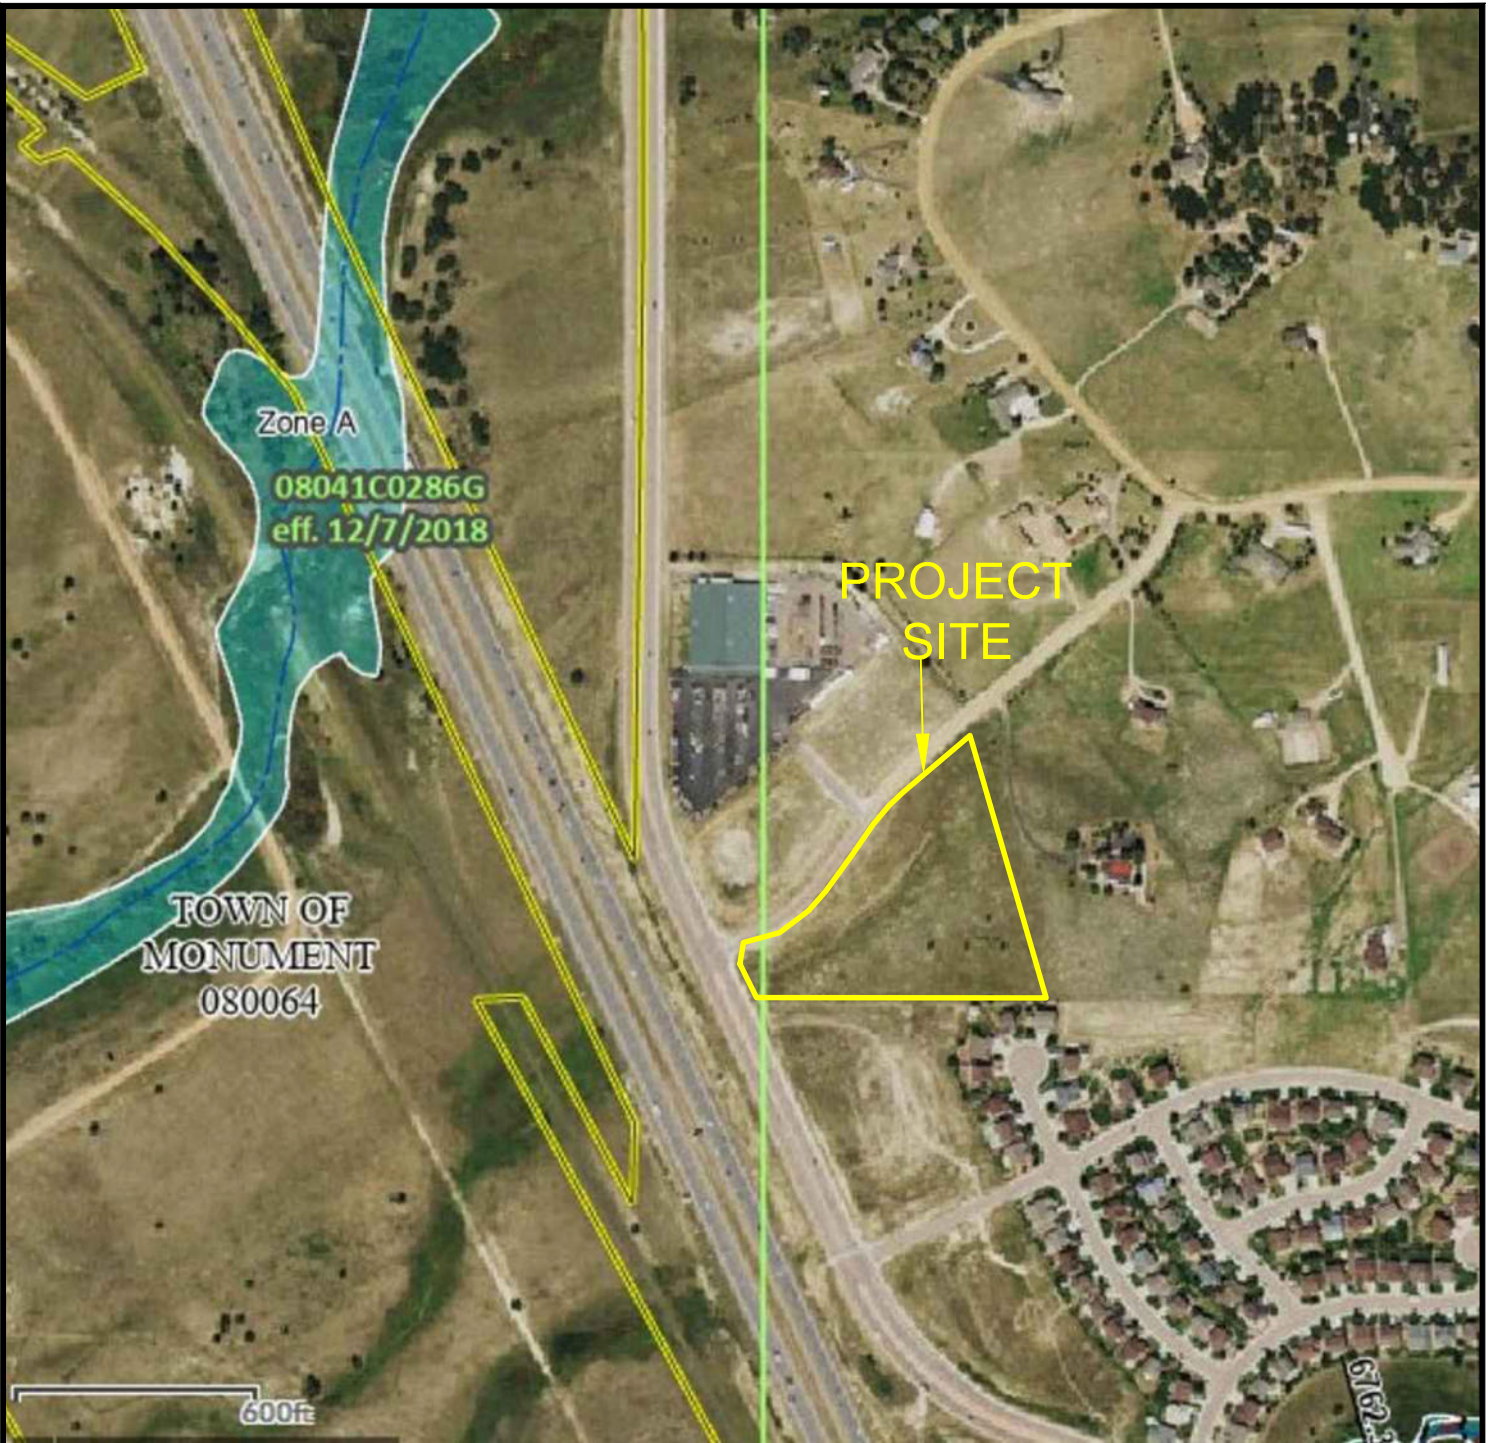
FIG. 7

FEMA FLOODPLAIN MAP
URBAN LANDING
ELITE PROPERTIES OF AMERICA, INC.

floodplain zones according to the FEMA Map No. 08041CO286G and 08041CO287G, (Figure 7, Reference 10). **Exact floodplain locations and drainage studies are beyond the scope of this report.**

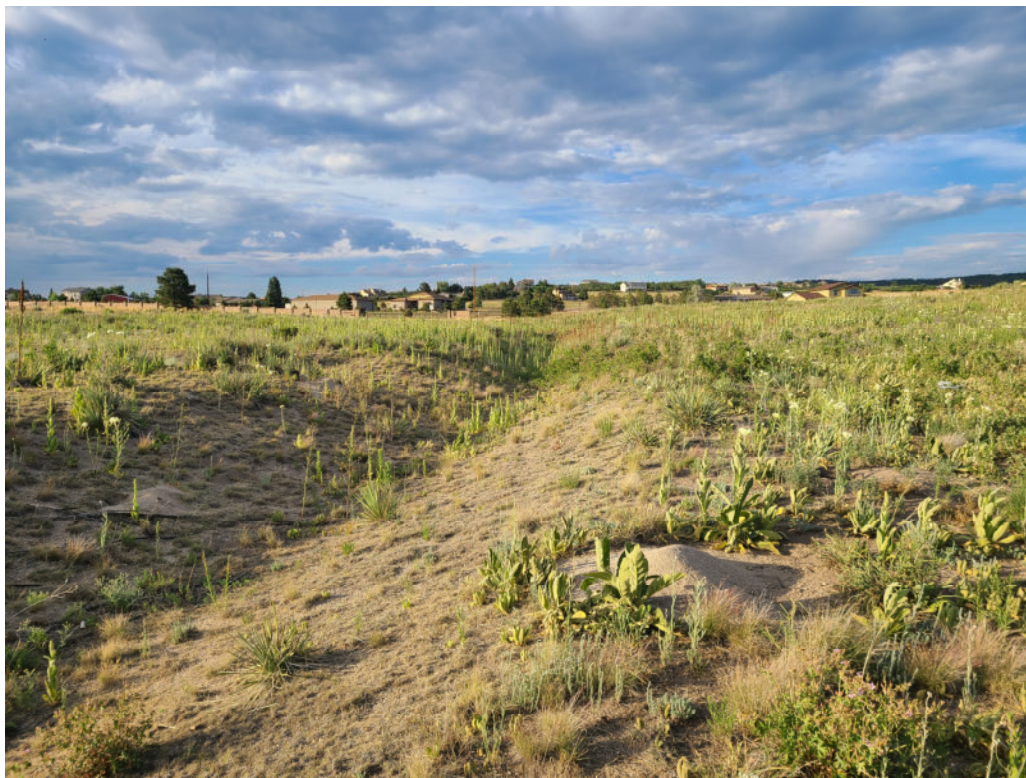
**Looking northeast
along drainage swale
in central portion of
the site.**

The topography of the site is generally gradually sloping to the southwest. A minor drainage swale is located in the central portion of the site south of Spanish Bit Drive. The drainage swale flows in a southwesterly direction towards existing culverts at the intersection of Struthers Road and Spanish Bit Drive. Water was not observed in the minor drainage swale at the time of this investigation. The site boundaries are indicated on the USGS Map, Figure 2. Previous land uses have included agricultural grazing and undeveloped land. The site contains primarily field grasses, weeds, cacti and yuccas. Site photographs, taken July 9, 2024, are included in Appendix A.

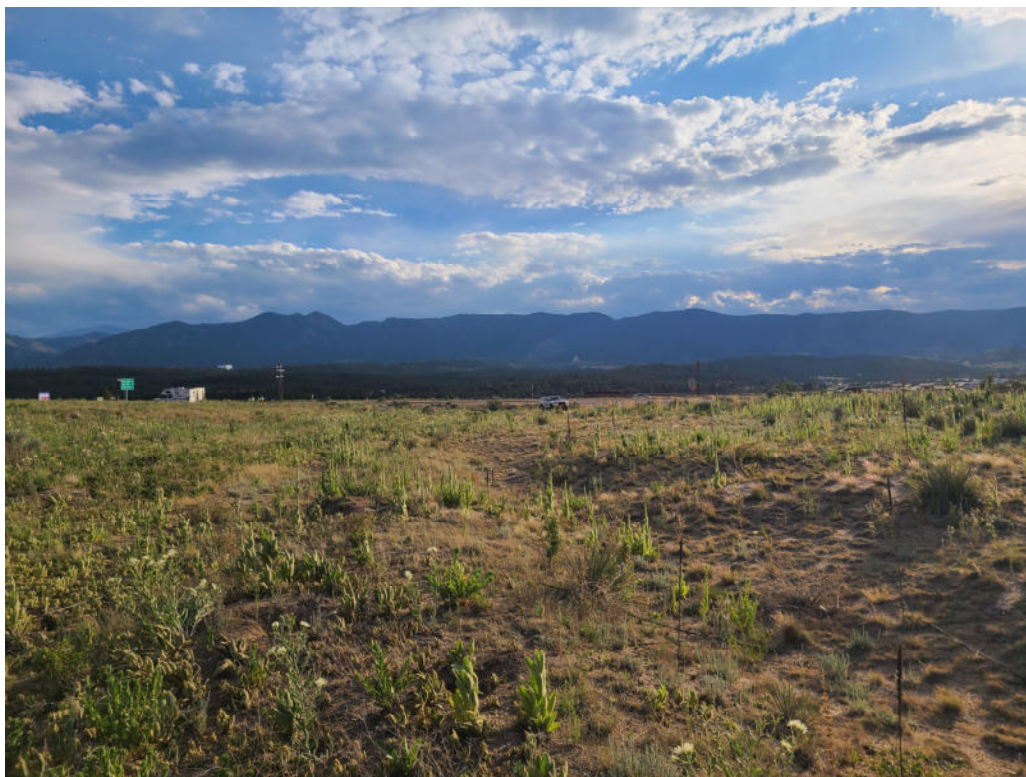
**Looking southwest
along drainage swale
in central portion of
the site.**
