ENTECH
ENGINEERING, INC.

**SOILS AND GEOLOGY STUDY
RETREAT AT PRAIRIERIDGE
FILINGS 1, 2, AND 3 – PRELIMINARY PLAN
POCO ROAD AND VOLLMER ROAD
EL PASO COUNTY, COLORADO**

November 21, 2023
Revised February 29, 2024
Revised April 2, 2024
Revised June 5, 2024

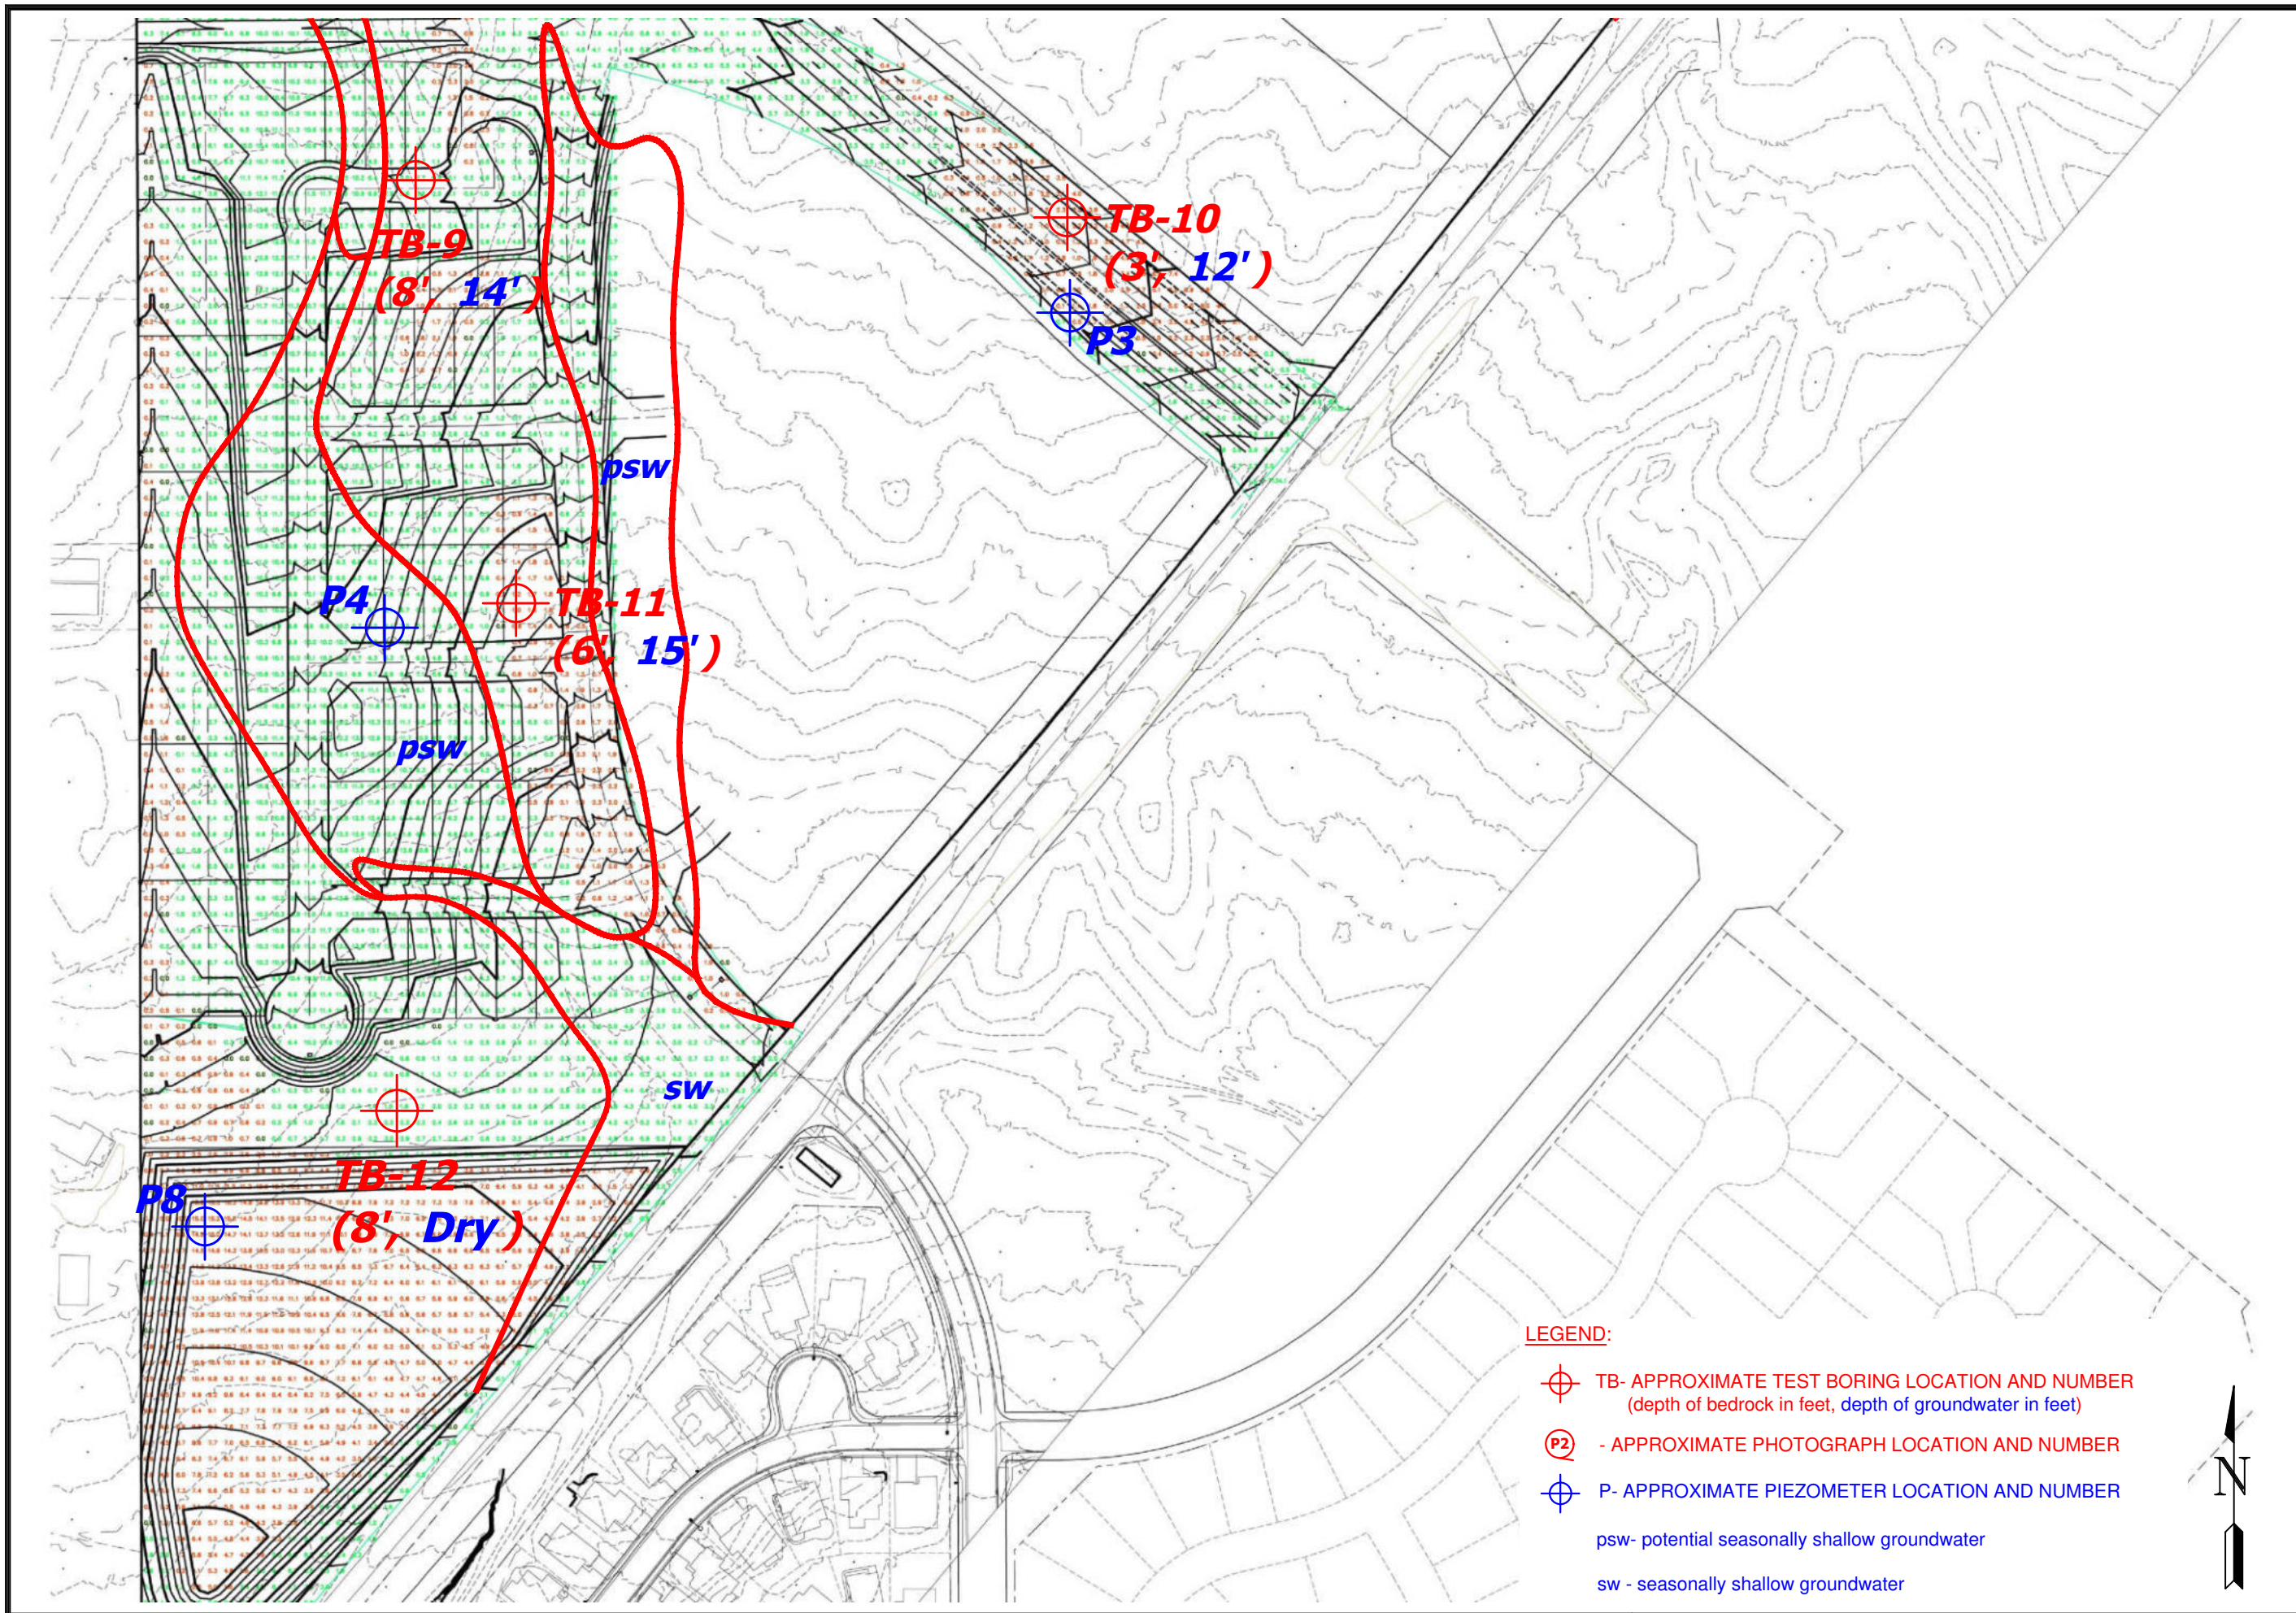
JOB NO.
212381
FIG. 5

**PROPOSED CUT/FILL SOUTHERN
RETREAT AT PRAIRIERIDGE**
 POCO ROAD & VOLLMER ROAD
 EL PASO COUNTY, CO
 ELITE PROPERTIES OF AMERICA, INC.

- LEGEND:**
- TB- APPROXIMATE TEST BORING LOCATION AND NUMBER
(depth of bedrock in feet, depth of groundwater in feet)
 - APPROXIMATE PHOTOGRAPH LOCATION AND NUMBER
 - P- APPROXIMATE PIEZOMETER LOCATION AND NUMBER
 - psw- potential seasonally shallow groundwater
 - sw - seasonally shallow groundwater

Total acreage involved in the proposed development is one hundred and forty-two acres. The development will consist of residential, neighborhood commercial, a detention pond, and parks/open spaces. The development will be serviced by central sewer and water. Preliminary development and grading plans show significant cuts in the central portion of the site. The proposed cut/fill maps are presented in Figures 4 and 5.

mapped as psw – potential seasonally shallow groundwater, or sw – seasonally shallow groundwater areas and are shown on the Proposed Cut/Fill Maps Figures 4 and 5, and the Geology/Engineering Geology Map, Figure 8.
