**ENTECH**  
ENGINEERING, INC.

**SOILS AND GEOLOGY STUDY  
RETREAT AT PRAIRIERIDGE  
FILINGS 1, 2, AND 3 – PRELIMINARY PLAN  
POCO ROAD AND VOLLMER ROAD  
EL PASO COUNTY, COLORADO**

November 21, 2023  
Revised February 29, 2024  
Revised April 2, 2024

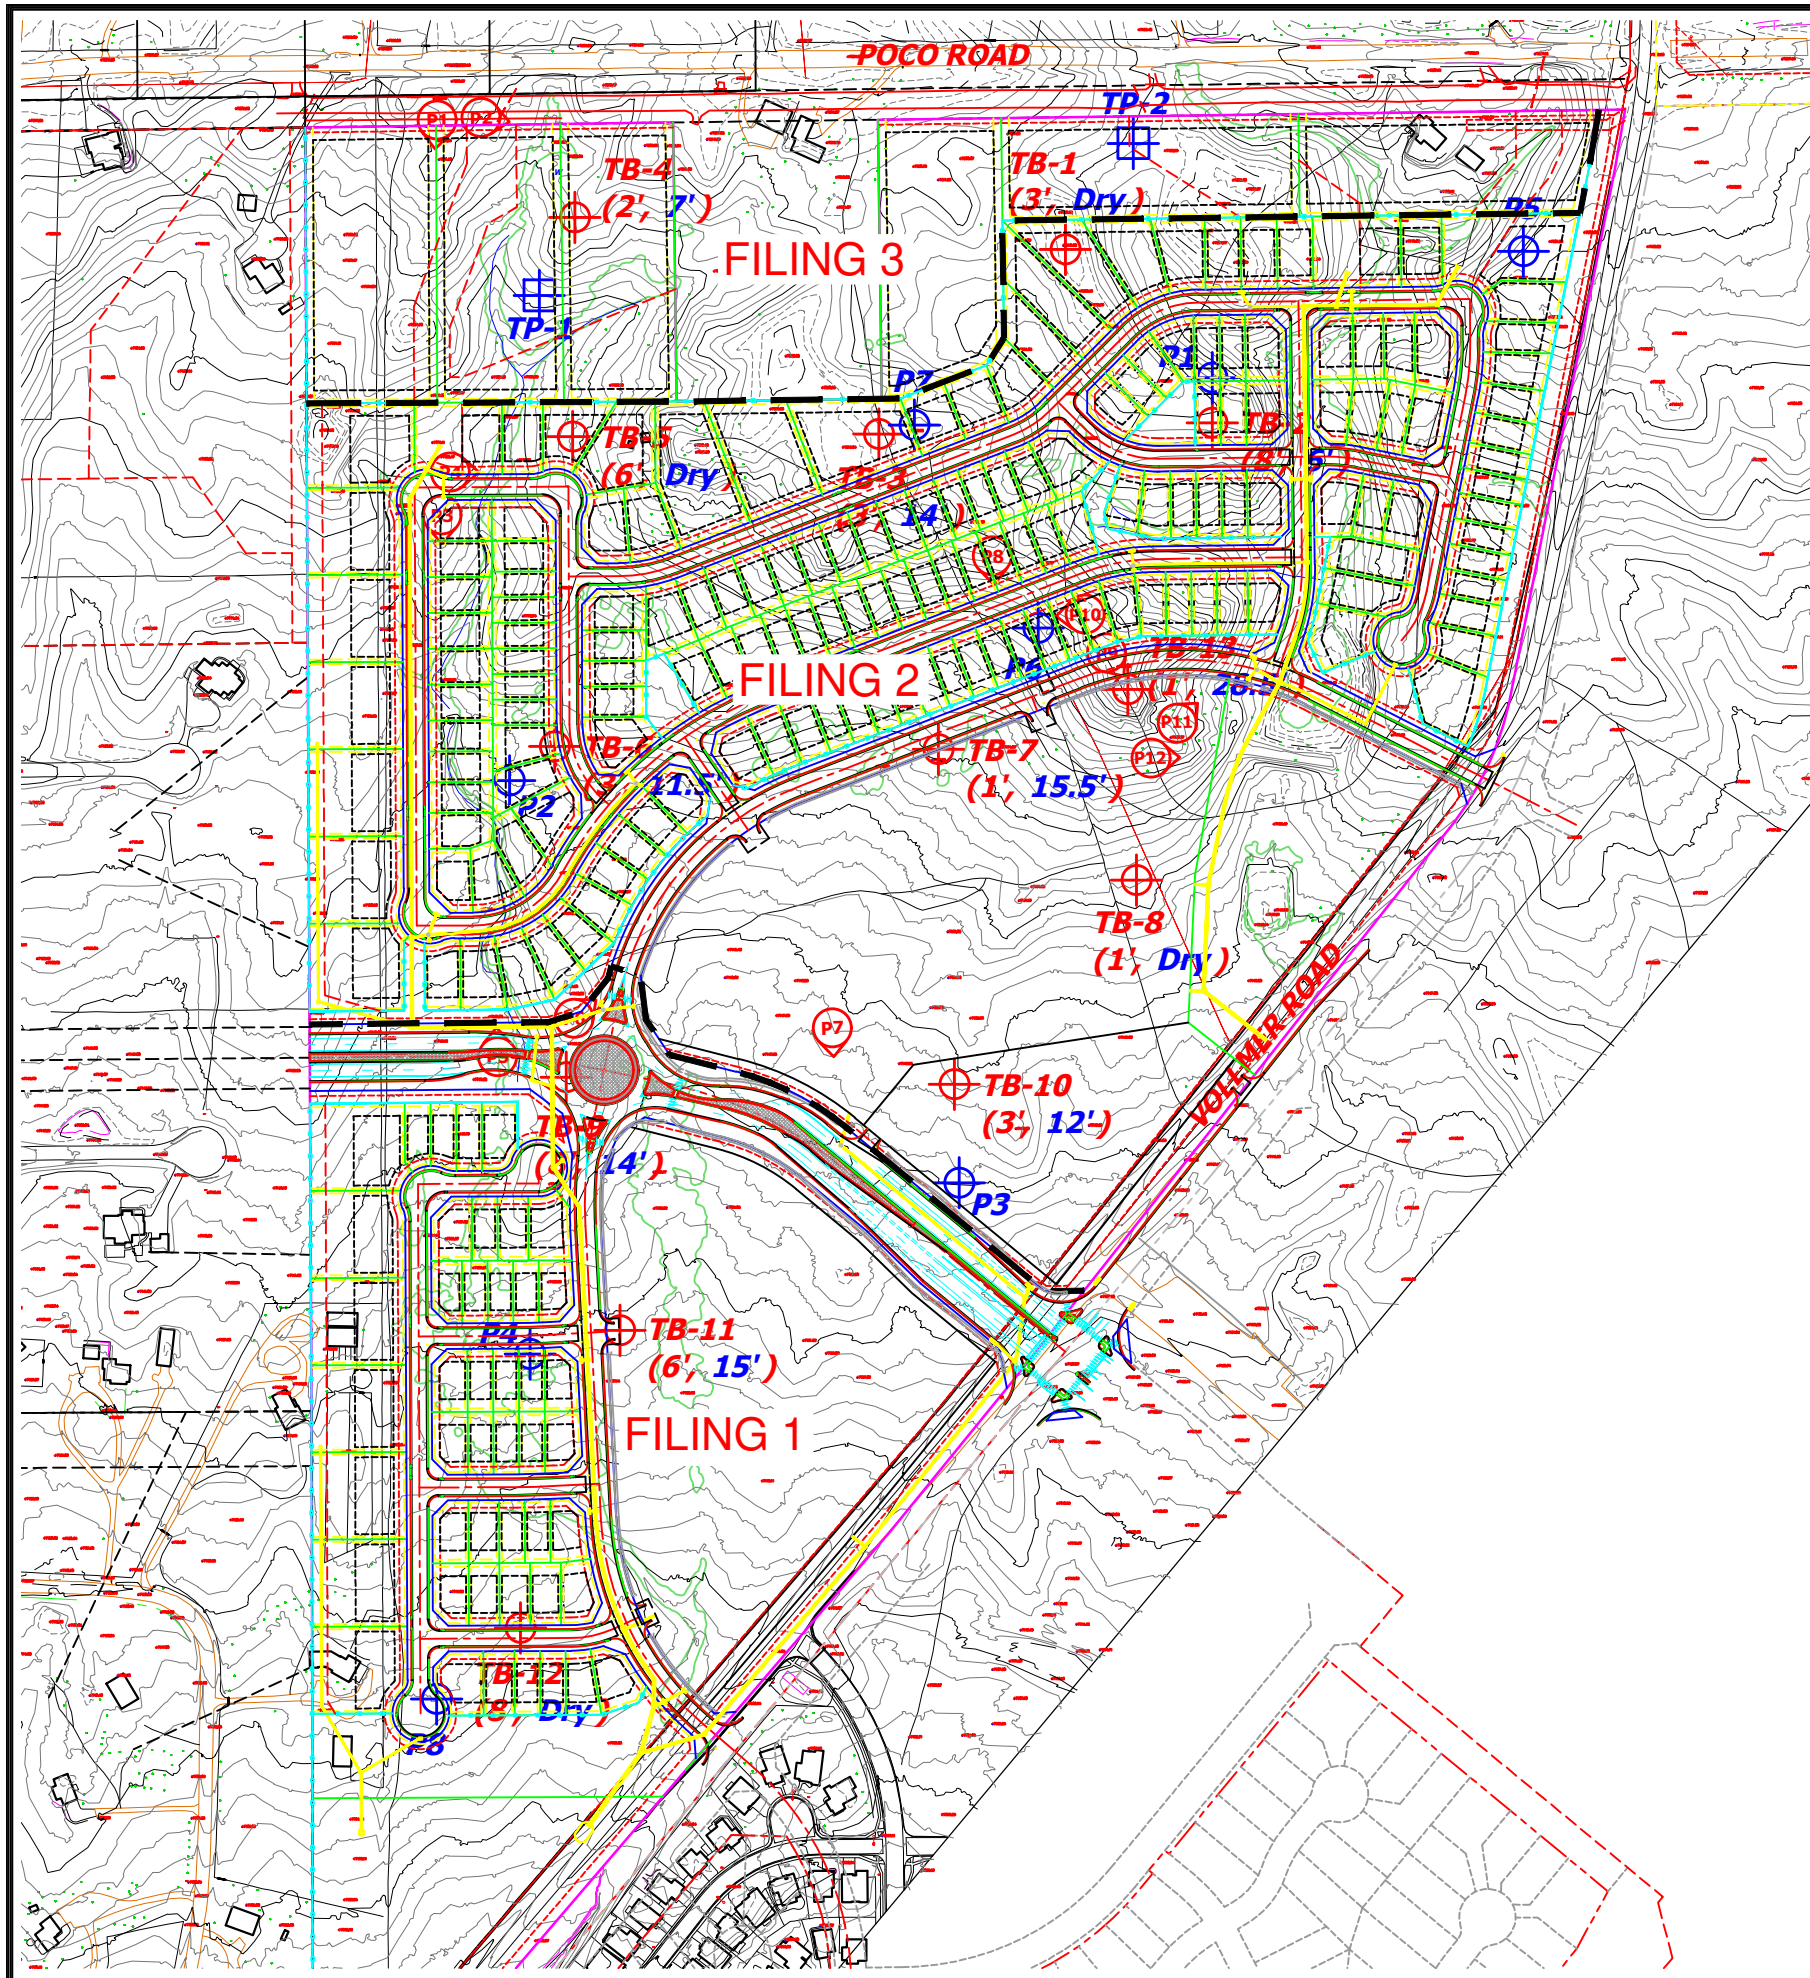
JOB NO.  
212381  
**FIG. 3**

- ⊕ TB- APPROXIMATE TEST BORING LOCATION AND NUMBER  
(depth of bedrock in feet, depth of groundwater in feet)
- Ⓟ - APPROXIMATE PHOTOGRAPH LOCATION AND NUMBER
- ⊕ P- APPROXIMATE PIEZOMETER LOCATION AND NUMBER

**DEVELOPMENT PLAN/ TEST BORING MAP**  
 RETREAT AT PRAIRIERIDGE  
 POCO ROAD & VOLLMER ROAD  
 EL PASO COUNTY, CO  
 ELITE PROPERTIES OF AMERICA, INC.

Generally, the topography of the site is gradually to moderately sloping to the south. The drainages on site flow in a southerly direction through the central portion of the site. Drainages area located in the eastern and western portions of the site, and a pond is located in the eastern portion of the site. The pond had standing water at the time of our site observations, and water was not observed in the drainages. The site boundaries are indicated on the USGS Map, Figure 2. Previous land uses have included rural residential, grazing and pasture land. The site contains primarily field grasses, weeds, cacti, and yuccas, with areas of scattered trees and ponderosa pine trees located across the north central portion of the site. Site photographs, taken October 19, 2021, are included in Appendix A and locations are shown on Figure 3.

Groundwater was encountered in Test Boring Nos. 2, 3, 4, 6, 7, 9, 10, 11, and 12 at depths ranging from 6 to 28 feet bgs subsequent to drilling. Depth to groundwater is shown in the Test Boring Location Map, Figure 3, and on each test boring log. Areas of water, seasonal shallow groundwater water, and potential seasonal shallow groundwater have been mapped along the drainages on-site. These areas are discussed in the following section. Fluctuation in groundwater conditions may occur due to variations in rainfall and other factors not readily apparent at this time.

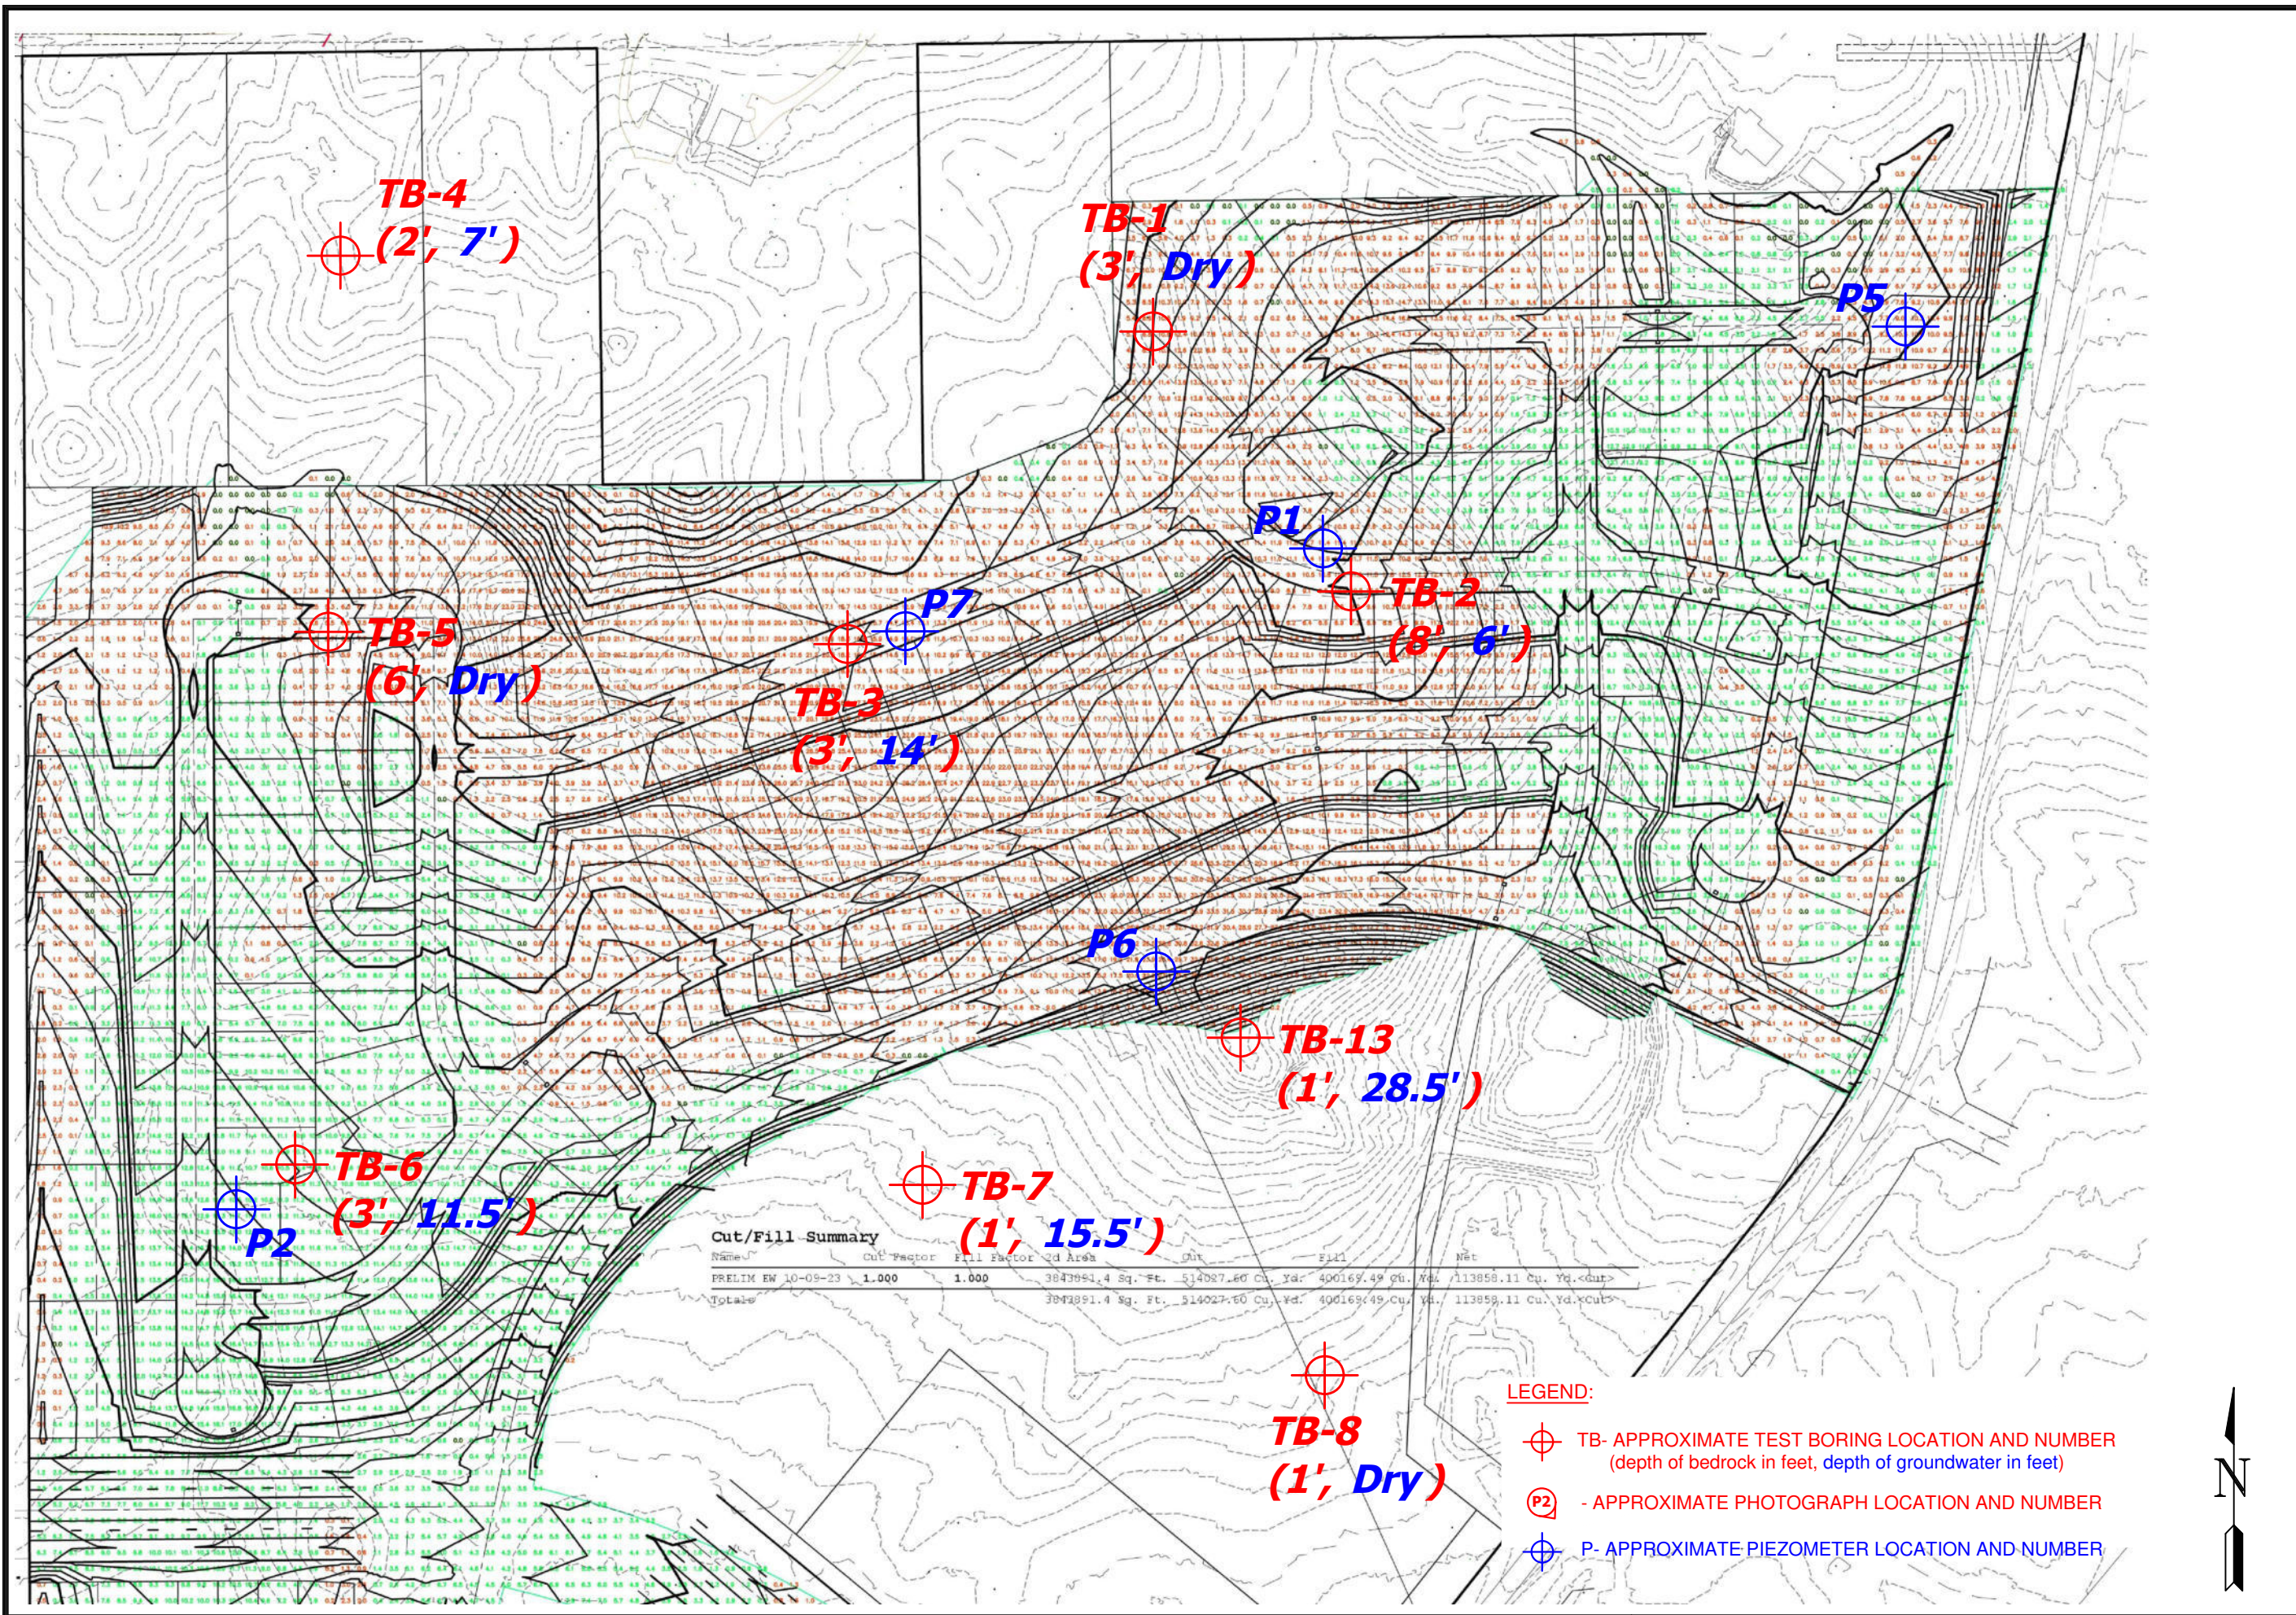
JOB NO.  
212381  
**FIG. 4**

**PROPOSED CUT/FILL NORTHERN  
RETREAT AT PRAIRIERIDGE**  
 POCO ROAD & VOLLMER ROAD  
 EL PASO COUNTY, CO  
 ELITE PROPERTIES OF AMERICA, INC.

Total acreage involved in the proposed development is one hundred and forty-two acres. The development will consist of residential, neighborhood commercial, a detention pond, and parks/open spaces. The development will be serviced by central sewer and water. Preliminary development and grading plans show significant cuts in the central portion of the site. The proposed cut/fill maps are presented in Figures 4 and 5.

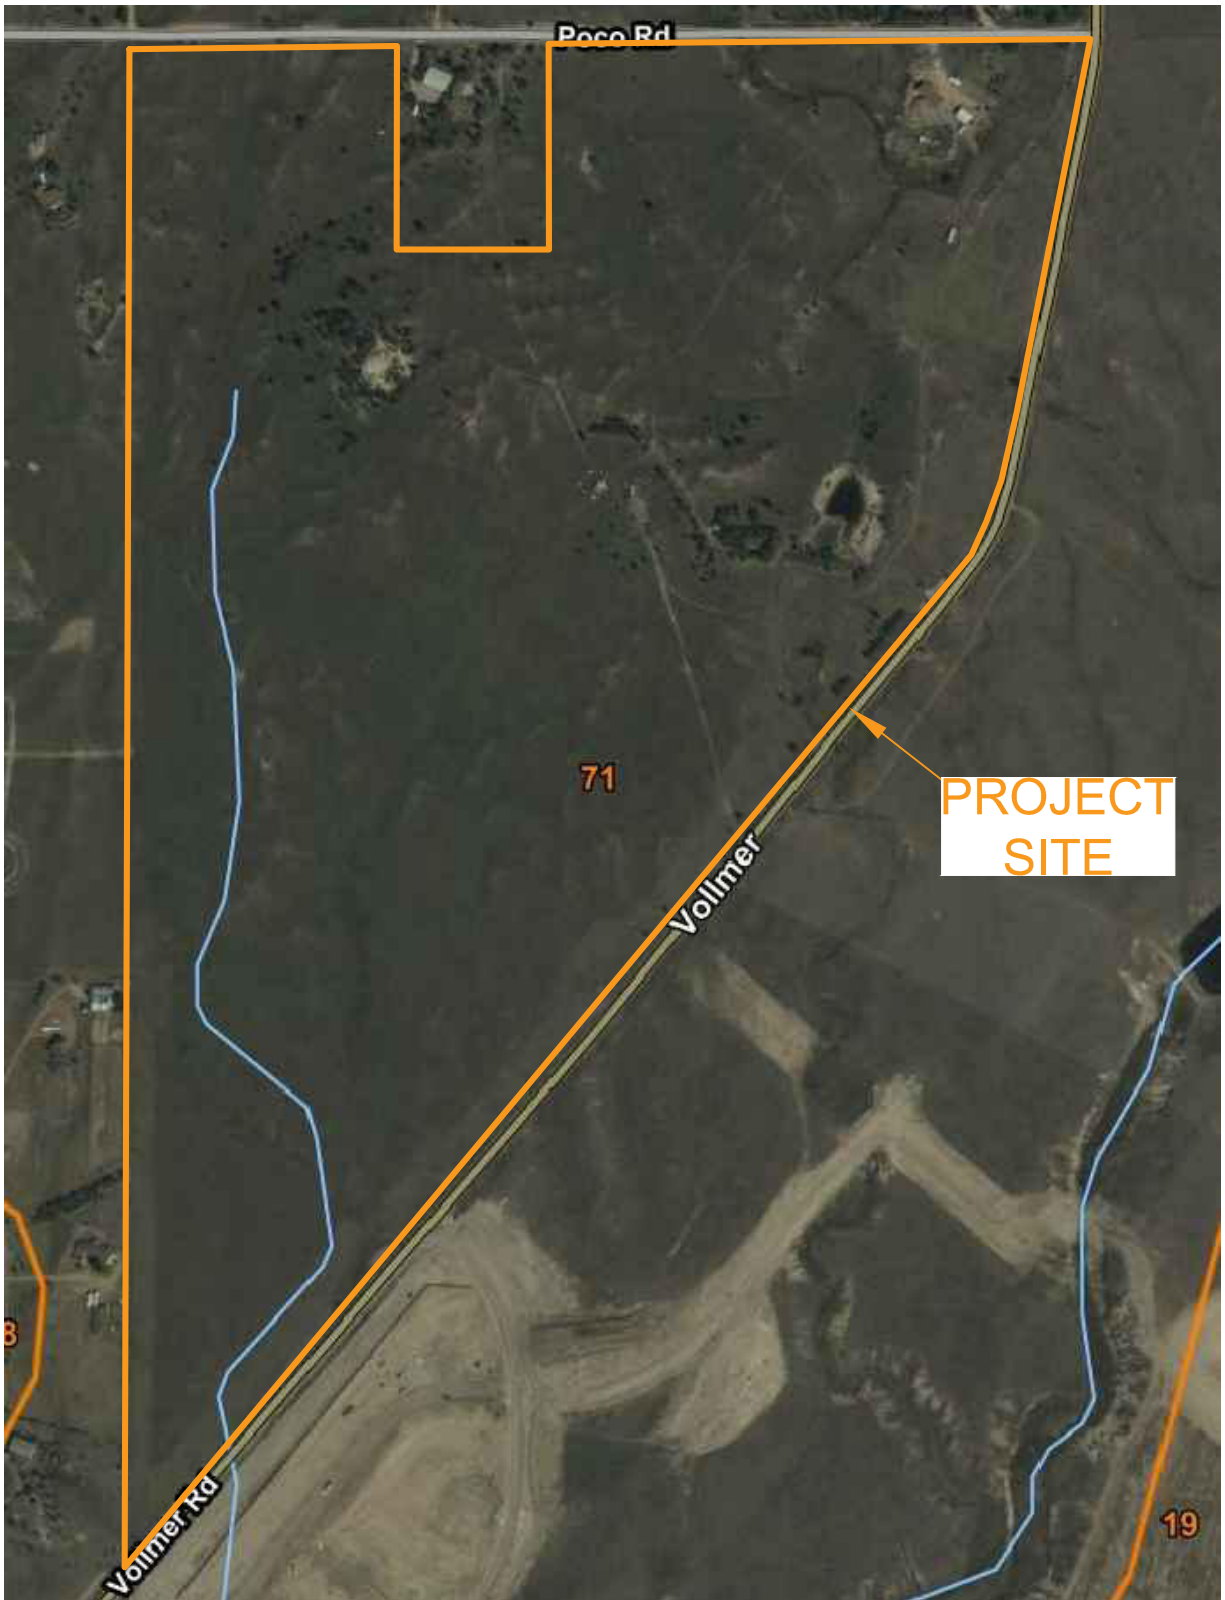
FIG. 6

**SOIL SURVEY MAP**  
RETREAT AT PRAIRIERIDGE  
POCO ROAD & VOLLMER ROAD  
EL PASO COUNTY, CO  
ELITE PROPERTIES OF AMERICA, INC.

The Natural Resource Conservation Service (Reference 2), previously the Soil Conservation Service (Reference 3) has mapped one soil type on the site (Figure 6). In general, the soils classify as coarse sandy loam. The soils are described as follows:

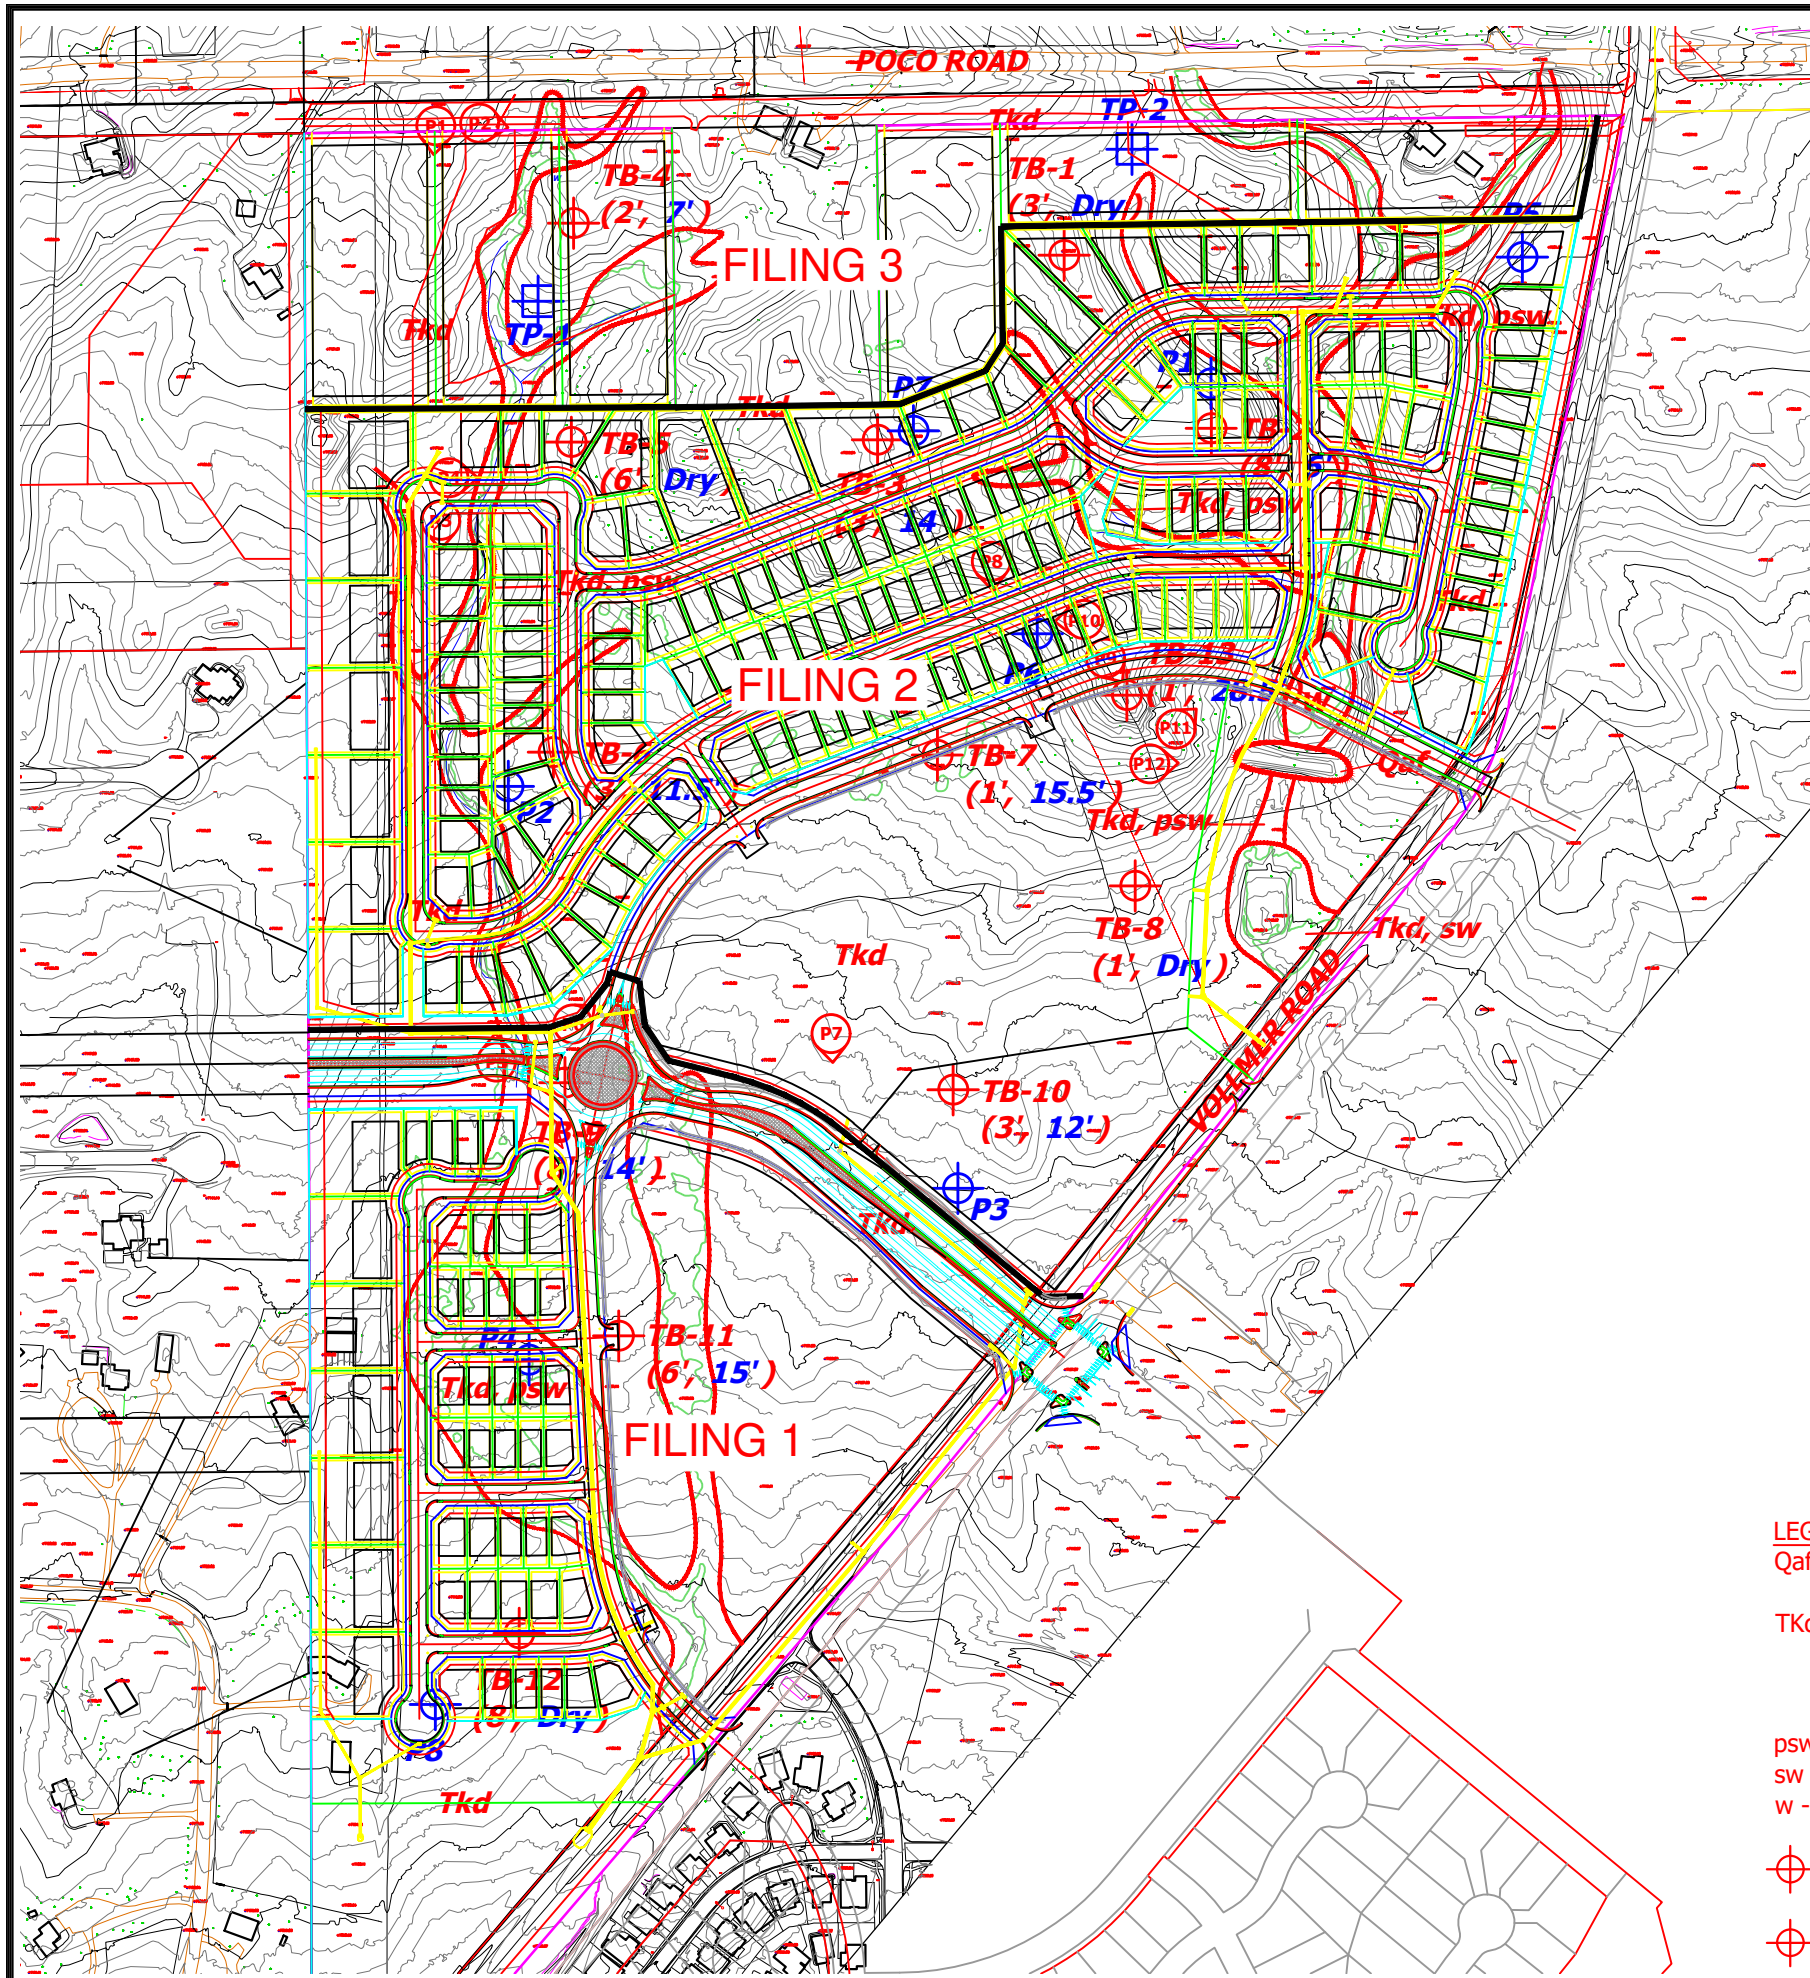
**FIG. 8**

- Qaf - Artificial Fill of Quaternary Age:  
man-made fill deposits
- Tkd - Dawson Formation of Tertiary to Cretaceous Age:  
variable layer of sheetwash and residual soil deposits overlying  
arkosic sandstone with siltstone and claystone lenses
- psw - potential seasonally shallow groundwater area
- sw - seasonally wet area
- w - areas of ponded/flowing water
- ⊕ - TB- APPROXIMATE TEST BORING LOCATION AND NUMBER  
(depth of bedrock in feet, depth of groundwater in feet)
- ⊕ - P- APPROXIMATE PIEZOMETER LOCATION AND NUMBER

**GEOLOGY/ENGINEERING MAP**  
 RETREAT AT PRAIRIERIDGE  
 POCO ROAD & VOLLMER ROAD  
 EL PASO COUNTY, CO  
 ELITE PROPERTIES OF AMERICA, INC.

Detailed mapping has been performed on this site to produce an Engineering Geology Map Figure 7. This map shows the location of various geologic conditions of which the developers should be cognizant during the planning, design and construction stages of the project. These hazards and the recommended mitigation techniques are as follows:

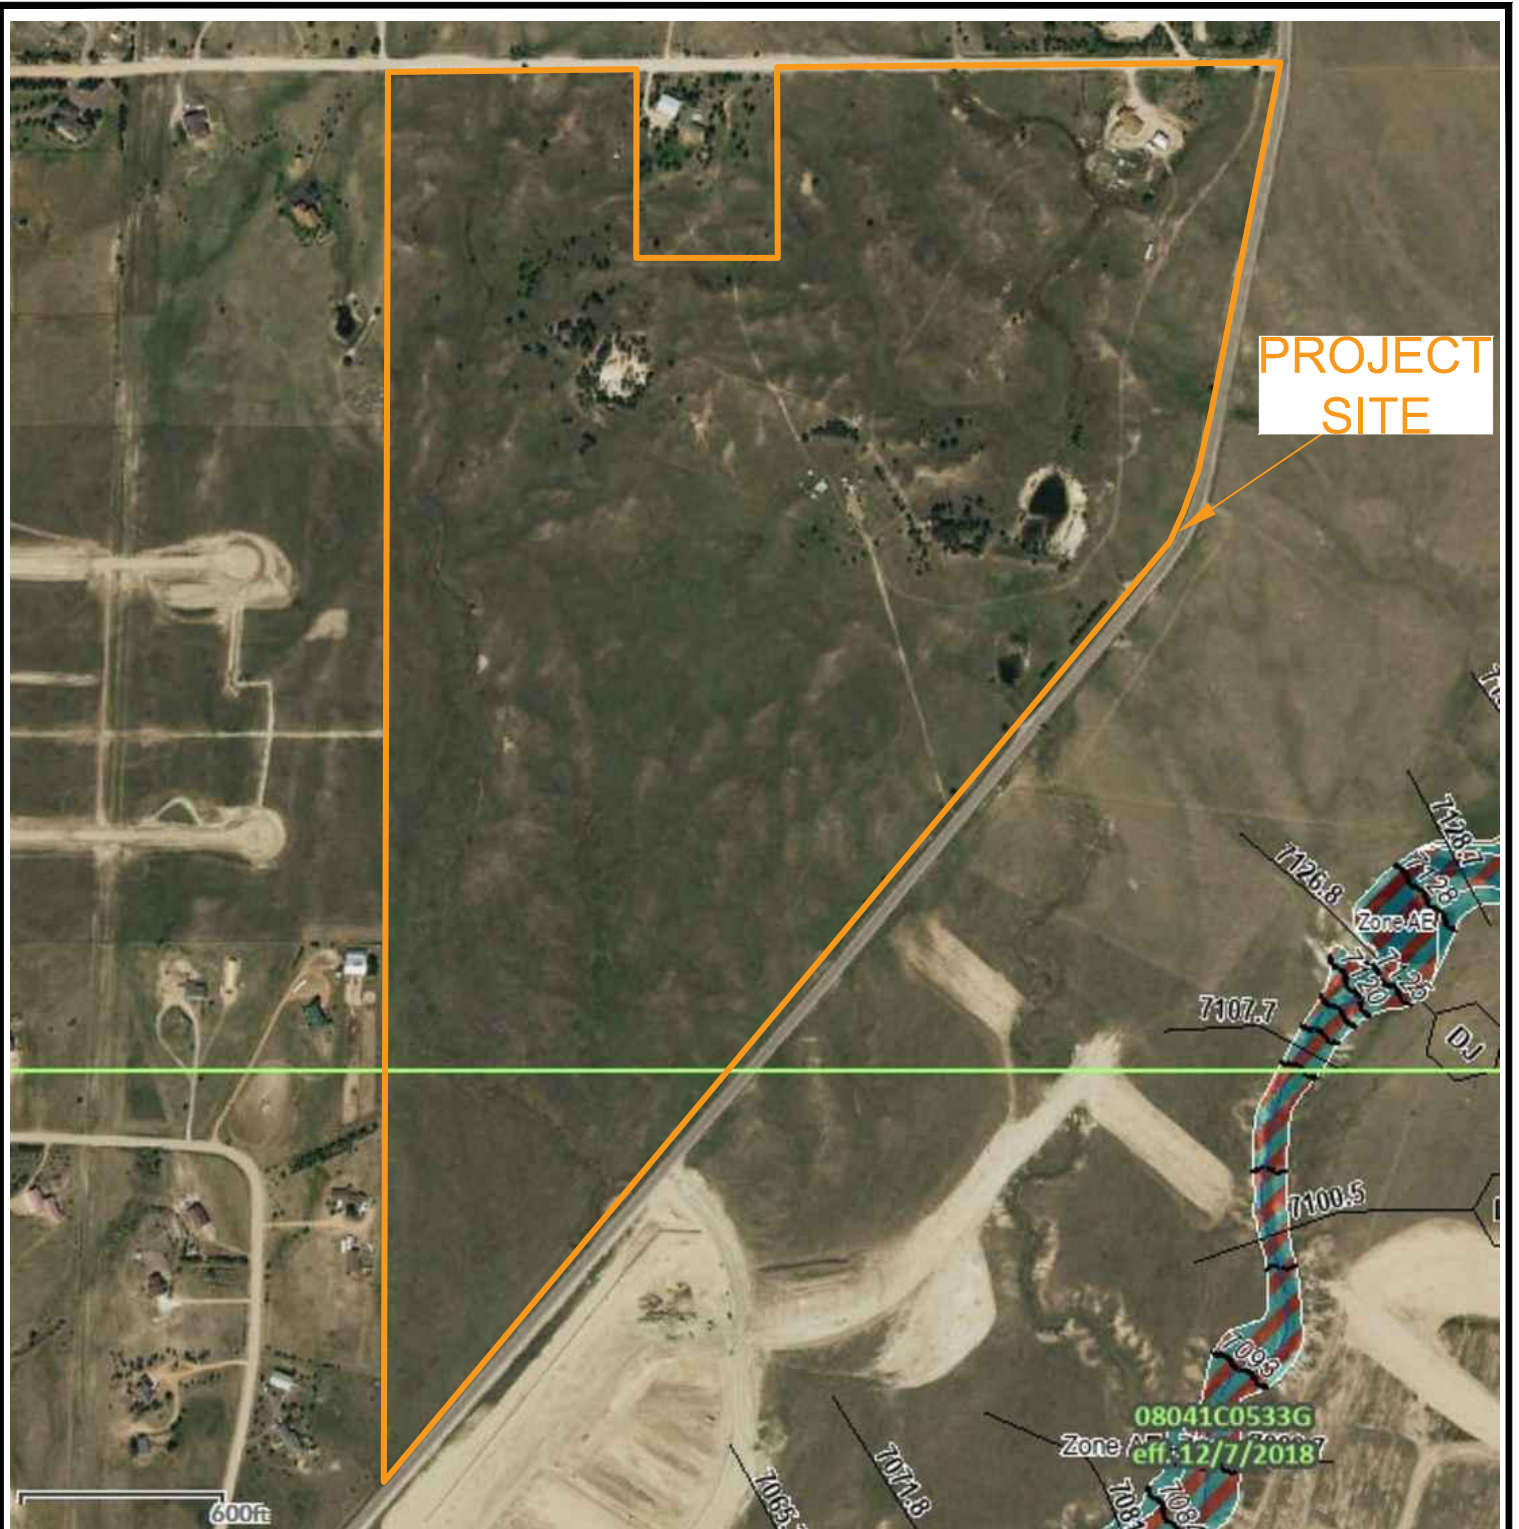
FIG. 9

**FEMA FLOODPLAIN MAP**  
 RETREAT AT PRAIRIERIDGE  
 POCO ROAD & VOLLMER ROAD  
 EL PASO COUNTY, CO  
 ELITE PROPERTIES OF AMERICA, INC.

Two drainages exist in the eastern and western portions of the site that have been identified as areas of seasonally wet and/or seasonally high groundwater areas. Water was observed in the pond located in the eastern portion of the site, and portions of the drainage in the southwestern side of the site. The site is not mapped within floodplain zones according to the FEMA Map Nos. 08041CO533G and 08041CO535G, (Figure 9, Reference 8). These areas are discussed as follows:

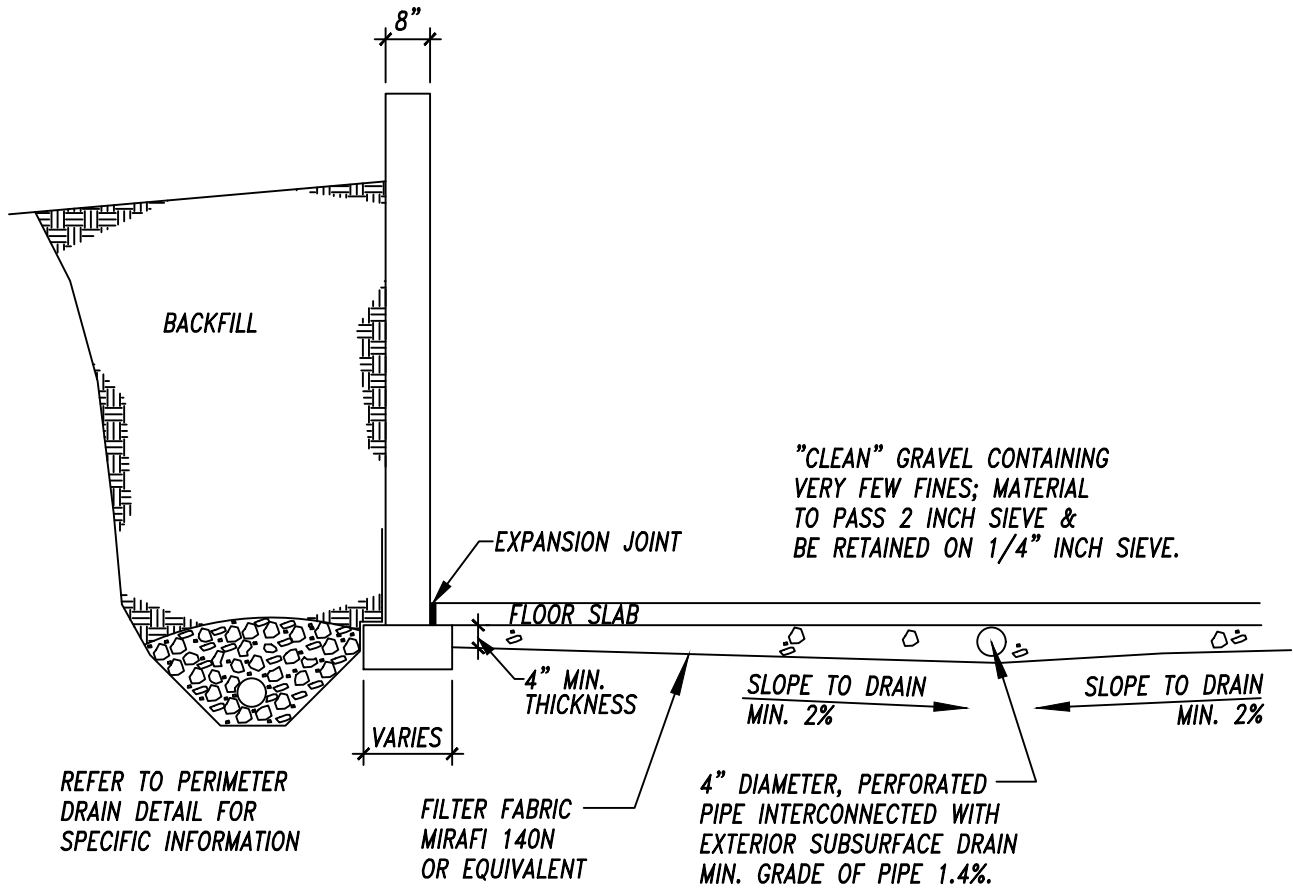
FIG. 11

**TYP. UNDERSLAB DRAINAGE LAYER  
(CAPILLARY BREAK)**  
 RETREAT AT PRAIRIERIDGE  
 POCO ROAD & VOLLMER ROAD  
 EL PASO COUNTY, CO  
 ELITE PROPERTIES OF AMERICA, INC.

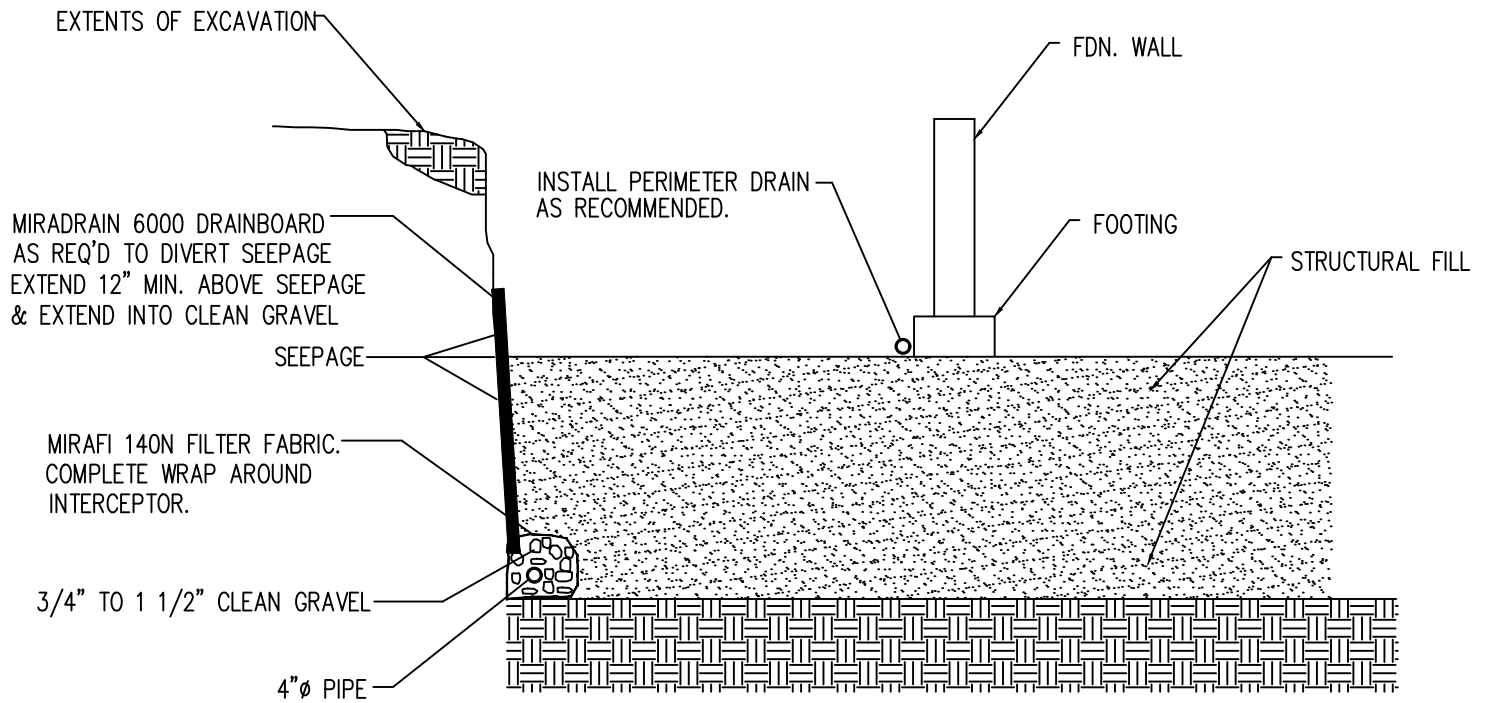
**FIG. 12**

NOTE:  
 EXTEND INTERCEPTOR DRAIN TO UNDERDRAIN OR TO SUMP.  
 BENCH DRAIN INTO NATIVE SOILS 12 INCHES MINIMUM.

## INTERCEPTOR DRAIN DETAIL

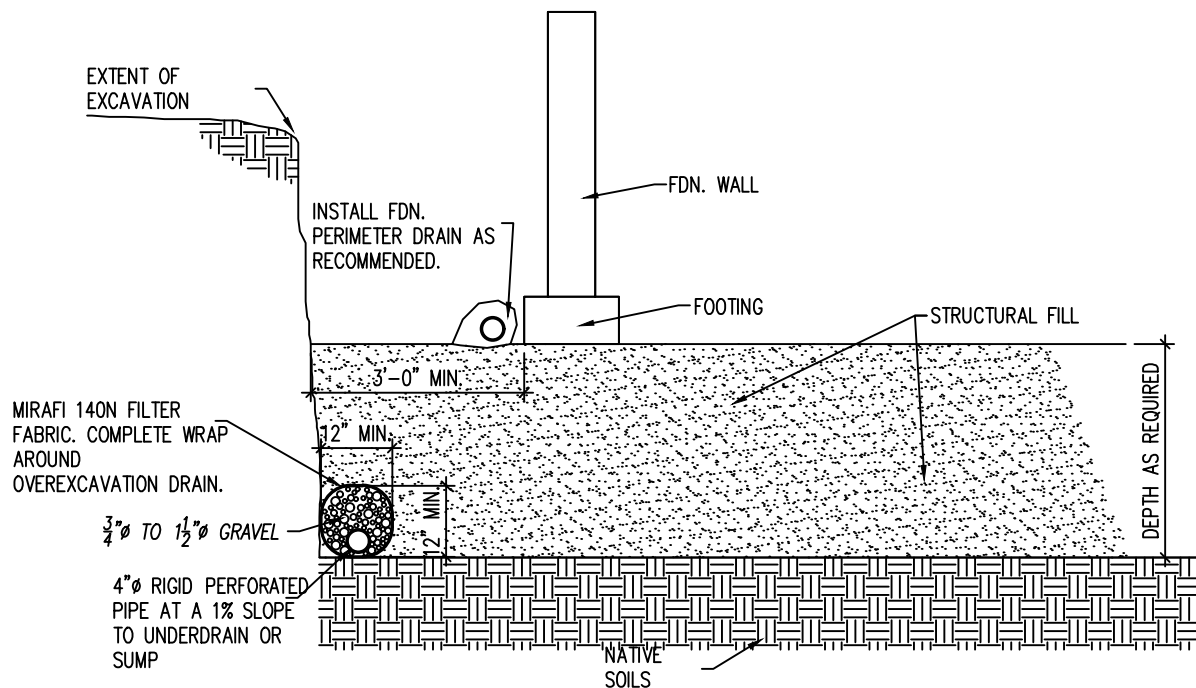
**FIG. 13**

## OVEREXCAVATION DRAIN DETAIL

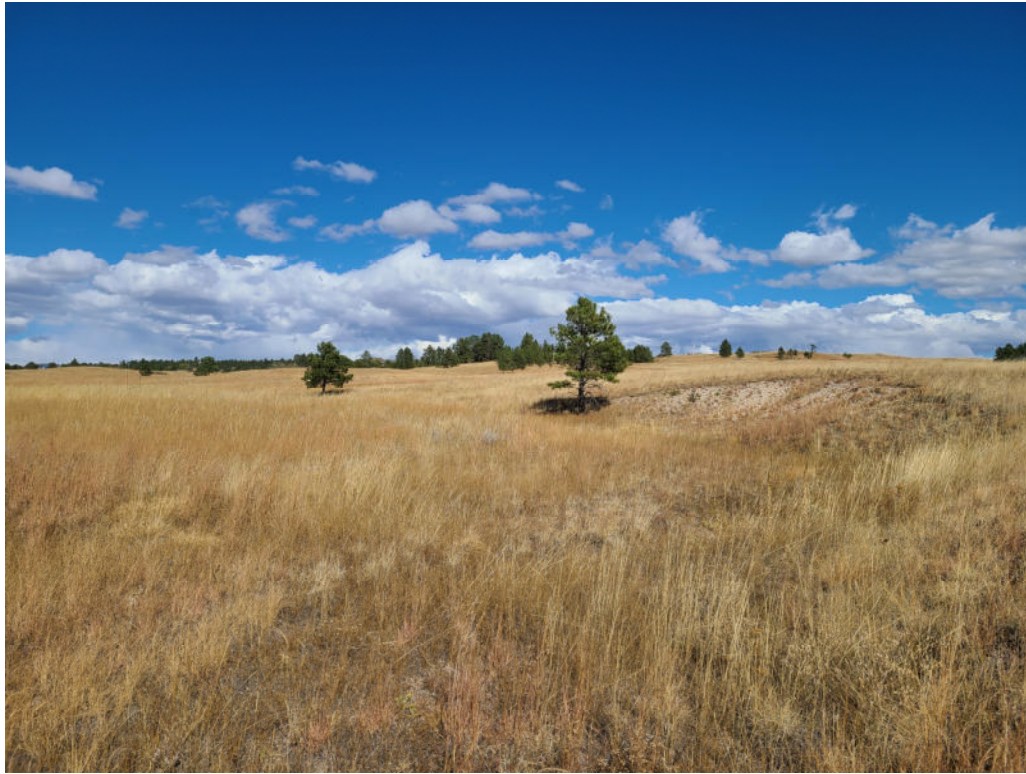
**Looking north along  
drainage in the  
southwestern portion  
of the site.**

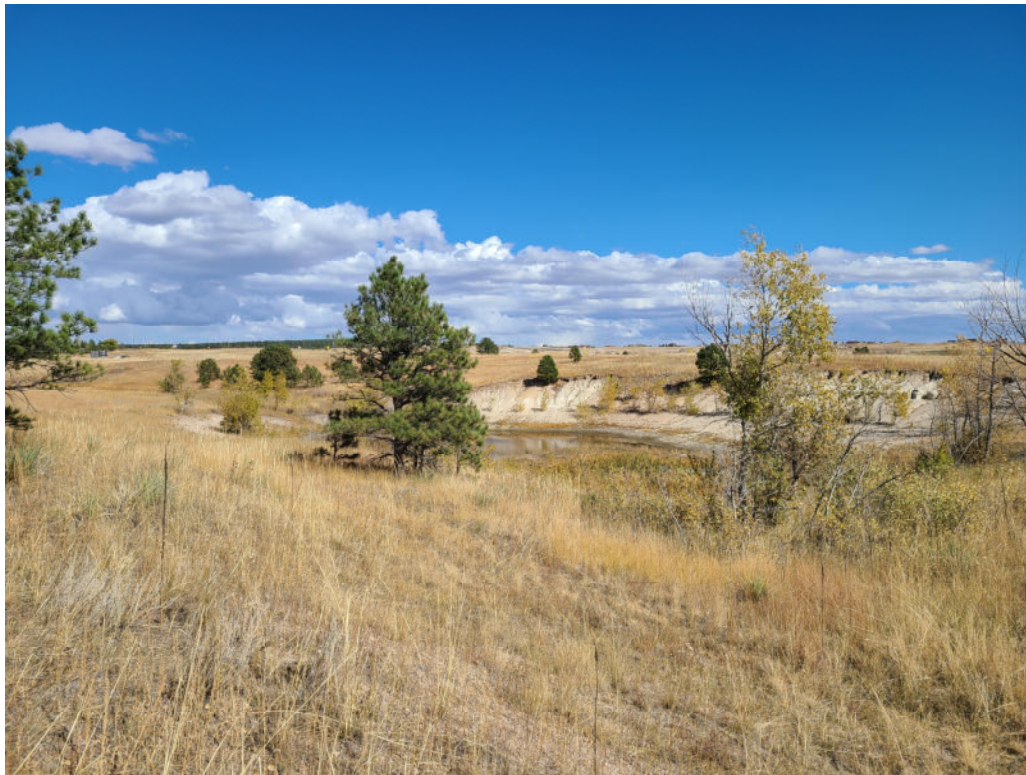
**Looking northeast  
towards pond in the  
northeastern portion of  
the site.**

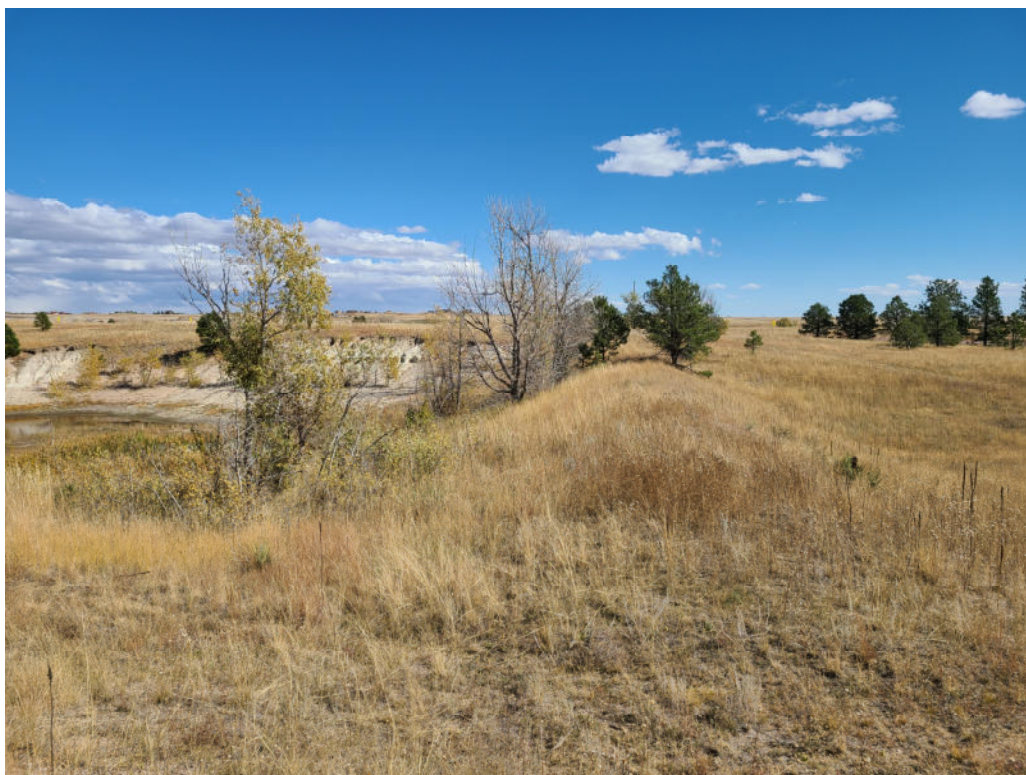
**Looking east along  
earthen dam in the  
eastern portion of the  
site.**

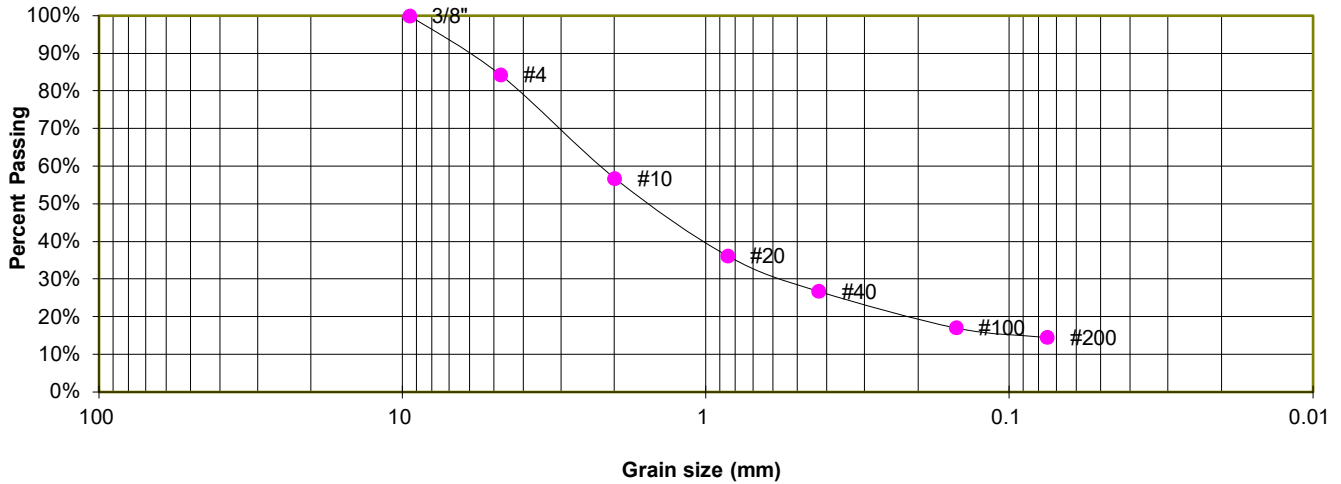
SOIL DESCRIPTION SAND, SILTY  
 SOIL TYPE 1

**Sieve Analysis  
 Grain Size Distribution**

**GRAIN SIZE ANALYSIS**

U.S. Sieve #	Percent Finer
3"	
1 1/2"	
3/4"	
1/2"	
3/8"	100.0%
4	84.3%
10	56.8%
20	36.2%
40	26.8%
100	17.1%
200	14.6%
