**ENTECH**  
ENGINEERING, INC.

**SOILS AND GEOLOGY STUDY  
RETREAT AT PRAIRIERIDGE  
FILINGS 1, 2, AND 3 – PRELIMINARY PLAN  
POCO ROAD AND VOLLMER ROAD  
EL PASO COUNTY, COLORADO**

November 21, 2023  
Revised February 29, 2024  
Revised April 2, 2024

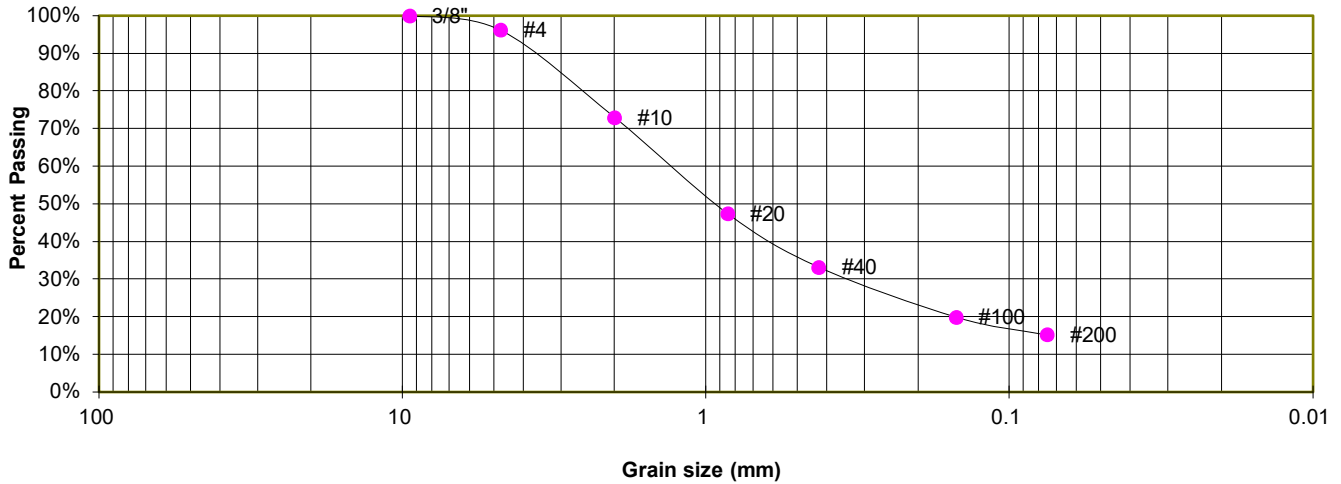
SOIL DESCRIPTION SAND, SILTY  
SOIL TYPE 1

### Sieve Analysis Grain Size Distribution

#### GRAIN SIZE ANALYSIS

U.S. Sieve #	Percent Finer
3"	
1 1/2"	
3/4"	
1/2"	
3/8"	100.0%
4	96.2%
10	72.9%
20	47.5%
40	33.2%
100	19.9%
200	15.2%

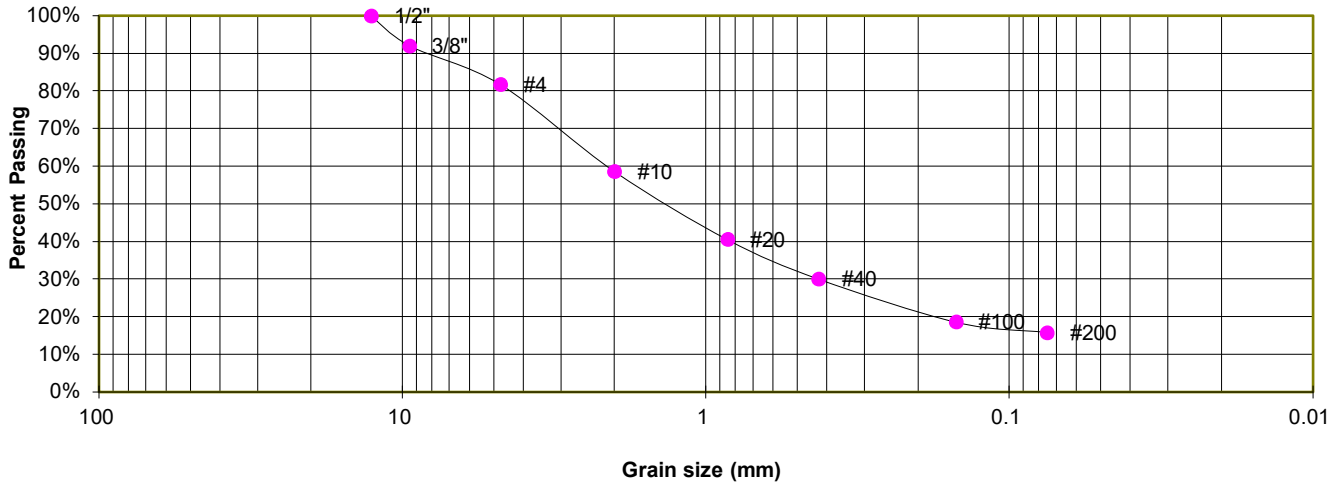
SOIL DESCRIPTION SAND, SILTY  
 SOIL TYPE 1

**Sieve Analysis  
 Grain Size Distribution**

**GRAIN SIZE ANALYSIS**

U.S. Sieve #	Percent Finer
3"	
1 1/2"	
3/4"	
1/2"	100.0%
3/8"	92.0%
4	81.7%
10	58.6%
20	40.6%
40	30.0%
100	18.6%
200	15.8%

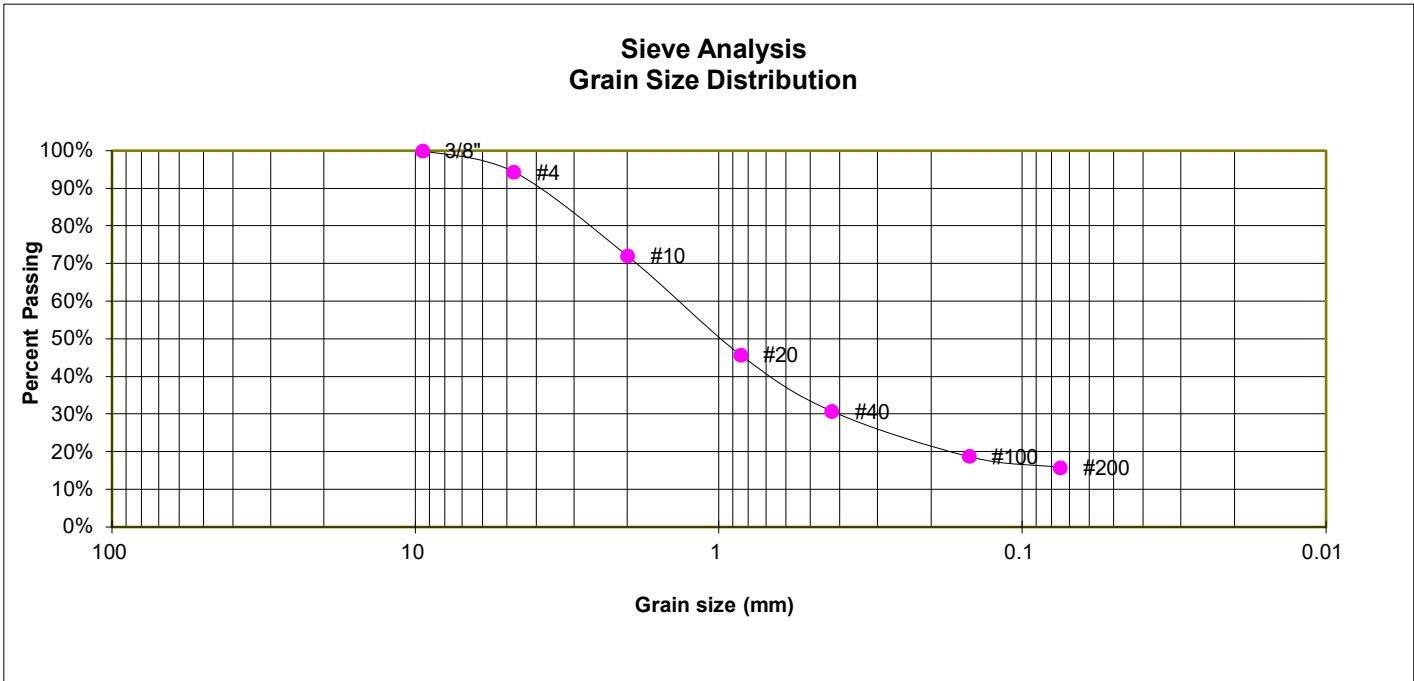
TEST BORING 9  
DEPTH (FT) 5

SOIL DESCRIPTION SAND, SILTY  
SOIL TYPE 1

**GRAIN SIZE ANALYSIS**

U.S. Sieve #	Percent Finer
3"	
1 1/2"	
3/4"	
1/2"	
3/8"	100.0%
4	94.4%
10	72.0%
20	45.8%
40	30.8%
100	18.8%
200	15.8%

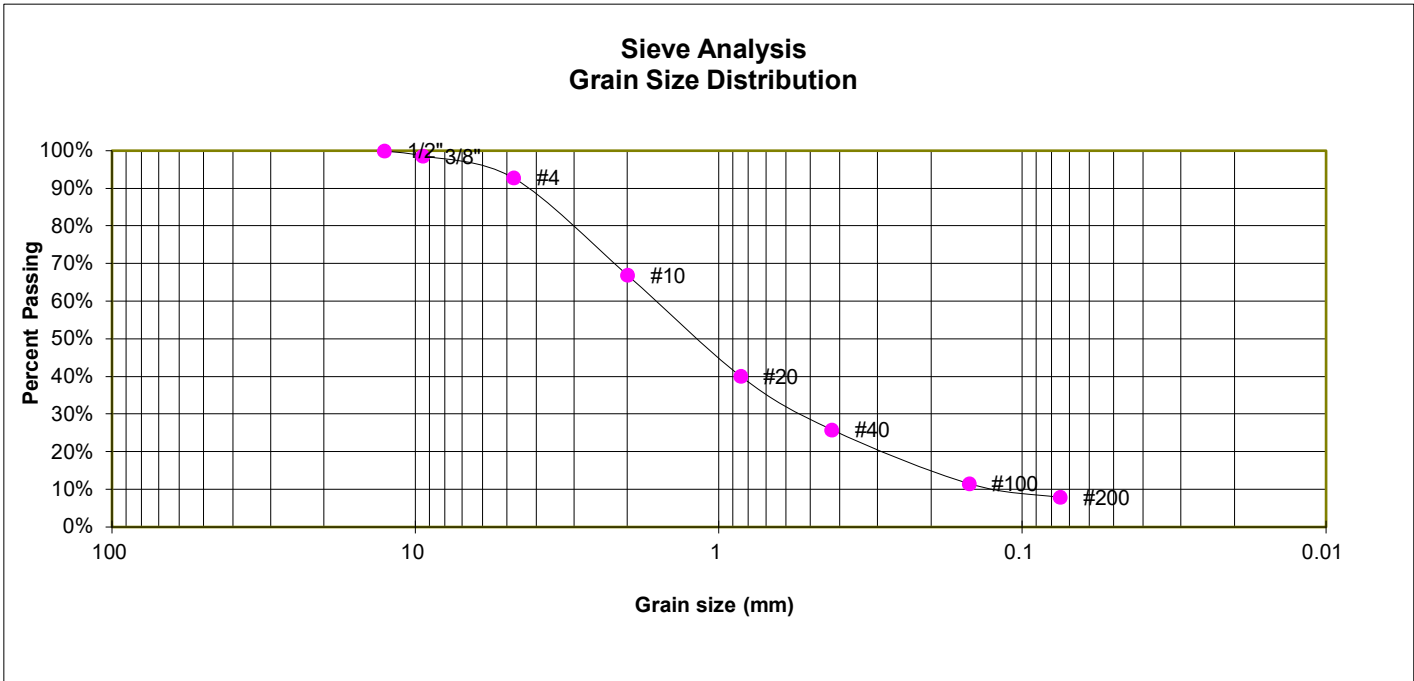
TEST BORING 11  
 DEPTH (FT) 2-3

SOIL DESCRIPTION SAND, WITH SILT  
 SOIL TYPE 1

**GRAIN SIZE ANALYSIS**

U.S. Sieve #	Percent Finer
3"	
1 1/2"	
3/4"	
1/2"	100.0%
3/8"	98.6%
4	92.8%
10	67.0%
20	40.1%
40	25.9%
100	11.6%
200	7.9%

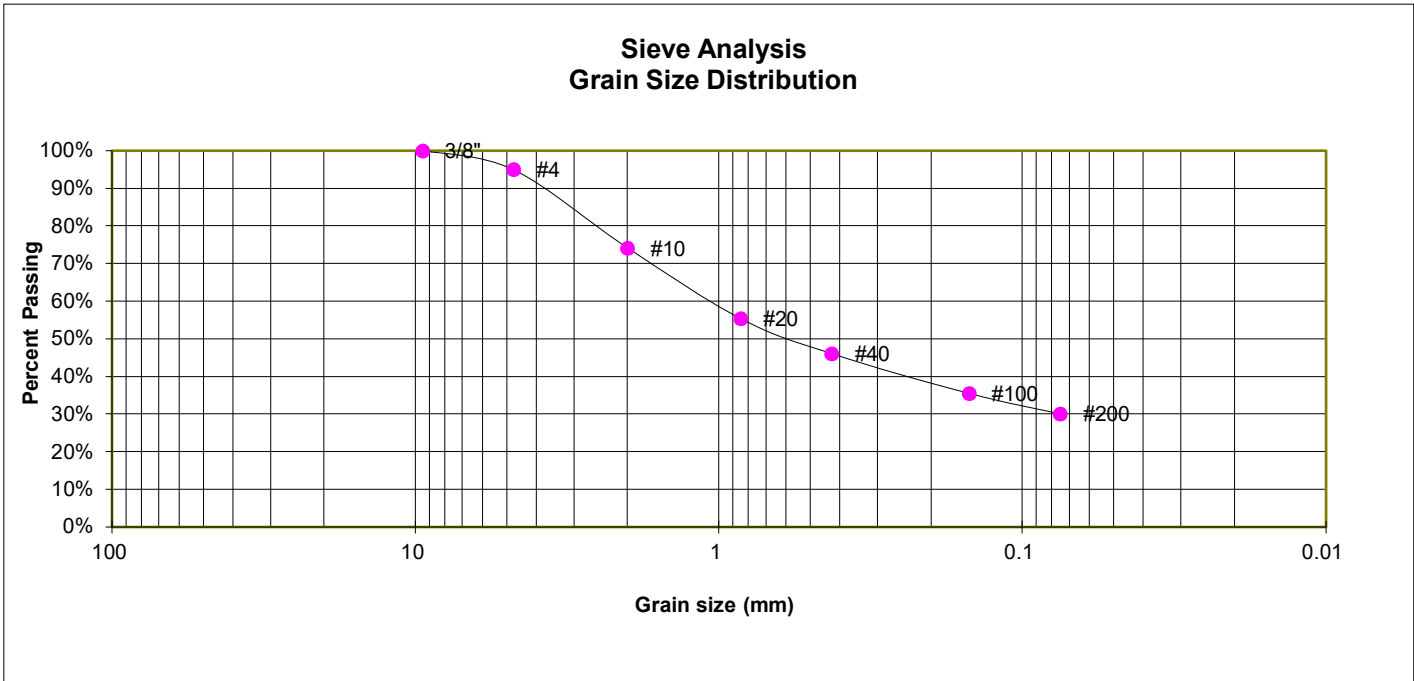
TEST BORING 12  
 DEPTH (FT) 5

SOIL DESCRIPTION SAND, CLAYEY  
 SOIL TYPE 1

**GRAIN SIZE ANALYSIS**

U.S. Sieve #	Percent Finer
3"	
1 1/2"	
3/4"	
1/2"	
3/8"	100.0%
4	95.0%
10	74.1%
20	55.4%
40	46.1%
100	35.6%
200	30.1%

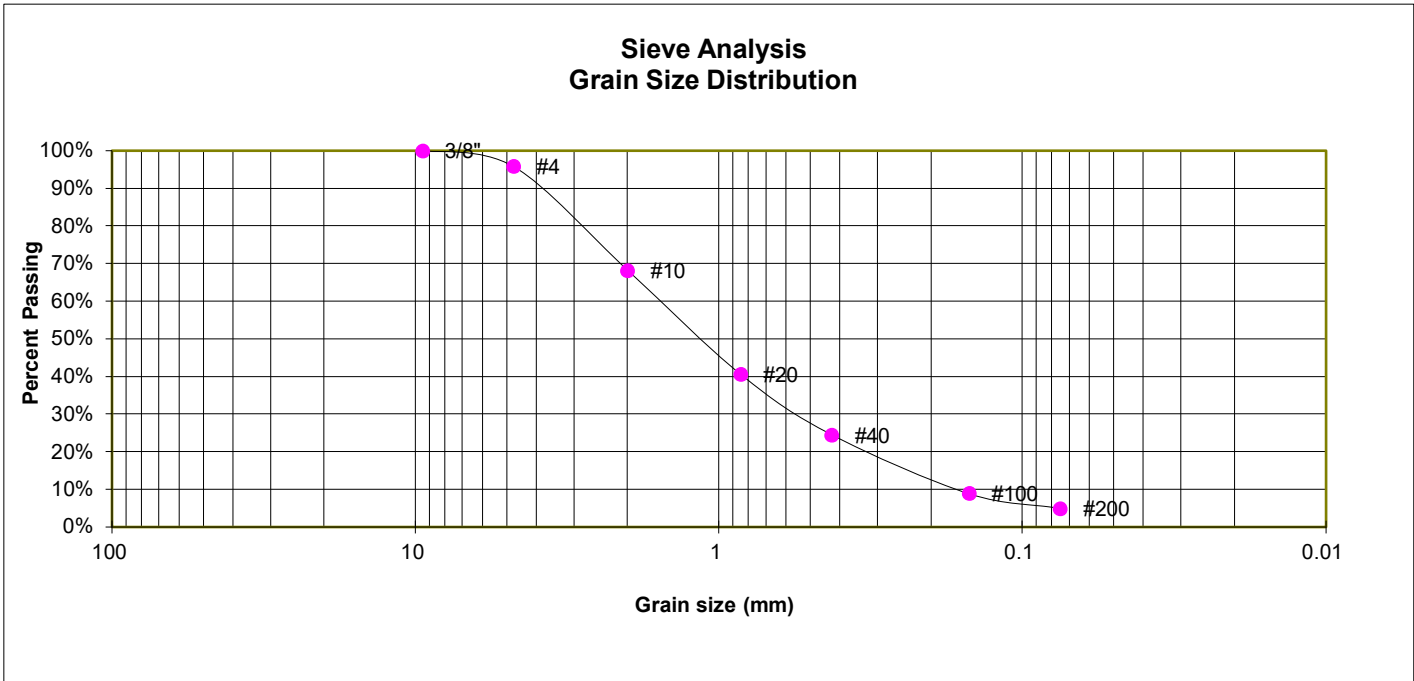
TEST BORING P-1  
 DEPTH (FT) 2-3

SOIL DESCRIPTION SAND, WITH SILT  
 SOIL TYPE 1

**GRAIN SIZE ANALYSIS**

U.S. Sieve #	Percent Finer
3"	
1 1/2"	
3/4"	
1/2"	
3/8"	100.0%
4	95.8%
10	68.2%
20	40.6%
40	24.5%
100	8.9%
200	5.0%

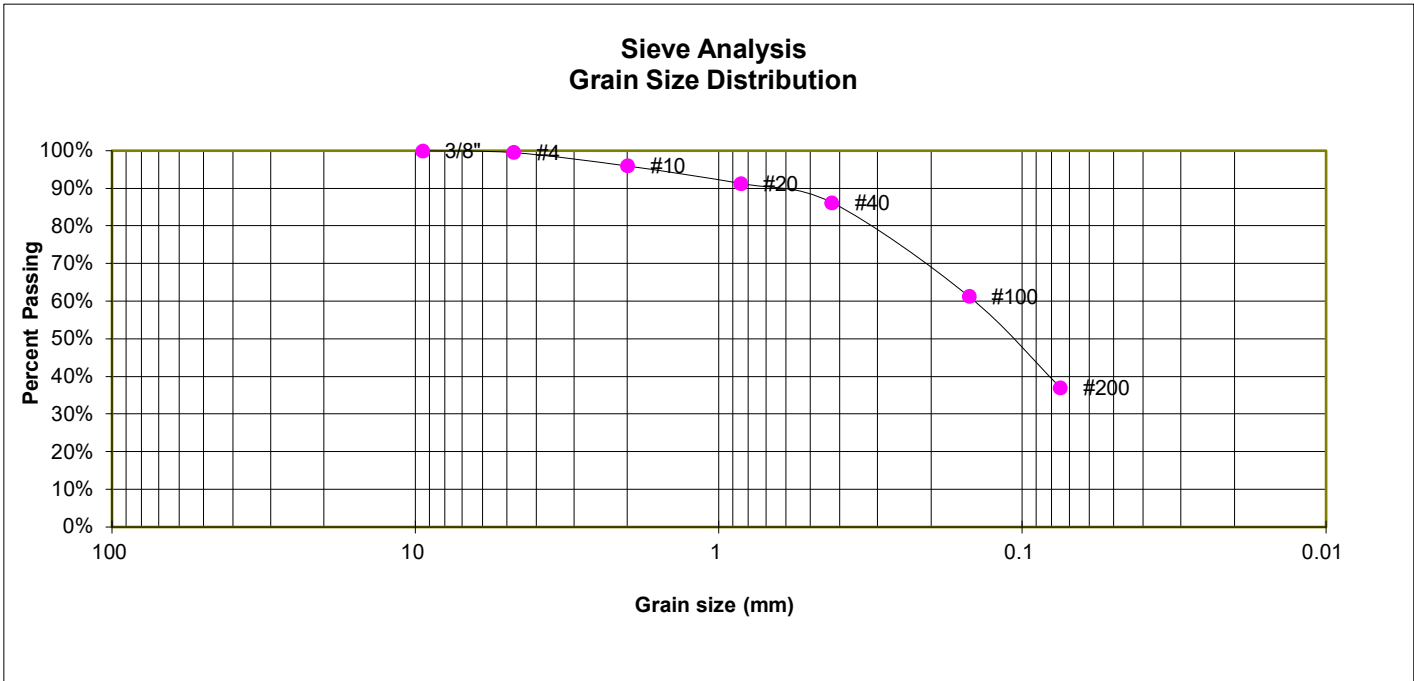
TEST BORING P-3  
 DEPTH (FT) 1-2

SOIL DESCRIPTION SAND, CLAYEY  
 SOIL TYPE 1

**GRAIN SIZE ANALYSIS**

U.S. Sieve #	Percent Finer
3"	
1 1/2"	
3/4"	
1/2"	
3/8"	100.0%
4	99.6%
10	96.0%
20	91.3%
40	86.2%
100	61.4%
200	37.1%

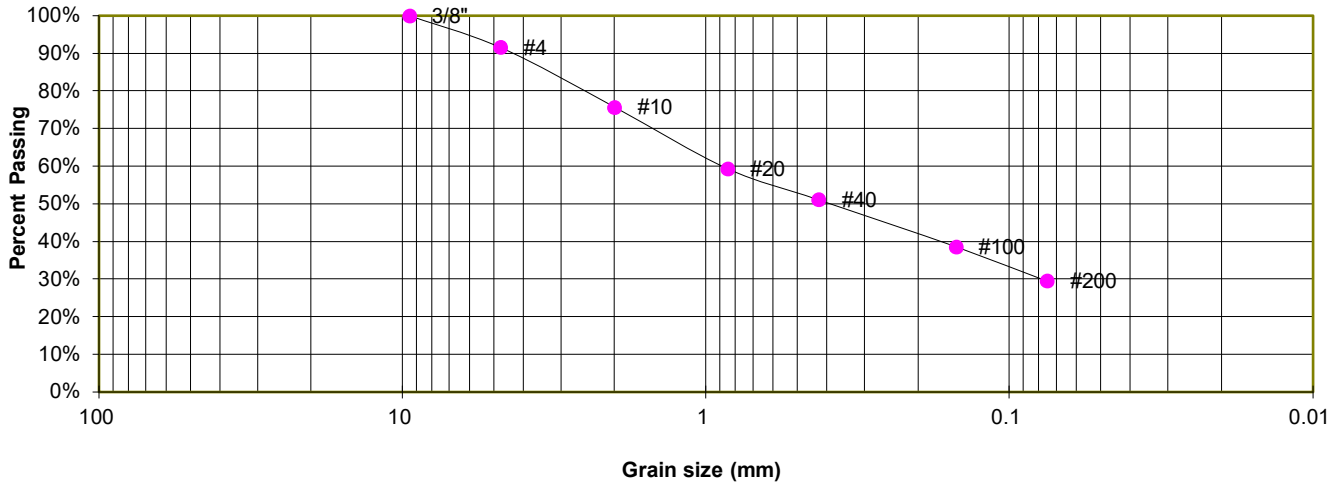
SOIL DESCRIPTION SAND, CLAYEY  
SOIL TYPE 1

### Sieve Analysis Grain Size Distribution

#### GRAIN SIZE ANALYSIS

U.S. Sieve #	Percent Finer
3"	
1 1/2"	
3/4"	
1/2"	
3/8"	100.0%
4	91.6%
10	75.7%
20	59.3%
40	51.2%
100	38.6%
200	29.6%

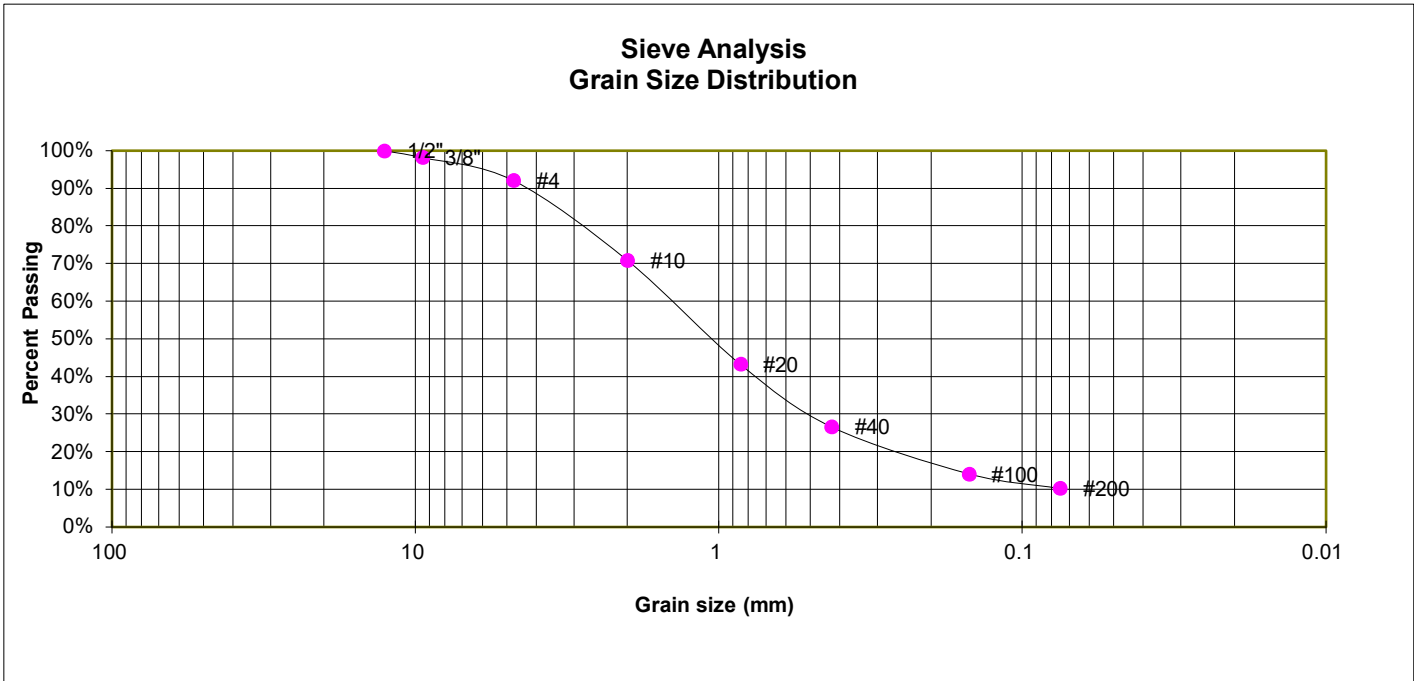
TEST BORING P-5  
 DEPTH (FT) 2-3

SOIL DESCRIPTION SANDSTONE (SAND, WITH SILT)  
 SOIL TYPE 2

**GRAIN SIZE ANALYSIS**

U.S. Sieve #	Percent Finer
3"	
1 1/2"	
3/4"	
1/2"	100.0%
3/8"	98.2%
4	92.1%
10	70.8%
20	43.3%
40	26.6%
100	14.1%
200	10.3%

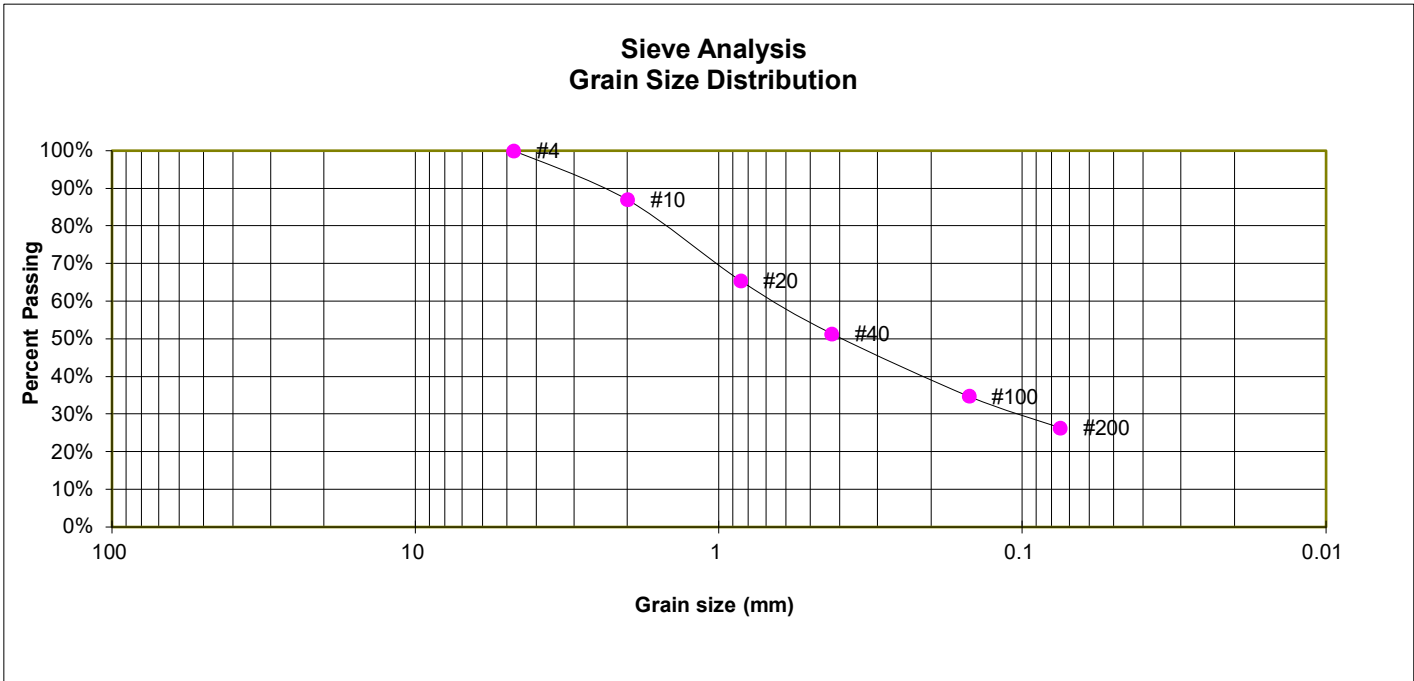
TEST BORING P-6  
DEPTH (FT) 30

SOIL DESCRIPTION SANDSTONE (SAND, SILTY)  
SOIL TYPE 2

**GRAIN SIZE ANALYSIS**

U.S. Sieve #	Percent Finer
3"	
1 1/2"	
3/4"	
1/2"	
3/8"	
4	100.0%
10	87.0%
20	65.5%
40	51.4%
100	34.8%
200	26.4%

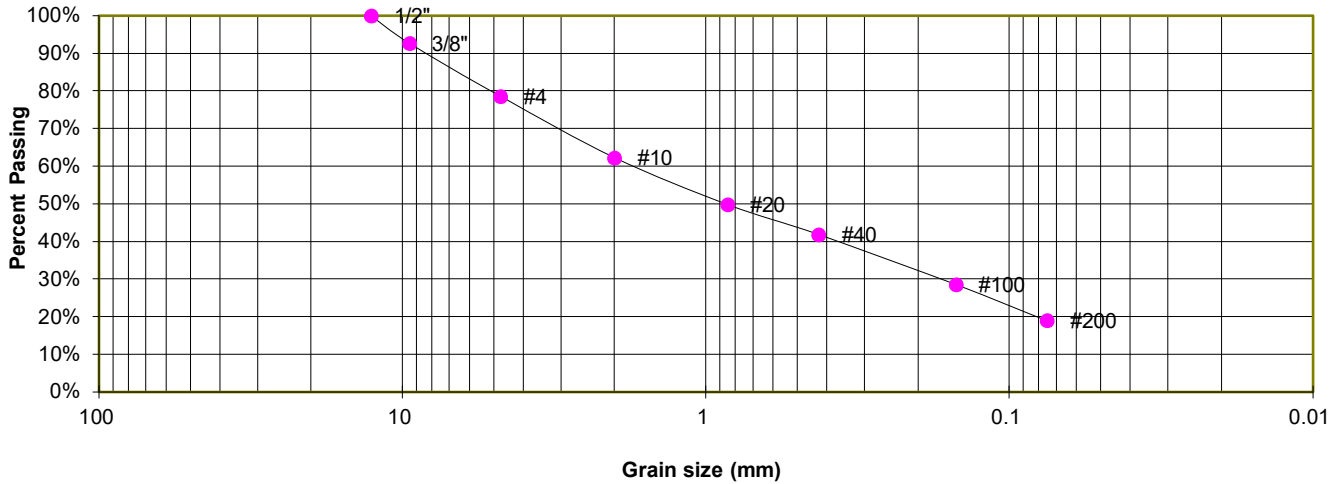
SOIL DESCRIPTION SANDSTONE (SAND, SILTY)  
 SOIL TYPE 2

**Sieve Analysis  
 Grain Size Distribution**

**GRAIN SIZE ANALYSIS**

U.S. Sieve #	Percent Finer
3"	
1 1/2"	
3/4"	
1/2"	100.0%
3/8"	92.7%
4	78.6%
10	62.2%
20	49.9%
40	41.9%
100	28.6%
200	19.0%

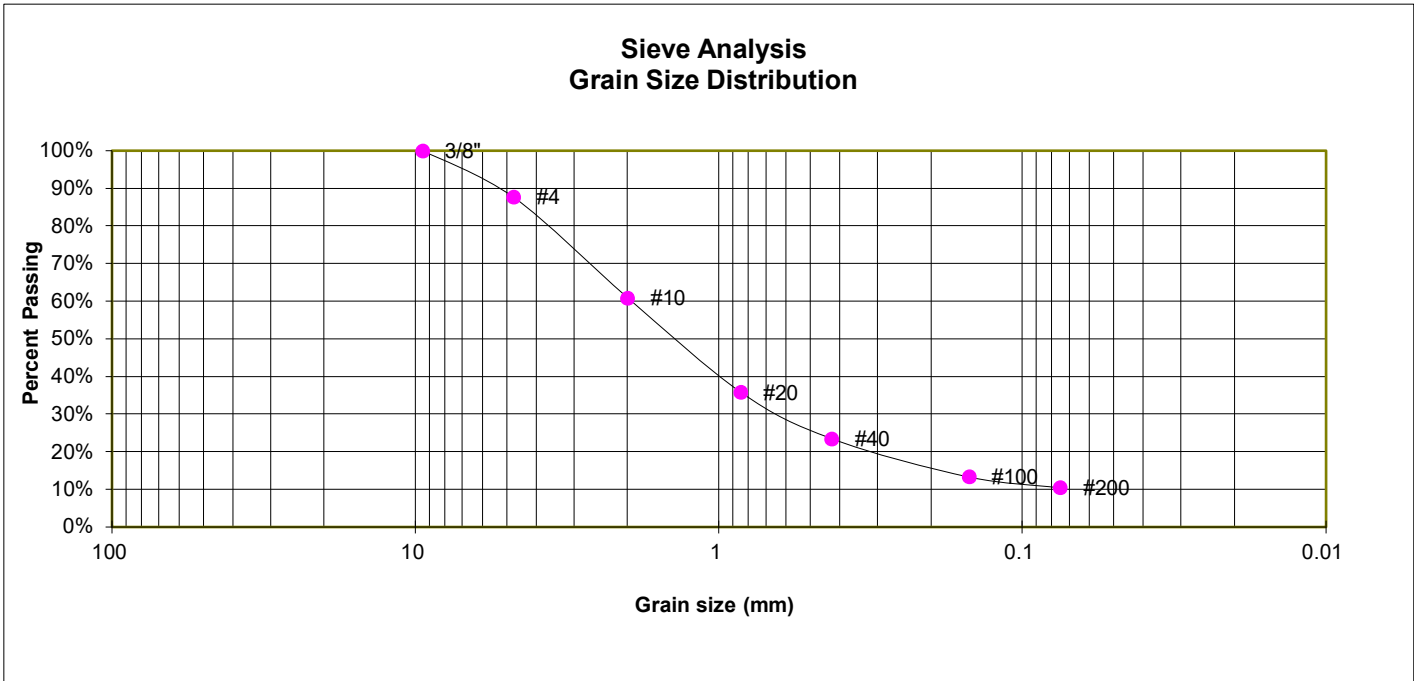
TEST BORING 2  
 DEPTH (FT) 10

SOIL DESCRIPTION SANDSTONE, (SAND, WITH SILT)  
 SOIL TYPE 2

**GRAIN SIZE ANALYSIS**

U.S. Sieve #	Percent Finer
3"	
1 1/2"	
3/4"	
1/2"	
3/8"	100.0%
4	87.6%
10	60.9%
20	35.9%
40	23.4%
100	13.4%
200	10.5%

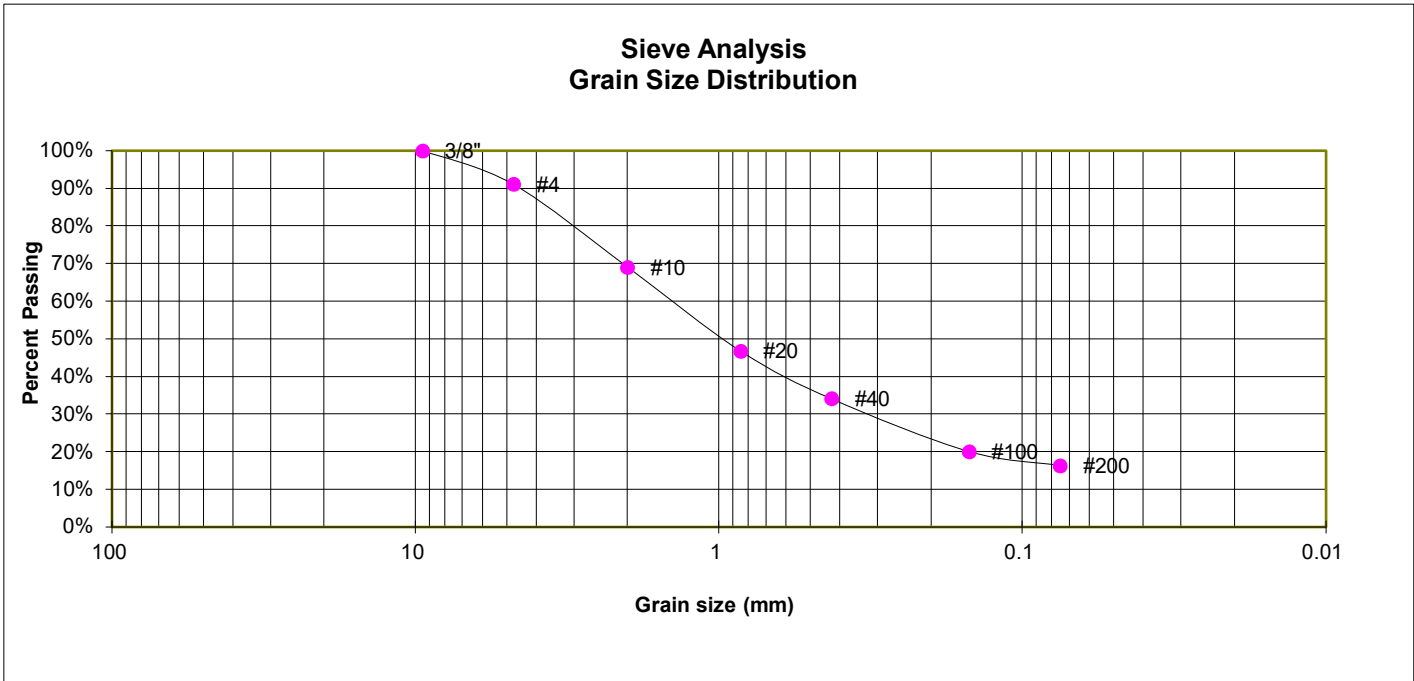
TEST BORING 4  
DEPTH (FT) 5

SOIL DESCRIPTION SANDSTONE, (SAND, SILTY)  
SOIL TYPE 2

**GRAIN SIZE ANALYSIS**

U.S. Sieve #	Percent Finer
3"	
1 1/2"	
3/4"	
1/2"	
3/8"	100.0%
4	91.1%
10	69.0%
20	46.8%
40	34.1%
100	20.1%
200	16.3%

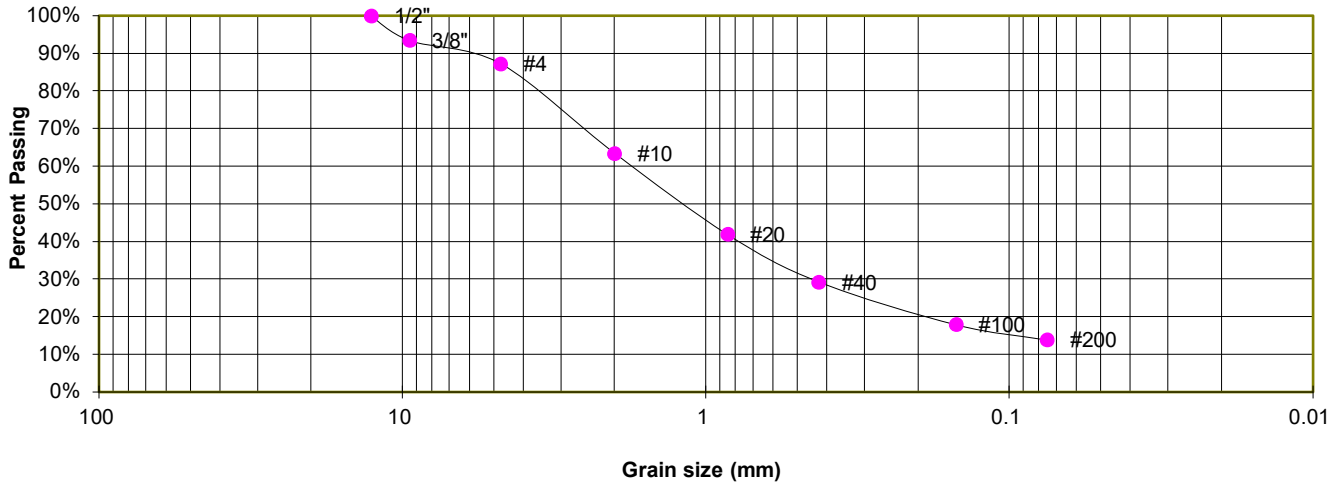
SOIL DESCRIPTION SANDSTONE, (SAND, SILTY)  
SOIL TYPE 2

### Sieve Analysis Grain Size Distribution

#### GRAIN SIZE ANALYSIS

U.S. Sieve #	Percent Finer
3"	
1 1/2"	
3/4"	
1/2"	100.0%
3/8"	93.5%
4	87.3%
10	63.5%
20	41.9%
40	29.3%
100	18.0%
200	13.9%

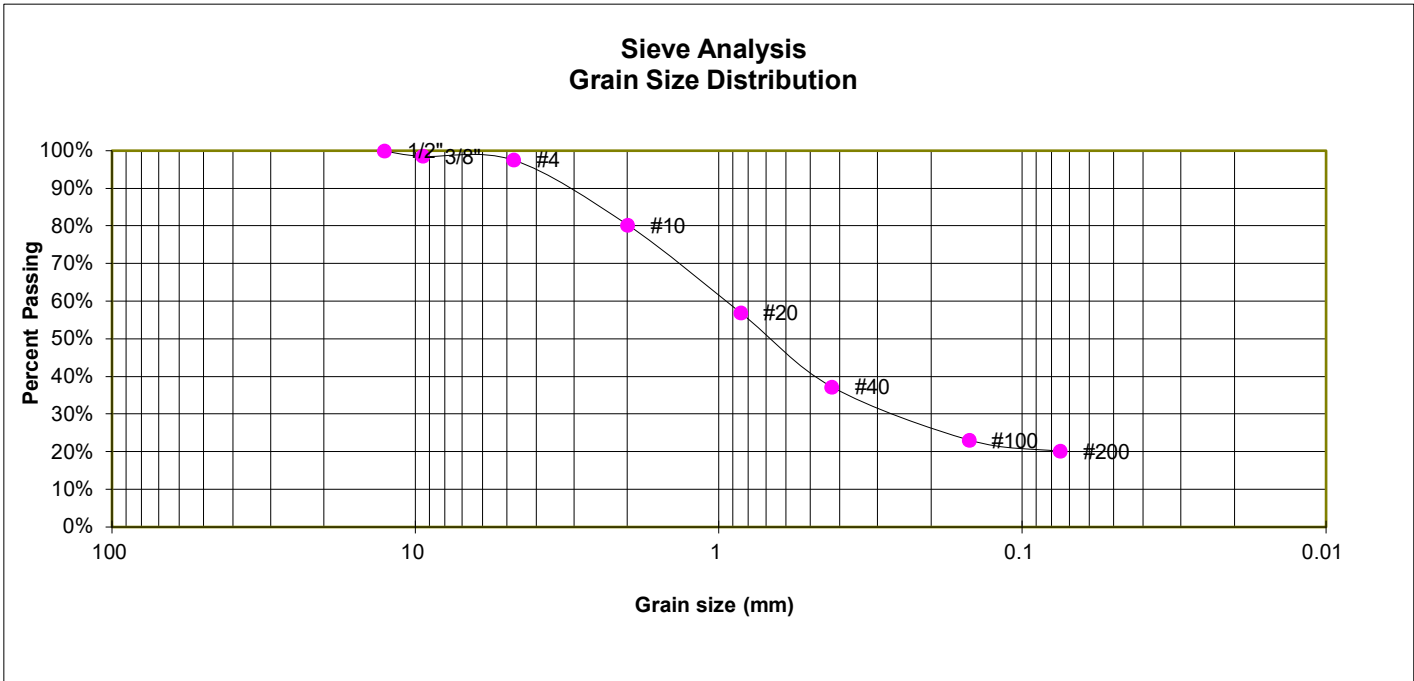
TEST BORING 7  
DEPTH (FT) 10

SOIL DESCRIPTION SANDSTONE, (SAND, SILTY)  
SOIL TYPE 2

**GRAIN SIZE ANALYSIS**

U.S. Sieve #	Percent Finer
3"	
1 1/2"	
3/4"	
1/2"	100.0%
3/8"	98.6%
4	97.6%
10	80.3%
20	57.0%
40	37.3%
100	23.2%
200	20.1%

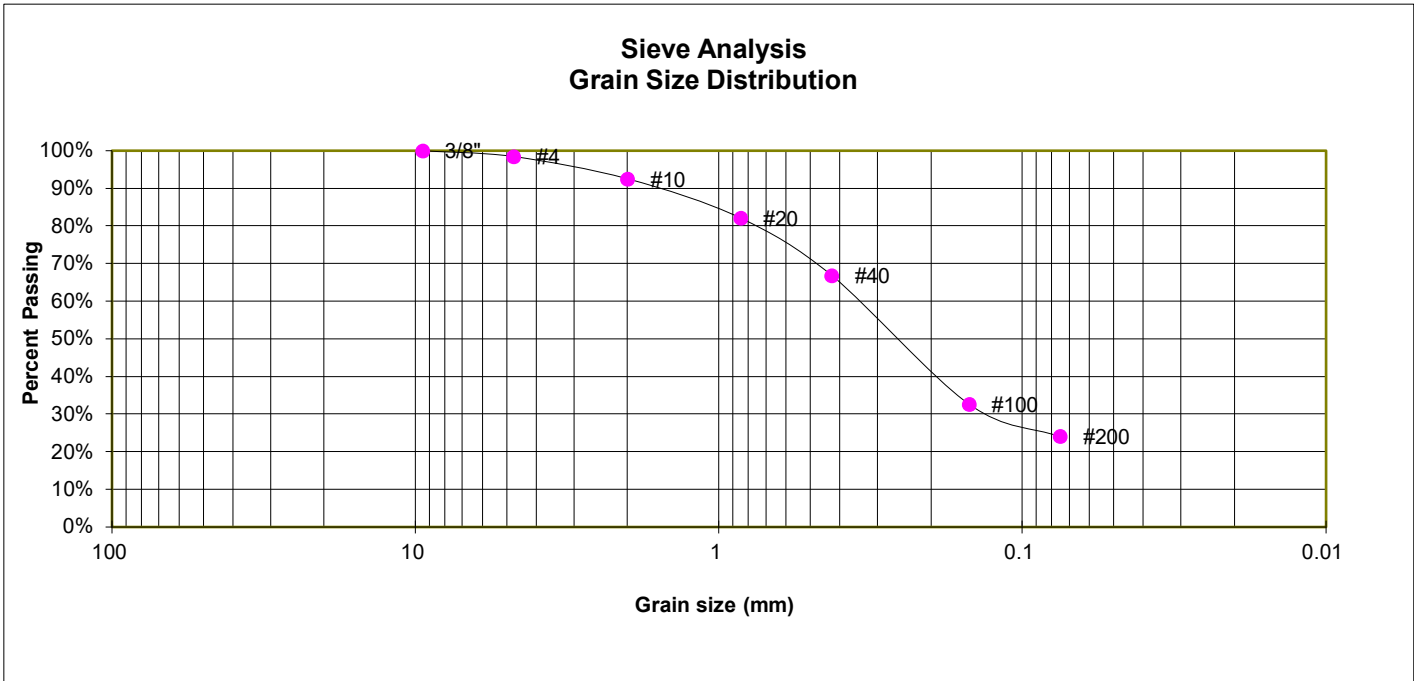
TEST BORING 8  
 DEPTH (FT) 2-3

SOIL DESCRIPTION SANDSTONE, (SAND, SILTY)  
 SOIL TYPE 2

**GRAIN SIZE ANALYSIS**

U.S. Sieve #	Percent Finer
3"	
1 1/2"	
3/4"	
1/2"	
3/8"	100.0%
4	98.5%
10	92.5%
20	82.1%
40	66.8%
100	32.6%
200	24.1%

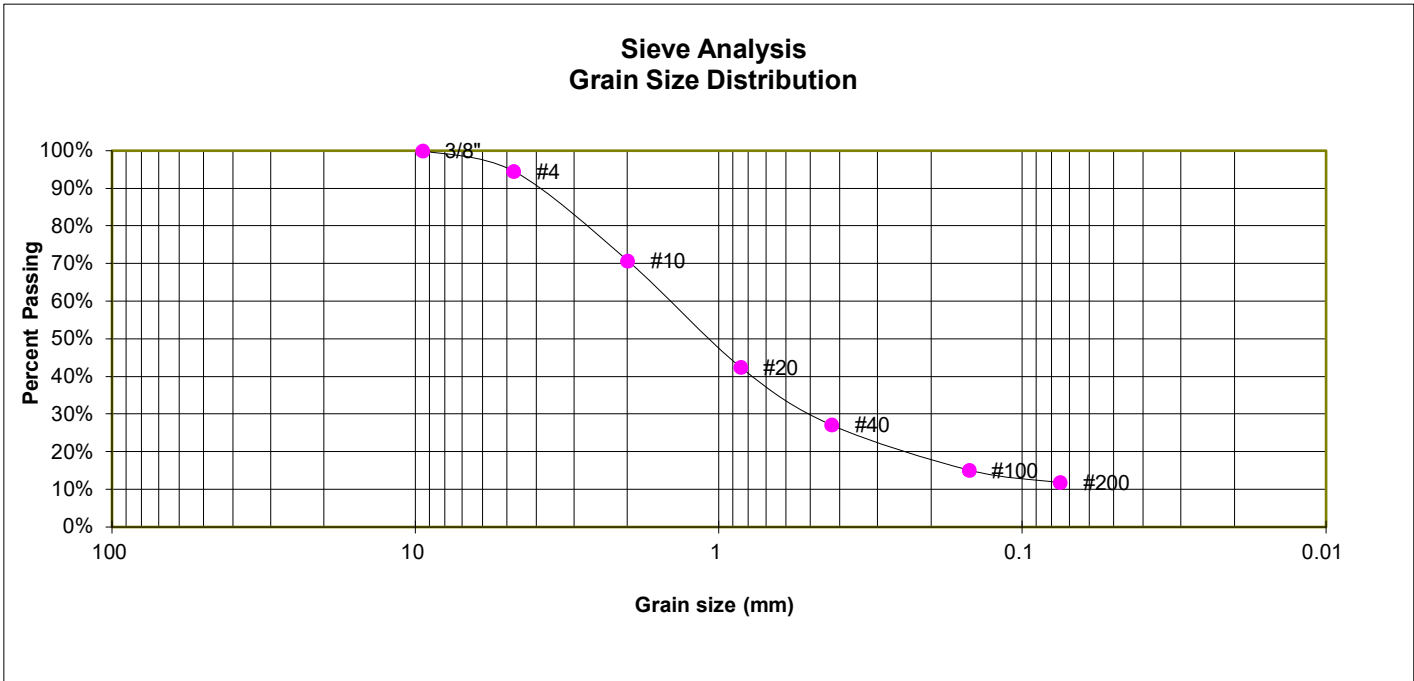
TEST BORING 10  
 DEPTH (FT) 10

SOIL DESCRIPTION SANDSTONE, (SAND, WITH SILT)  
 SOIL TYPE 2

**GRAIN SIZE ANALYSIS**

U.S. Sieve #	Percent Finer
3"	
1 1/2"	
3/4"	
1/2"	
3/8"	100.0%
4	94.6%
10	70.8%
20	42.5%
40	27.2%
100	15.2%
200	11.9%

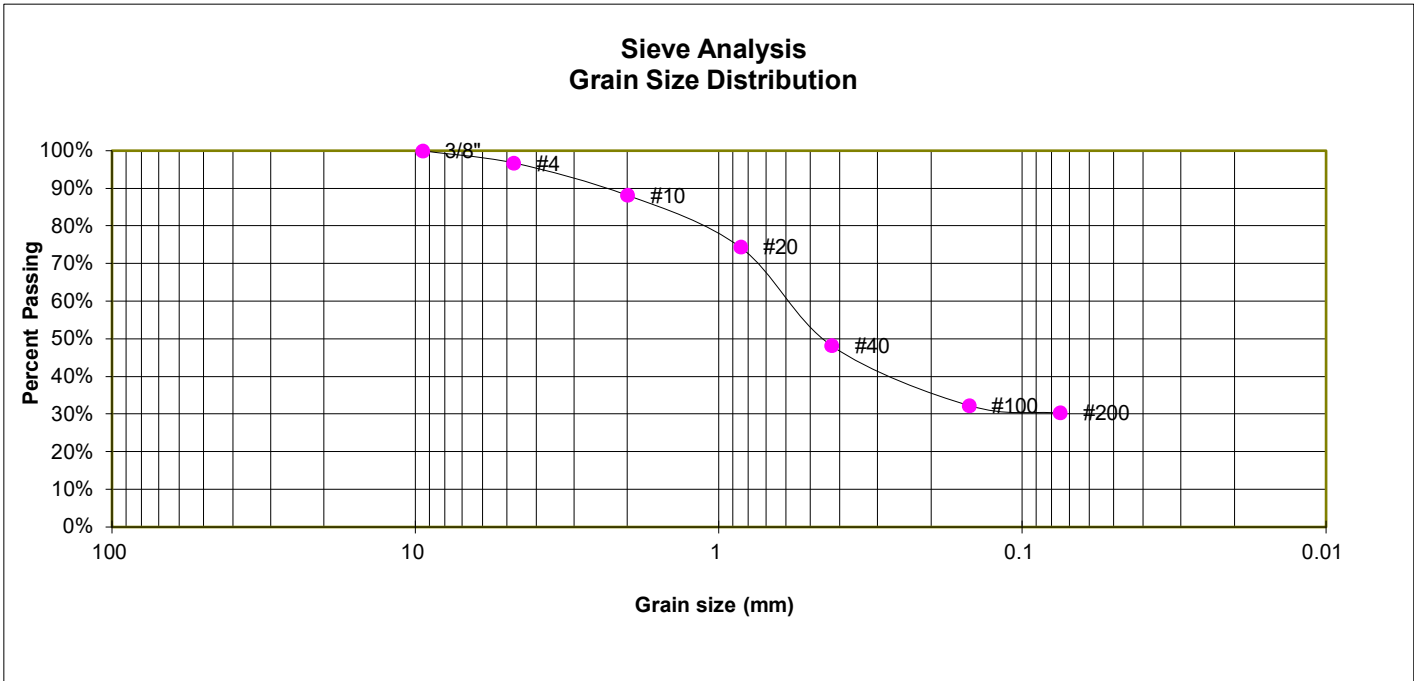
TEST BORING 13  
 DEPTH (FT) 5

SOIL DESCRIPTION SANDSTONE (SAND, SILTY)  
 SOIL TYPE 3

**GRAIN SIZE ANALYSIS**

U.S. Sieve #	Percent Finer
3"	
1 1/2"	
3/4"	
1/2"	
3/8"	100.0%
4	96.7%
10	88.2%
20	74.4%
40	48.2%
100	32.3%
200	30.4%

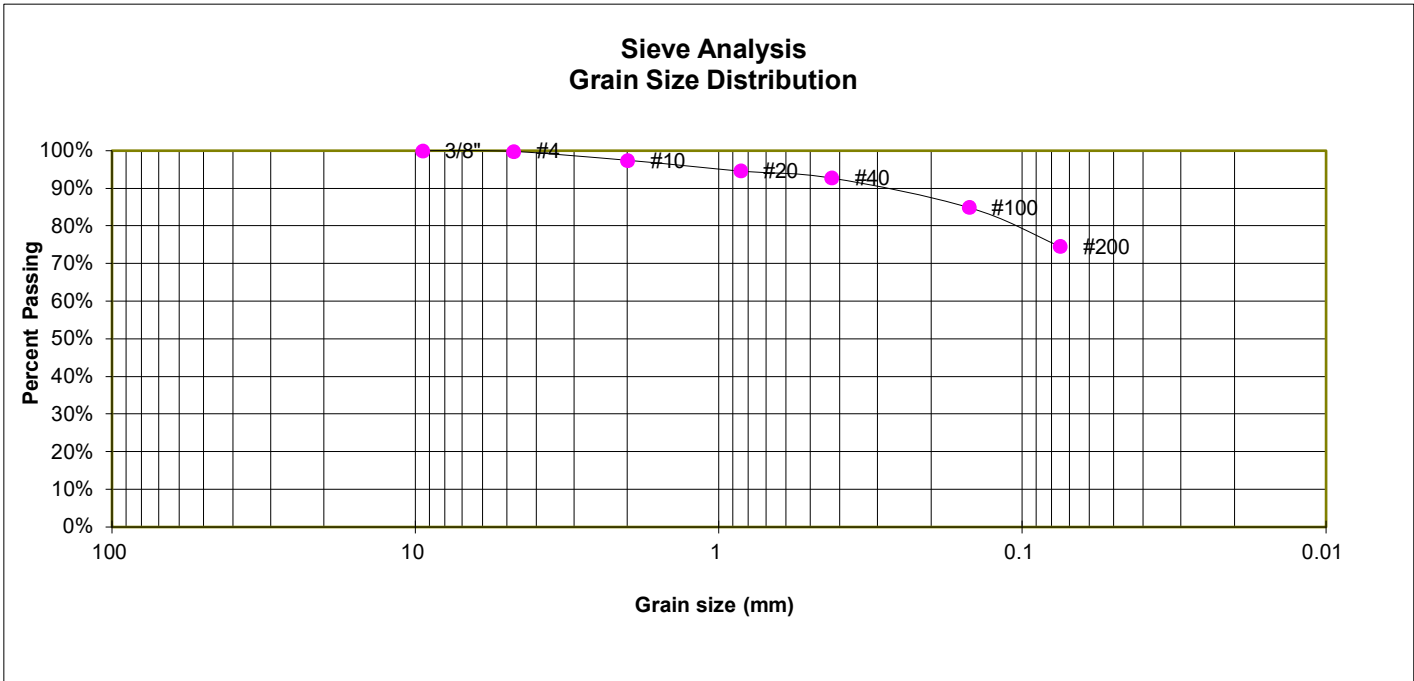
TEST BORING 13  
 DEPTH (FT) 20

SOIL DESCRIPTION CLAYSTONE (CLAY, SANDY)  
 SOIL TYPE 3

**GRAIN SIZE ANALYSIS**

U.S. Sieve #	Percent Finer
3"	
1 1/2"	
3/4"	
1/2"	
3/8"	100.0%
4	99.9%
10	97.4%
20	94.6%
40	92.8%
100	85.0%
200	74.6%

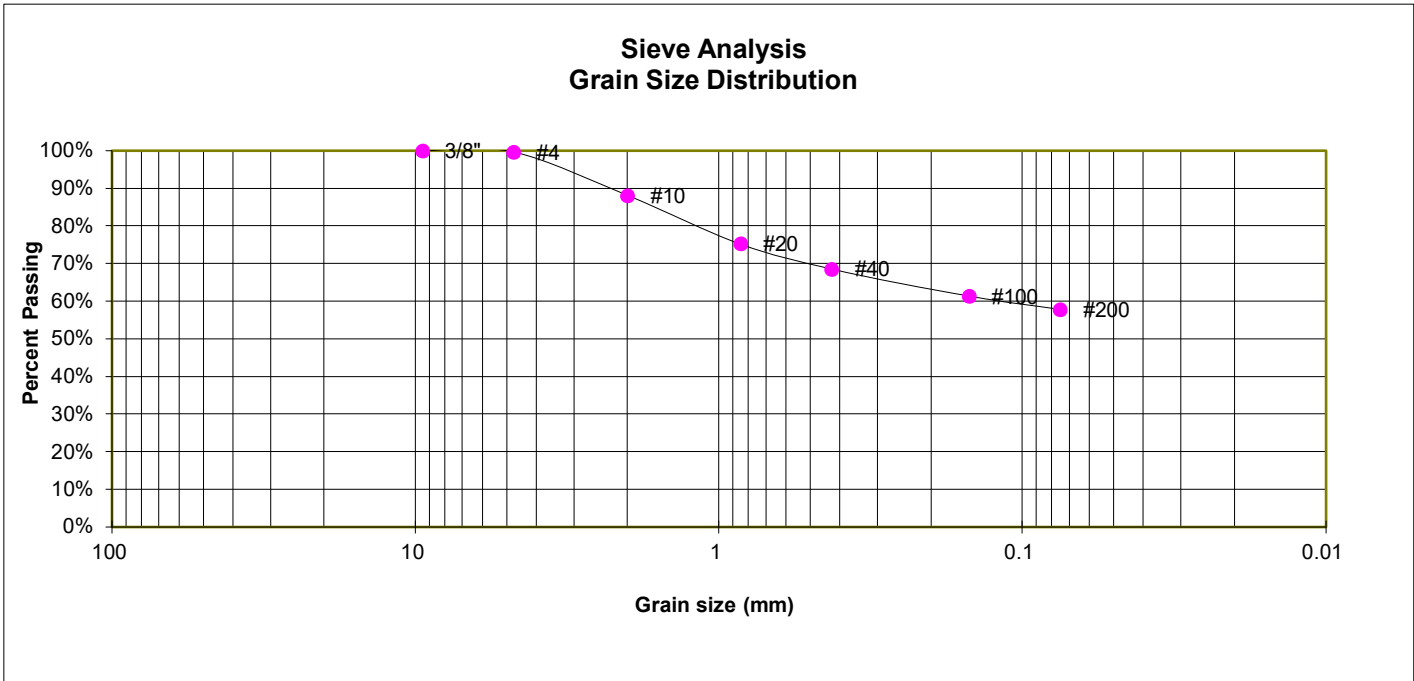
TEST BORING 3  
 DEPTH (FT) 20

SOIL DESCRIPTION SILTSTONE, (SILT, SANDY)  
 SOIL TYPE 3

**GRAIN SIZE ANALYSIS**

U.S. Sieve #	Percent Finer
3"	
1 1/2"	
3/4"	
1/2"	
3/8"	100.0%
4	99.7%
10	88.1%
20	75.3%
40	68.6%
100	61.4%
200	57.9%

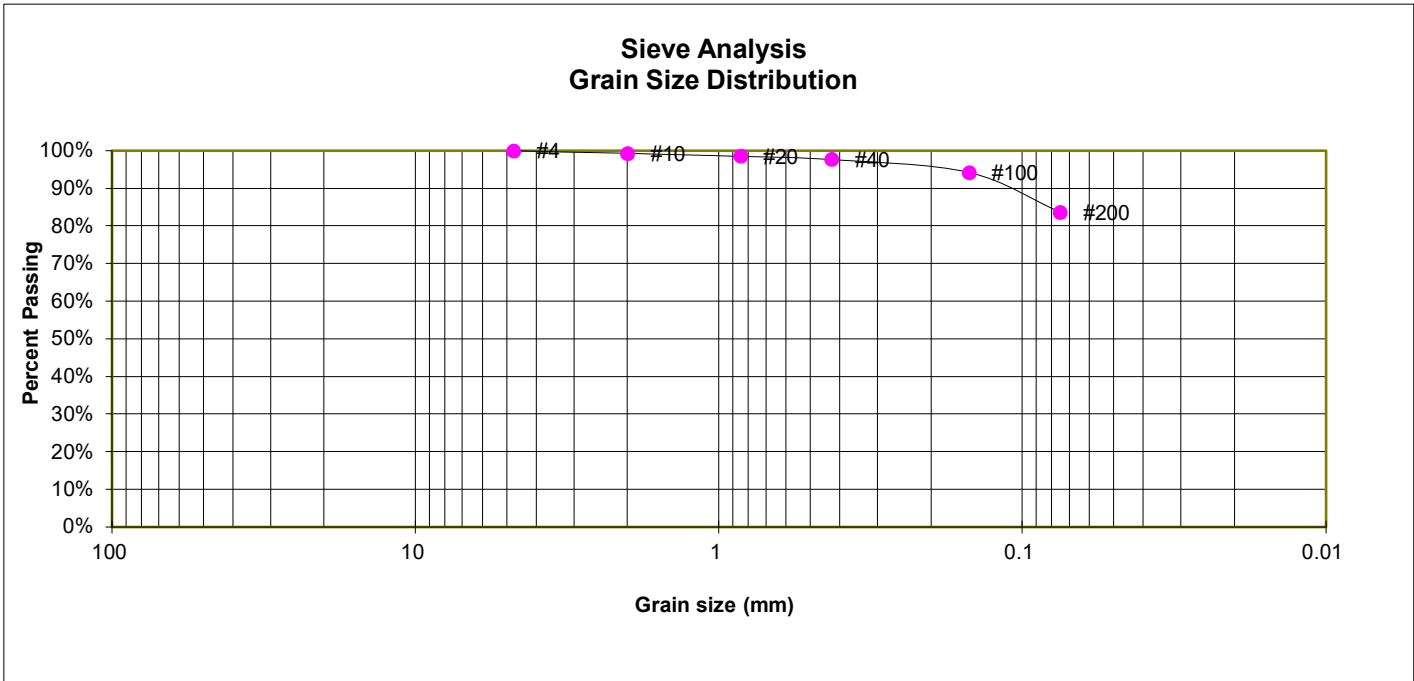
TEST BORING 6  
DEPTH (FT) 20

SOIL DESCRIPTION CLAYSTONE, (CLAY, SANDY)  
SOIL TYPE 3

**GRAIN SIZE ANALYSIS**

U.S. Sieve #	Percent Finer
3"	
1 1/2"	
3/4"	
1/2"	
3/8"	
4	100.0%
10	99.3%
20	98.5%
40	97.7%
100	94.2%
200	83.7%

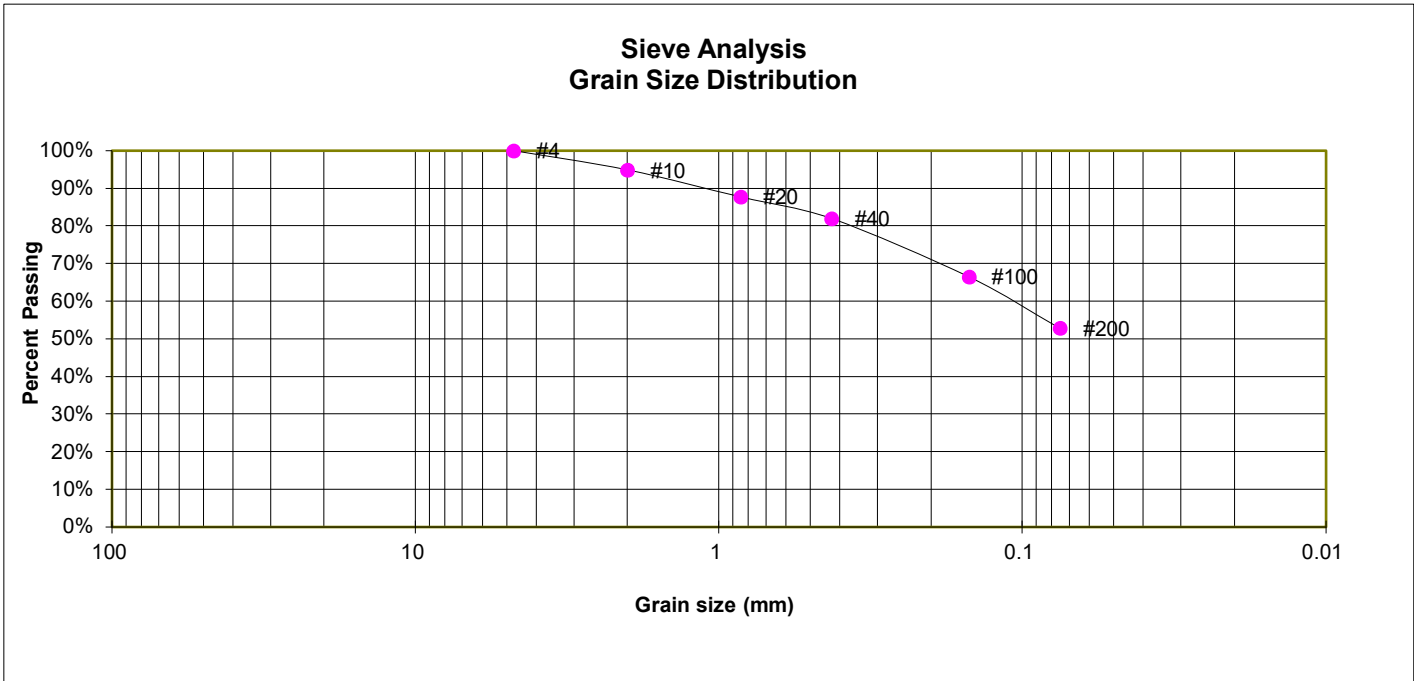
TEST BORING P-8  
DEPTH (FT) 10

SOIL DESCRIPTION CLAYSTONE (CLAY, SANDY)  
SOIL TYPE 3

**GRAIN SIZE ANALYSIS**

U.S. Sieve #	Percent Finer
3"	
1 1/2"	
3/4"	
1/2"	
3/8"	
4	100.0%
10	94.9%
20	87.7%
40	82.0%
100	66.5%
200	52.9%

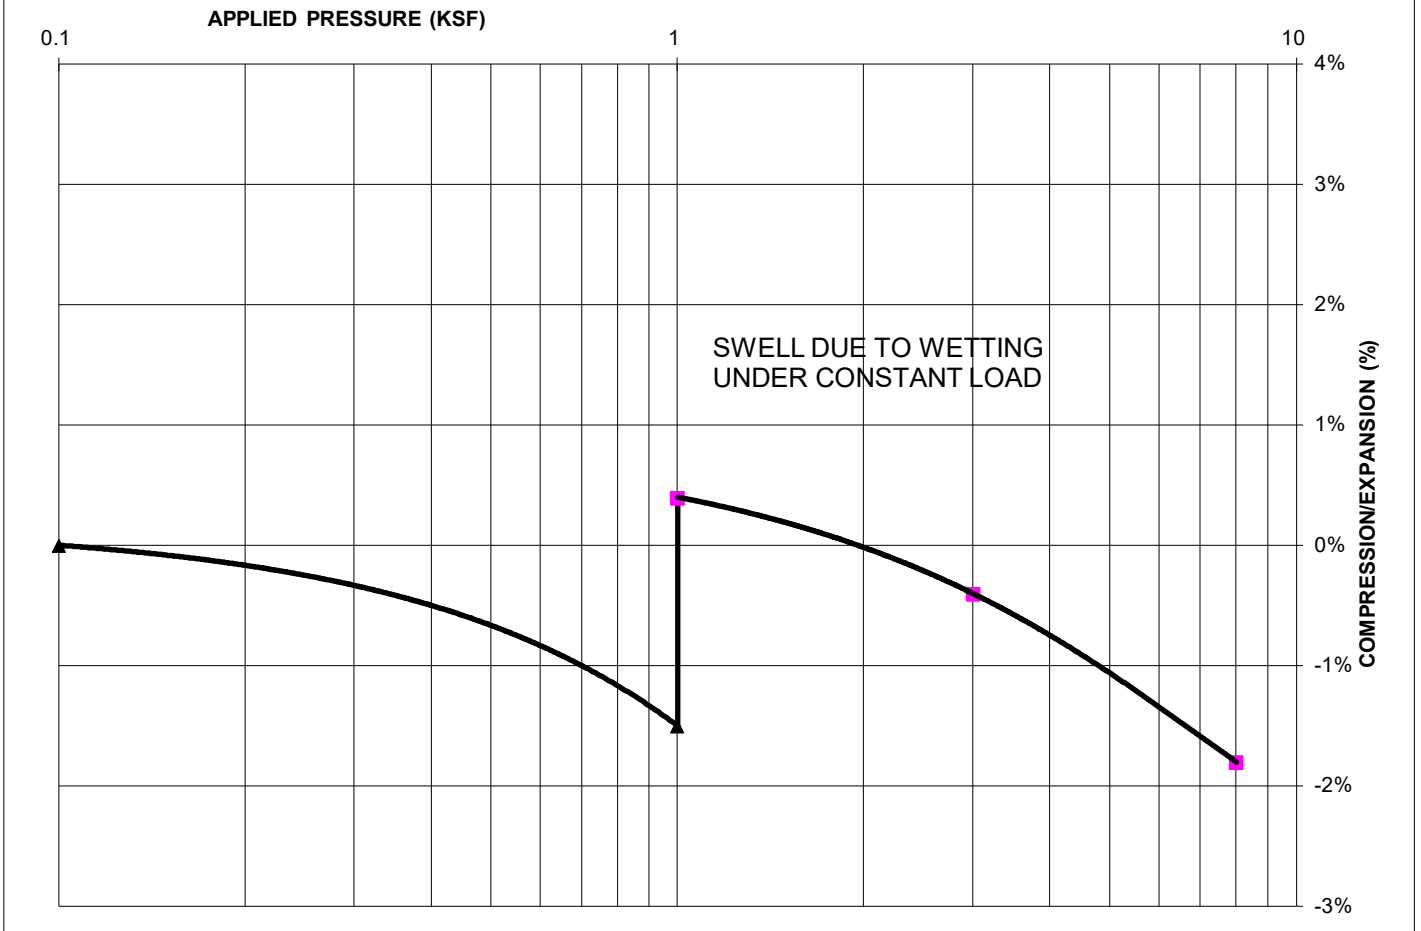
SOIL DESCRIPTION SAND, SILTY  
SOIL TYPE 1

### SWELL CONSOLIDATION

#### SWELL/CONSOLIDATION TEST RESULTS

NATURAL UNIT DRY WEIGHT (PCF): 112  
NATURAL MOISTURE CONTENT: 16.9%  
SWELL/CONSOLIDATION (%): 1.9%
