**ENTECH**  
ENGINEERING, INC.

**SOILS AND GEOLOGY STUDY  
RETREAT AT PRAIRIERIDGE  
FILINGS 1, 2, AND 3 – PRELIMINARY PLAN  
POCO ROAD AND VOLLMER ROAD  
EL PASO COUNTY, COLORADO**

November 21, 2023  
Revised February 29, 2024  
Revised April 2, 2024

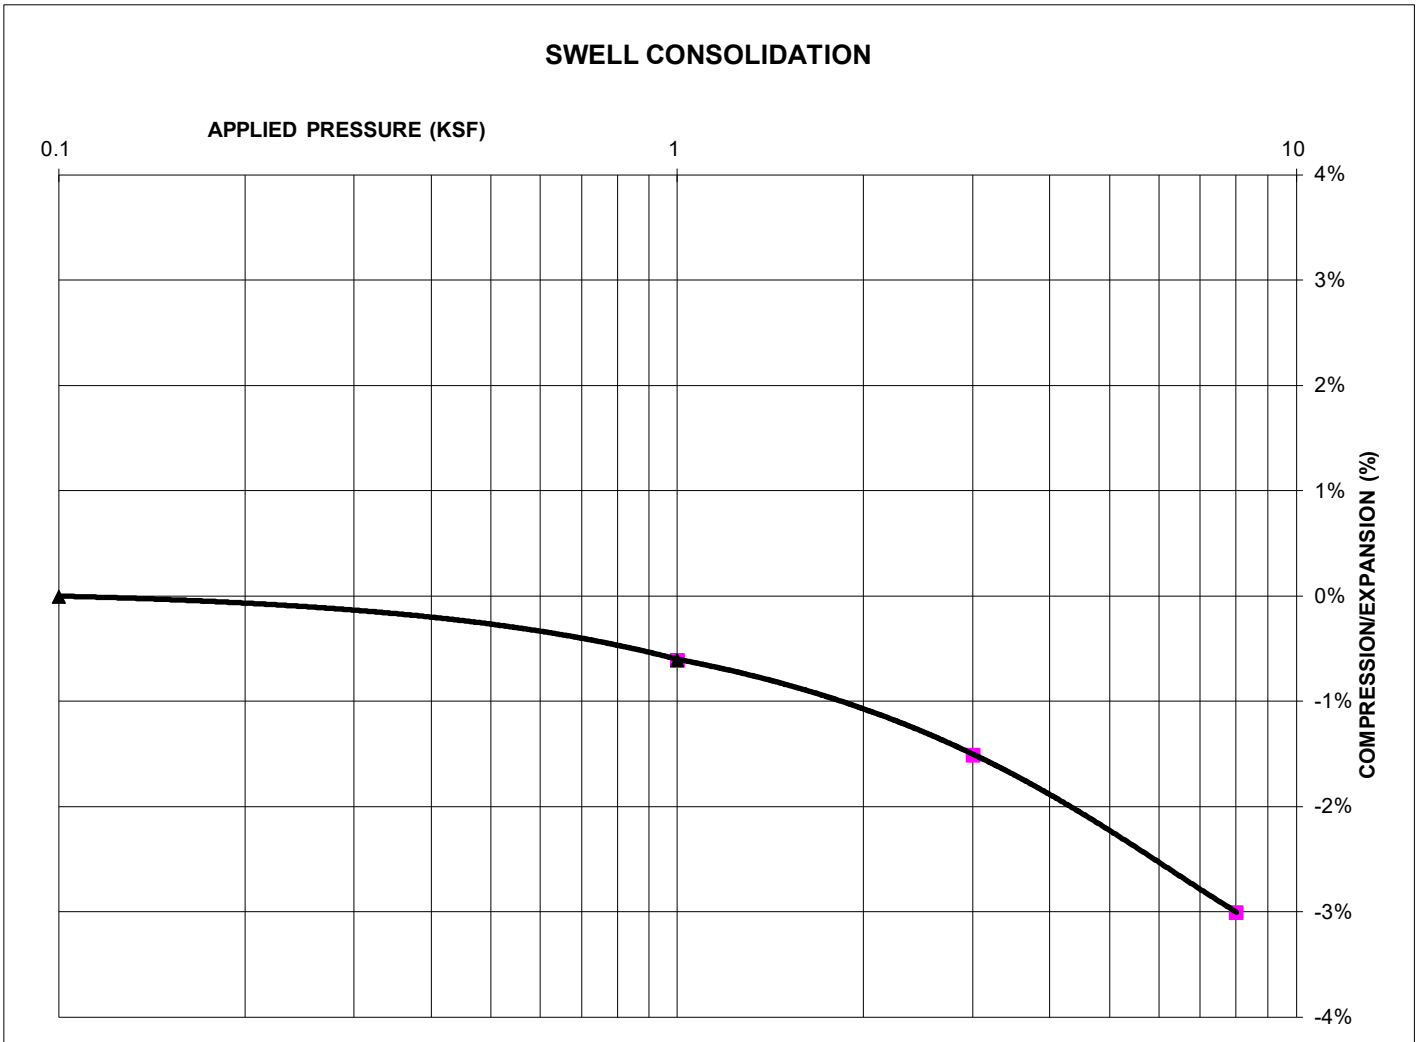
TEST BORING 13  
DEPTH (FT) 20

SOIL DESCRIPTION CLAYSTONE (CLAY, SANDY)  
SOIL TYPE 3

**SWELL/CONSOLIDATION TEST RESULTS**

NATURAL UNIT DRY WEIGHT (PCF): 102  
NATURAL MOISTURE CONTENT: 16.9%  
SWELL/CONSOLIDATION (%): 0.0%

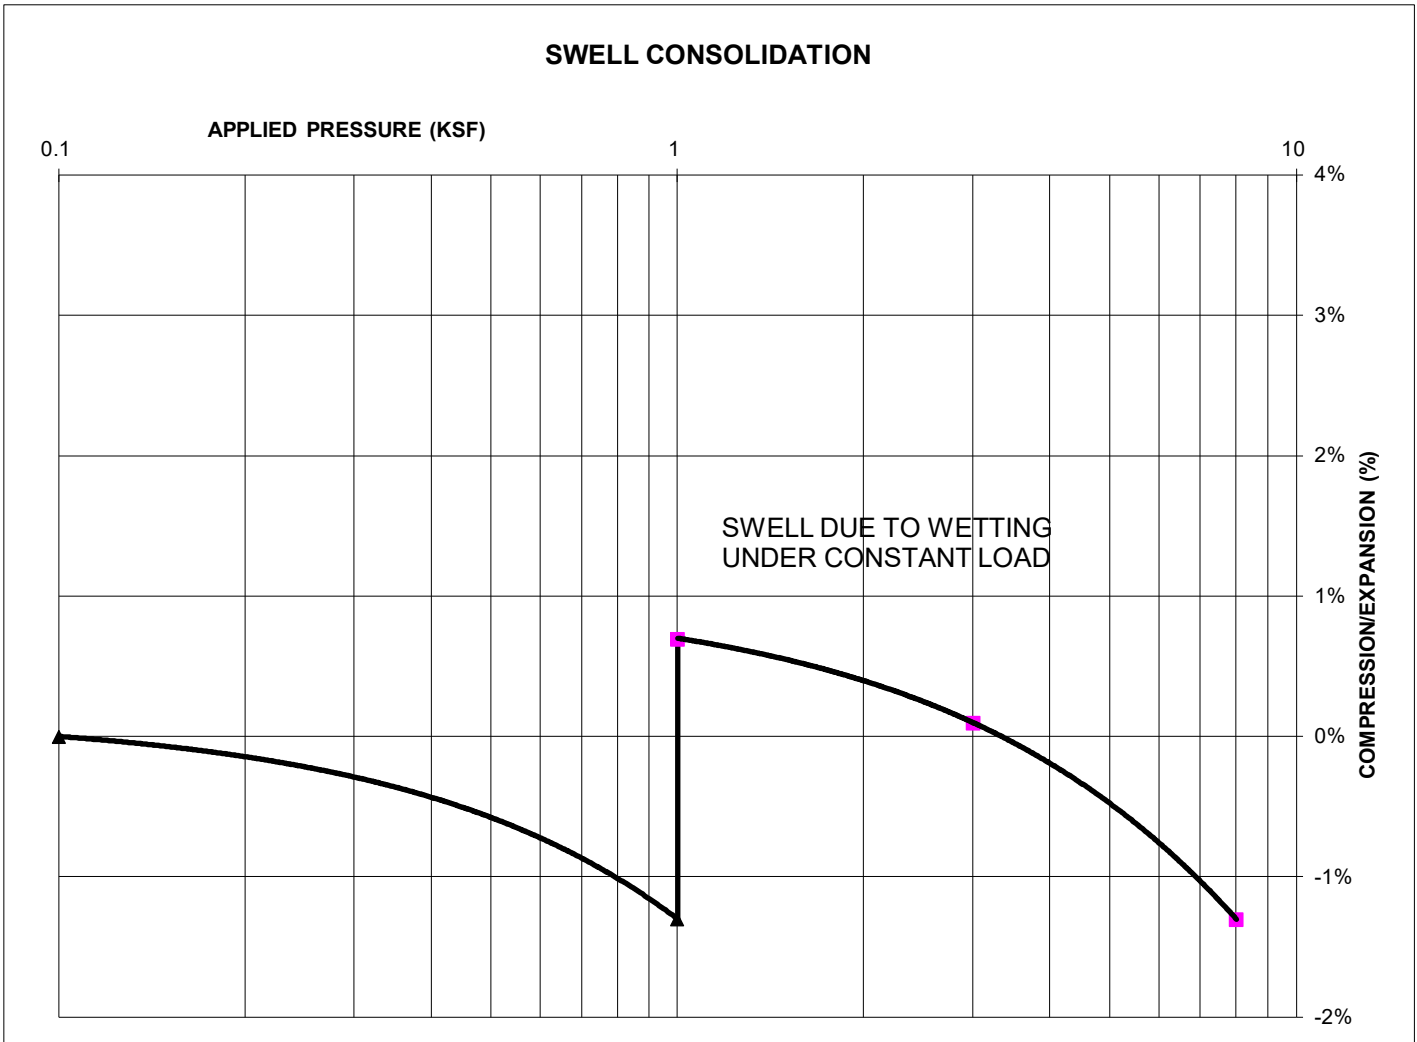
TEST BORING P-8  
DEPTH (FT) 10

SOIL DESCRIPTION CLAYSTONE (CLAY, SANDY)  
SOIL TYPE 3

**SWELL/CONSOLIDATION TEST RESULTS**

NATURAL UNIT DRY WEIGHT (PCF): 102  
NATURAL MOISTURE CONTENT: 22.3%  
SWELL/CONSOLIDATION (%): 2.0%
