Kumar & Associates, Inc.
Geotechnical and Materials Engineers
and Environmental Scientists

GEOLOGY AND SOILS STUDY
MOUNTAINS EDGE DEVELOPMENT
EL PASO COUNTY, COLORADO

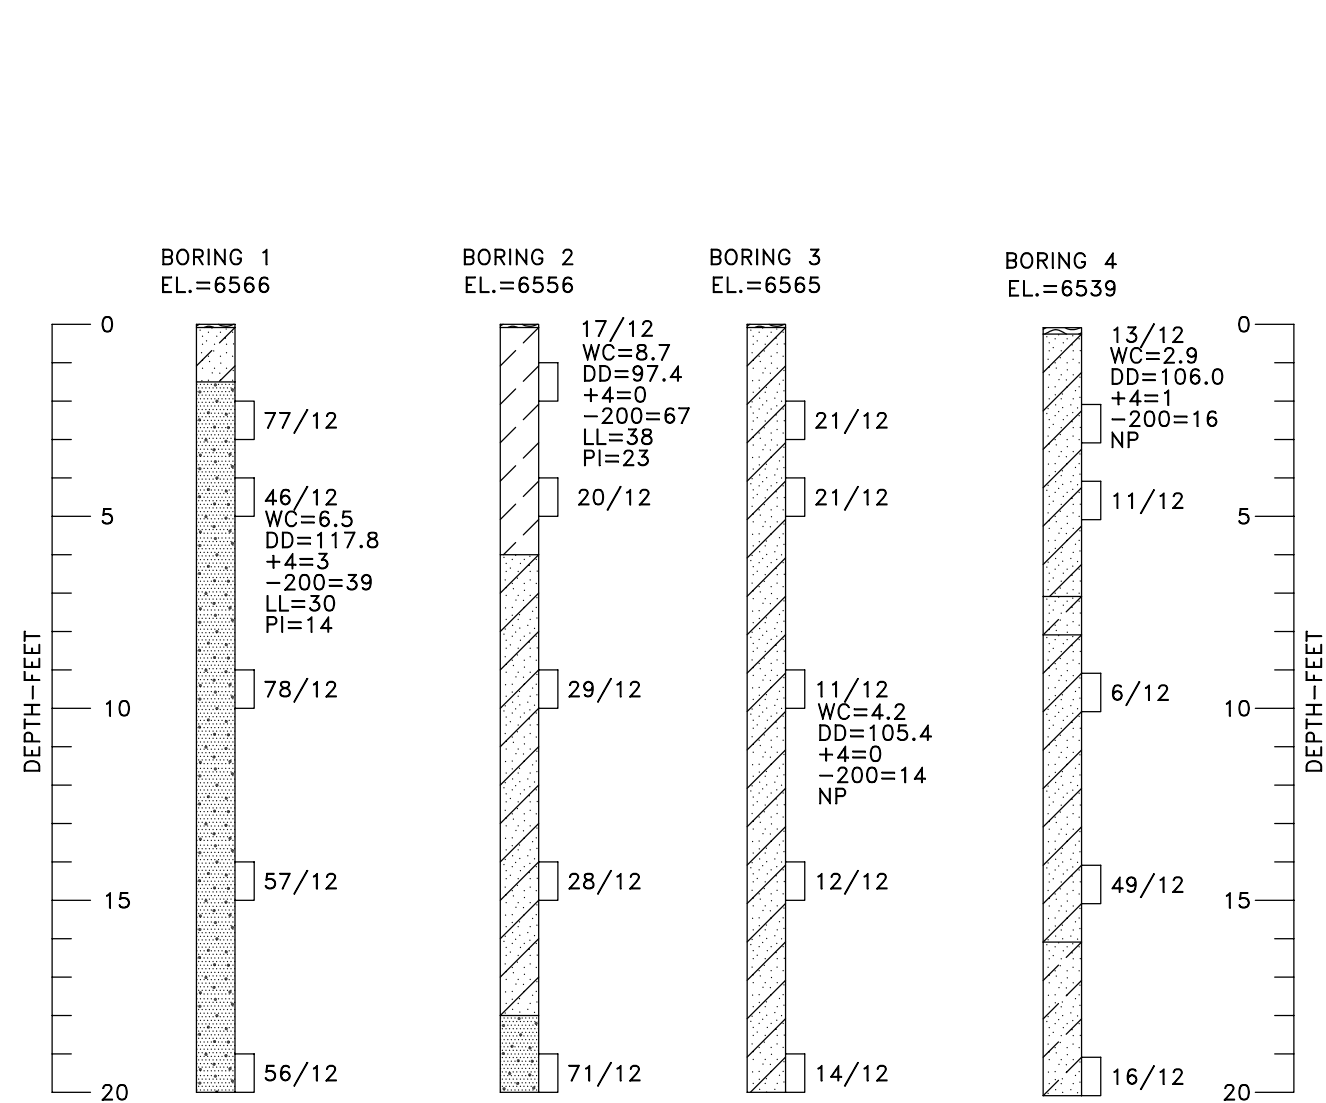
1. THE EXPLORATORY BORINGS WERE DRILLED ON OCTOBER 21, 2008, WITH A 4-INCH DIAMETER CONTINUOUS FLIGHT POWER AUGER.
2. THE LOCATIONS OF THE EXPLORATORY BORINGS WERE MEASURED BY INSTRUMENT SURVEY PRIOR TO DRILLING AND WERE PROVIDED BY LDC-INC.
3. THE ELEVATIONS OF THE EXPLORATORY BORINGS WERE OBTAINED BY INTERPOLATION BETWEEN CONTOURS ON THE PLAN PROVIDED. THE LOGS OF THE EXPLORATORY BORINGS ARE PLOTTED TO DEPTH.
4. THE EXPLORATORY BORING LOCATIONS AND ELEVATIONS SHOULD BE CONSIDERED ACCURATE ONLY TO THE DEGREE IMPLIED BY THE METHOD USED.
5. THE LINES BETWEEN MATERIALS SHOWN ON THE EXPLORATORY BORING LOGS REPRESENT THE APPROXIMATE BOUNDARIES BETWEEN MATERIAL TYPES AND THE TRANSITIONS MAY BE GRADUAL.
6. GROUND WATER WAS NOT ENCOUNTERED IN THE BORINGS AT THE TIME OF DRILLING, OR WHEN CHECKED THREE DAYS LATER. FLUCTUATIONS IN THE WATER LEVEL MAY OCCUR WITH TIME.

FIG. 4 - LOGS OF EXPLORATORY BORINGS

Information regarding subsurface conditions was obtained by drilling four exploratory borings at the approximate locations shown on Figs. 1 and 2. Logs of the exploratory borings are presented on Fig. 4. The results of laboratory tests performed on selected samples obtained from the borings are presented on Figs. 4 through 7, and are summarized in Table I. The following subsurface descriptions are of a generalized nature to highlight the major stratification features encountered in the borings. The boring logs should be referenced for more detailed information.

Beneath the topsoil in Borings 1, 3 and 4, and the clay soils in Boring 2, the overburden soils generally consisted of silty sand, clayey sand and poorly- to well-graded sand with silt to depths ranging from approximately 1.5 feet in Boring 1 to the maximum depth explored of 20 feet in Borings 3 and 4. Sampler penetration blow counts indicate the silty sand and poorly- to well-graded sand with silt is loose to dense and the clayey sand is very stiff.

Ground water was not encountered in the borings at the time of drilling or when checked three days later. Iron staining observed at a depth of approximately 9 feet in Boring 4 suggests ground-water levels have been higher in this area in the past. Fluctuations in the water level may occur with time.
