WASTEWATER STUDY FLYING HORSE NORTH, FILING NO. 5 EL PASO COUNTY, COLORADO

September 11, 2024

ENTECH ENGINEERING, INC.

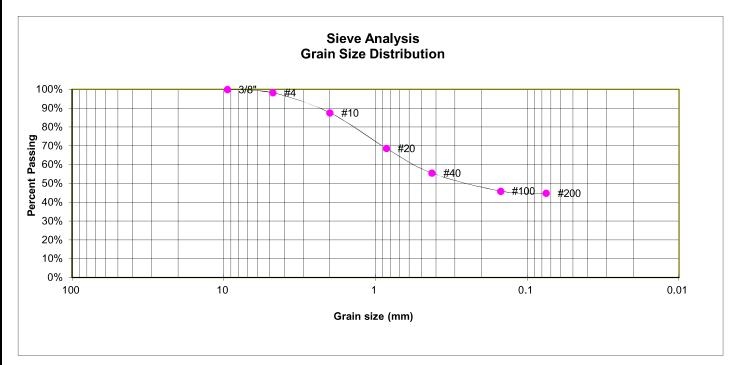
GRAIN SIZE ANALYSIS

U.S.	Percent
Sieve #	<u>Finer</u>
3"	
1 1/2"	
3/4"	
1/2"	
3/8"	100.0%
4	98.2%
10	87.6%
20	68.7%
40	55.6%
100	46.0%
200	44.8%

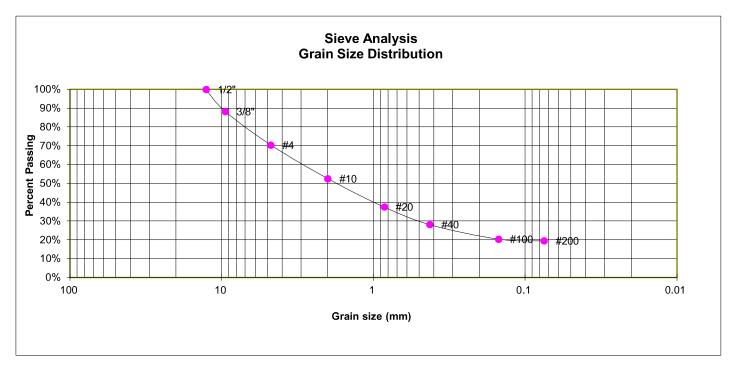
GRAIN SIZE ANALYSIS

U.S.	Percent
Sieve#	<u>Finer</u>
3"	
1 1/2"	
3/4"	
1/2"	100.0%
3/8"	88.3%
4	70.4%
10	52.5%
20	37.5%
40	28.1%
100	20.4%
200	19.5%

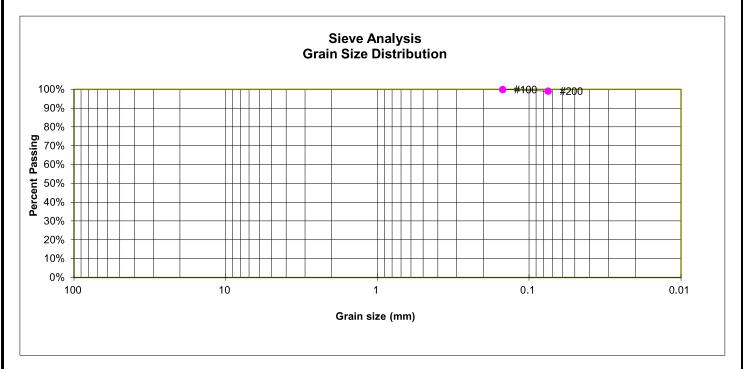
GRAIN SIZE ANALYSIS

U.S.	Percent
Sieve #	<u>Finer</u>
3"	
1 1/2"	
3/4"	
1/2"	
3/8"	
4	
10	
20	
40	
100	100.0%
200	99.1%

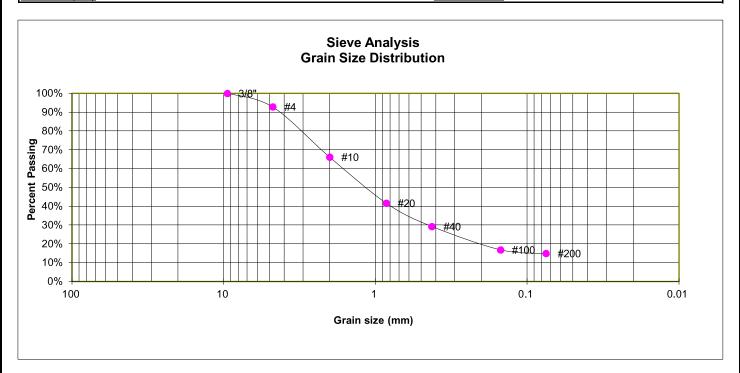
GRAIN SIZE ANALYSIS

TEST BORING2SOIL DESCRIPTION
SOIL TYPESANDSTONE (SAND, SILTY)DEPTH (FT)20SOIL TYPE4

U.S.	Percent
Sieve#	<u>Finer</u>
3"	
1 1/2"	
3/4"	
1/2"	
3/8"	100.0%
4	92.8%
10	66.1%
20	41.7%
40	29.3%
100	16.8%
200	14.9%

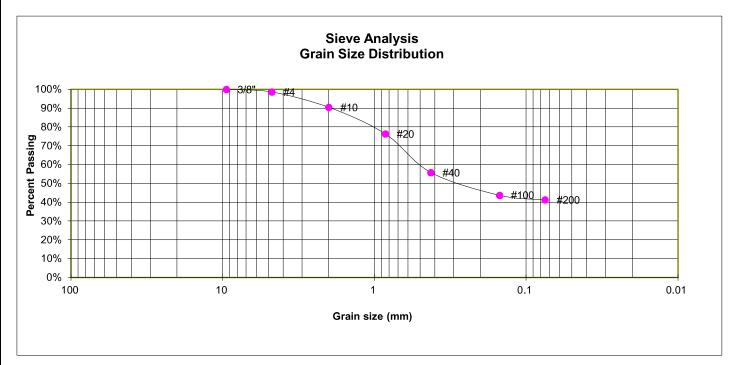
SOIL CLASSIFICATION

U.S.	Percent
Sieve #	<u>Finer</u>
3"	
1 1/2"	
3/4"	
1/2"	
3/8"	100.0%
4	98.6%
10	90.5%
20	76.4%
40	55.8%
100	43.8%
200	41.2%

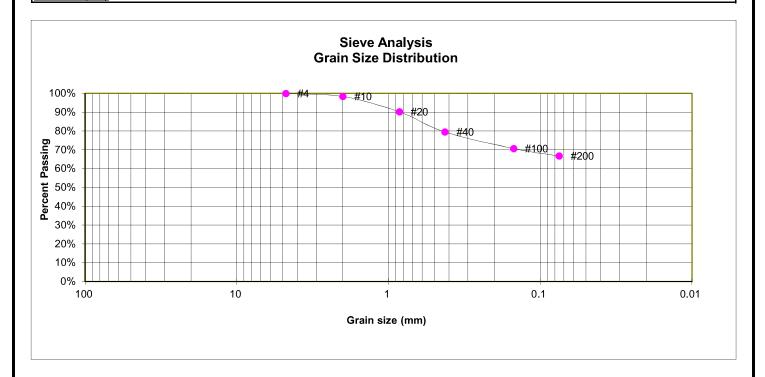
SOIL CLASSIFICATION

U.S.	Percent
Sieve #	<u>Finer</u>
3"	
1 1/2"	
3/4"	
1/2"	
3/8"	
4	100.0%
10	98.4%
20	90.2%
40	79.5%
100	70.7%
200	66.7%

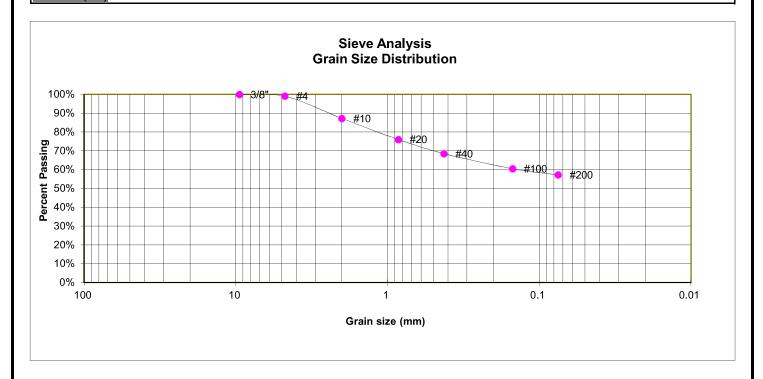
SOIL CLASSIFICATION

U.S.	Percent
Sieve #	<u>Finer</u>
3"	
1 1/2"	
3/4"	
1/2"	
3/8"	100.0%
4	99.1%
10	87.2%
20	76.1%
40	68.6%
100	60.5%
200	57.3%

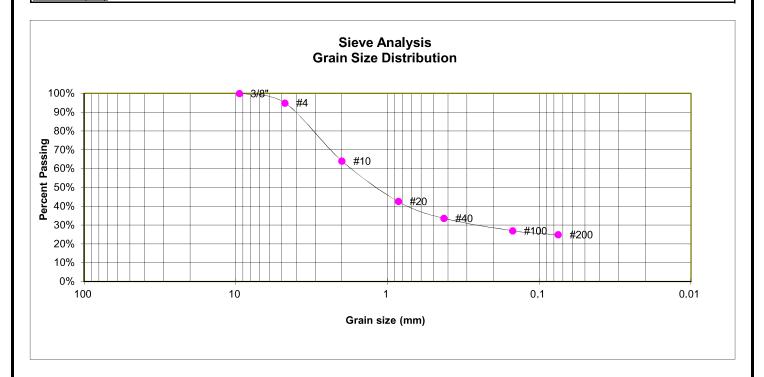
SOIL CLASSIFICATION

U.S.	Percent
Sieve#	<u>Finer</u>
3"	
1 1/2"	
3/4"	
1/2"	
3/8"	100.0%
4	95.0%
10	64.1%
20	42.6%
40	33.7%
100	27.0%
200	25.0%

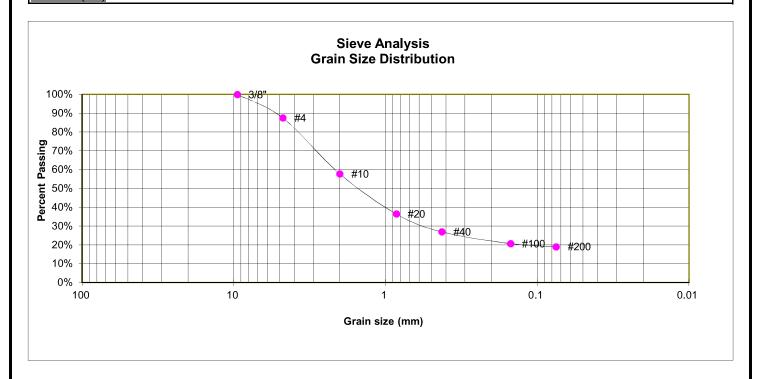
SOIL CLASSIFICATION

U.S.	Percent
Sieve #	<u>Finer</u>
3"	
1 1/2"	
3/4"	
1/2"	
3/8"	100.0%
4	87.5%
10	57.8%
20	36.5%
40	26.9%
100	20.7%
200	19.1%
