Pavement Study Falcon Meadows at Bent Grass, Filing No. 1 El Paso County, Colorado

Project Number 214061-P2 September 15, 2021 Revised October 1, 2021

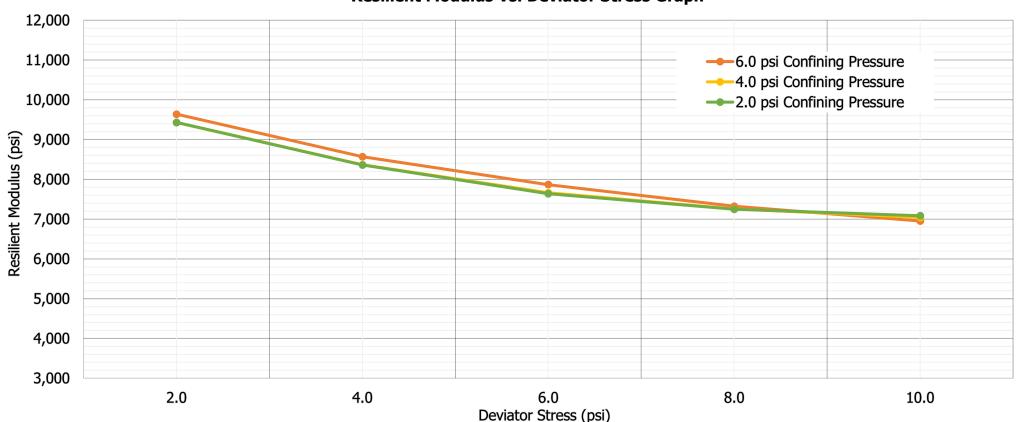
Resilient Modulus Vs. Deviator Stress Graph

A-7-6 (7) **Sample Location TB-1 AASHTO Classification Soil Description** Sand, very clayey -No. 200 (%) 48 Height (in) **5.6 Liquid Limit** 42 Diameter (in) 2.8 **Plastic Limit** 18 **Plasticy Index** Area (in^2) 6.2 24 Volume (in^3) **Proctor Type** 34.5 **ASTM D698** Remold Dry Density (pcf) 107.4 **Proctor Max Dry Density (pcf)** 111.9 Remold Moisture (%) **15.1 Optimum Moisture (%)** 14.7 **Percent Compaction (%) Material Type** 2 96 **Moisture Content after (%)**
