PAVEMENT DESIGN REPORT

The Hills at Lorson Ranch - Area "B"

El Paso County, Colorado

JOB NO. 181479

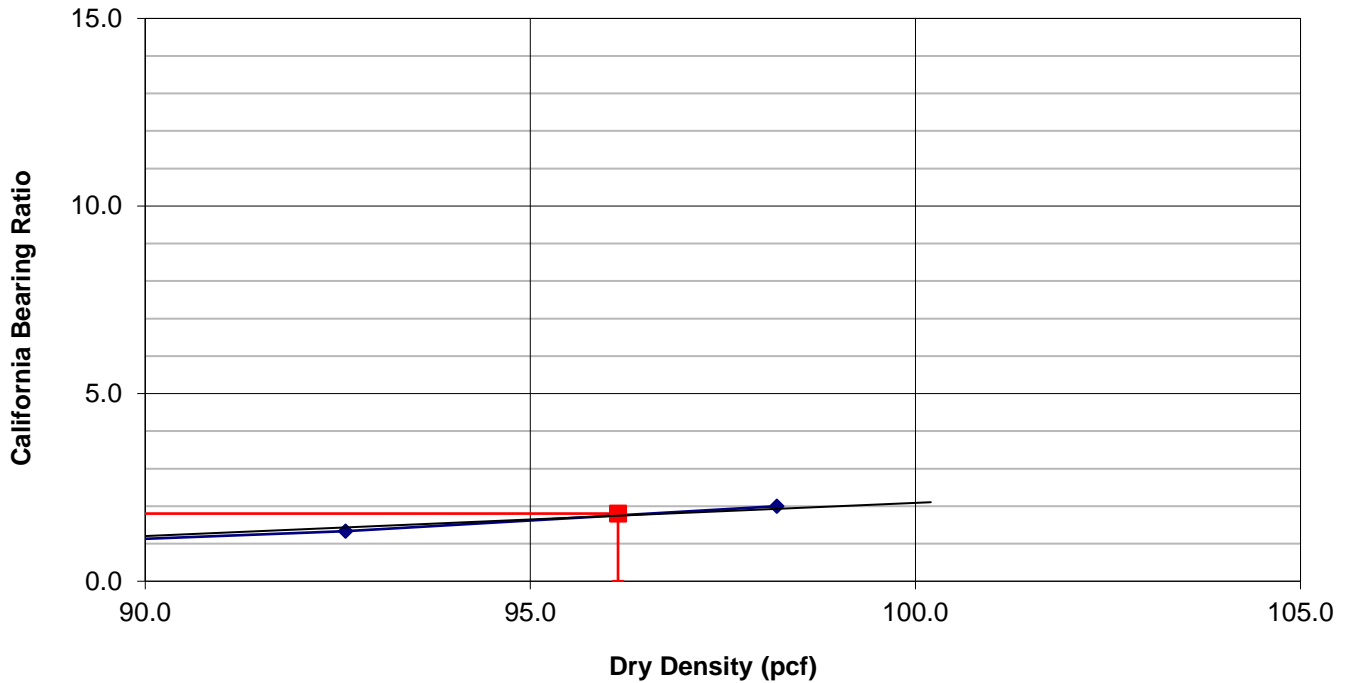
PROJECT: The Hills at Lorson Ranch - Area B
 JOB NUMBER: 181479 TEST DATE: 5/17/2021
 AASHTO CLASSIFICATION: A-7-6
 SAMPLE NUMBER: CBR
 SAMPLE LOCATION: Combined Bulk Sample
 SOIL DESCRIPTION: Lean Clay

10 blows/lift	25 blows/lift	56 blows/lift
Corrected California Bearing Ratio	0.3	1.3	2.0
Dry Density (pcf)	79.8	92.6	98.2
Percent Compaction	79	92	97
Percent Moisture After Soaking	35.5	40.6	33.1
Percent Expansion/Compression	1.3	1.3	1.3
Surcharge Weight (lbs)	12.60	12.60	12.60

California Bearing Ratio	1.8
Dry Density (pcf)	101.2
Percent Compaction	95.00%
Target Dry Density	96.1
Compaction Test Method	ASTM D-698
Condition of sample	Soaked

California Bearing Ratio tests (CBR) were performed. A Combined bulk sample of A-7-6 soil was tested to determine the optimum moisture-density relationship in accordance with ASTM D-698 (Standard Proctor compaction test). CBR tests were performed at varying densities with moisture content near optimum. At 95% of the maximum Standard Proctor Density, the CBR of the A-7-6 soil was 1.8. The Moisture-Density Relation Curve is presented in Figure 17. CBR Test Results are presented in Figures 18 and 19.

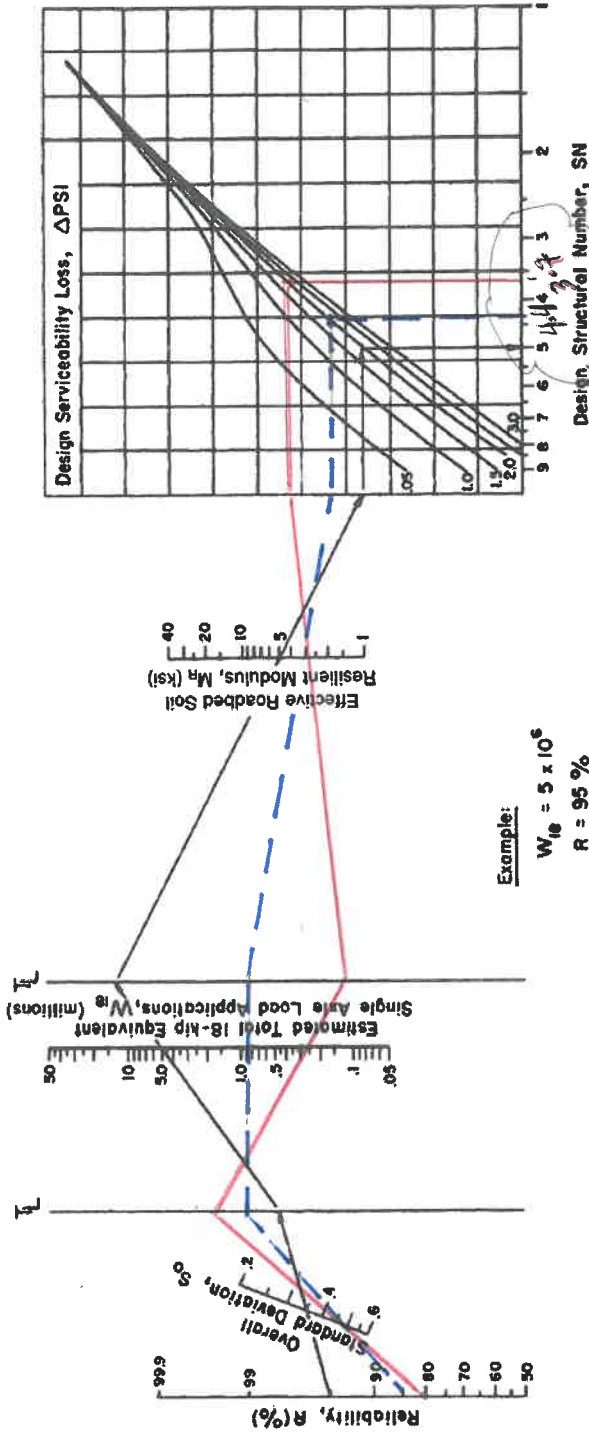
NOMOGRAPH SOLVES:

$$\log_{10} W_{18} = Z_R S_o + 9.36 \log_{10} (SN+1) - 0.20 + \frac{1094}{0.40 + \frac{1094}{(SN+1)^{5.19}}} + 2.32 \log_{10} M_R - 8.07$$

GENERAL SITE AND PROJECT DESCRIPTION	3
Location	3
Existing Conditions.....	3
Project Description.....	3
FIELD INVESTIGATION AND SUBSURFACE CONDITIONS.....	3
Drilling.....	3
Subsurface Materials.....	4
Groundwater	4
LABORATORY TESTING.....	4
Laboratory Testing.....	4
PAVEMENT DESIGN	6
Pavement Thickness.....	7
Pavement Materials.....	8
Soil Mitigation	8
Subgrade Preparation.....	8
Surface Drainage.....	9
Subgrade Observations and Testing.....	9
CLOSING	9
FIGURES	
Site Vicinity Map.....	1
Test Boring Location Plan	2
Recommended Pavement Sections	2.1
Explanation of Test Boring Logs	3
Test Boring Logs	4-9
Summary of Laboratory Test Results	10
Soil Classification Data.....	11-13
Swell/Consolidation Test Results	14-16
Moisture-Density Relation Curve	17
California Bearing Ratio Test Results	18-19
APPENDIX A	
Figure D-1 Flexible Pavement Nomograph - Urban Residential Local and Collector
