MONUMENT ACADEMY

Operation and Maintenance Manual for

Extended Detention Basins (EDBs)

MONUMENT ACADEMY HIGH SCHOOL

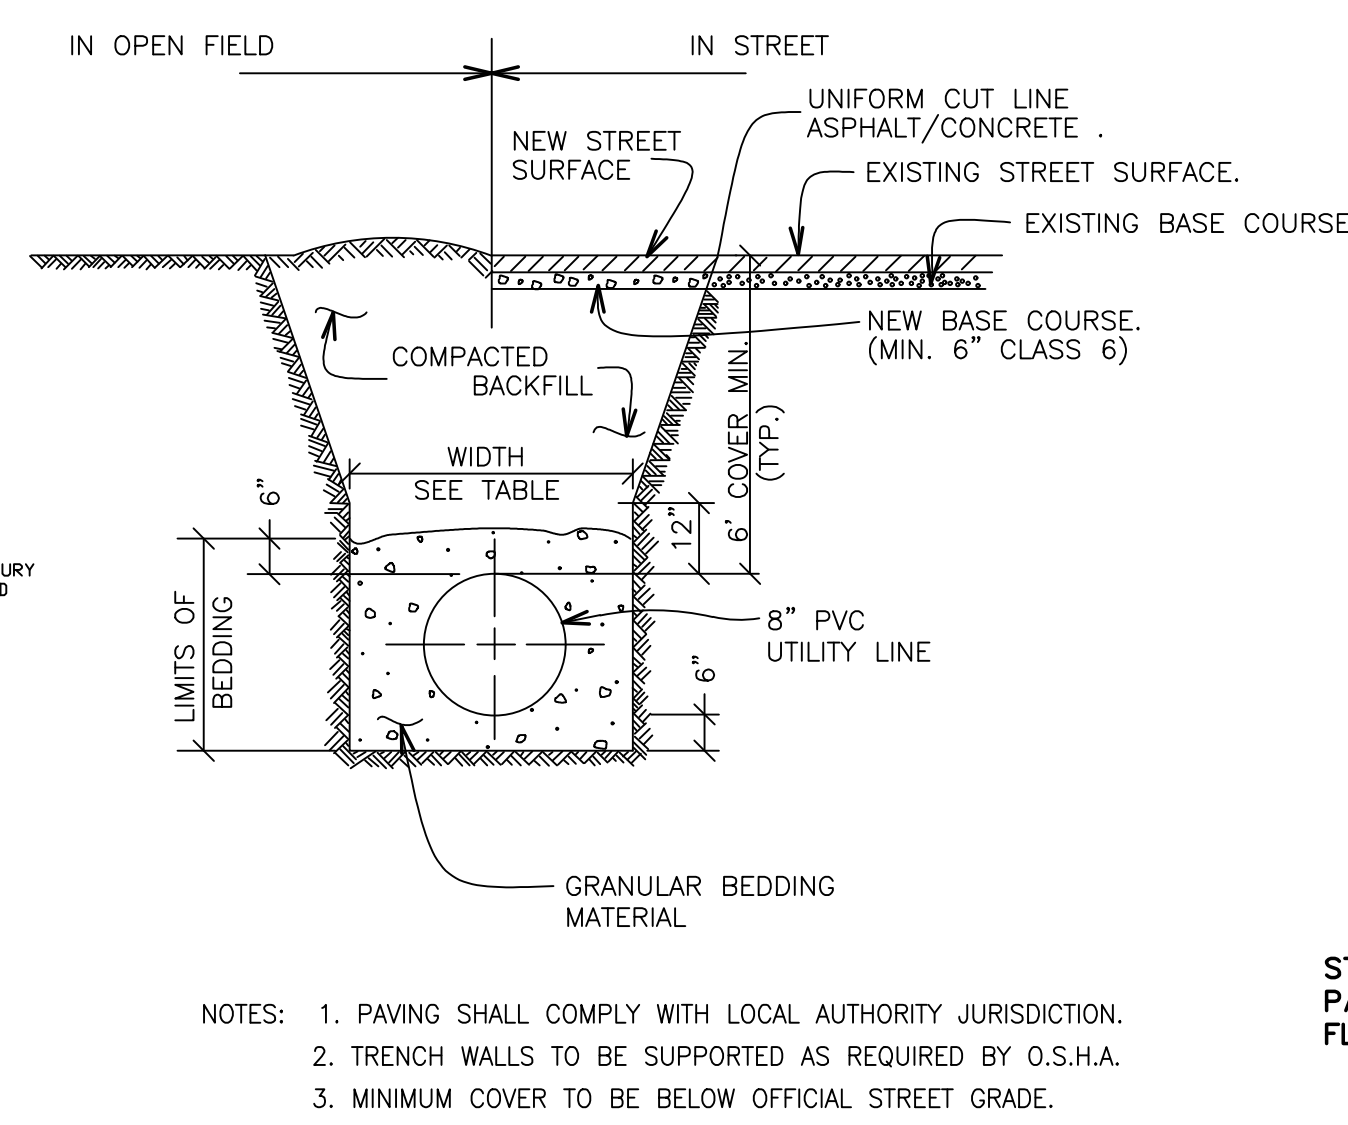
TYPICAL TRENCH SECTION (2)
NOT TO SCALE

PIPE DIAMETER	MINIMUM WIDTH	MAXIMUM WIDTH
4"	1'-4"	2'-4"
6"	1'-6"	2'-6"
8"	1'-8"	2'-8"
12"	2'-0"	3'-0"
16"	2'-4"	3'-4"

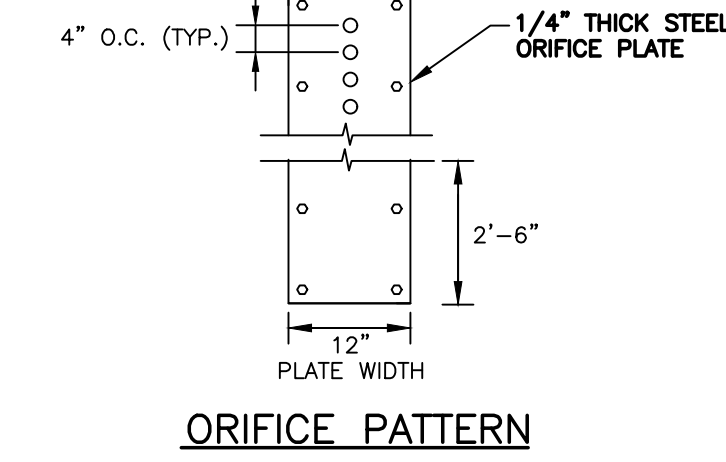
TYPICAL WQCV ORIFICE PLATE DETAIL D
SCALE: NTS

ORIFICE PATTERN

- ORIFICE PLATE NOTES:**
1. MINIMIZE THE NUMBER OF COLUMNS.
 2. PROVIDE GASKET MATERIAL BETWEEN THE ORIFICE PLATE AND CONCRETE.
 3. BOLT PLATE TO CONCRETE 12" MAX. ON CENTER.

- EURY AND WQCV TRASH RACKS:**
1. WELL-SCREEN TRASH RACKS (FOR CIRCULAR ORIFICES) SHALL BE STAINLESS STEEL AND SHALL BE ATTACHED BY INTERMITTENT WELDS ALONG THE EDGE OF THE MOUNTING FRAME.

2. STRUCTURAL DESIGN OF TRASH RACKS SHALL BE BASED ON FULL HYDROSTATIC HEAD WITH ZERO HEAD DOWNSTREAM OF THE RACK.
- OVERFLOW TRASH RACKS:**
1. ALL TRASH RACKS SHALL BE MOUNTED USING STAINLESS STEEL HARDWARE AND PROVIDED WITH HINGED AND LOCKABLE OR BOLTABLE ACCESS PANELS.

2. TRASH RACKS SHALL BE STAINLESS STEEL, ALUMINUM, OR STEEL. STEEL TRASH RACKS SHALL BE HOT DIP GALVANIZED AND MAY BE HOT POWDER COATED AFTER GALVANIZING.

3. TRASH RACKS SHALL BE DESIGNED SUCH THAT THE DIAGONAL DIMENSION OF EACH OPENING IS SMALLER THAN THE DIAMETER OF THE OUTLET PIPE.
 4. STRUCTURAL DESIGN OF TRASH RACKS SHALL BE BASED ON FULL HYDROSTATIC HEAD WITH ZERO HEAD DOWNSTREAM OF THE RACK.
