# ***WASTEWATER DISPOSAL REPORT***

***Joan Hathcock  
Double Spur Ranch Subdivision***

***EPC Parcel # 5213000007***

**August 2022**

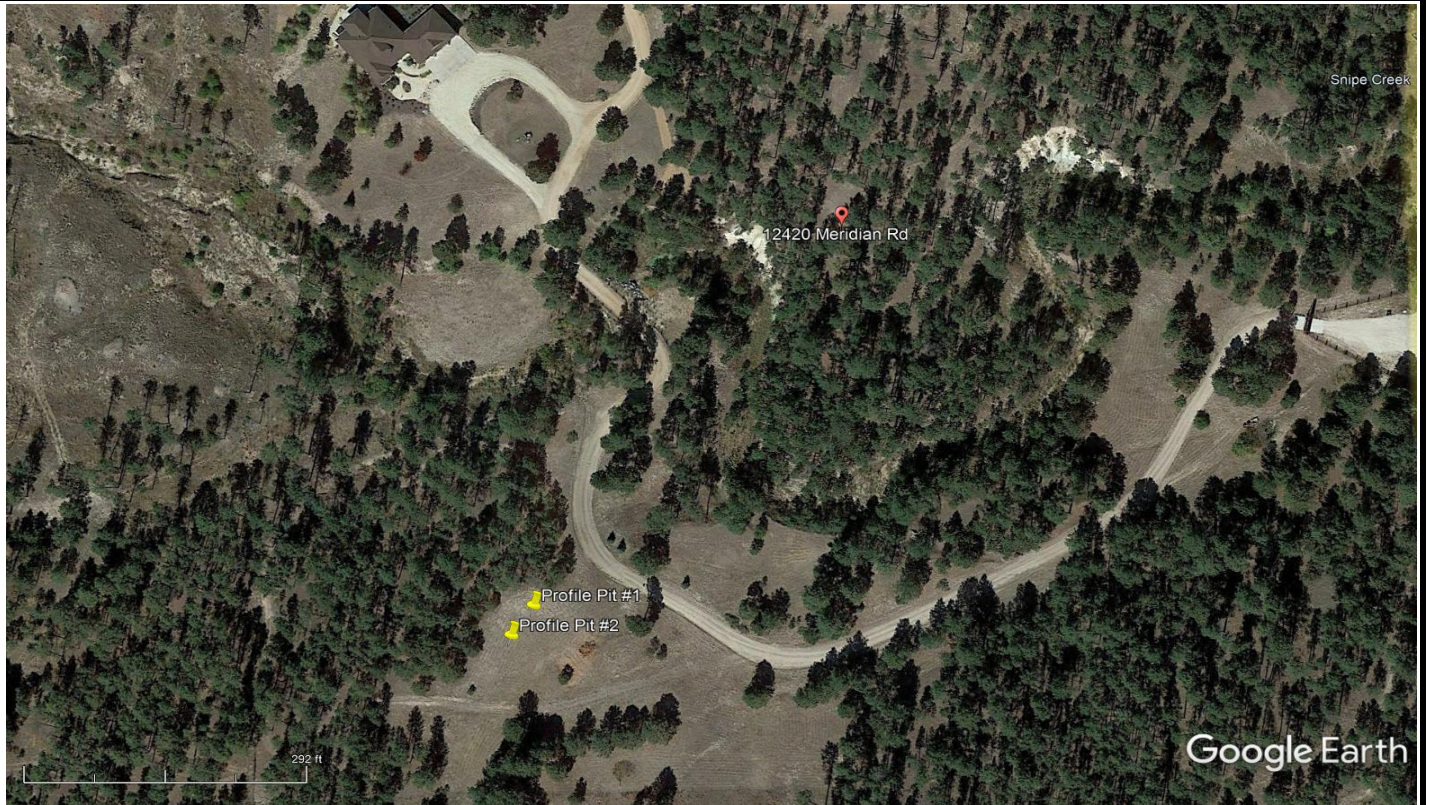
## Site Map:

Profile Pit Summary	
Profile Pit #1	
Lat:	39° 0'36.82"N
Long:	104°36'40.48"W
0 - 0'-6"	Topsoil
0'-6" - 3'-0"	Soil Type 2
3'-0" - 5'-0"	Soil Type 3
5'-0" - 8'-0"	Soil Type 2
-	-
Profile Pit #2	
Lat:	39° 0'36.48"N
Long:	104°36'40.78"W
0 - 0'-6"	Topsoil
0'-6" - 3'-0"	Soil Type 2
3'-0" - 8'-0"	Soil Type 3
-	-
-	-
Existing Well (If applicable)	
Lat:	N/A
Long:	N/A
