ENTECH
ENGINEERING, INC.

Re: Geologic Hazard Additional Borings
Springs at Waterview East (Trails at Aspen Ridge)
South Powers and Bradley Road
Colorado Springs, Colorado

SITE PLAN/TEST BORING LOCATION MAP
SPRINGS AT WATERVIEW EAST
S POWERS BOULEVARD AND BRADLEY ROAD
EL PASO COUNTY, CO.
FOR: COLA, LLC

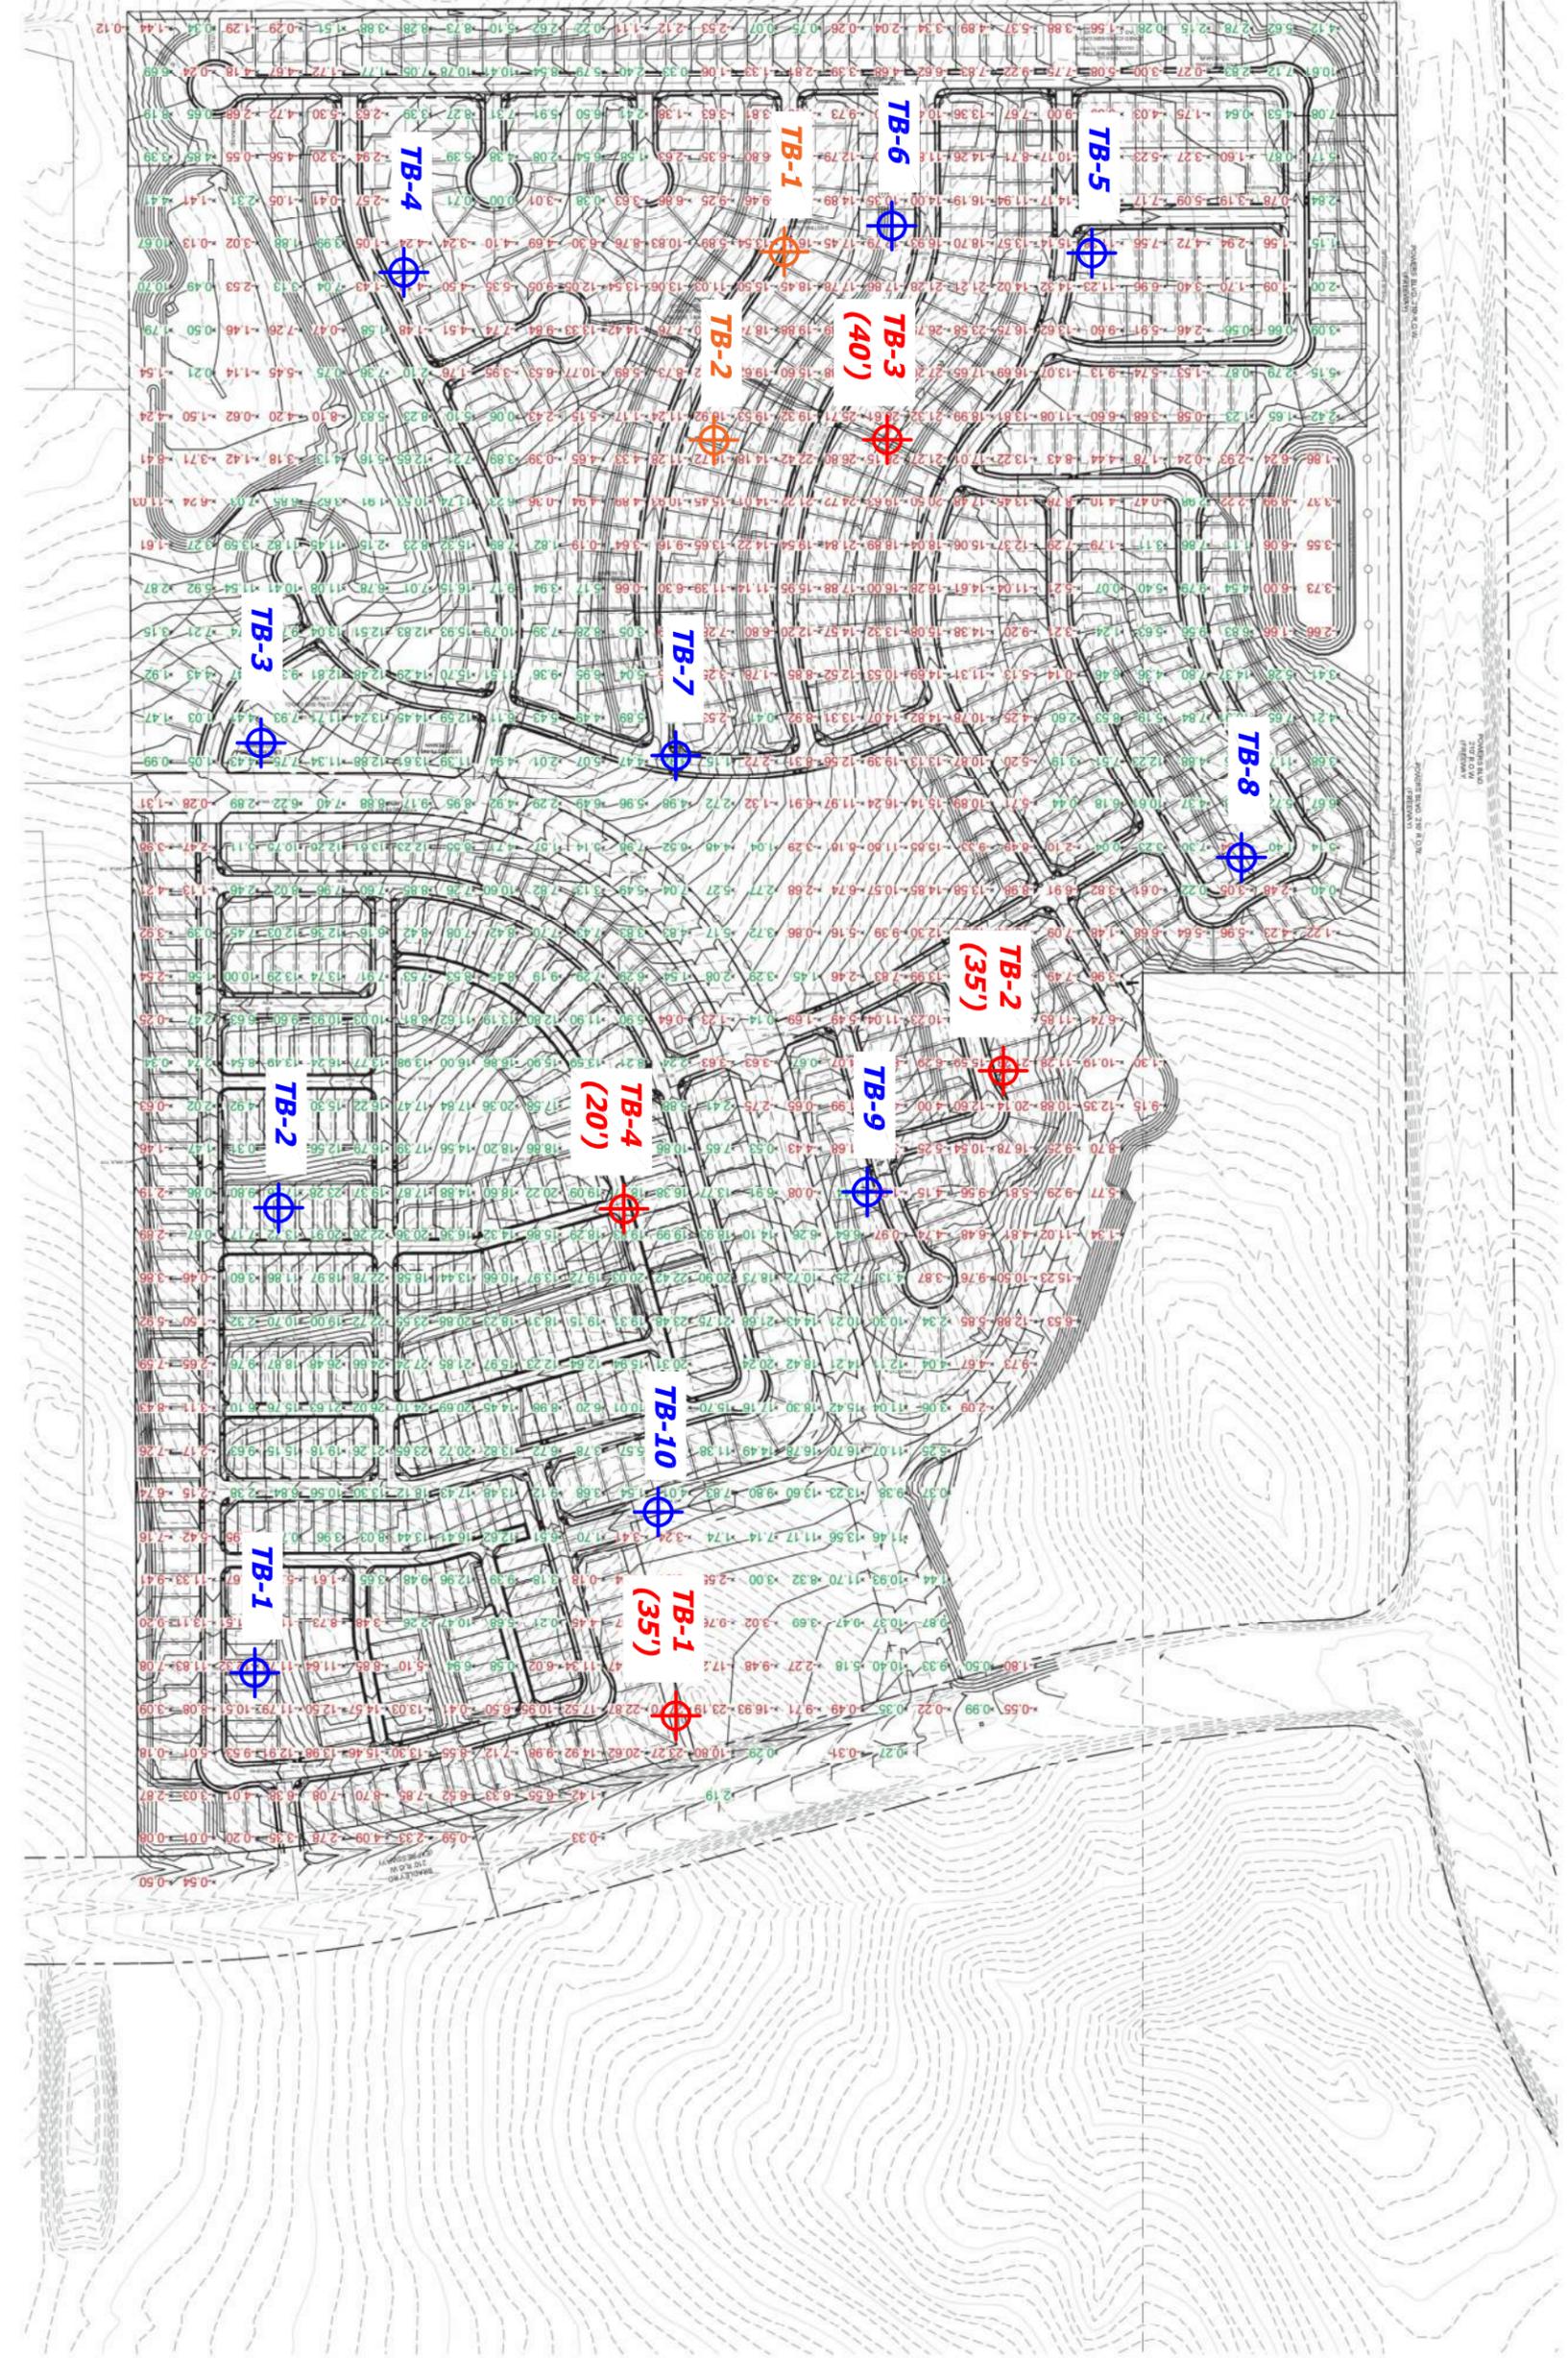
DRAWN	ALL
CHECKED	
DATE	8/8/19
SCALE	AS SHOWN
JOB NO.	170059
FIGURE NO.	1

TB - APPROXIMATE TEST BORING LOCATION AND NUMBER
(DRILLED 2/8/19)

CGS recommended additional investigation on the site in areas where significant cuts are proposed. Entech drilled four additional borings on August 7, 2019. Test Boring locations are shown on Figure 1. Test Boring Nos. 1 – 3 were drilled in areas of deep cuts, and Test Boring No. 4 was placed in an area of significant fill. Groundwater was not encountered during drilling or subsequent to drilling. The test borings were drilled to depths of 20 to 40 feet. Soils encountered in these borings consisted of predominantly sandy clay soils with underlying claystone and shale bedrock. The bedrock underlying the site is the Pierre Shale Formation of Cretaceous Age, which typically has a moderate to high expansion potential.

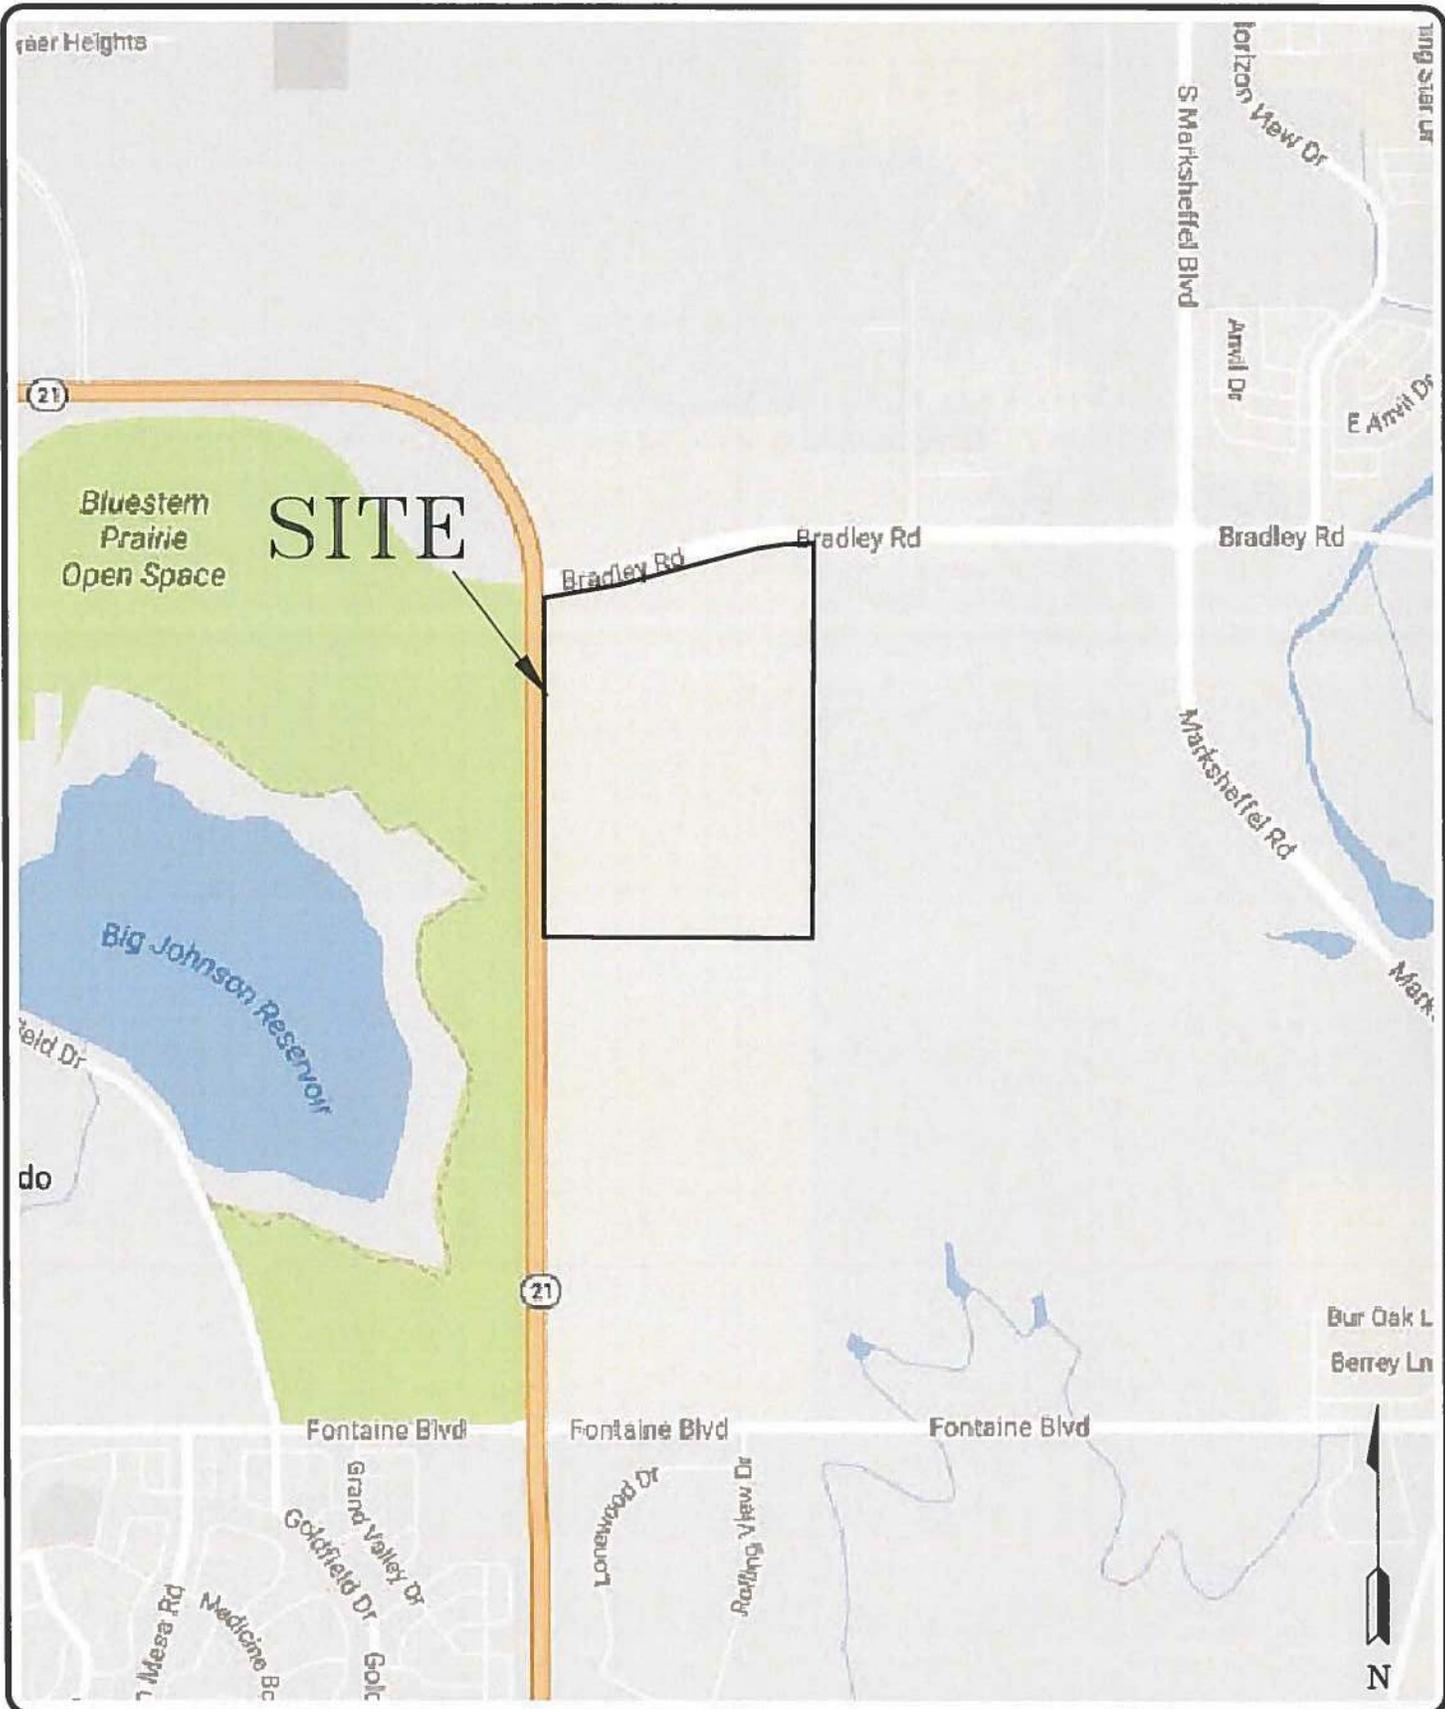
FIG NO.:
1

VICINITY MAP
SPRINGS AT WATERVIEW EAST
POWERS BOULEVARD AND BRADLEY ROAD
EL PASO COUNTY, CO.
FOR: DAKOTA SPRINGS ENGINEERING, INC.

The site is located in a portion of the W½ of Section 9, Township 15 South, Range 65 West of the 6th Principal Meridian in El Paso County, Colorado. The site is located approximately 2½ miles east of Security-Widefield, Colorado, at the southeastern corner of South Powers Boulevard and Bradley Road. The location of the site is as shown on the Vicinity Map, Figure 1.

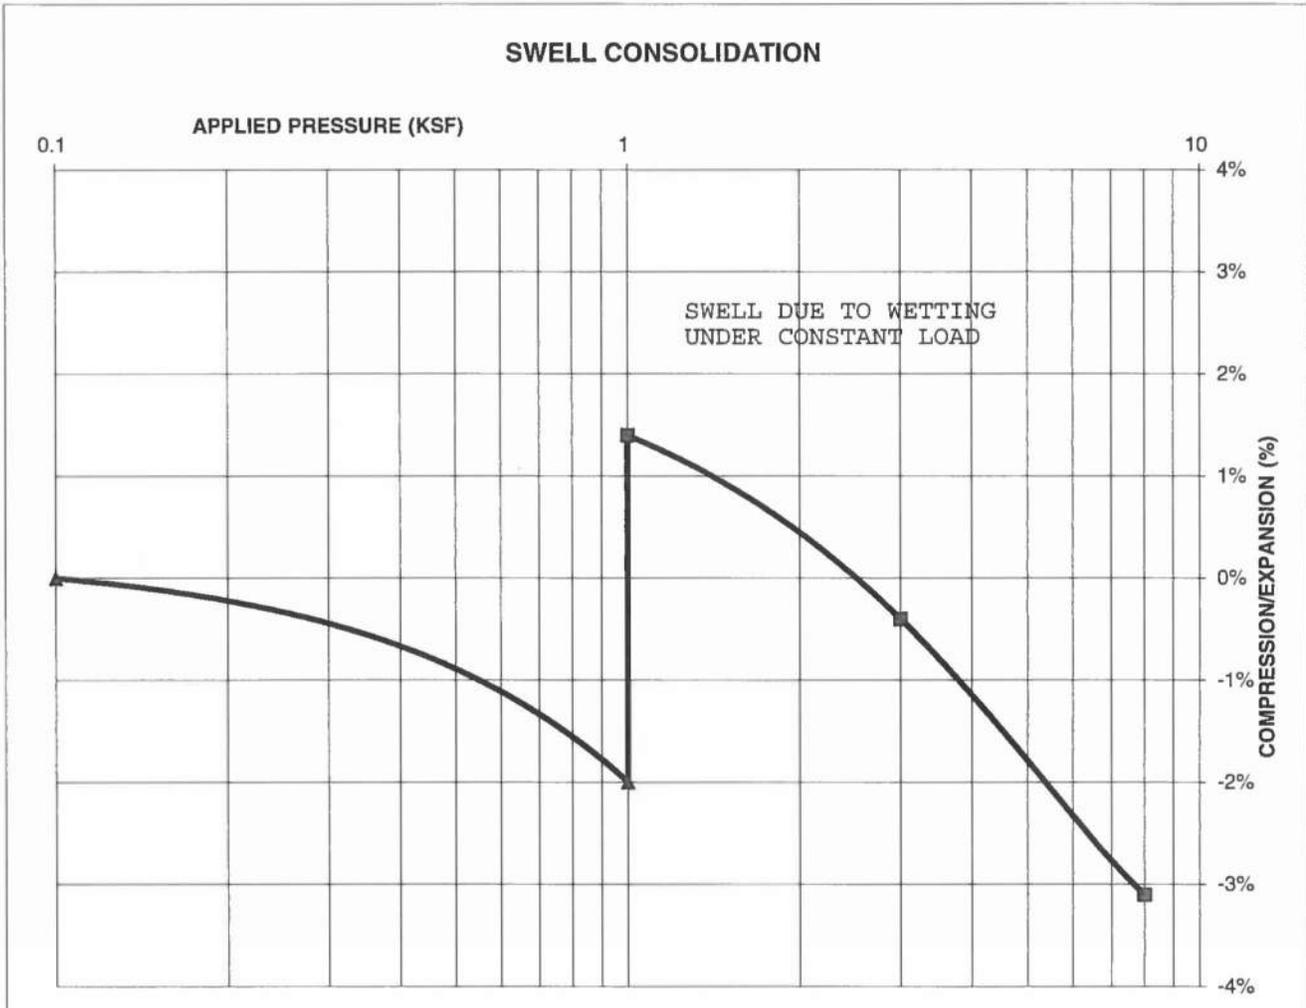
TEST BORING #	4	DEPTH(ft)	5
DESCRIPTION	CH	SOIL TYPE	3
NATURAL UNIT DRY WEIGHT (PCF)			114
NATURAL MOISTURE CONTENT			16.9%
SWELL/CONSOLIDATION (%)			3.4%
