Job No. 188268

March 30, 2022

Re: Addendum to Soils and Geology Study – Proposed Zone Change
Tract B, Windermere, Filing No. 1
El Paso County, Colorado

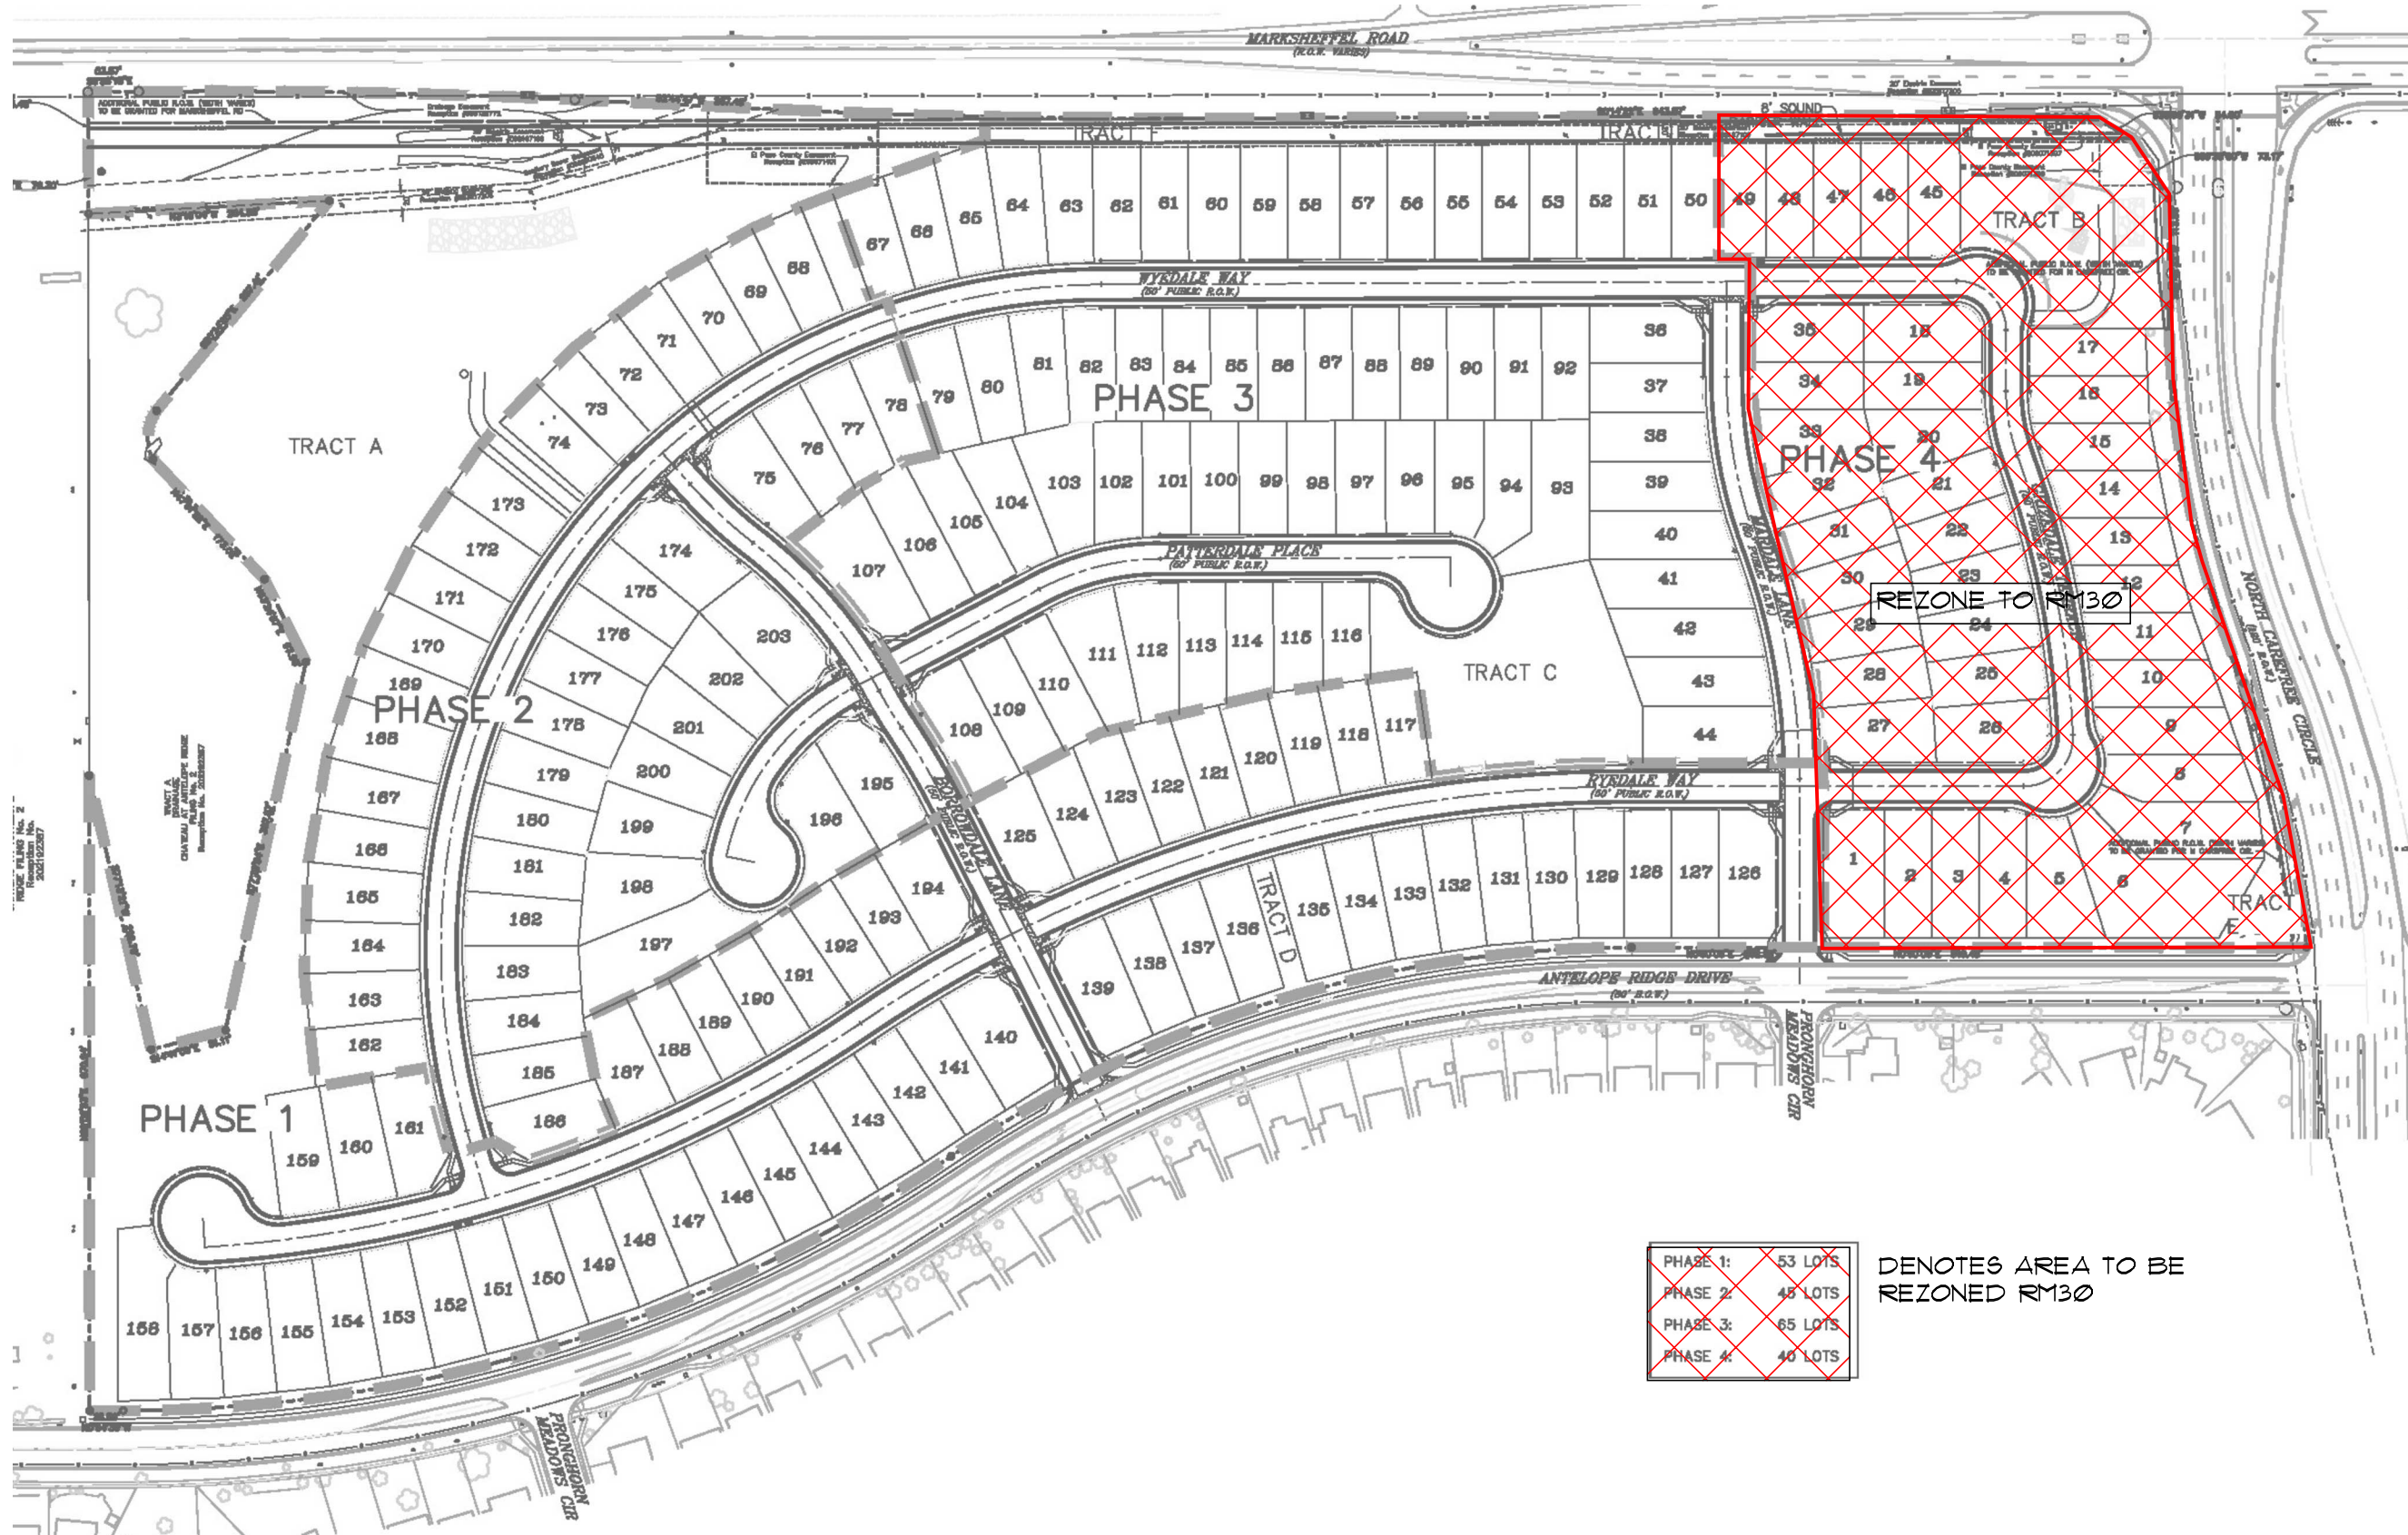
SHEET No.
FIG-2

DENOTES AREA TO BE
REZONED RM30

SITE PLAN

The purpose of this addendum is to review the geologic conditions present within the southern portion of the site (designated as Tract B on the updated plat drawings for Windermere Filing No. 1 by Drexel, Barrell & Co. last dated March 25, 2022, Job No. 21187-01) and provide an opinion regarding the negative impacts (if any) that the identified geologic conditions will have on the proposed zoning change. The figures originally presented in the *Soils and Geology Study* noted above have been revised to identify the area that is to be rezoned, and are attached and included as Figures 1-6 of this report. Figure 7 of this report depicts the currently proposed configuration of the site, with Tract B identified.

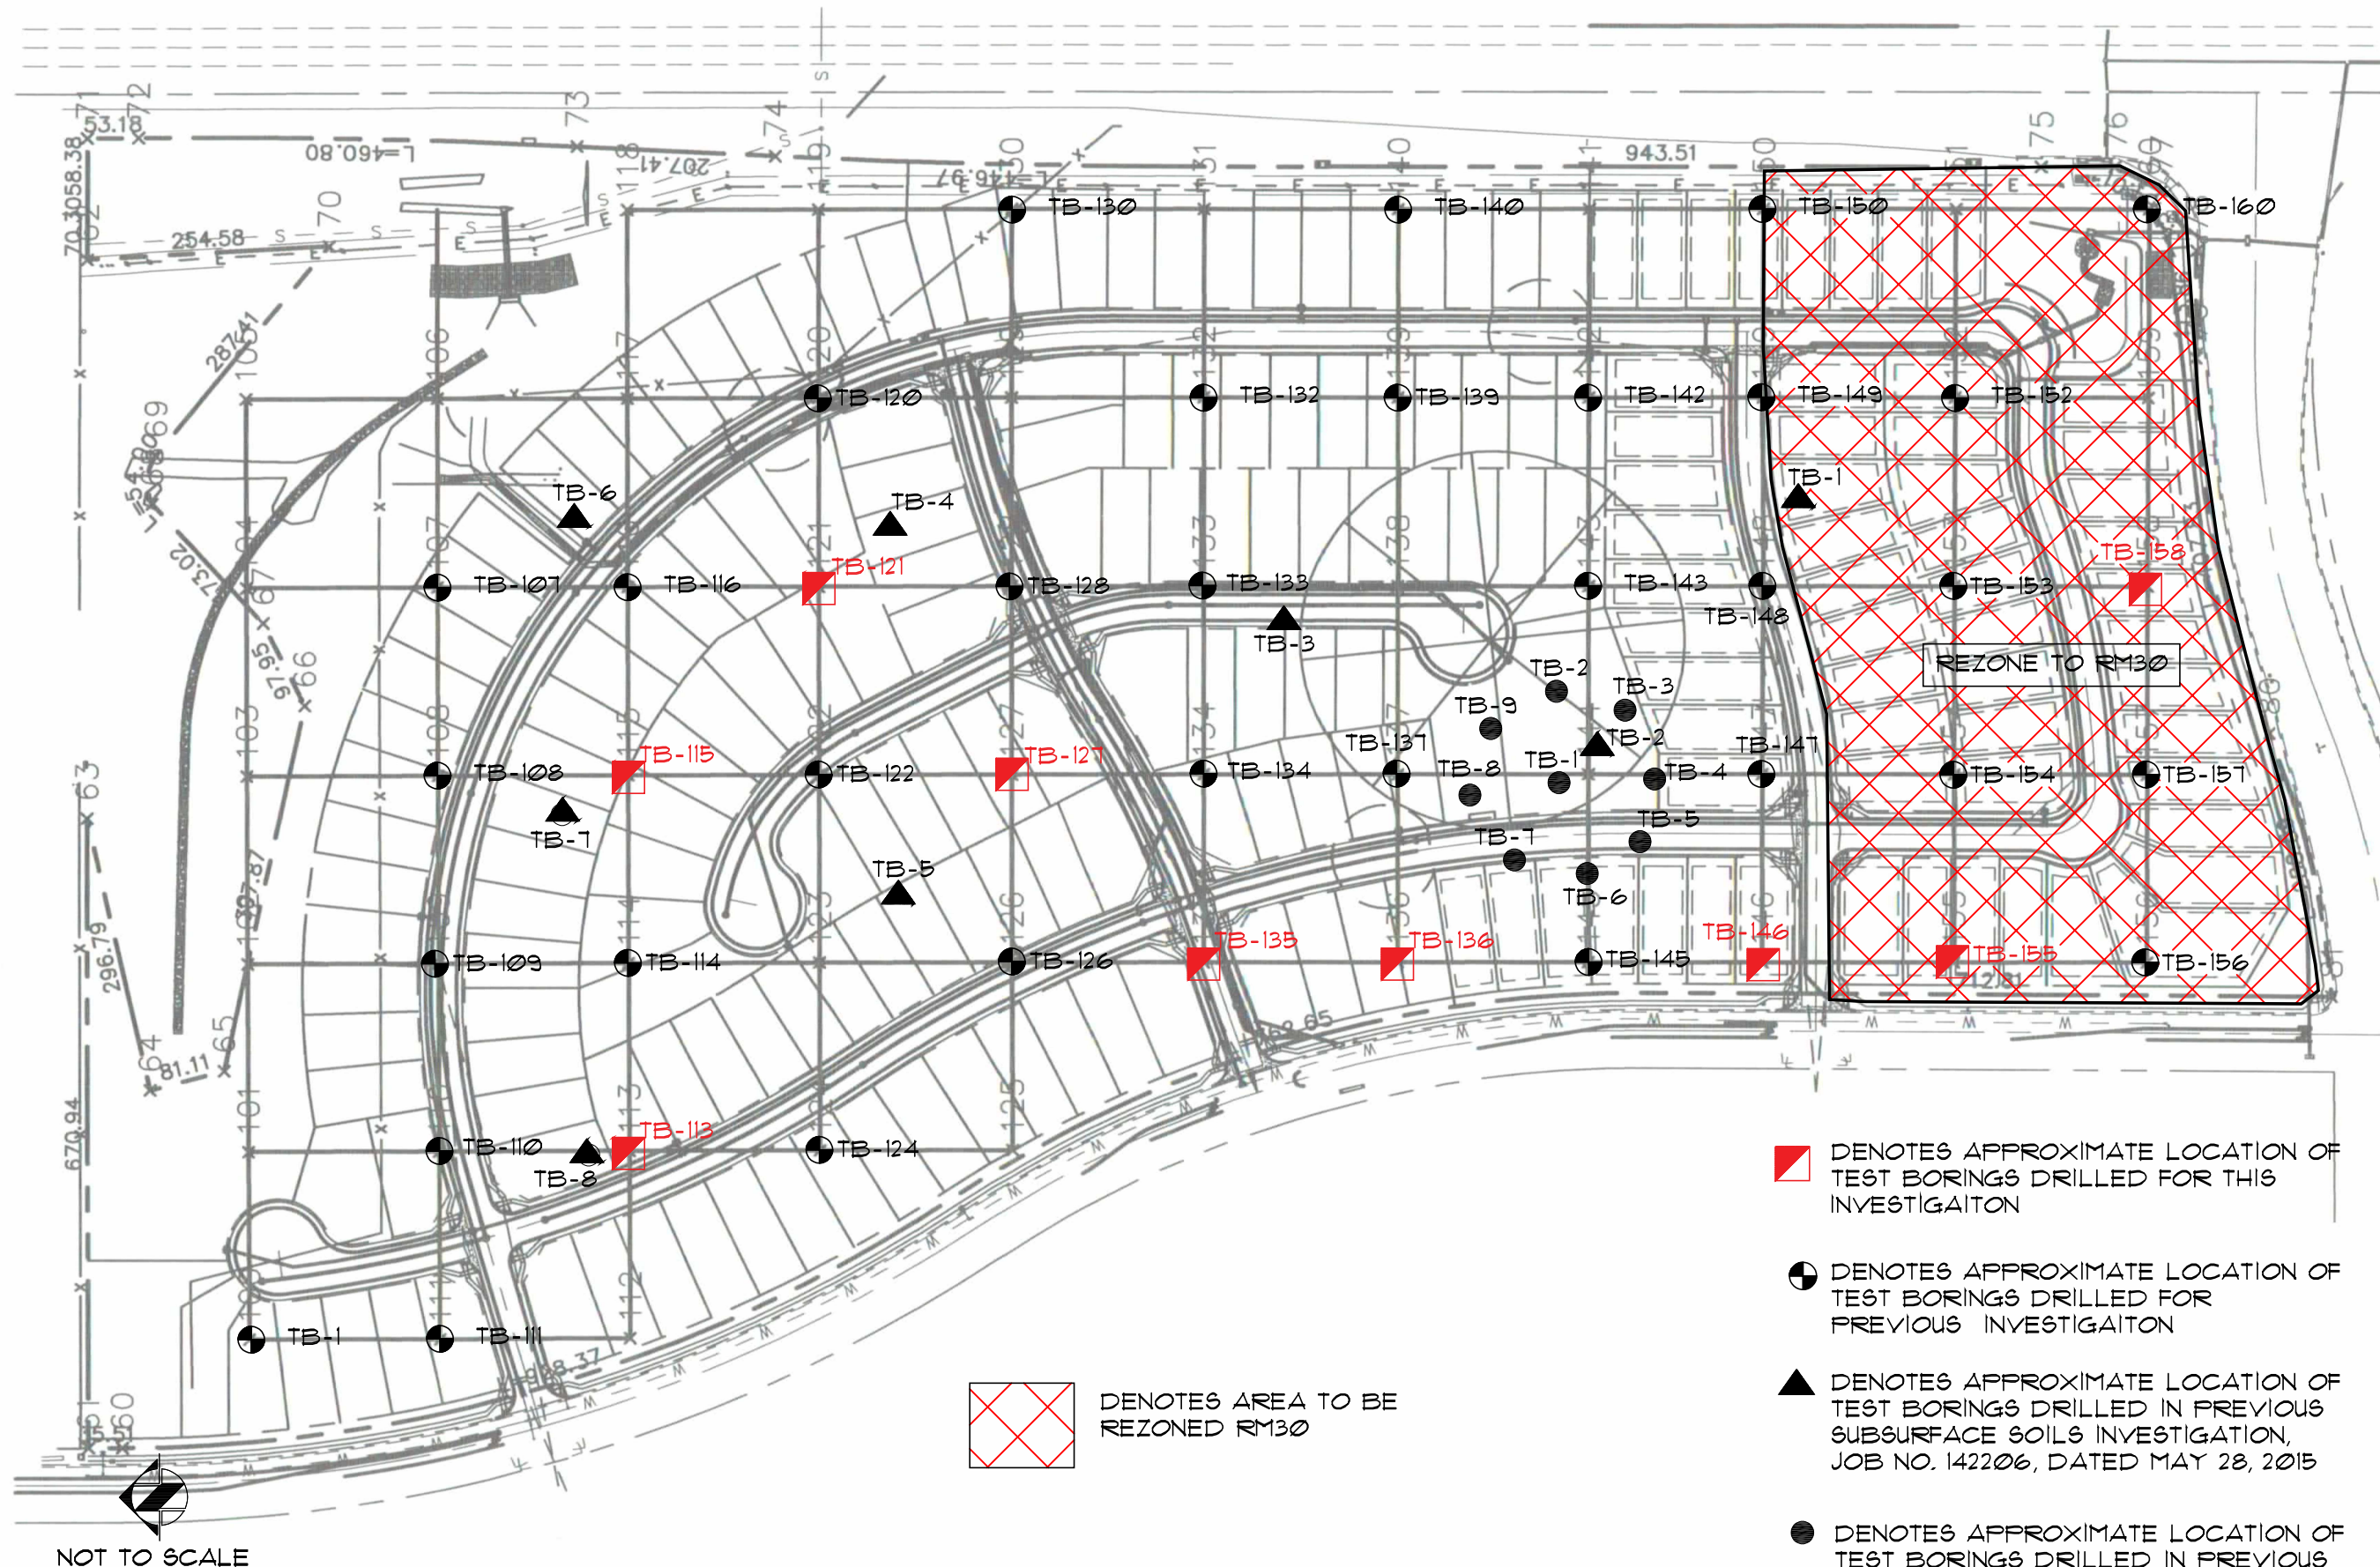
FIG-3

■ DENOTES APPROXIMATE LOCATION OF TEST BORINGS DRILLED FOR THIS INVESTIGATION

● DENOTES APPROXIMATE LOCATION OF TEST BORINGS DRILLED FOR PREVIOUS INVESTIGATION

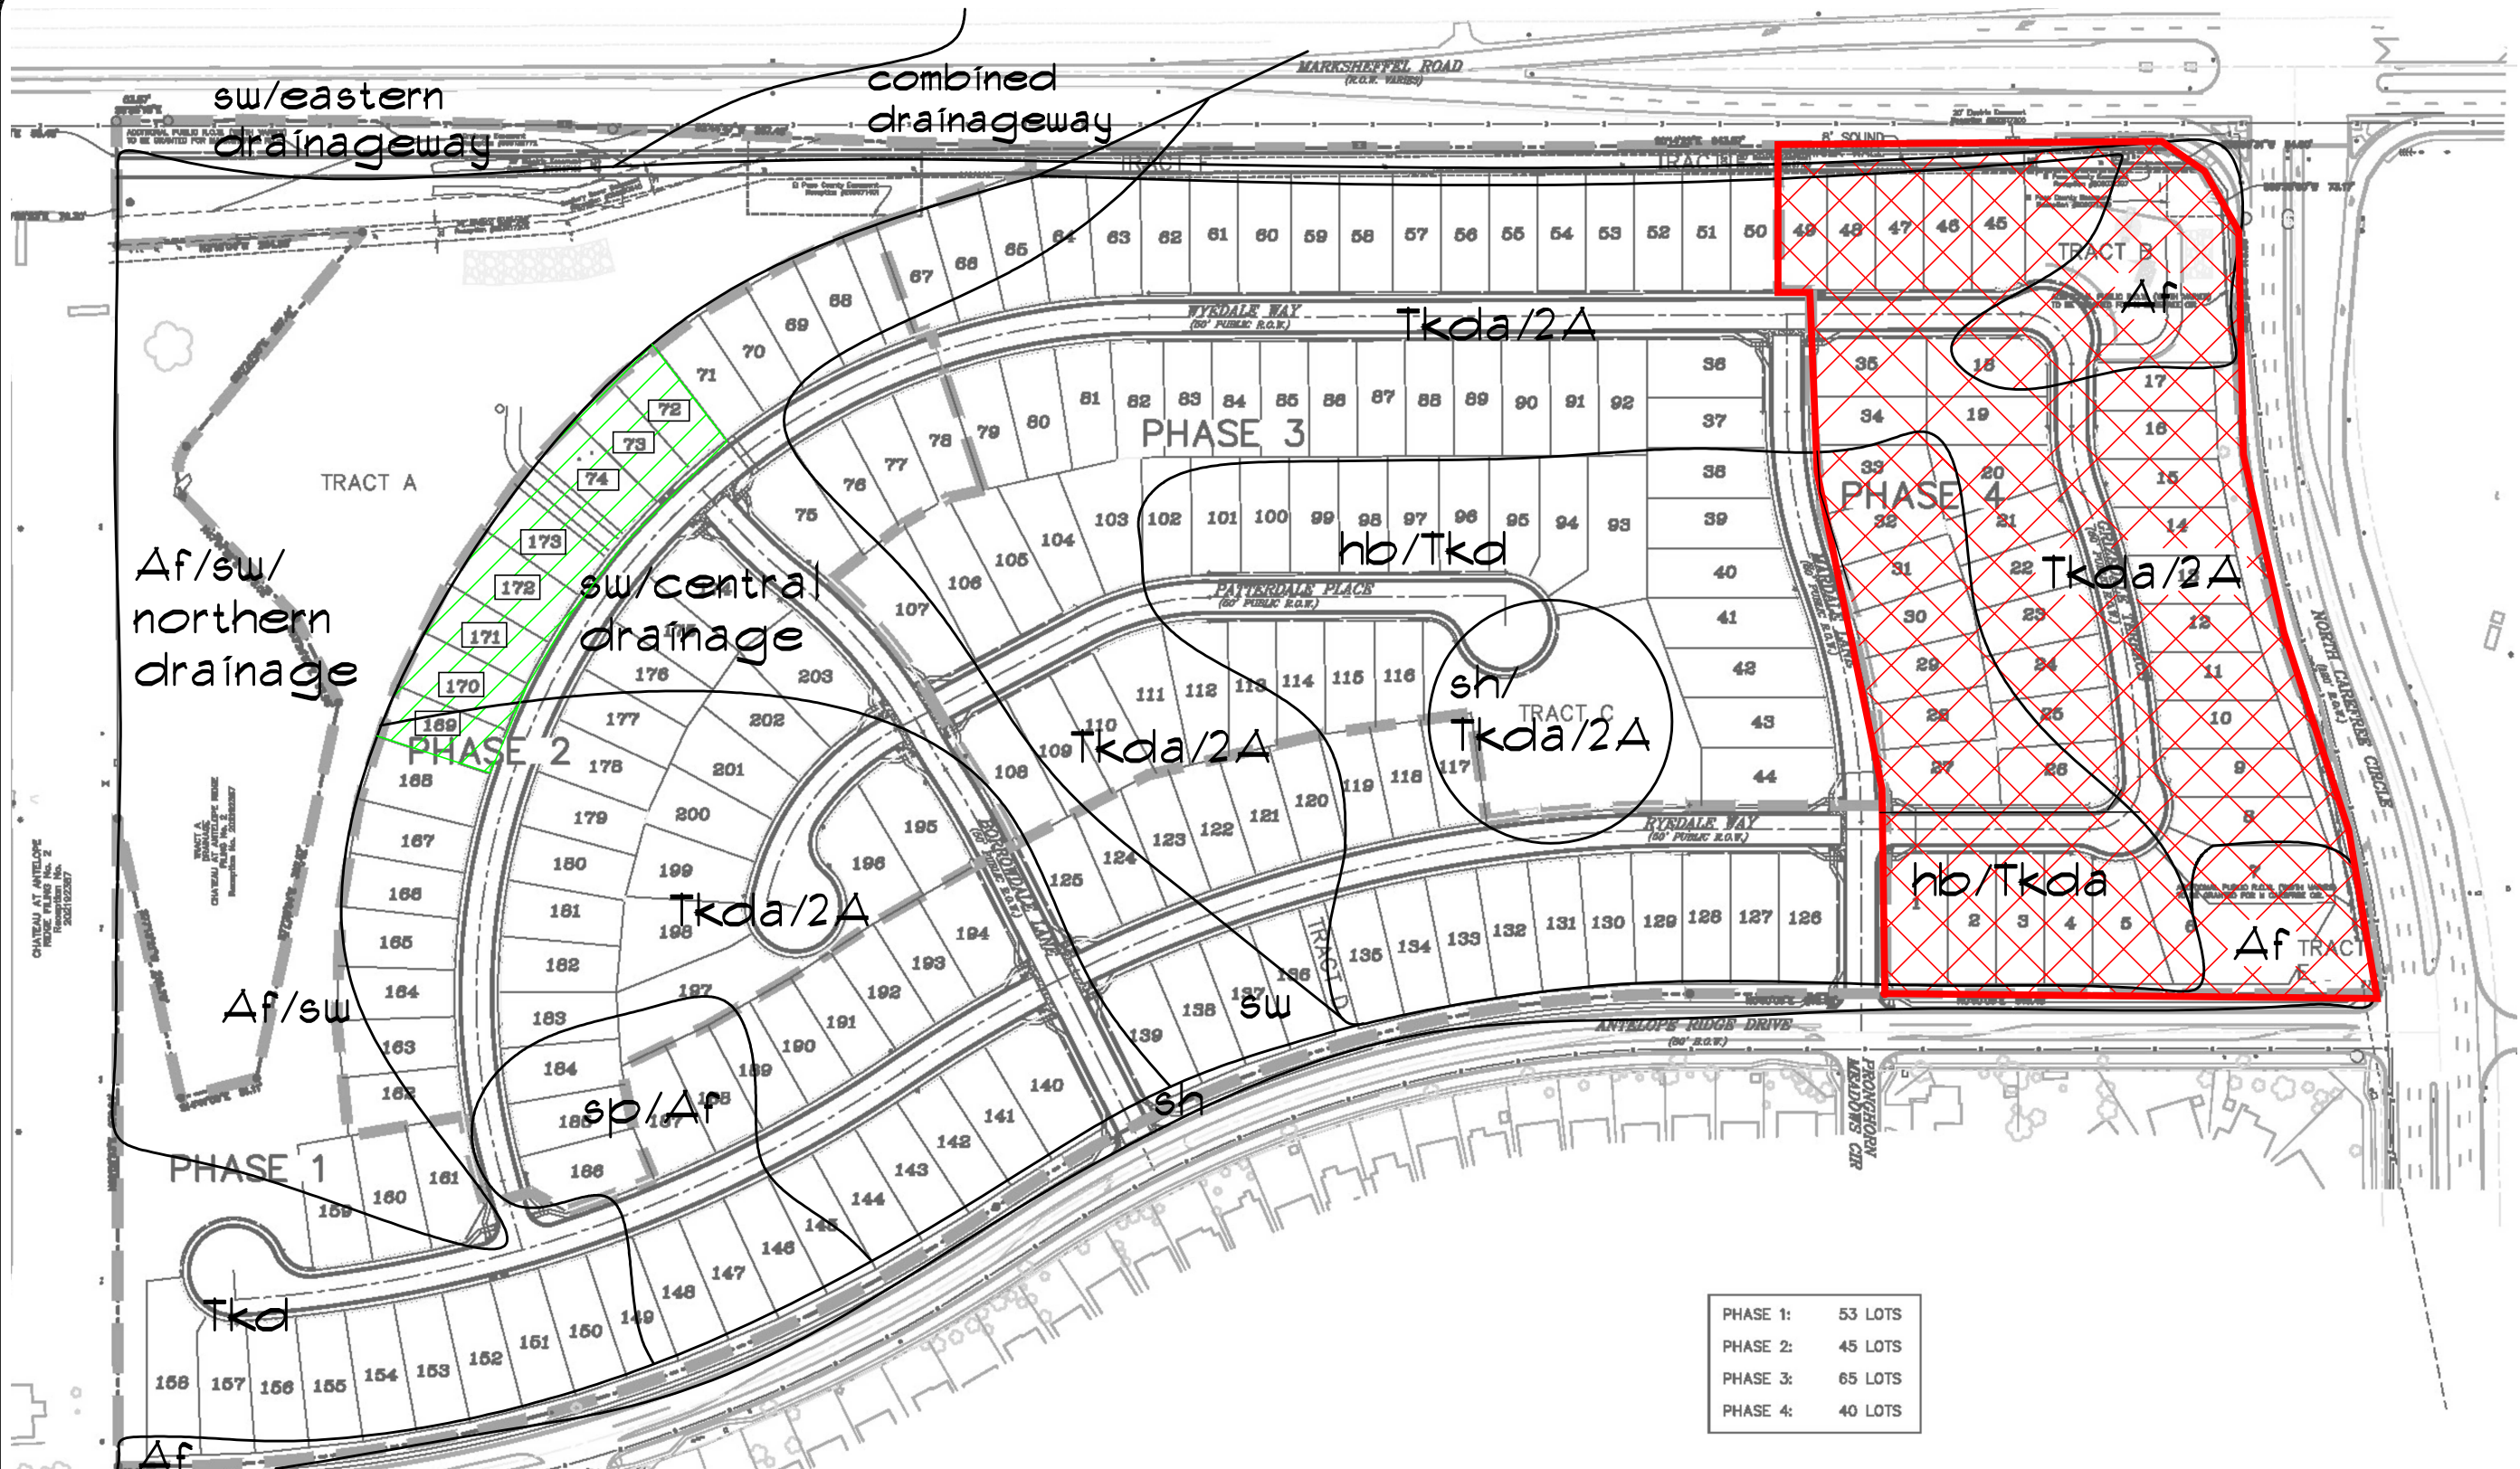
FIG-4

Geologic

- *Tkda* - Dawson Arkose Formation (Eocene) - Dawson Sandstone consists of silty sandstone with interbedded layers of claystone/siltstone.
- *Af* - Artificial fill - areas of visible known fill to include: the existing detention pond banks, berms along the western and southern property lines, stockpile
- *sw* - seasonally wet areas where near-surface moisture conditions may seasonally occur, includes areas where shallow groundwater was encountered in the test borings
- *sh* - sandstone "hill"
- *hb* - hard to very hard sandstone bedrock encountered at the surface
- *sp* - stockpile

With the indication of seasonally shallow groundwater near the existing detention pond, full-depth basements are not recommended on Lots 72-74, and 169-173.

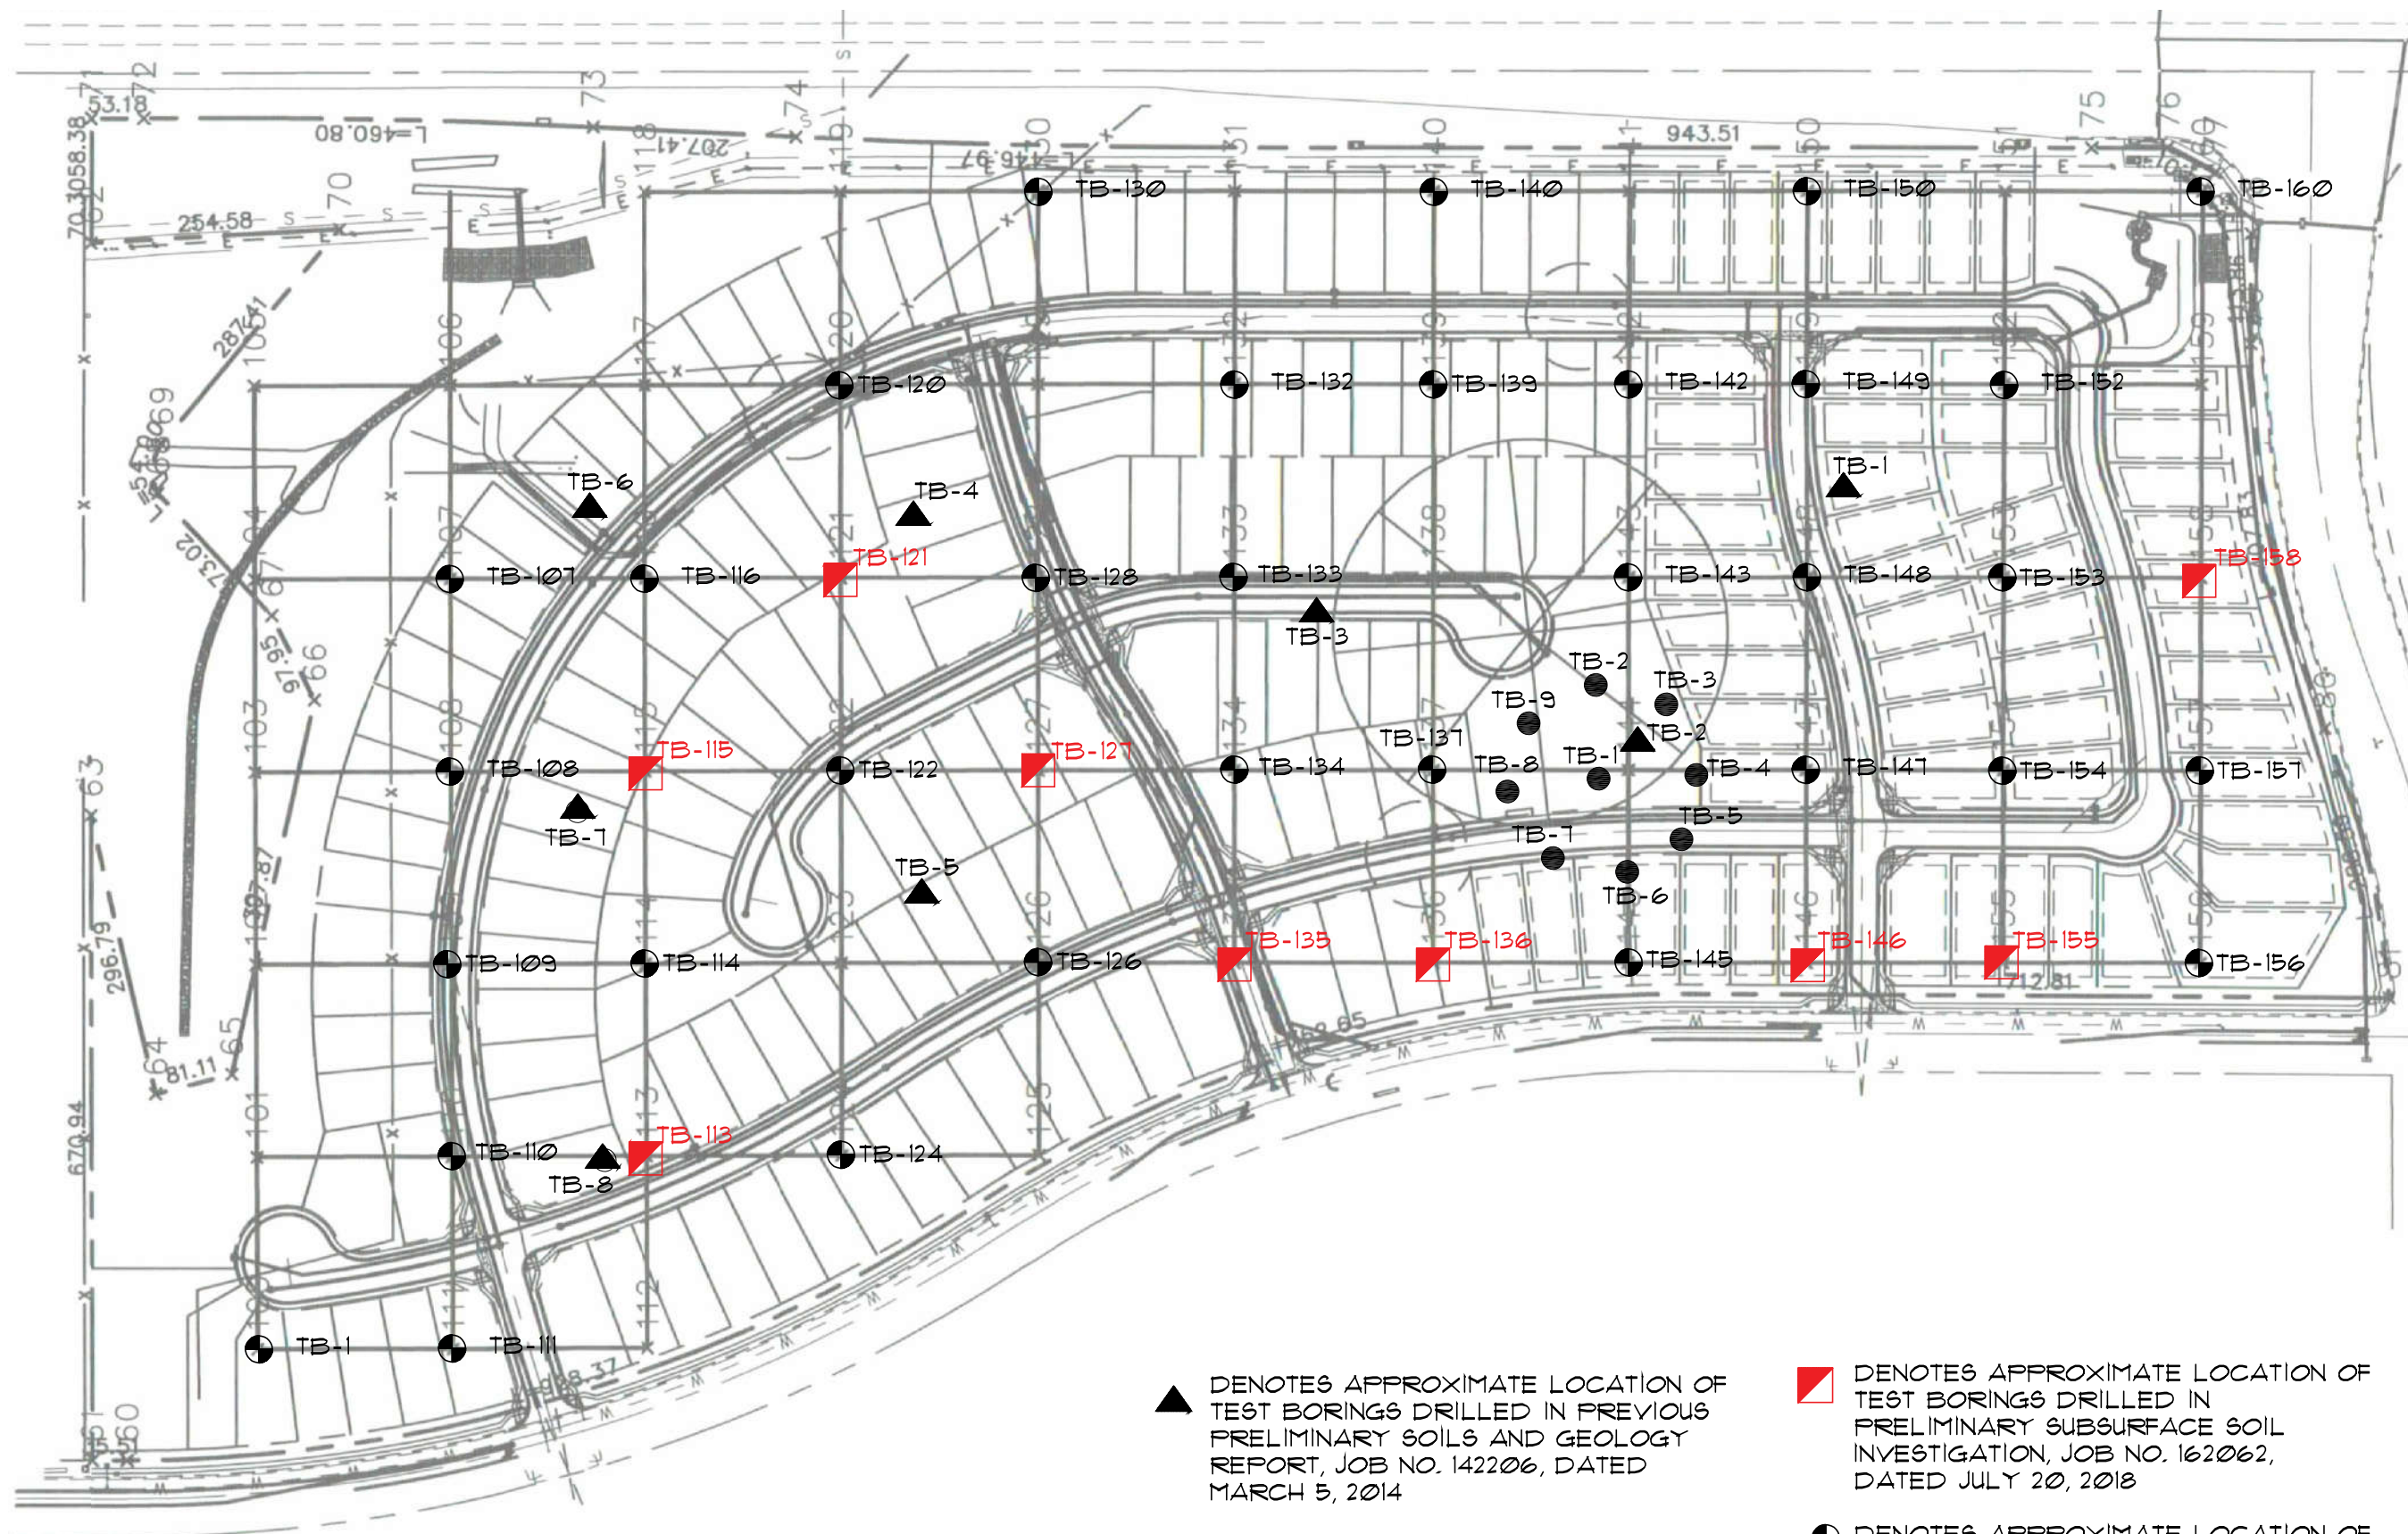
FIG-3

- ▲ DENOTES APPROXIMATE LOCATION OF TEST BORINGS DRILLED IN PREVIOUS PRELIMINARY SOILS AND GEOLOGY REPORT, JOB NO. 142206, DATED MARCH 5, 2014
- DENOTES APPROXIMATE LOCATION OF TEST BORINGS DRILLED IN PREVIOUS SUBSURFACE SOIL INVESTIGATION, JOB NO. 142206, DATED MAY 28, 2015

The subsurface conditions within the property were previously explored multiple times by RMG, by drilling a total of sixty (60) exploratory borings between March 2014 and March 2018. The test borings extended to depths of approximately 10 to 47 feet below the existing ground surface. The approximate locations of the test boring locations are presented on the Test Boring Location Plan, Figure 3.

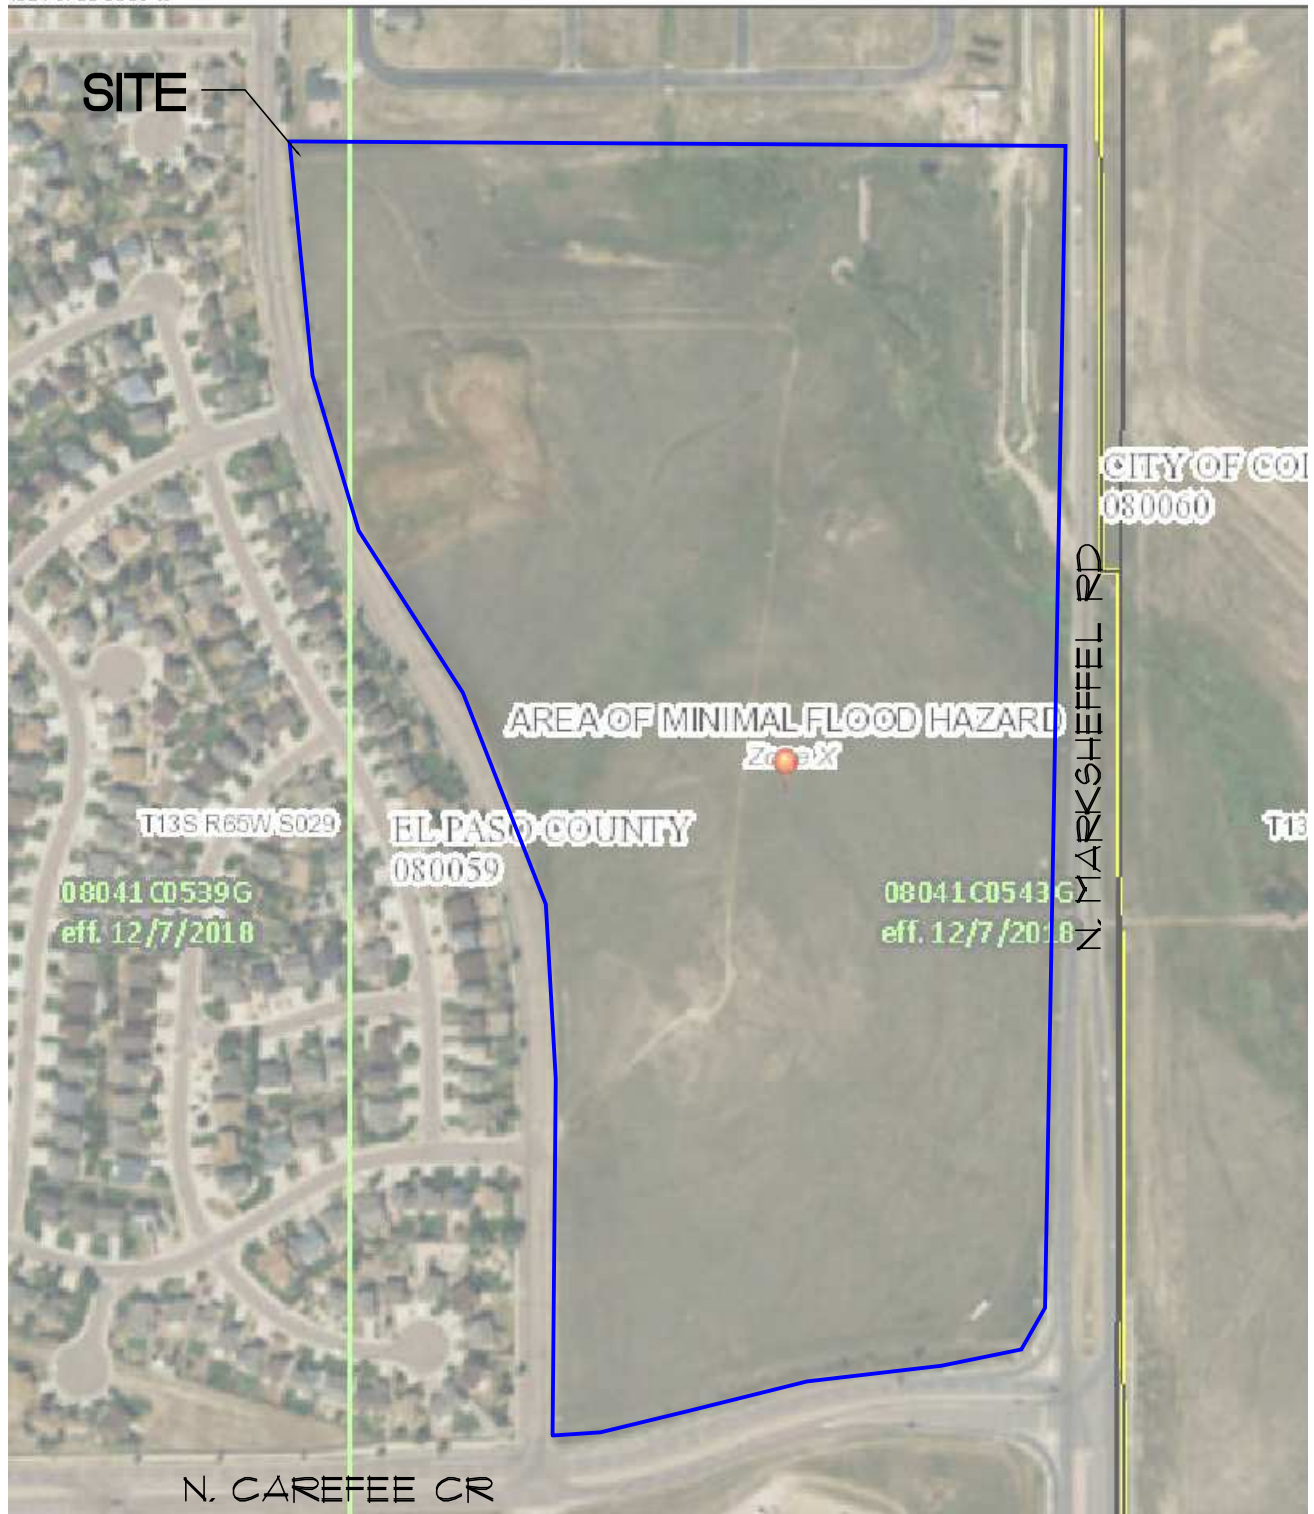
FIG No. 6

NOT TO SCALE
BASE MAP PROVIDED BY: FEMA

Based on our review of the Federal Emergency Management Agency (FEMA) Community Panel No. 08041C0539G and 08041C0543G effective December 7, 2018 and the online ArcGIS El Paso County Risk Map, the entire property lies outside of any designated 100-year and 500-year floodplains. The FEMA Map is presented in Figure 6.

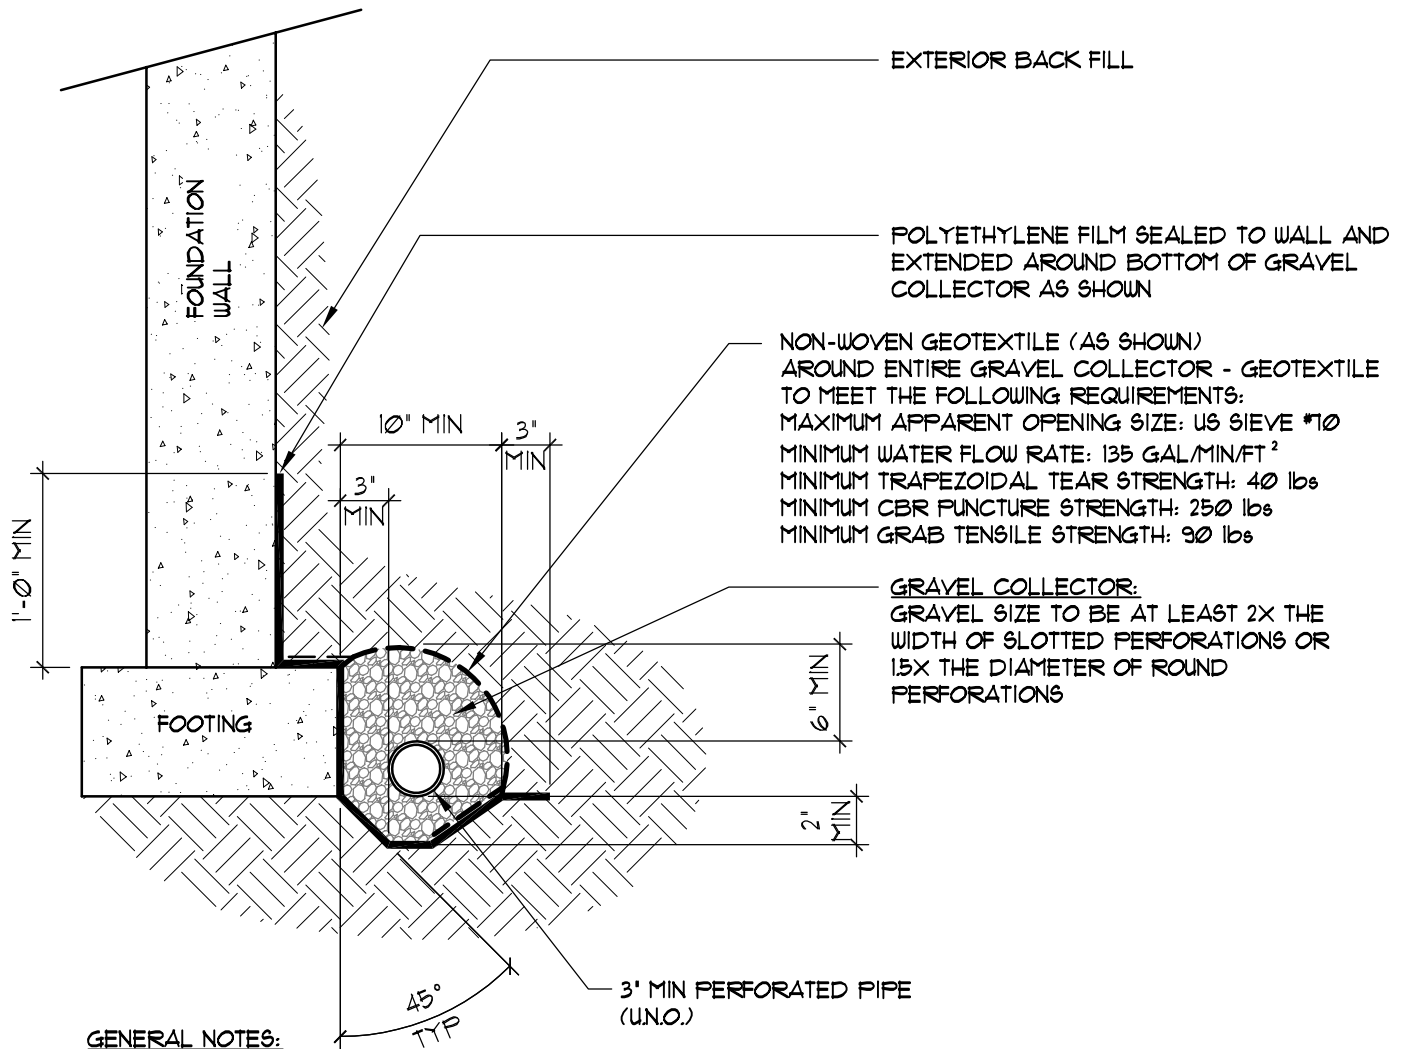
FIG No. 7

PERIMETER DRAIN

Foundations are required to have a minimum 30-inch depth for frost protection. In areas where potentially high subsurface moisture conditions are anticipated, subsurface drains are recommended to help minimize the intrusion of water into areas below grade. Typical drain details are presented in Figures 7 and 8.
