**GEOLOGIC HAZARDS EVALUATION AND
PRELIMINARY GEOTECHNICAL INVESTIGATION
WATERSIDE TOWNHOMES
SOUTHEAST OF WOODMOORE DRIVE AND
DEER CREEK ROAD
EL PASO COUNTY, COLORADO**

Project No. CS19463-115

January 27, 2022

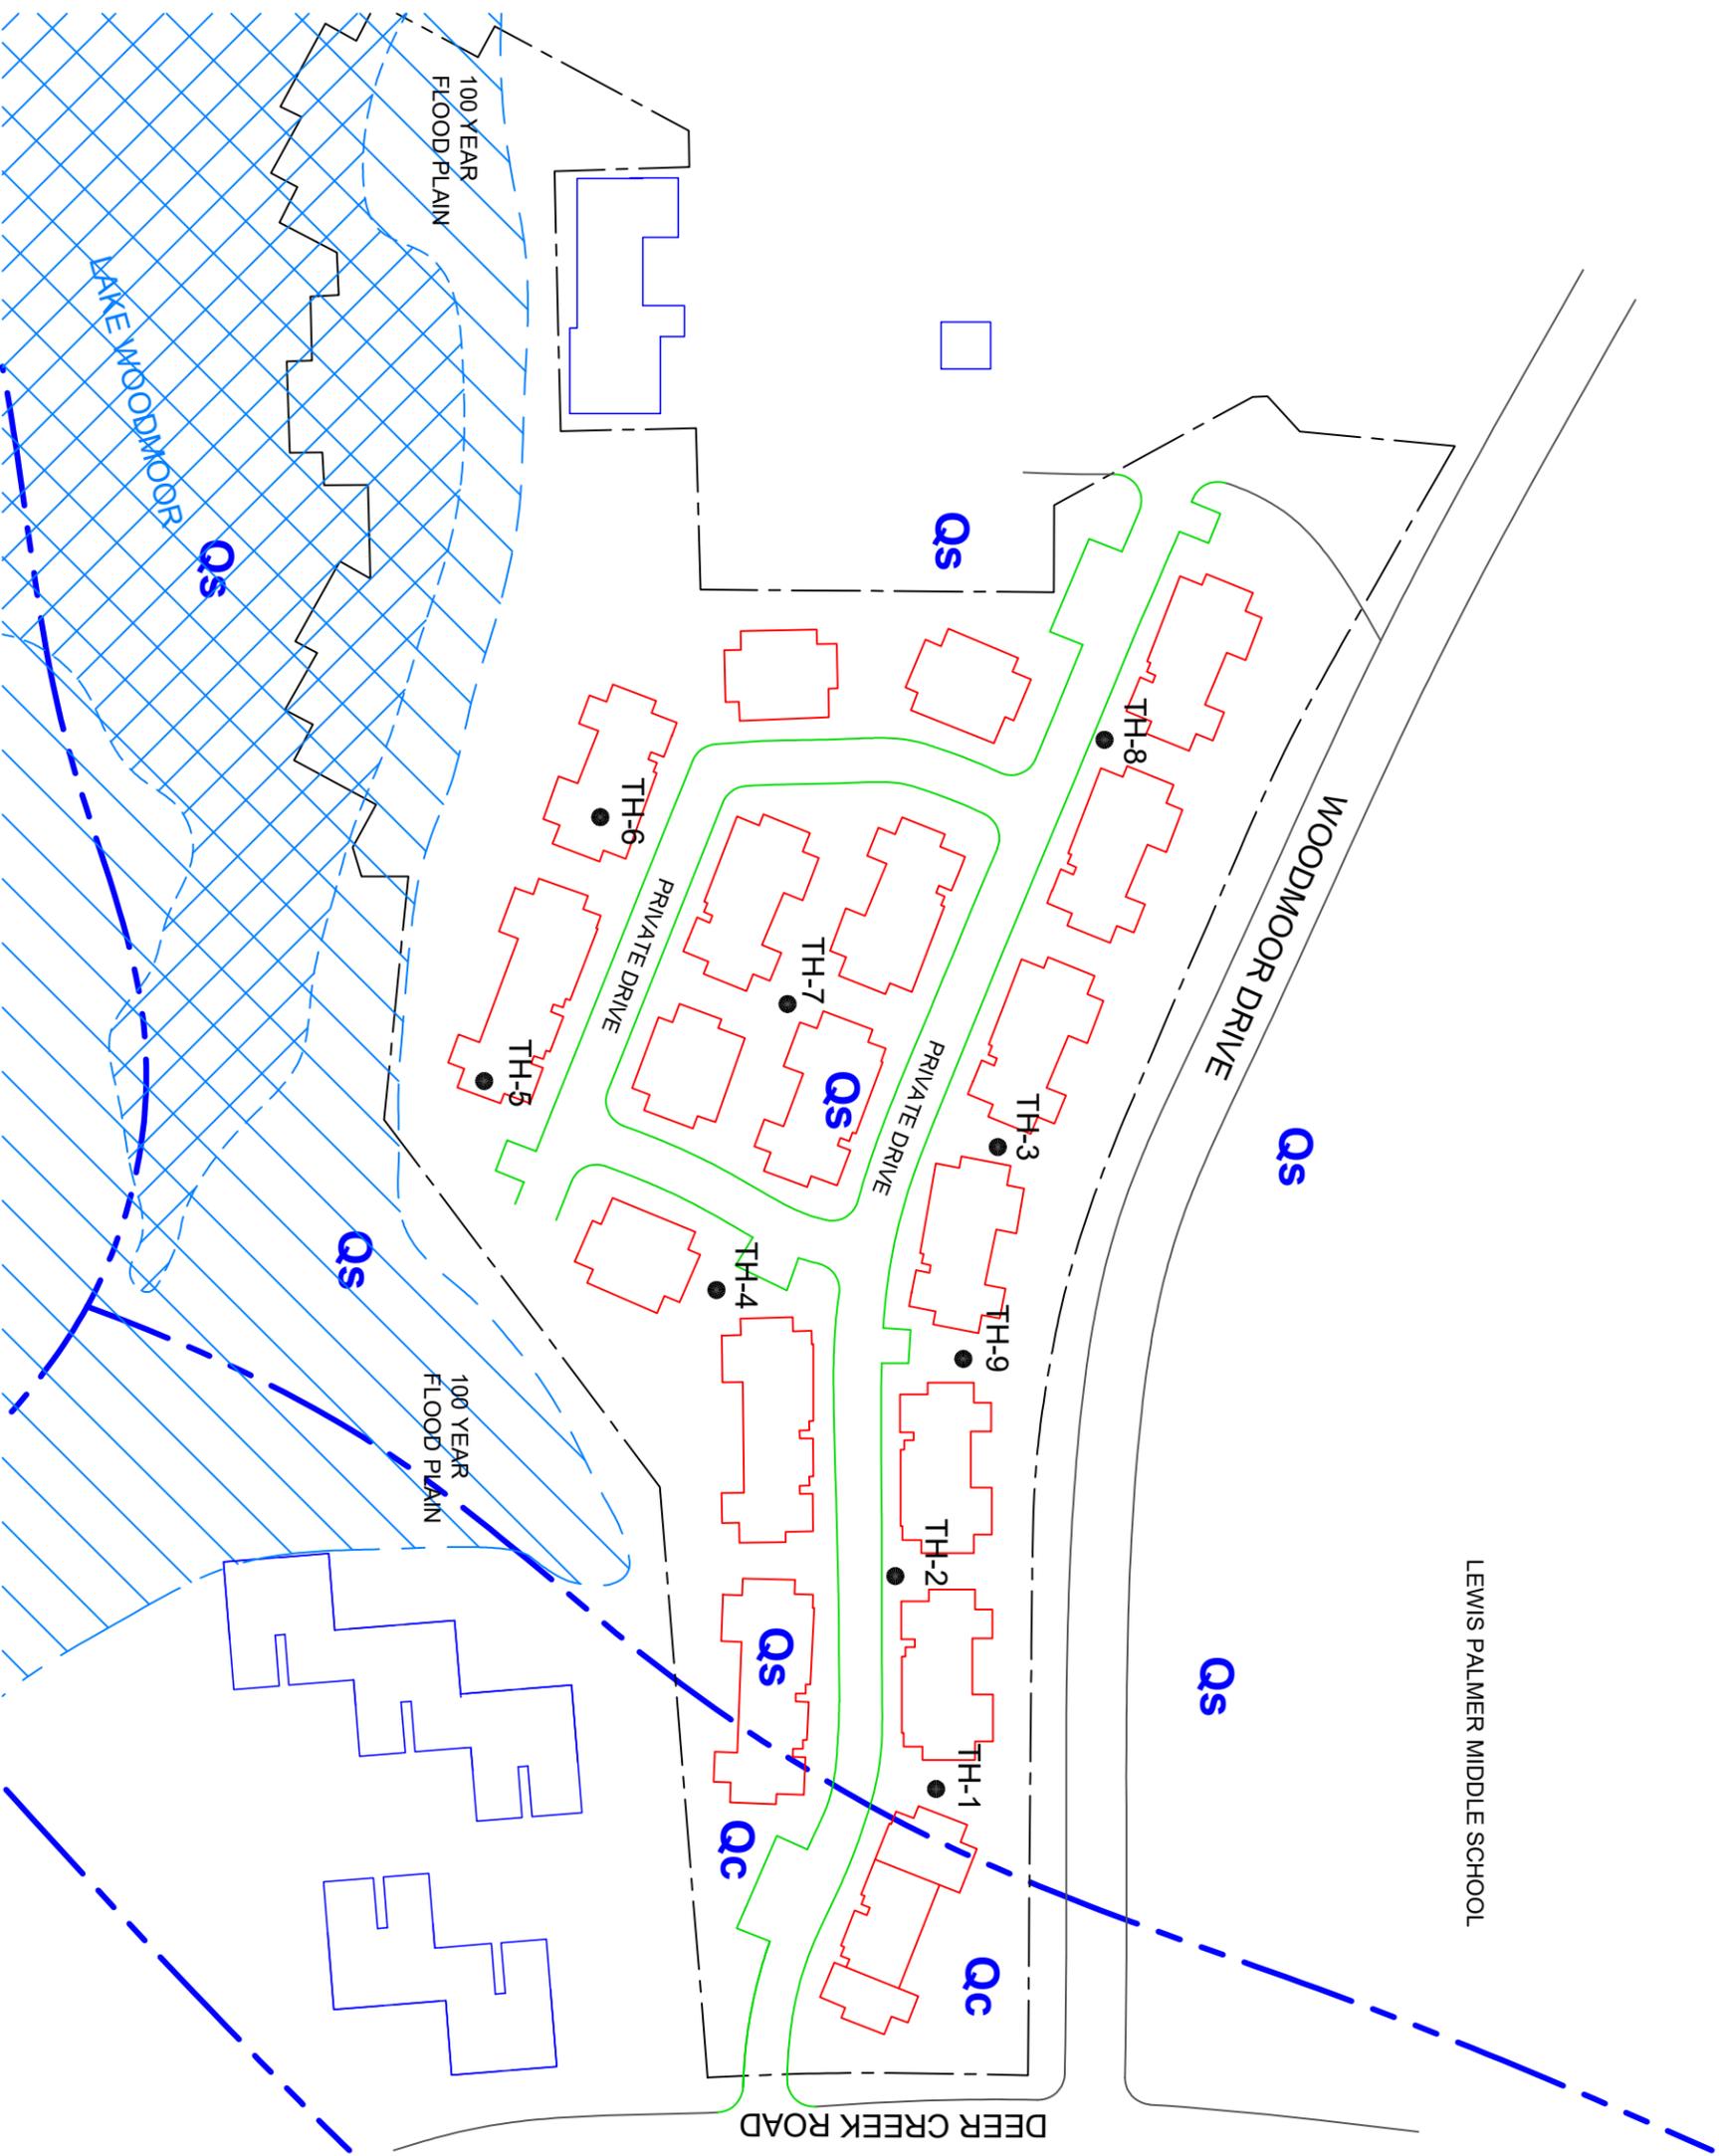
1. BASE DRAWING WAS PROVIDED BY N.E.S., INC., WATERSIDE CONCEPT DATED AUGUST 10, 2021.
2. ALL CONTACT BOUNDARIES SHOULD BE CONSIDERED APPROXIMATE. THE BOUNDARIES ARE BASED UPON A SUBJECTIVE INTERPRETATION OF PUBLISHED MAPS, AERIAL PHOTOGRAPHS AND AN INITIAL FIELD RECONNAISSANCE. CHANGES IN THE MAPPED BOUNDARIES SHOWN ARE POSSIBLE AND SHOULD BE EXPECTED WITH MORE DETAILED WORK AND FURTHER INFORMATION. ALL INTERPRETATIONS AND CONDITIONS SHOWN ARE PRELIMINARY AND FOR INITIAL LAND-USE PLANNING ONLY.
3. MAP LEGEND IS MODIFIED FROM CHARLES S. ROBINSON & ASSOCIATES, INC., GOLDEN, COLORADO, DATED 1977.

Our interpretation of the surficial geology and geologic hazards is presented in Fig. 2 and is described above. Our interpretation of the engineering geologic conditions is presented in Fig. 3. The site is shown as containing Map Units 1A and 3B per the classification system described in Robinson's "El Paso County, Colorado - Potential Geologic Hazards and Surficial Deposits, Environmental and Engineering Geologic Maps and Tables for Land Use," 1977.

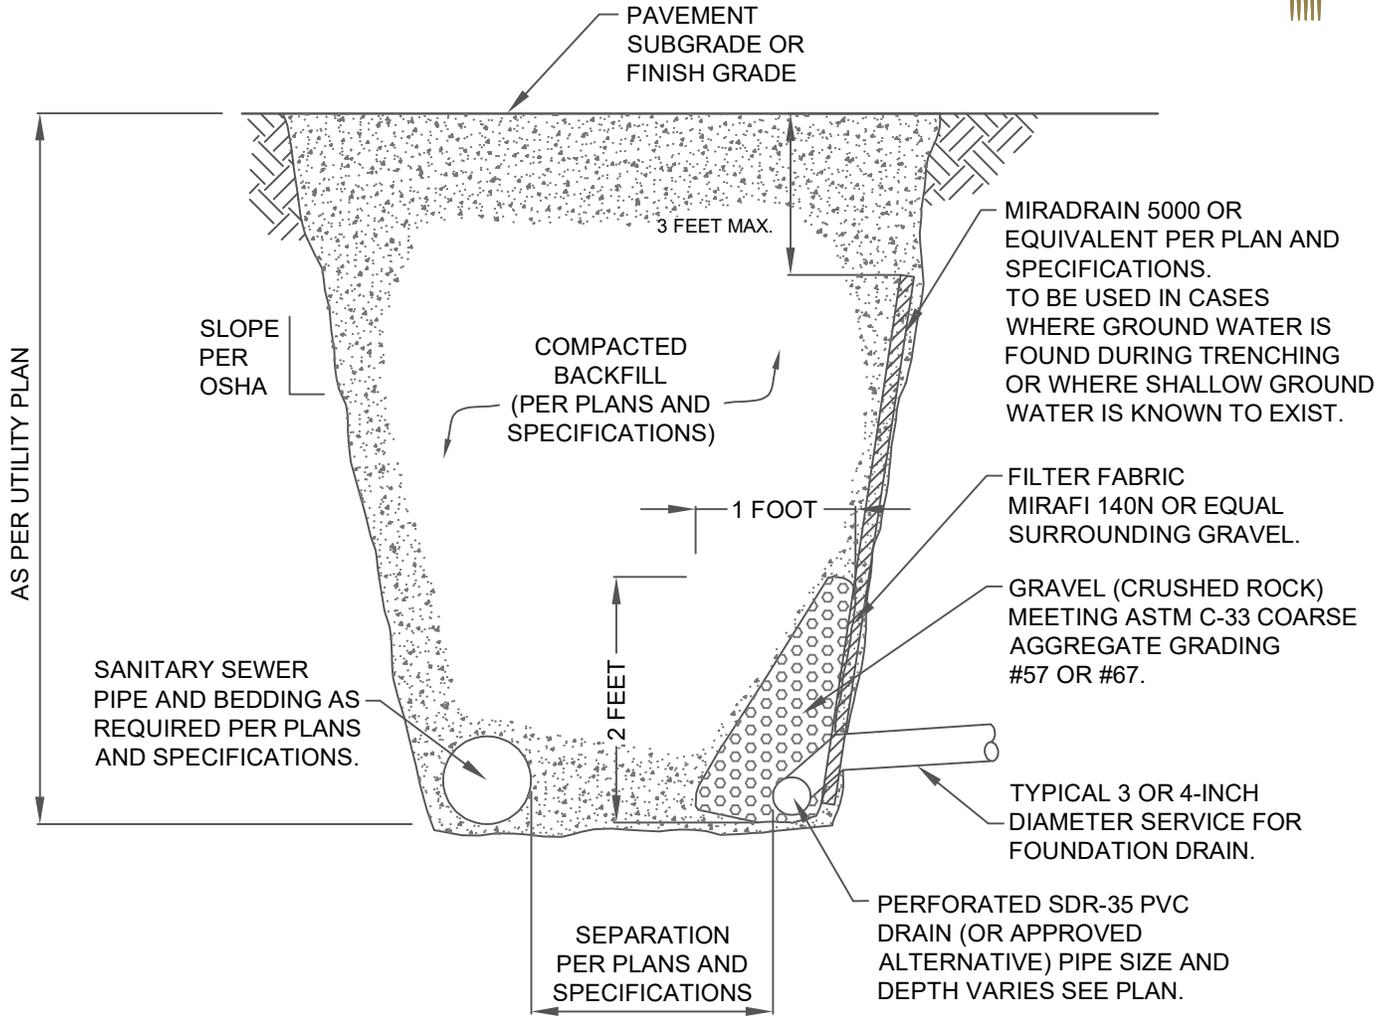
NOTE:
TO BE USED IN CASES WHERE GROUND WATER IS FOUND DURING TRENCHING OR WHERE SHALLOW GROUND WATER IS KNOWN TO EXIST, AND UPSTREAM OF MANHOLES.

If wet conditions or free water are encountered in the sanitary sewer trenches, we recommend an active underdrain system with perforated or slotted pipe for these areas. A conceptual drain detail is shown in Fig. 4. A cutoff collar should be constructed around the sewer pipe and underdrain pipe immediately downstream of the point the underdrain pipe exits the sewer trench or changes from active to passive. Solid pipe should be used down gradient of this cutoff collar to the point of discharge. The underdrain should be maintained at least 3 to 5 feet below the lowest nearby foundation elevation. Where no groundwater is encountered in sanitary sewer excavations, passive underdrains may be used as presented on Fig. 5.

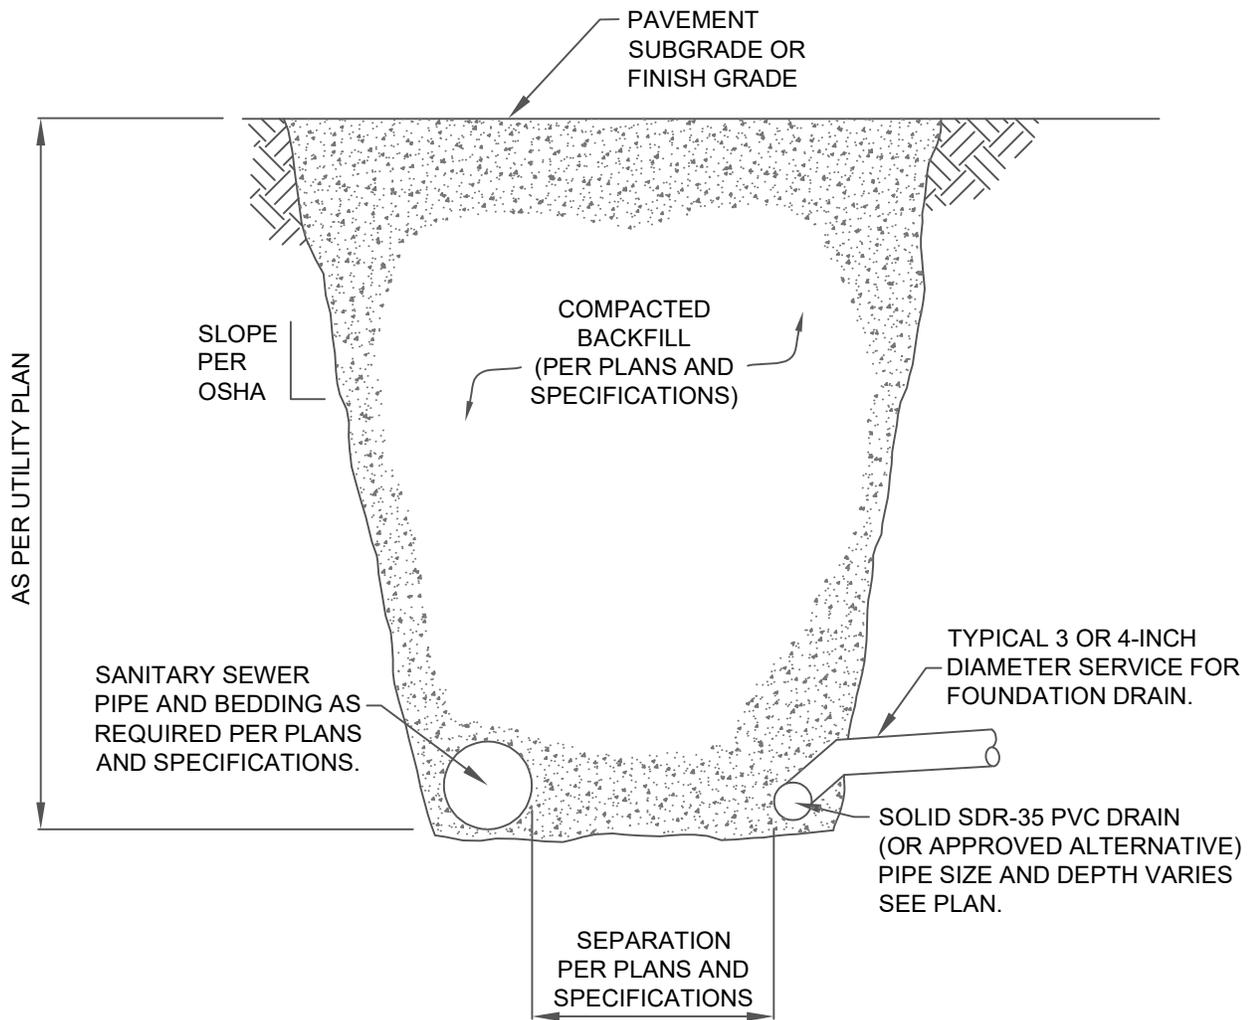
NOTE:
TO BE USED IN CASES WHERE NO
GROUND WATER IS KNOWN TO EXIST.

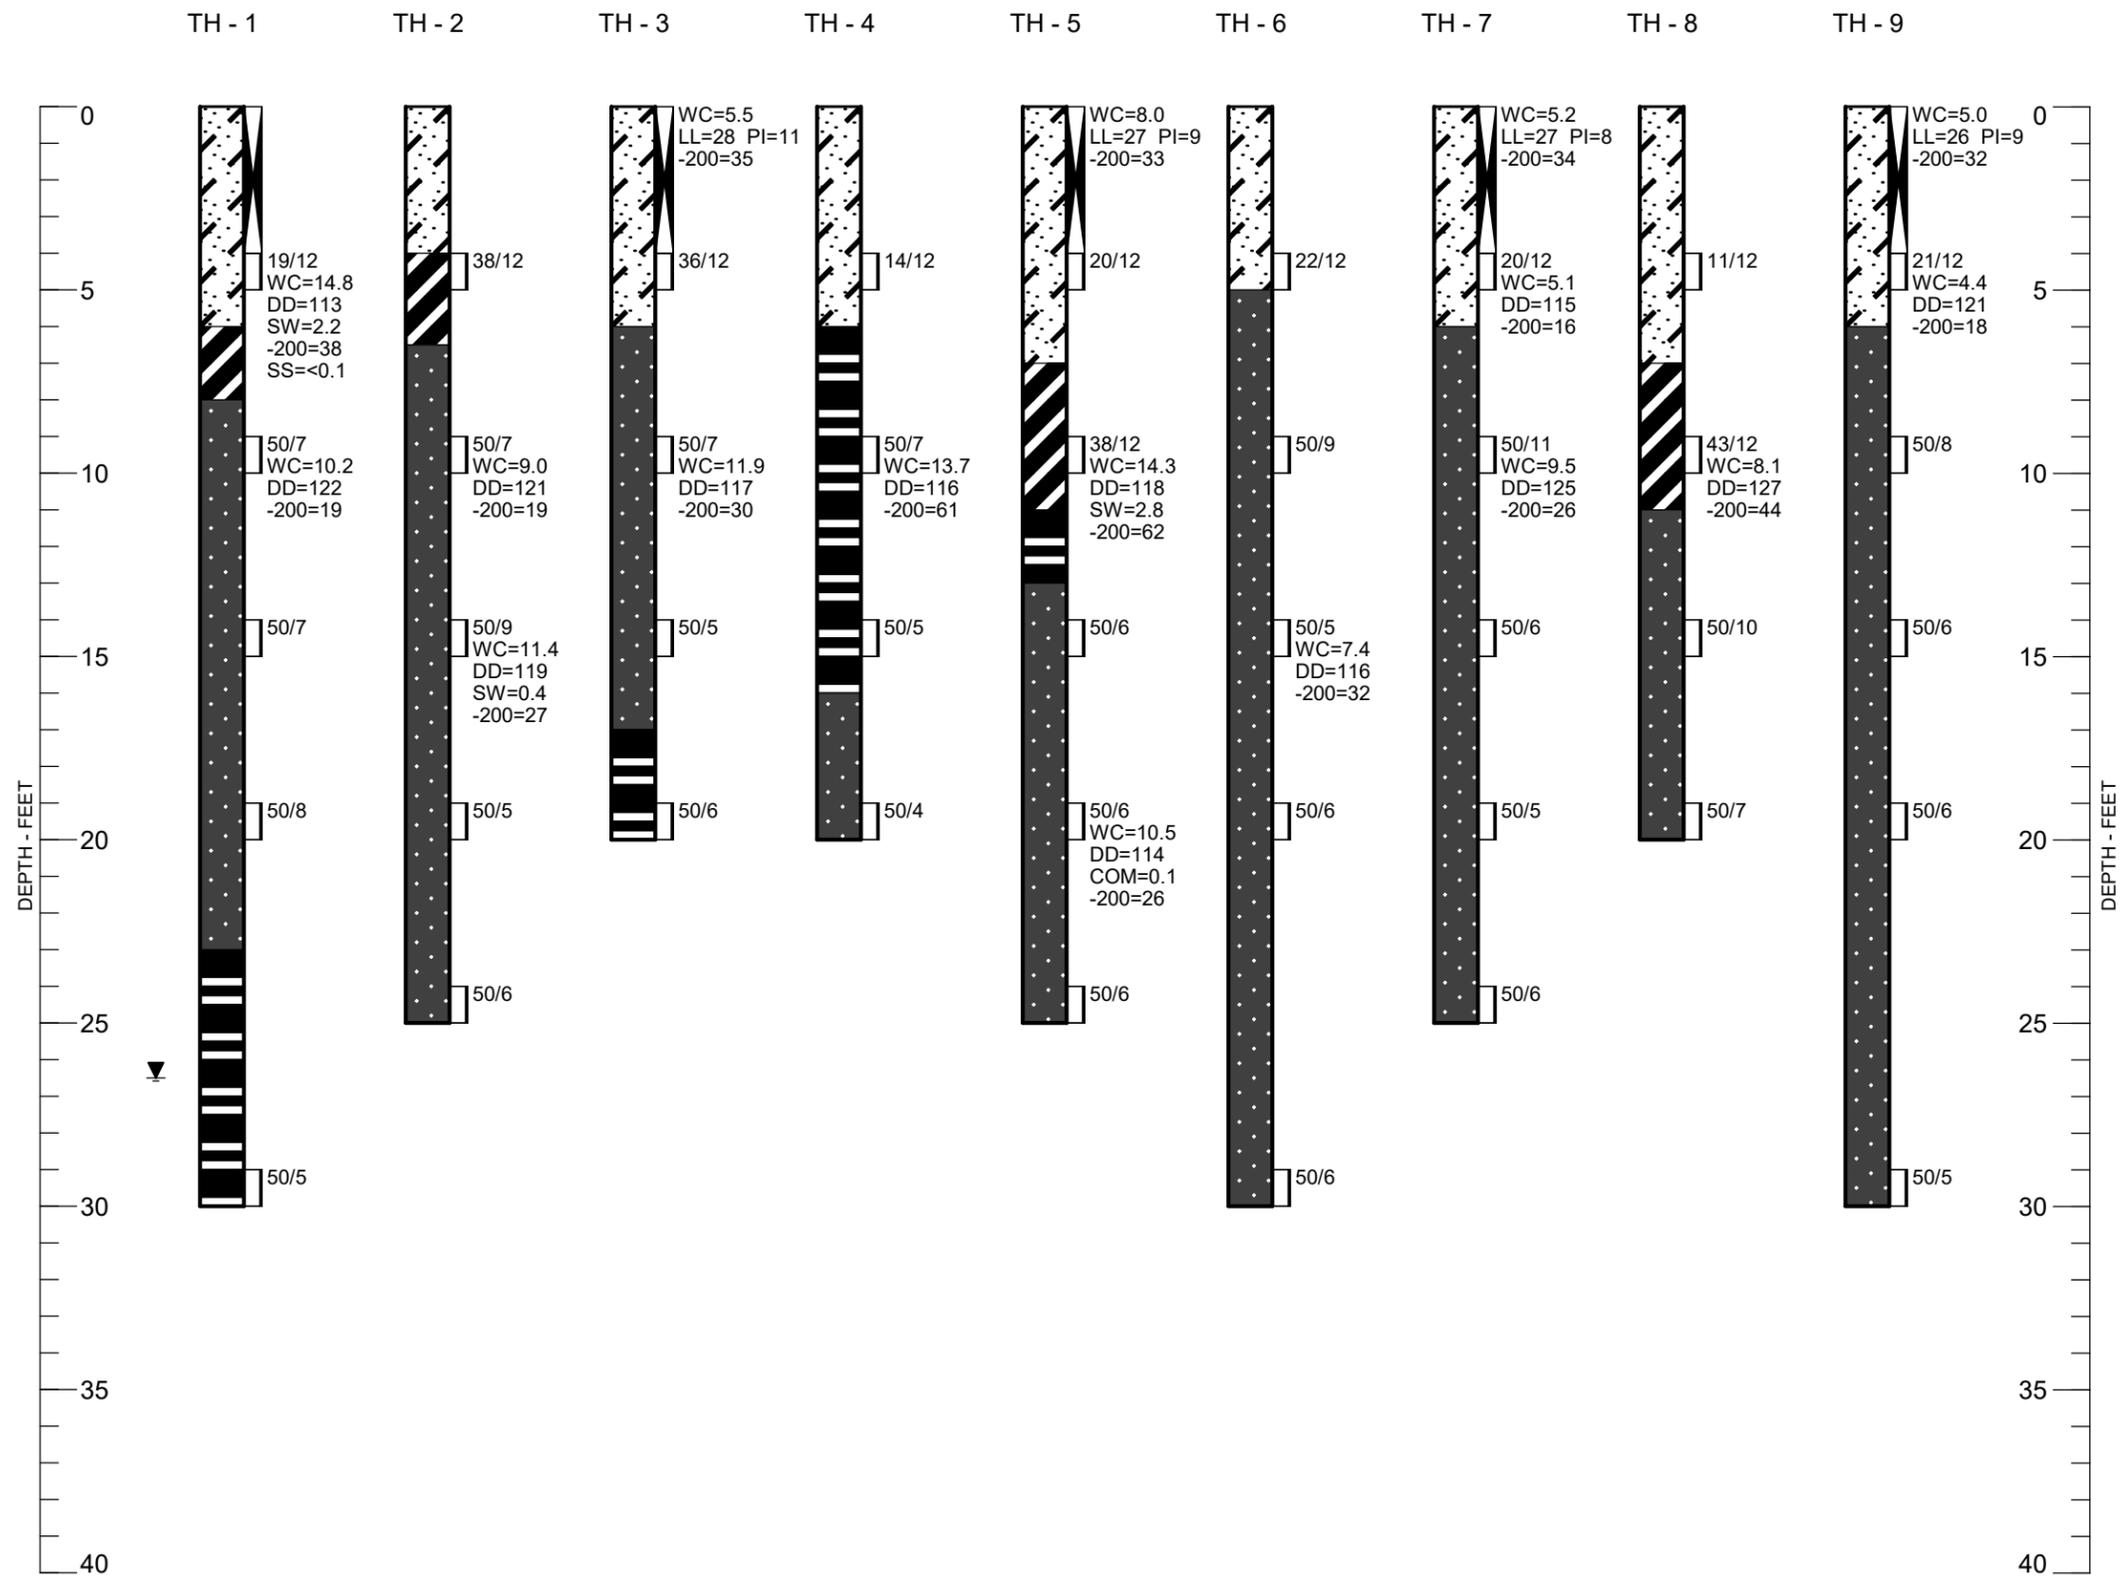
APPENDIX A
SUMMARY LOGS OF EXPLORATORY BORINGS

- SAND, CLAYEY TO VERY CLAYEY, MEDIUM DENSE TO DENSE, SLIGHTLY MOIST TO MOIST, LIGHT BROWN TO BROWN, REDDISH BROWN, GRAY BROWN (SC).
- WEATHERED CLAYSTONE AND SANDSTONE BEDROCK, VERY SANDY (CLAYSTONE) AND VERY CLAYEY (SANDSTONE), MEDIUM HARD, MOIST, LIGHT BROWN TO OLIVE BROWN.
- BEDROCK, CLAYSTONE, VERY SANDY, HARD TO VERY HARD, MOIST, BROWN.
- BEDROCK, SANDSTONE, SILTY TO CLAYEY, HARD TO VERY HARD, MOIST, LIGHT BROWN TO BROWN AND LIGHT GRAY TO GRAY.
- DRIVE SAMPLE. THE SYMBOL 19/12 INDICATES 19 BLOWS OF A 140-POUND HAMMER FALLING 30 INCHES WERE REQUIRED TO DRIVE A 2.5-INCH O.D. SAMPLER 12 INCHES.
- INDICATES BULK SAMPLE OBTAINED FROM AUGER CUTTINGS.
- GROUNDWATER LEVEL MEASURED EIGHT AFTER DRILLING.

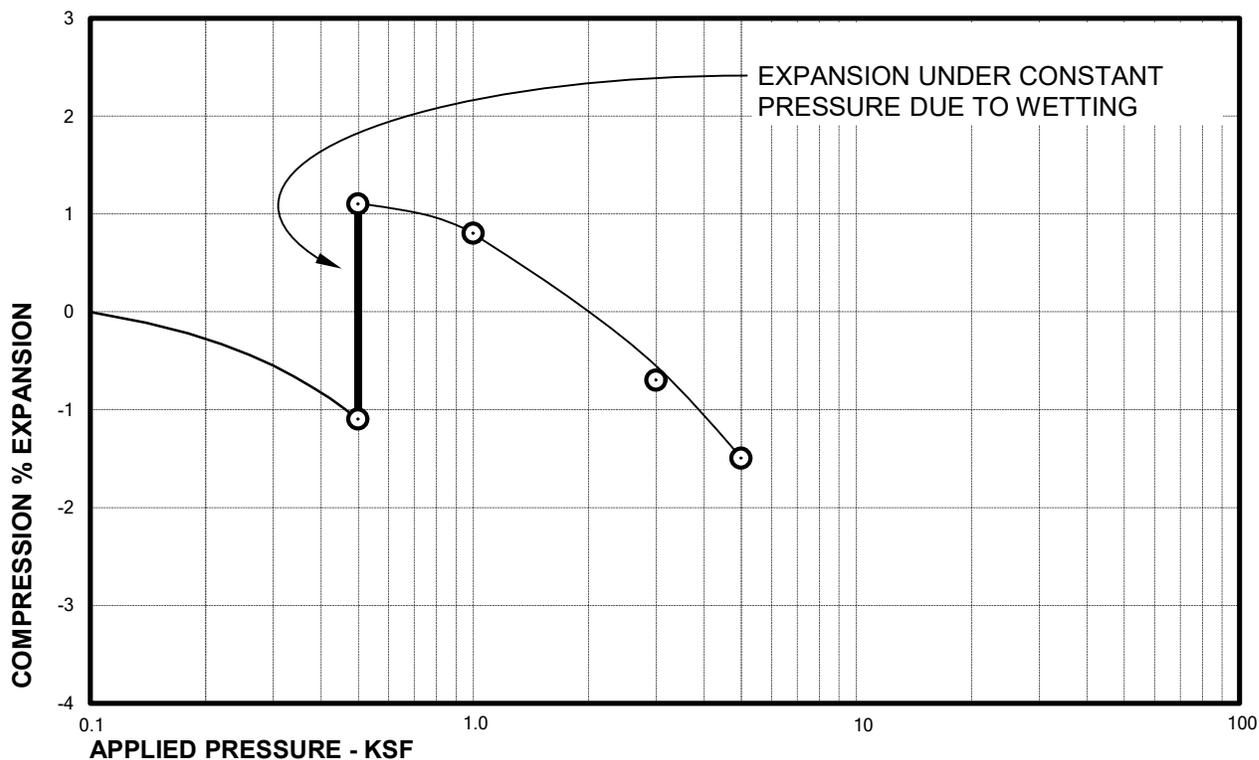
Sample of SAND, VERY CLAYEY (SC)
From TH-1 AT 4 FEET

DRY UNIT WEIGHT= 113 PCF
MOISTURE CONTENT= 14.8 %

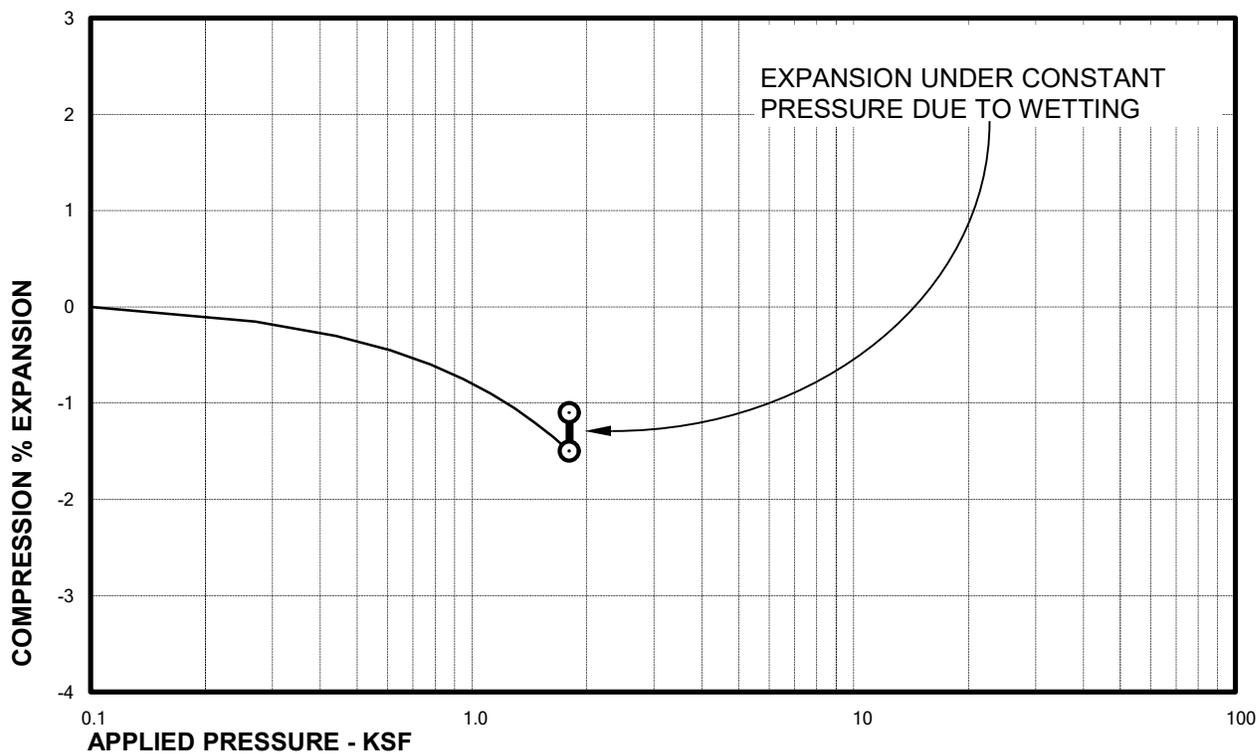
Sample of SANDSTONE, CLAYEY
From TH-2 AT 14 FEET

DRY UNIT WEIGHT= 119 PCF
MOISTURE CONTENT= 11.4 %

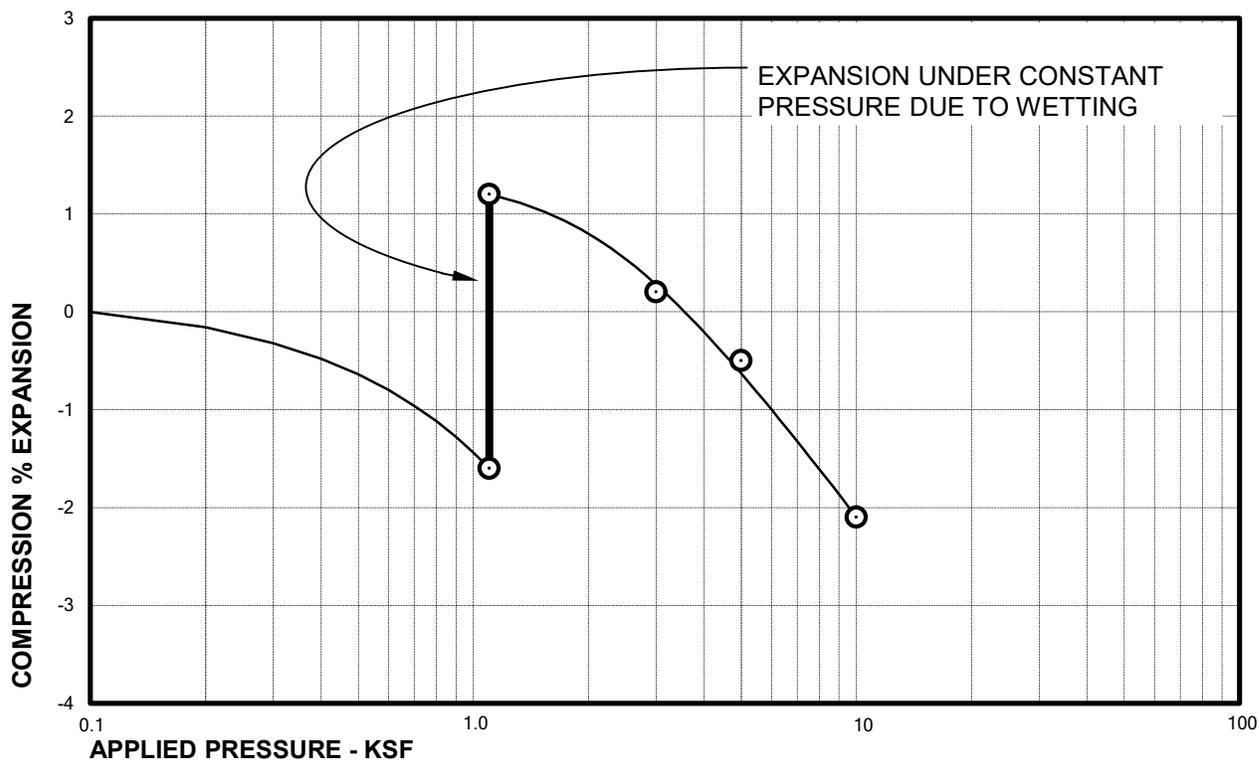
Sample of WEATHERED CLAYSTONE
From TH-5 AT 9 FEET

DRY UNIT WEIGHT= 118 PCF
MOISTURE CONTENT= 14.3 %

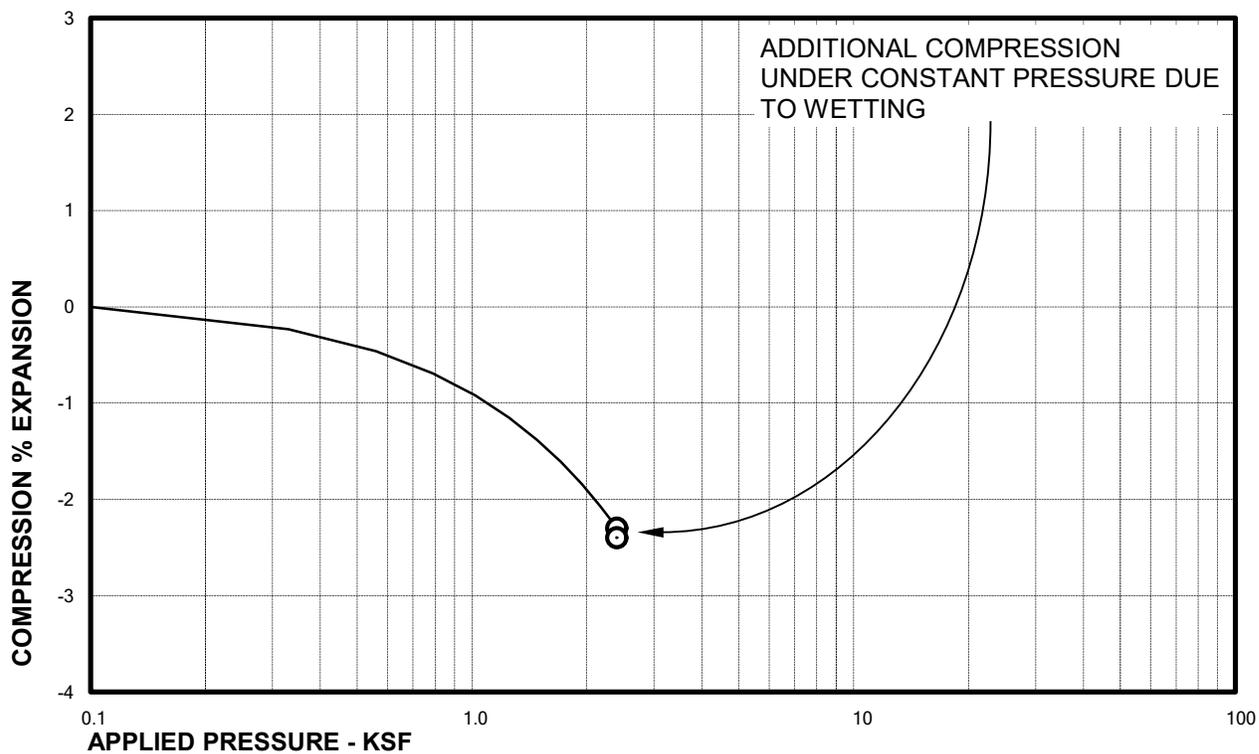
Sample of SANDSTONE, SILTY
From TH-5 AT 19 FEET

DRY UNIT WEIGHT= 114 PCF
MOISTURE CONTENT= 10.5 %

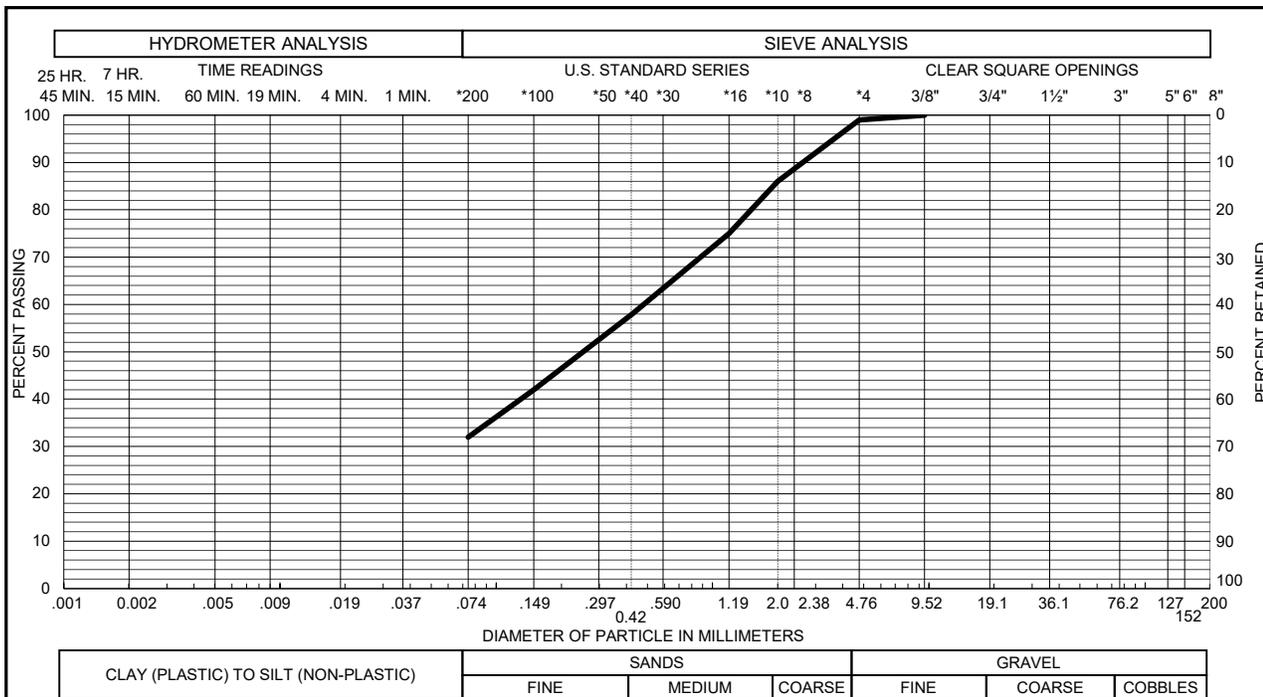
Sample of SAND, CLAYEY (SC) GRAVEL 1 % SAND 67 %
 From TH - 9 AT 0-4 FEET SILT & CLAY 32 % LIQUID LIMIT 26
 PLASTICITY INDEX 9
