**SOILS AND GEOLOGY STUDY
18735 Brown Road
Lots 1-3, Boyd Minor Subdivision
El Paso County, Colorado**

JOB NO. 186500

**January 26, 2022
Revised: February 8, 2021**

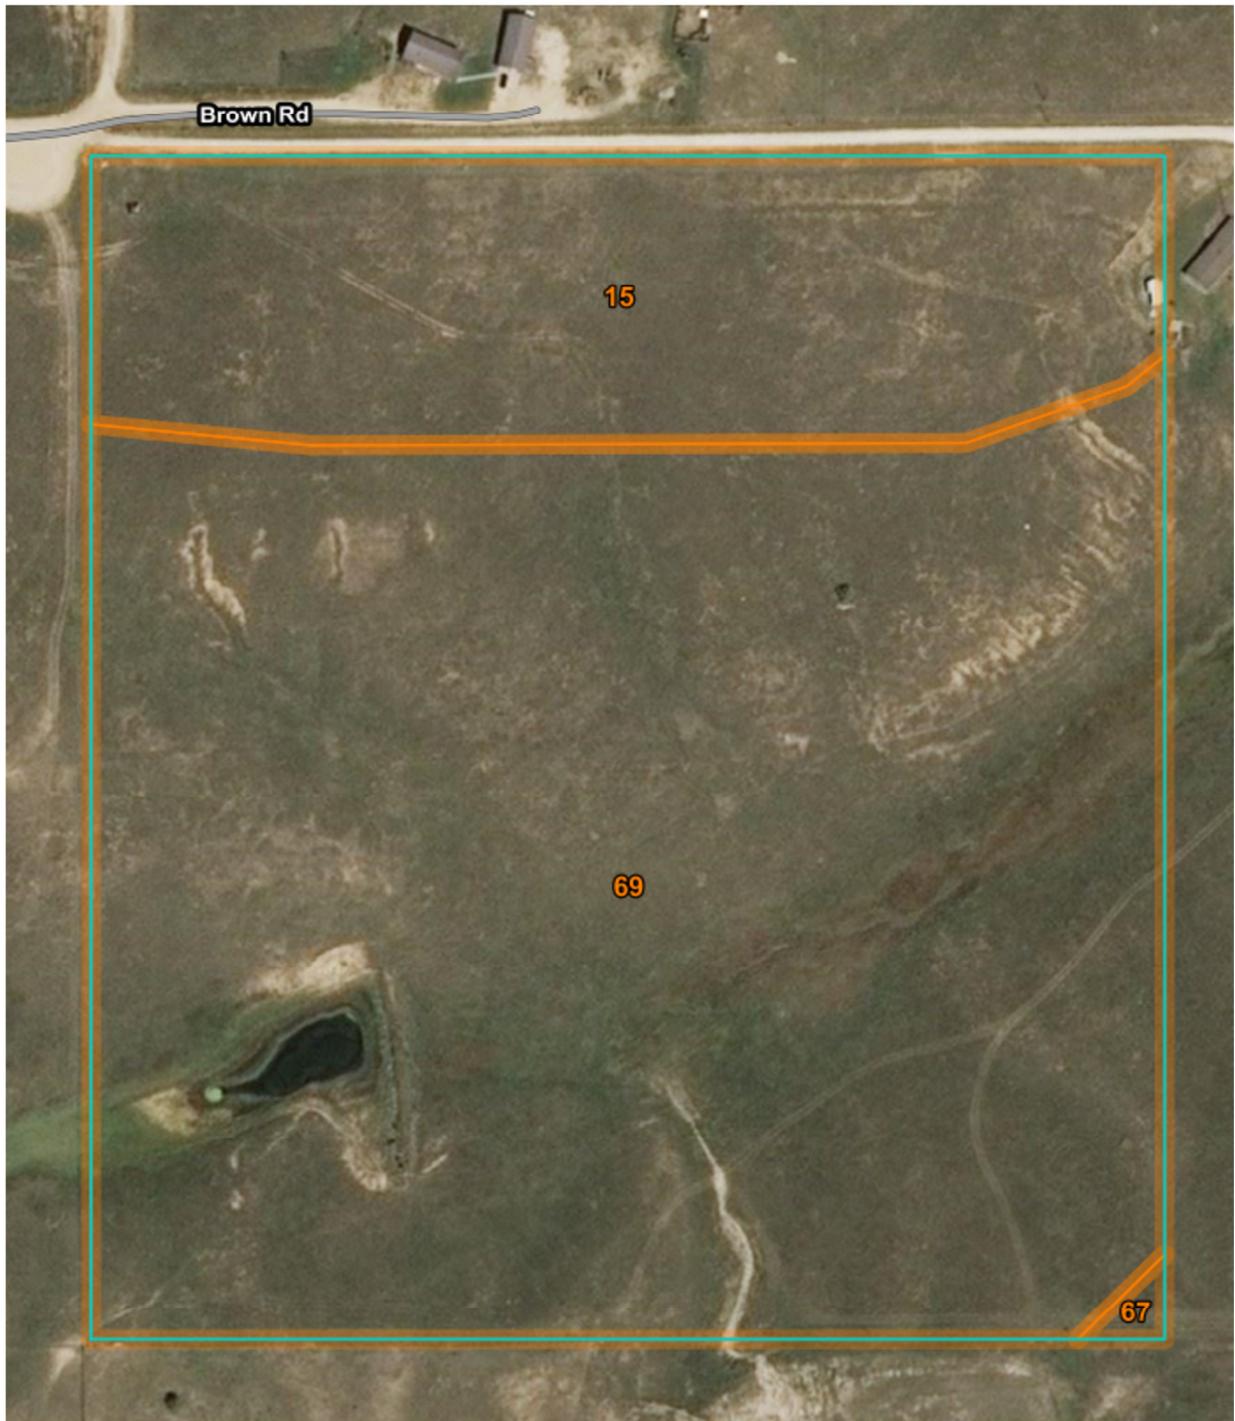
- 15 - Brussett loam, 3 to 5 percent slopes
- 67 - Peyton sandy loam, 5 to 9 percent slopes
- 69 - Peyton-Pring complex, 8 to 15 percent slopes

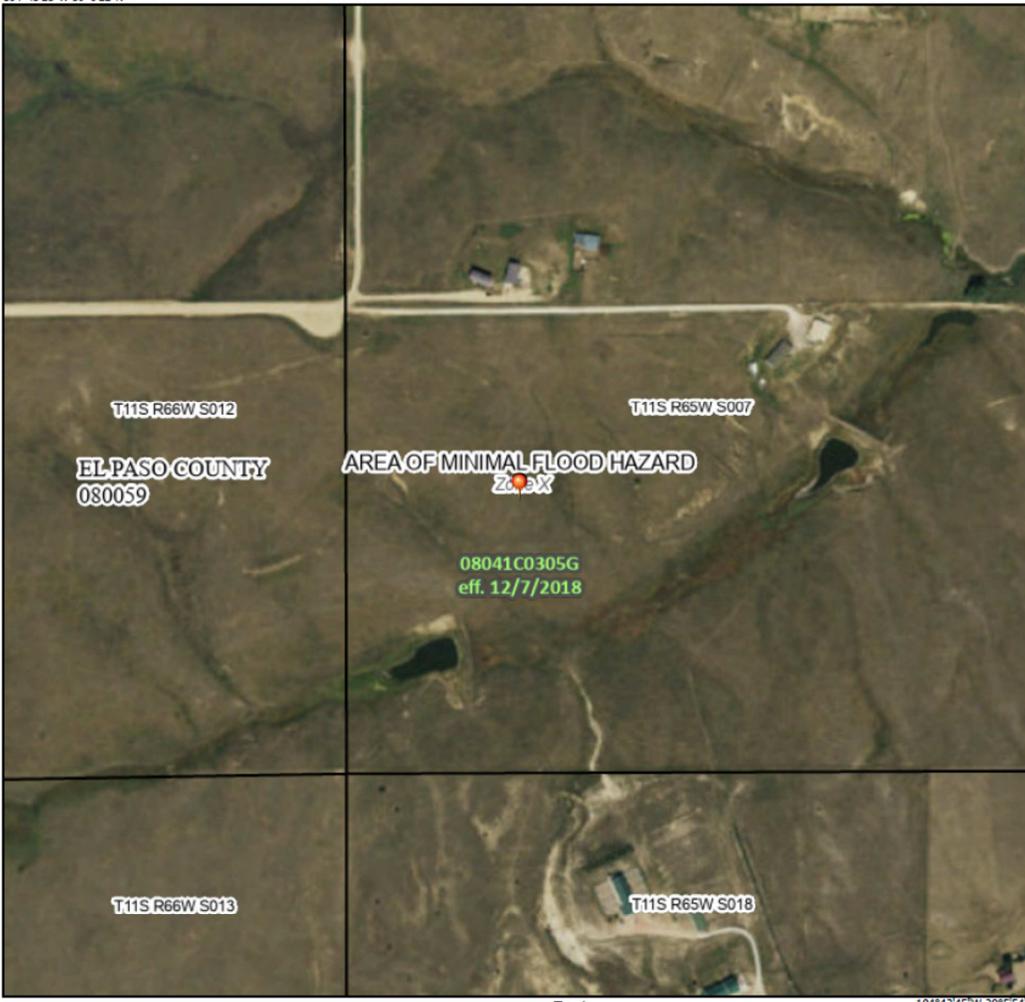
FIG No. 7

National Flood Hazard Layer FIRMette

Based on our review of the Federal Emergency Management Agency (FEMA) Community Panel No. 08041C0305G and the online ArcGIS El Paso County Risk Map, the entire site lies outside of identified 100 or 500-year floodplains. The site lies in Zone X. Zone X is defined by FEMA as an area of minimal flood hazard that is determined to be outside the Special Flood Hazard Area and higher than the elevation of the 0.2-percent-annual-chance (or 500-year) flood. The FEMA Map is presented in Figure 7.
