## SOILS AND GEOLOGY STUDY

**Falcon Reserve  
EPC Schedule No. 5225400001  
El Paso County, Colorado**

**JOB NO. 188276**

**July 14, 2022  
Amended May 20, 2026**

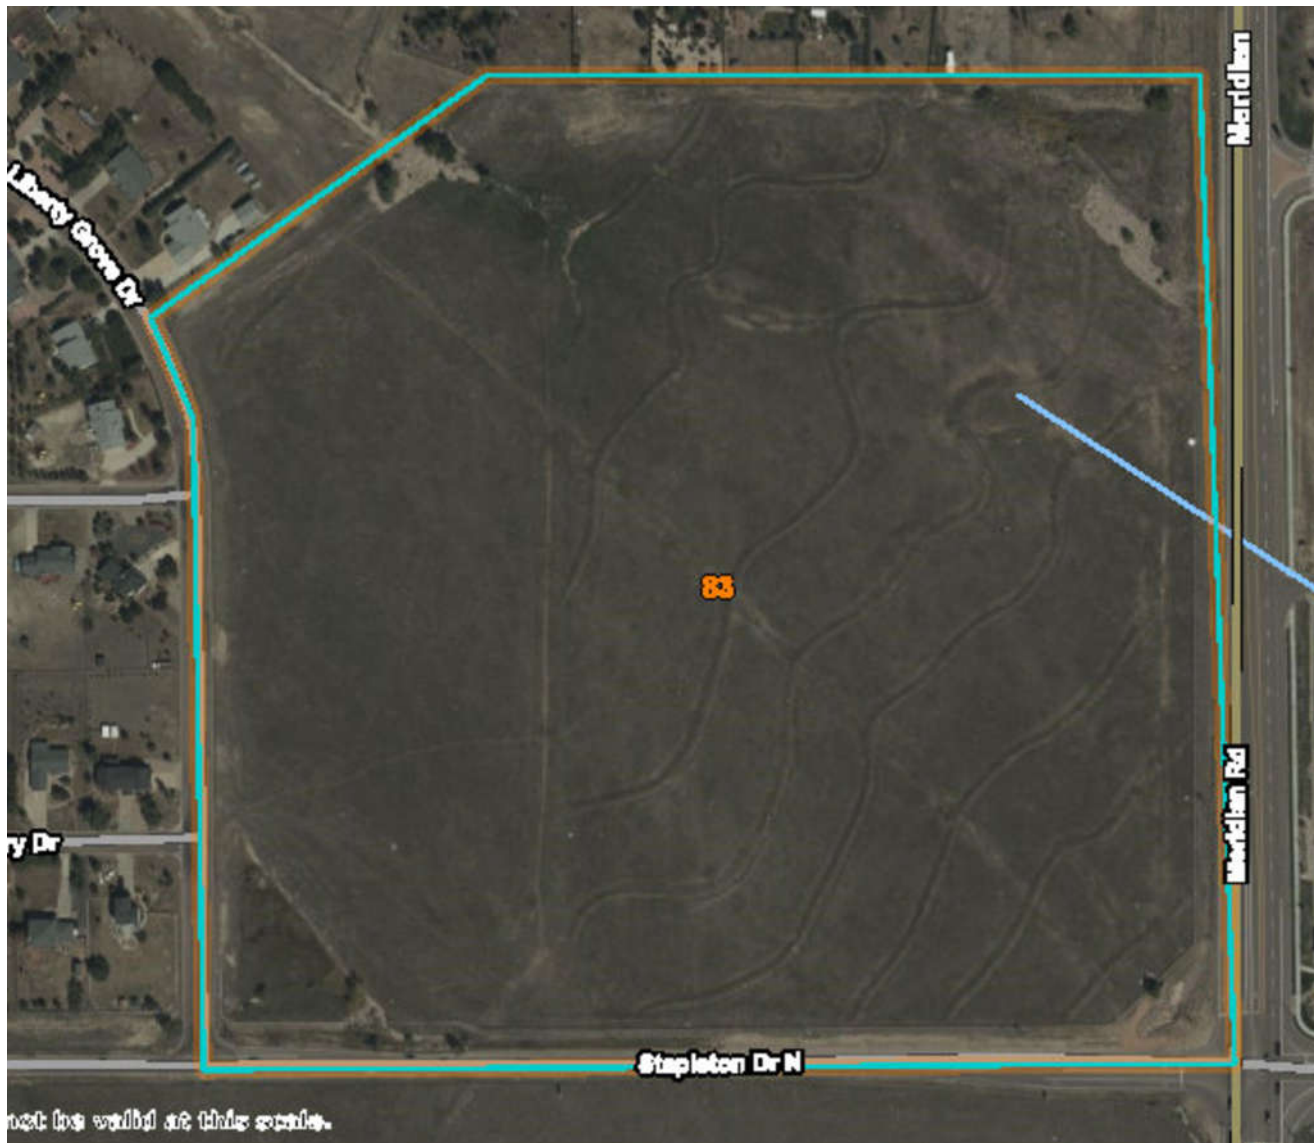
FIG No. 9

83 - STAPLETON SANDY LOAM, 3 TO 8% SLOPES

The USDA Soil Survey Map is presented in Figure 9.

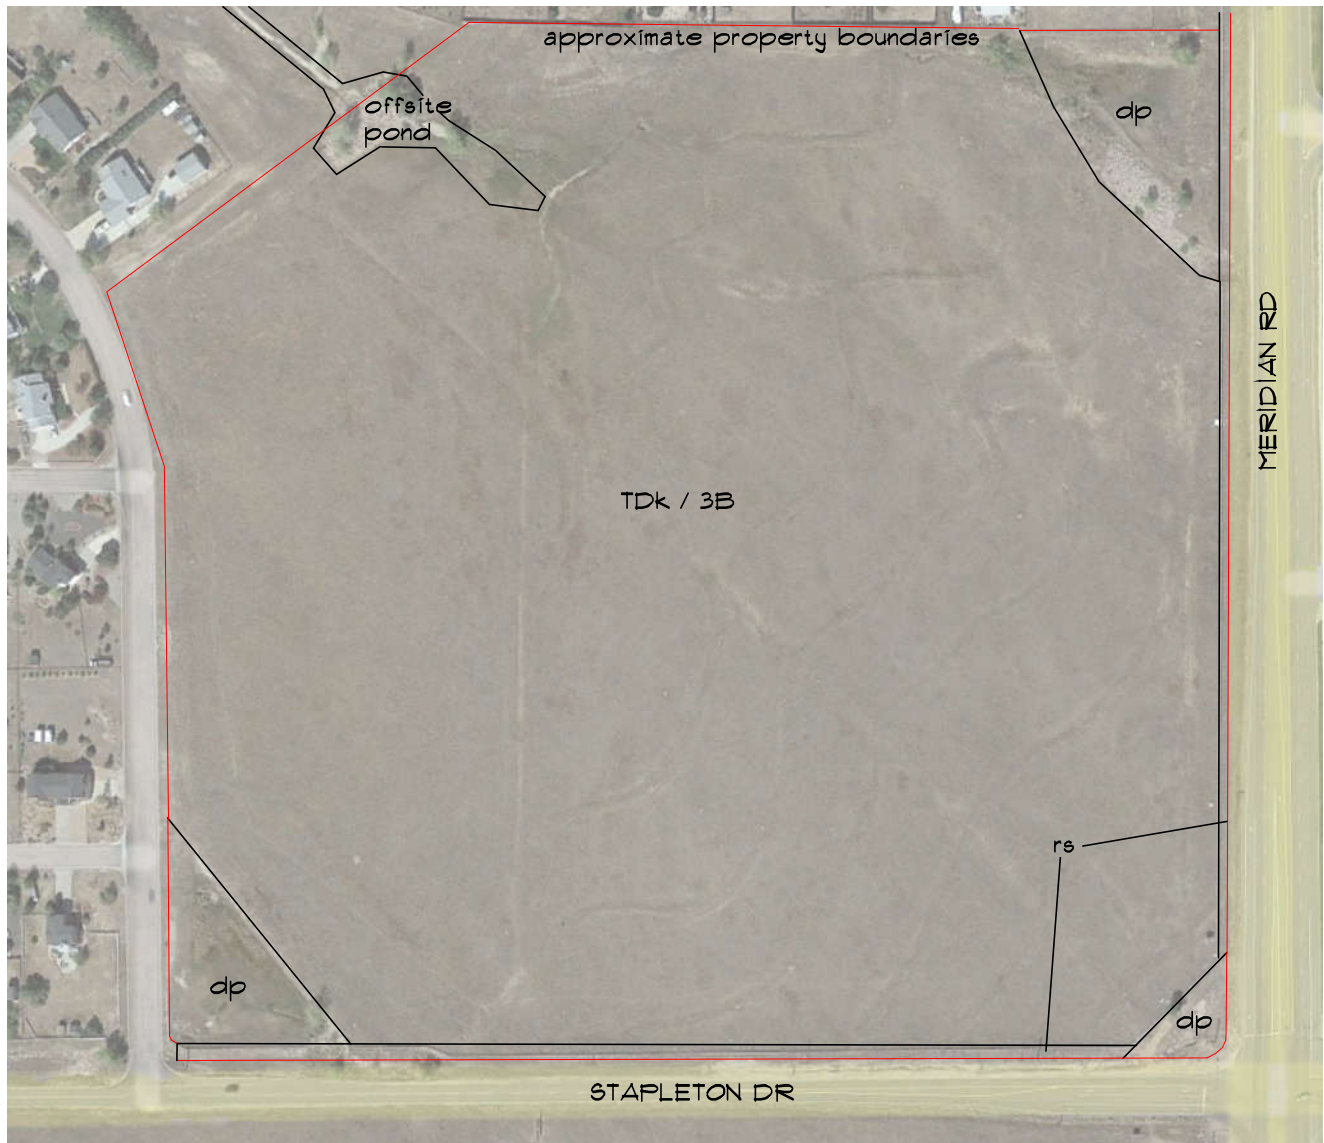
FIG No. 10

Geologic  
Tda - Dawson Arkose

Engineering  
3B - Stable alluvium, colluvium and bedrock on flat to moderate slopes (0% to 12%)

Based on our field observations, the USDA map and the Geologic Map of the Falcon quadrangle, an interpreted geologic map of significant surficial deposits and features was mapped for the site. The identified geologic conditions affecting the development are presented in the Engineering Geology Map, Figure 10.

The engineering geology is presented in the Engineering Geology Map, Figure 10.
