Geology and Soils Evaluation Report

Proposed Skye Vista Subdivision

16850 Stepler Road

VIVID Project No.: D24-2-807

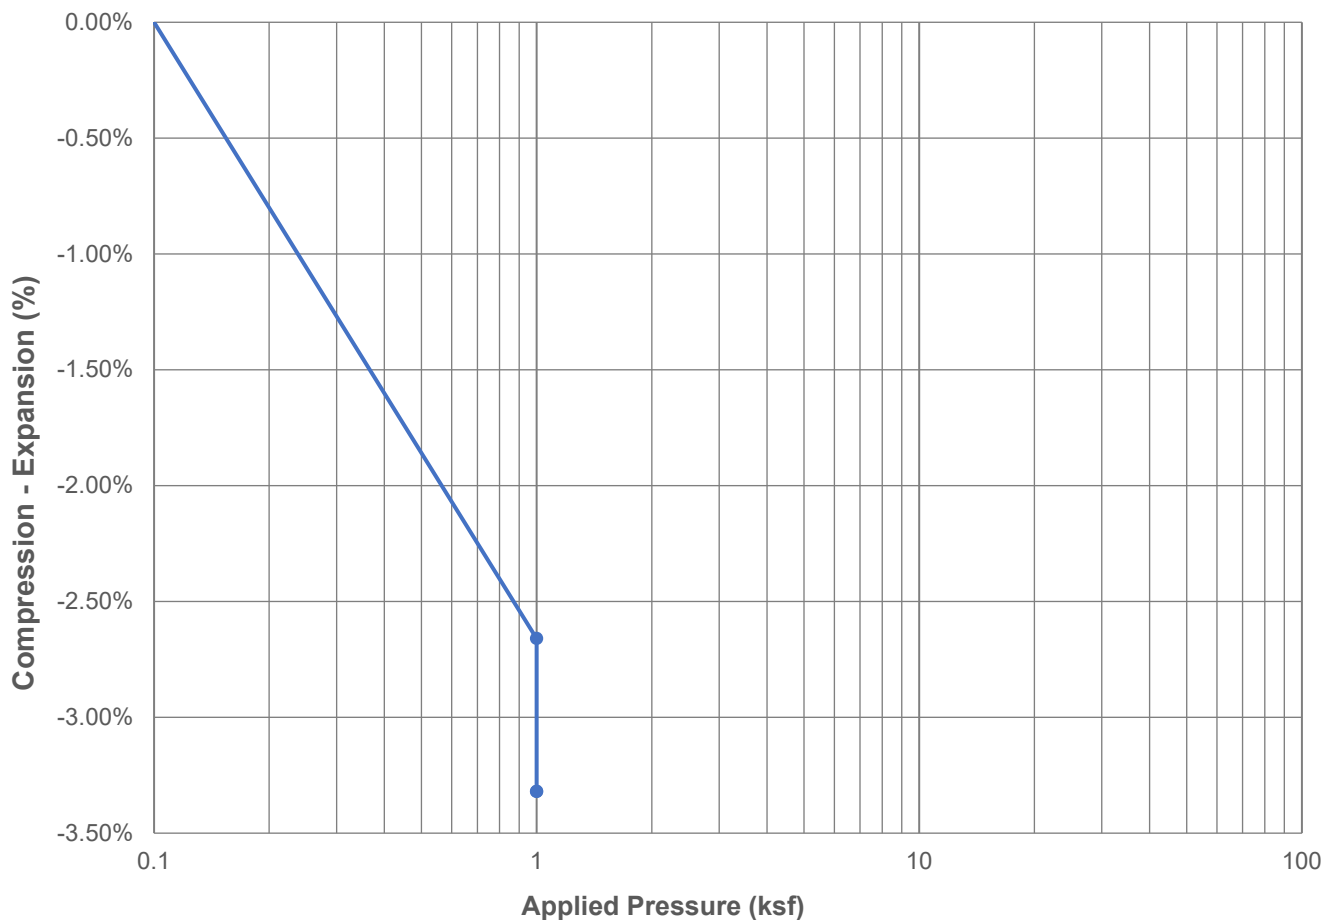
Borehole: TH-2
 Sample Depth: 14 Ft
 Classification: SC

Applied Load (lbs)	Displacement (in)
0	0.0000
1,000	-0.0266
Add Water	-0.0332
