PRELIMINARY WASTEWATER REPORT

SKYE VISTA DEVELOPMENT

Project No. 24.1676.001

VIVID Project No.: D24-2-807

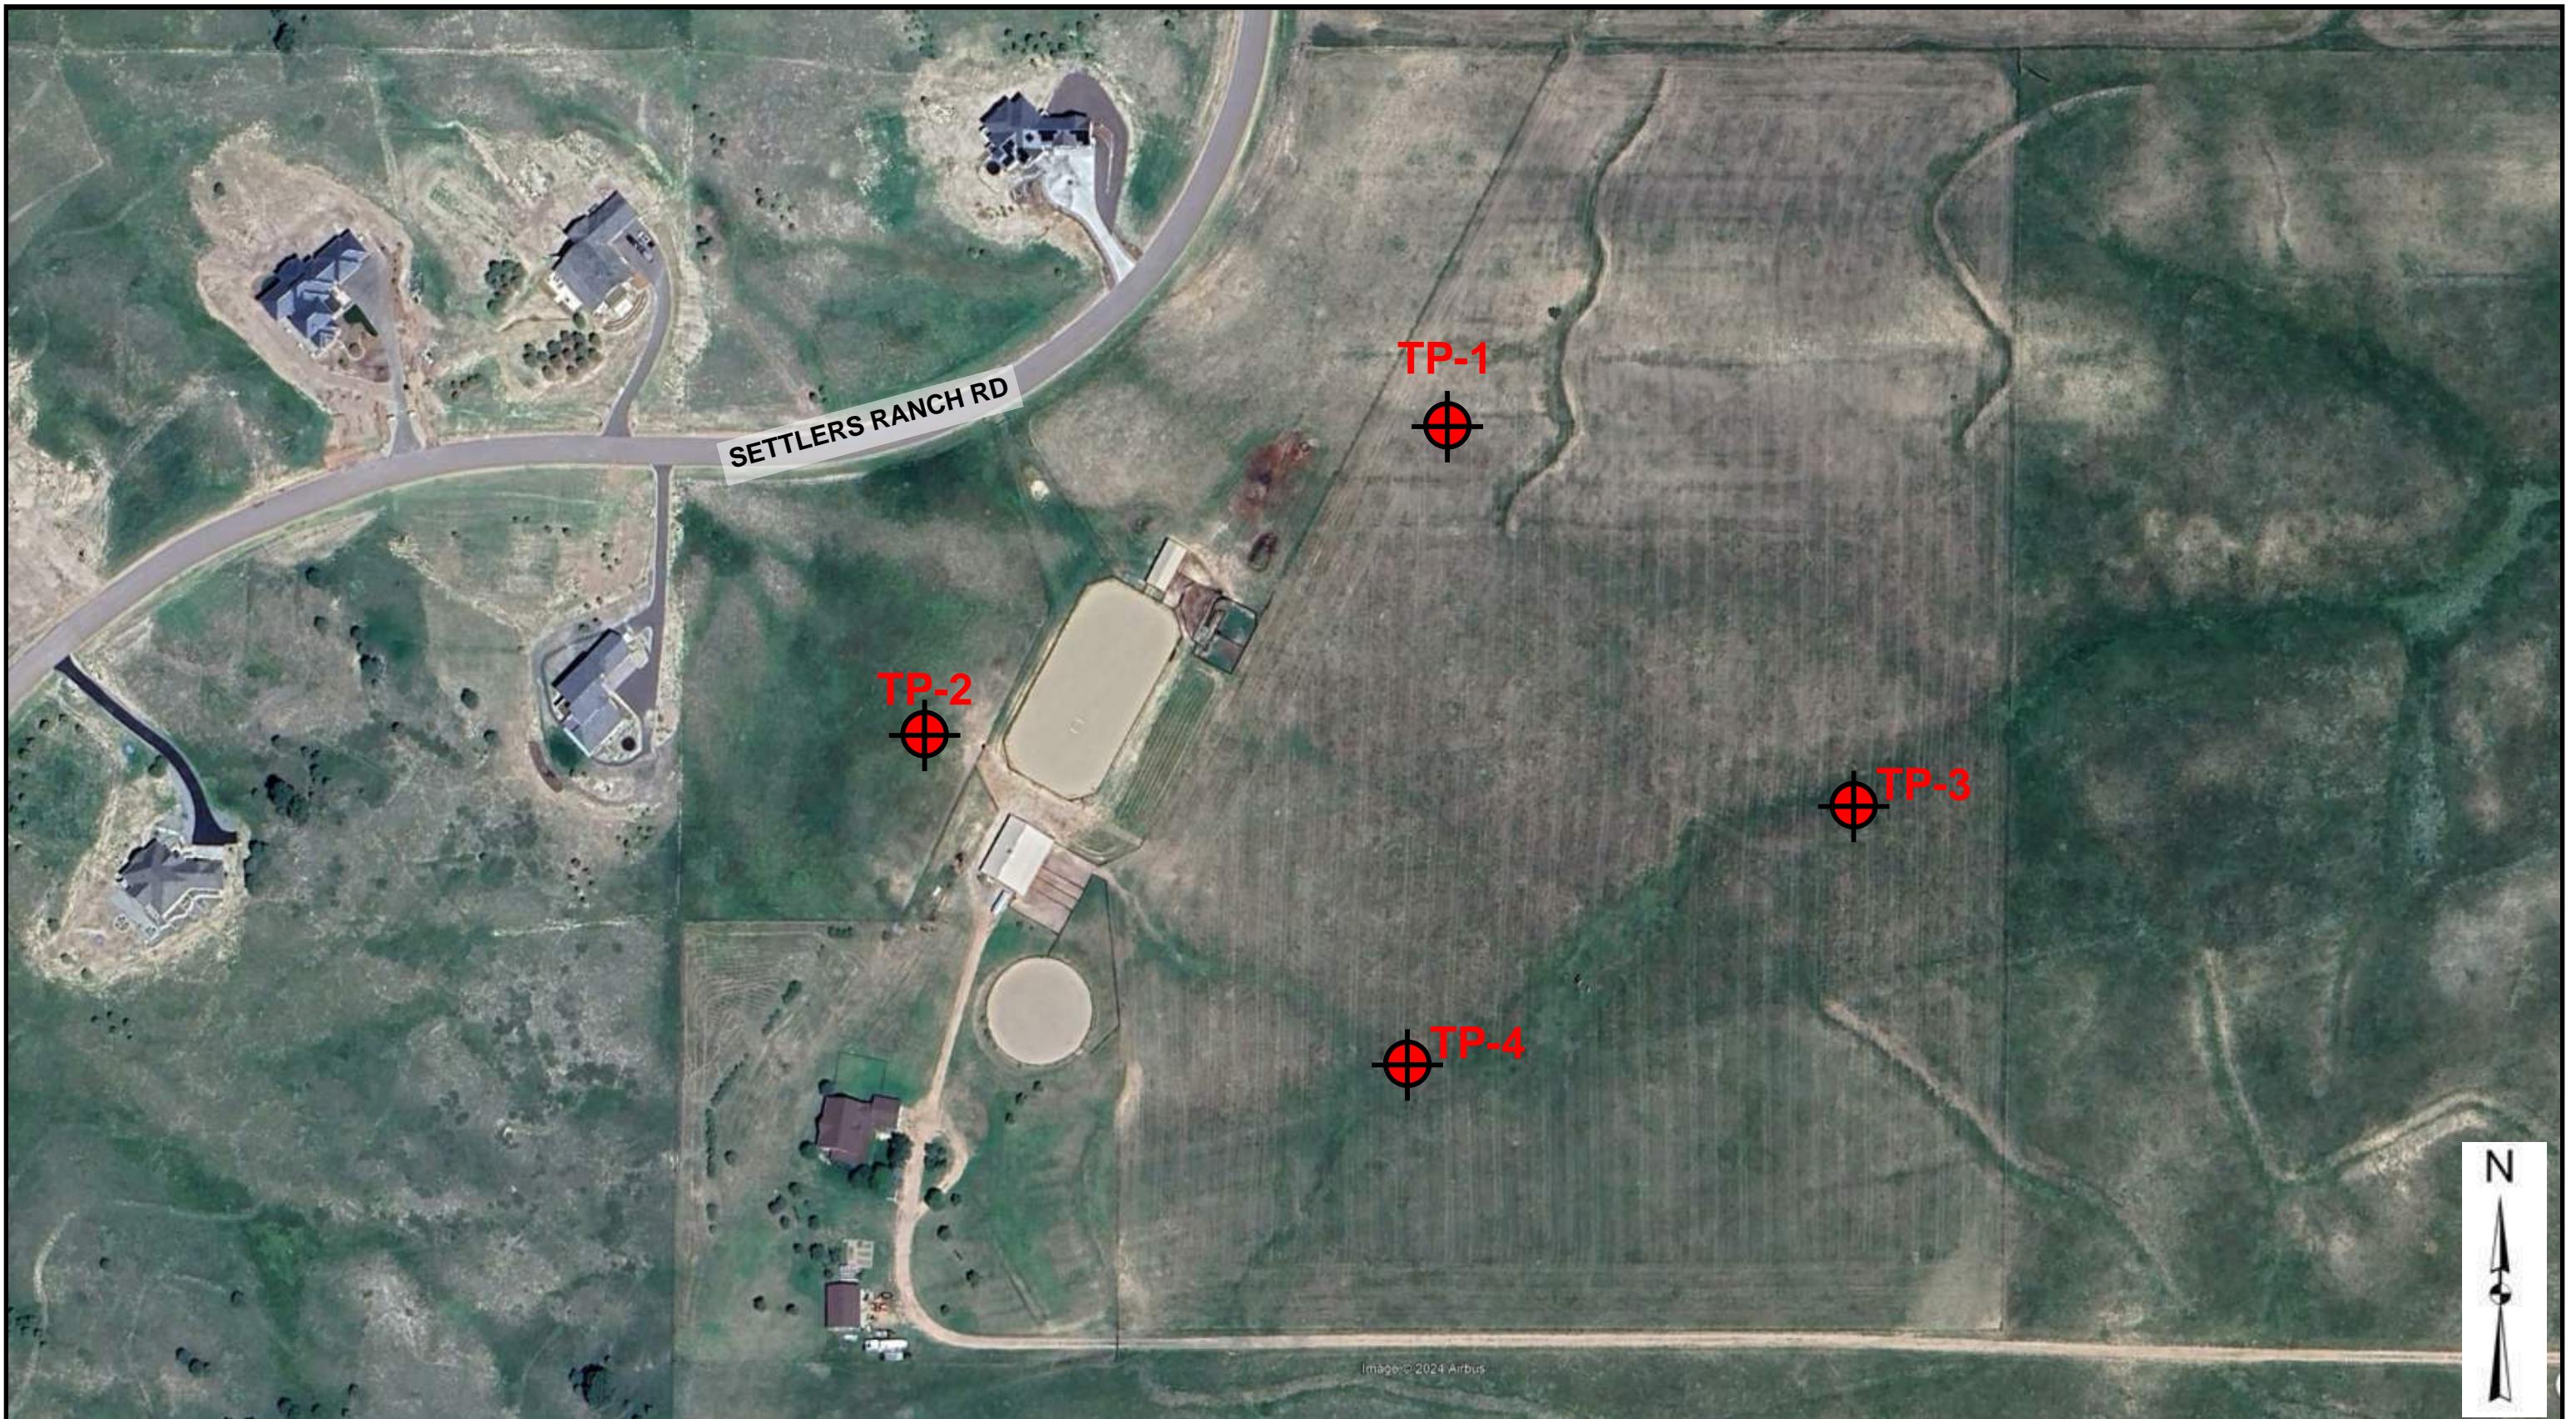
**FIGURE
2**

Figure 2: FIELD EXPLORATION PLAN (AERIAL)

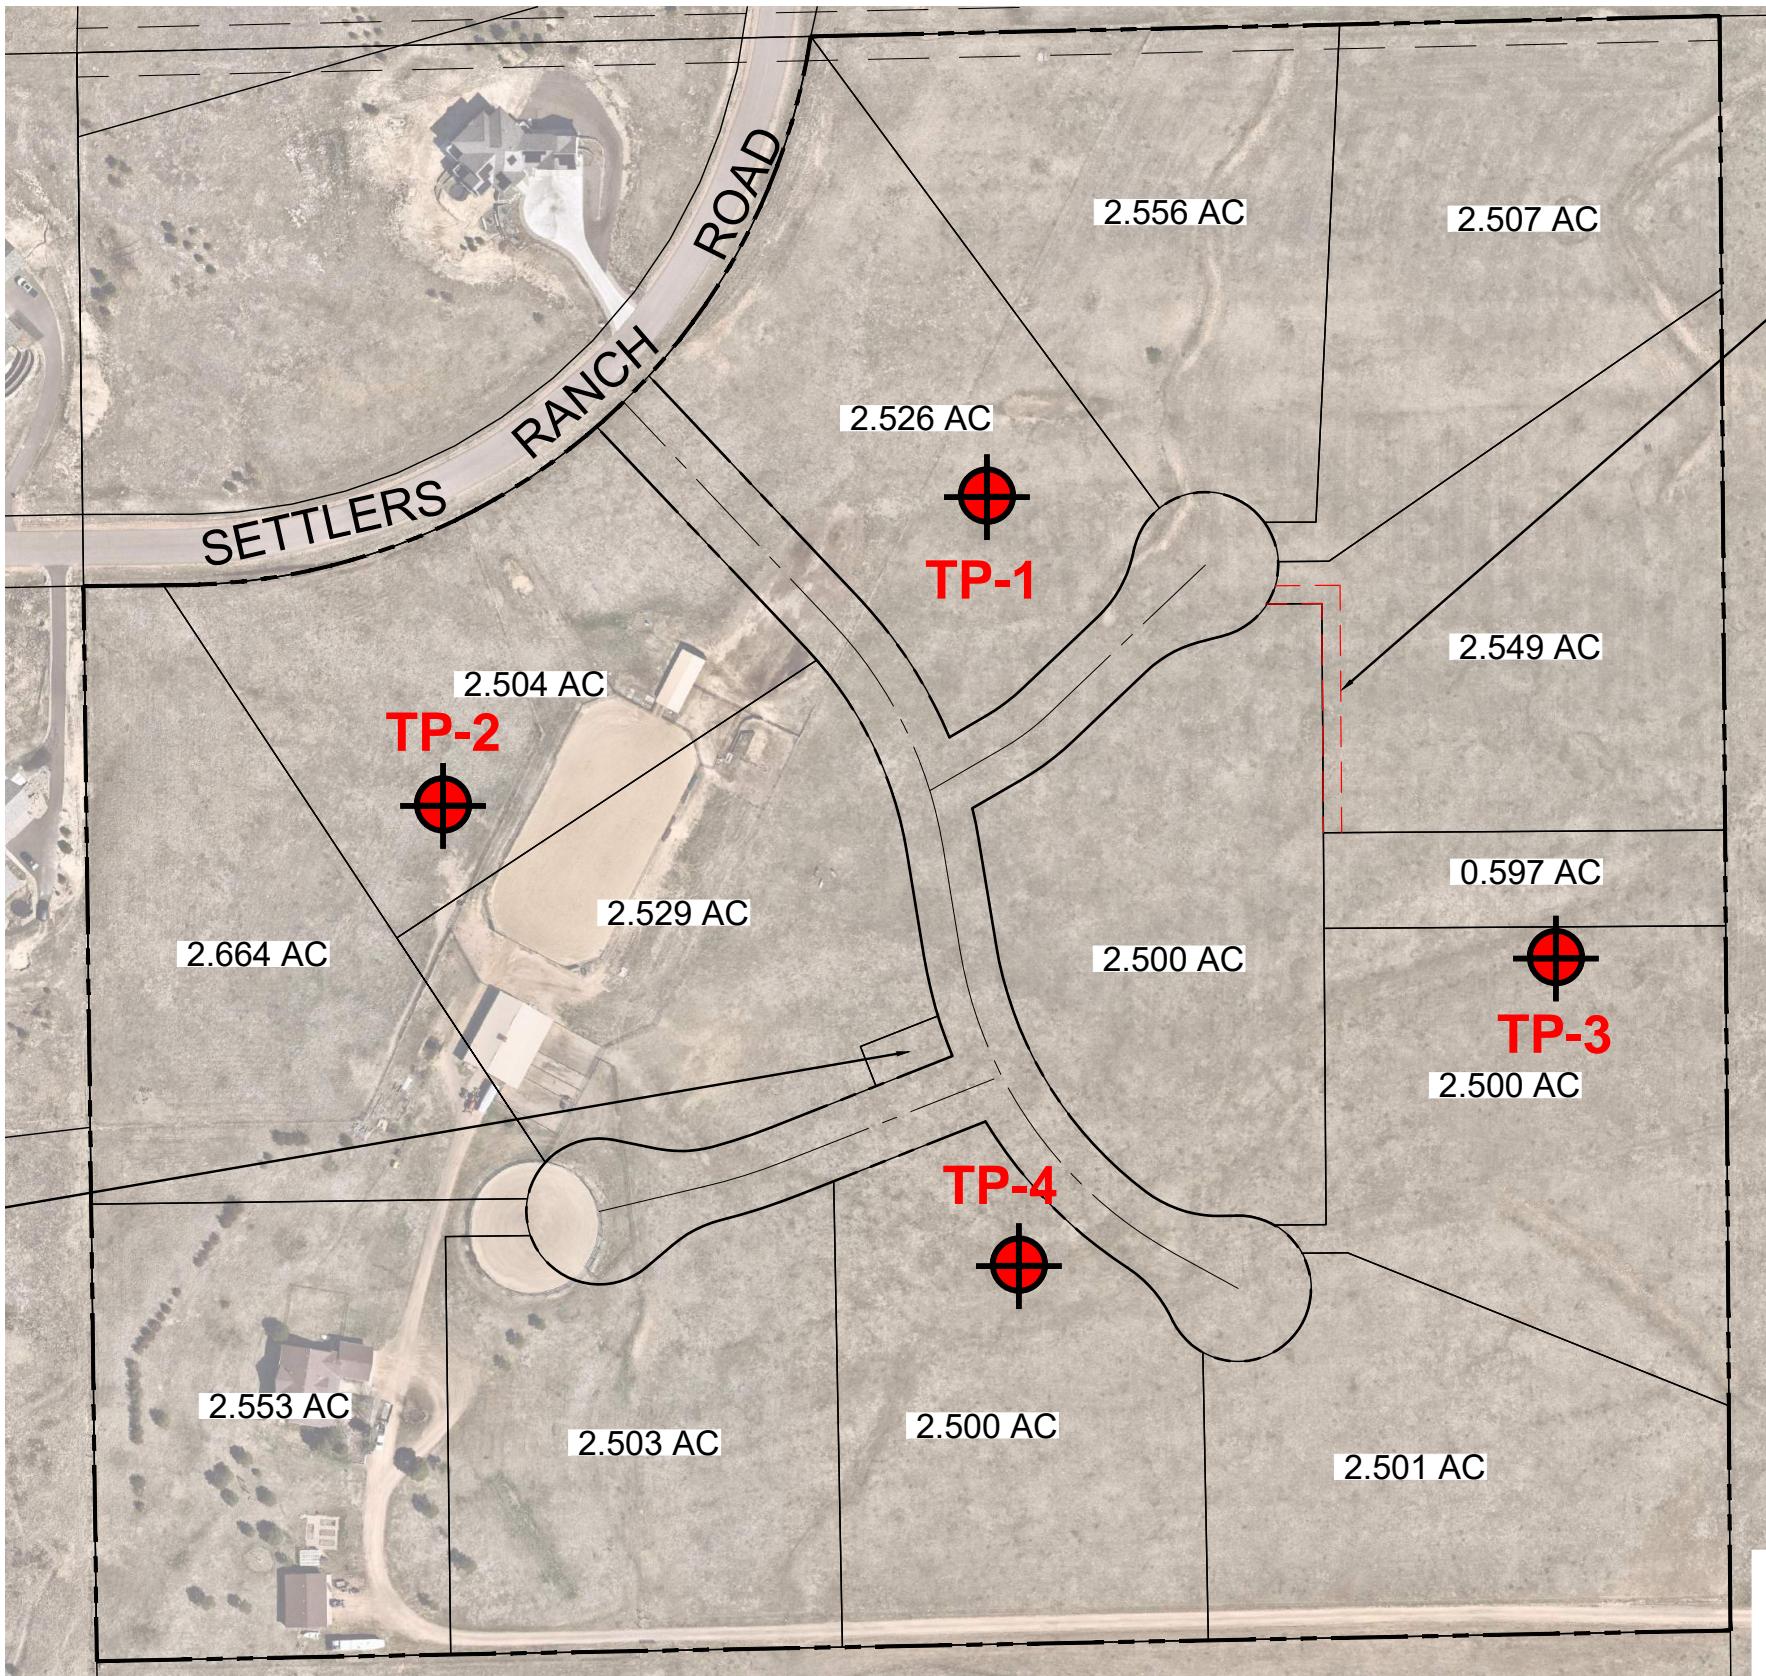
FIGURE
3

LEGEND
 TP-1 Approximate Test Pit Location

**FIELD EXPLORATION PLAN
(CONCEPTUAL)**

The proposed project includes the development of a 35-acre parcel into a residential subdivision. Thirteen lots are planned that will be approximately 2.5 acres in size. A home is currently on the property with horse stables and a small barn. The development will include construction of access roadways and utilities. Residential lots will require individual water well and septic systems. A preliminary site layout is shown on Figure 3, attached to this report.

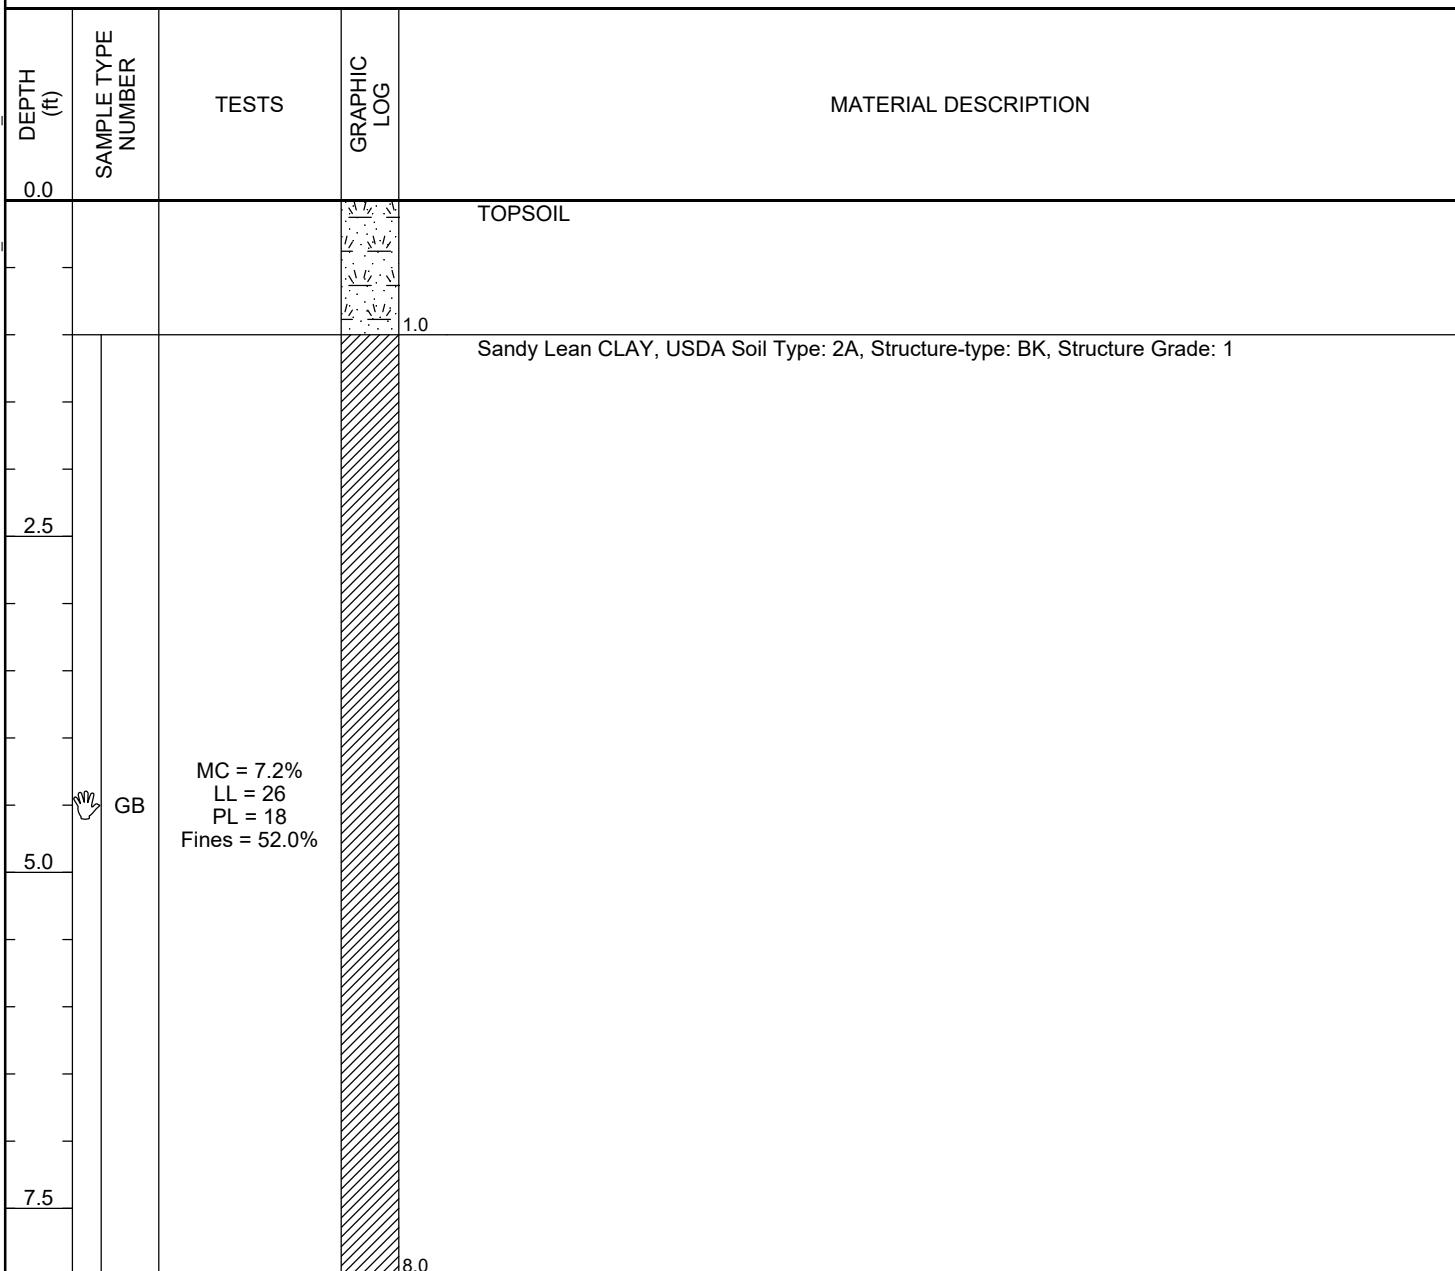
PROJECT NAME Skye Vista Subdivision
PROJECT LOCATION El Paso County, Colorado
GROUND ELEVATION _____ **TEST PIT SIZE** inches
GROUND WATER LEVELS:
AT TIME OF EXCAVATION ---
AT END OF EXCAVATION ---
AFTER EXCAVATION --- None Encountered

Bottom of test pit at 8.0 feet.

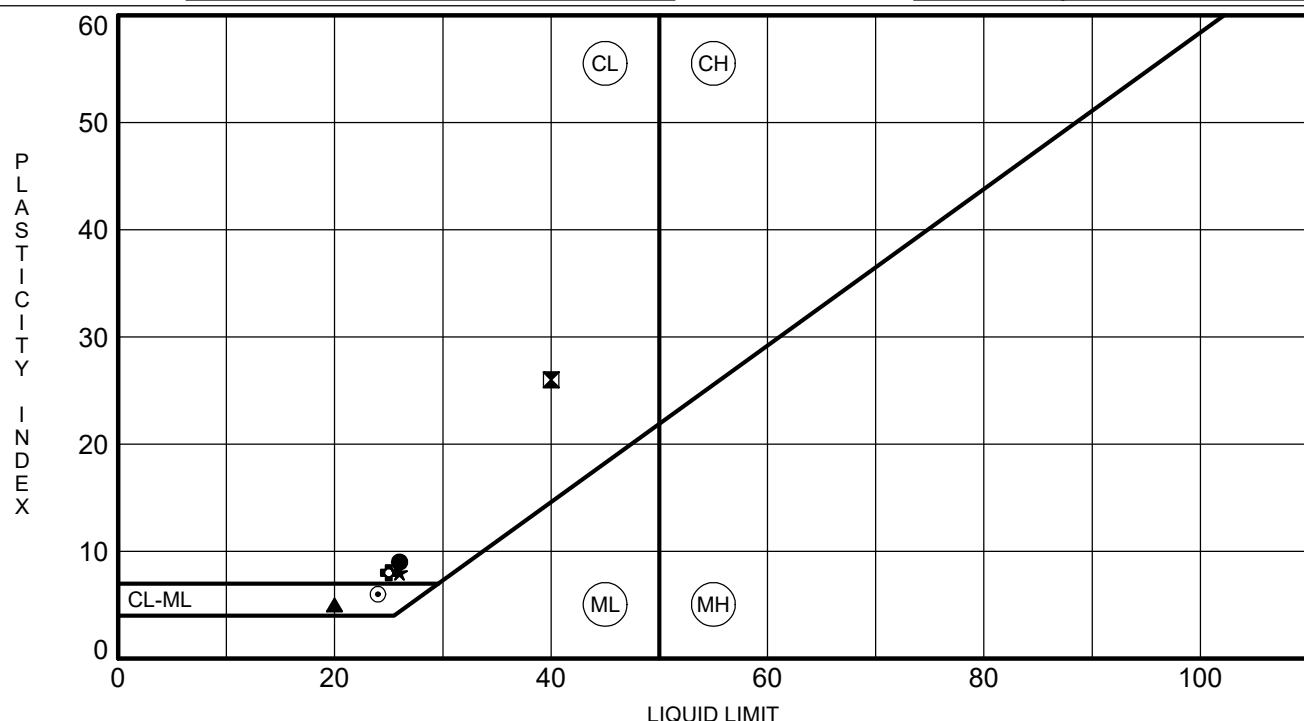
BOREHOLE	DEPTH	LL	PL	PI	Fines	Classification
● TP-1	1.0	26	17	9	39	CLAYEY SAND(SC)
■ TP-2	1.0	40	14	26	14	CLAYEY SAND(SC)
▲ TP-2	5.0	20	15	5	28	SILTY, CLAYEY SAND(SC-SM)
★ TP-3	1.0	26	18	8	52	SANDY LEAN CLAY(CL)
○ TP-4	1.0	24	18	6	69	SANDY SILTY CLAY(CL-ML)
◆ TP-4	4.0	25	17	8	53	SANDY LEAN CLAY(CL)

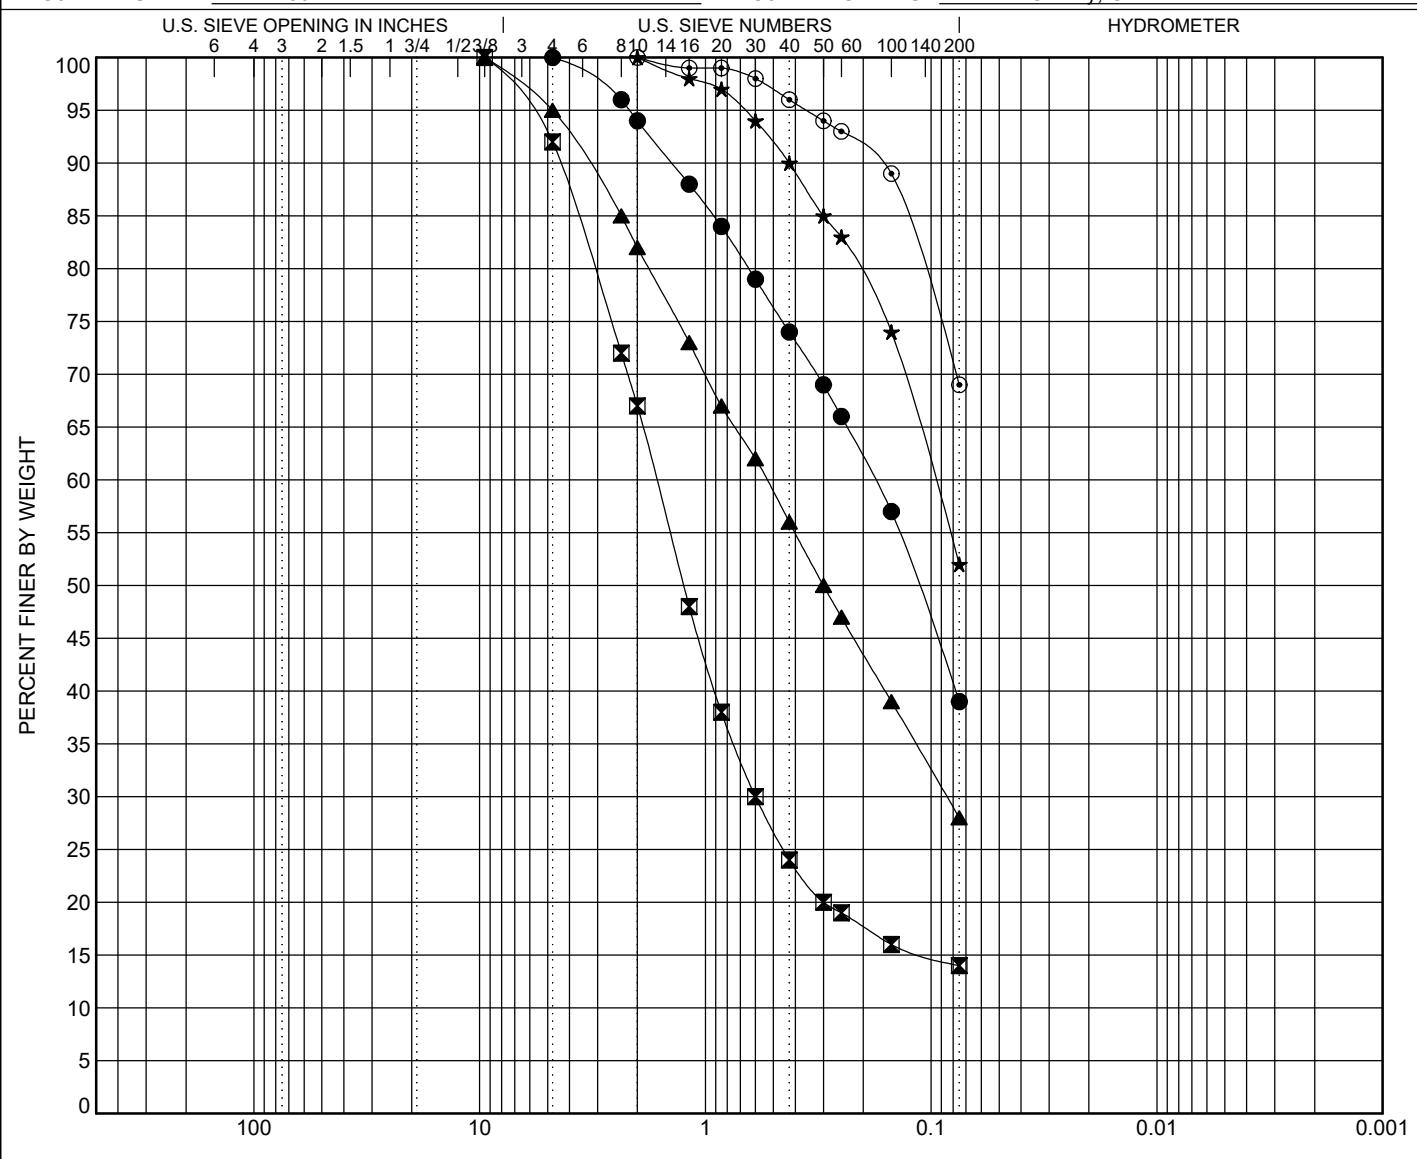
COBBLES	GRAVEL		SAND			SILT OR CLAY					
	coarse	fine	coarse	medium	fine	LL	PL	PI	Cc	Cu	
● TP-1 1.0	CLAYEY SAND(SC)				26	17	9				
☒ TP-2 1.0	CLAYEY SAND(SC)				40	14	26				
▲ TP-2 5.0	SILTY, CLAYEY SAND(SC-SM)				20	15	5				
★ TP-3 1.0	SANDY LEAN CLAY(CL)				26	18	8				
○ TP-4 1.0	SANDY SILTY CLAY(CL-ML)				24	18	6				
BOREHOLE DEPTH	Classification						LL	PL	PI	Cc	Cu
● TP-1 1.0	CLAYEY SAND(SC)						26	17	9		
☒ TP-2 1.0	CLAYEY SAND(SC)						40	14	26		
▲ TP-2 5.0	SILTY, CLAYEY SAND(SC-SM)						20	15	5		
★ TP-3 1.0	SANDY LEAN CLAY(CL)						26	18	8		
○ TP-4 1.0	SANDY SILTY CLAY(CL-ML)						24	18	6		
BOREHOLE DEPTH	D100	D60	D30	D10	%Gravel	%Sand	%Silt		%Clay		
● TP-1 1.0	4.75	0.178			0.0	61.0	39.0				
☒ TP-2 1.0	9.5	1.647	0.6		8.0	78.0	14.0				
▲ TP-2 5.0	9.5	0.535	0.085		5.0	67.0	28.0				
★ TP-3 1.0	2	0.096			0.0	48.0	52.0				
○ TP-4 1.0	2				0.0	31.0	69.0

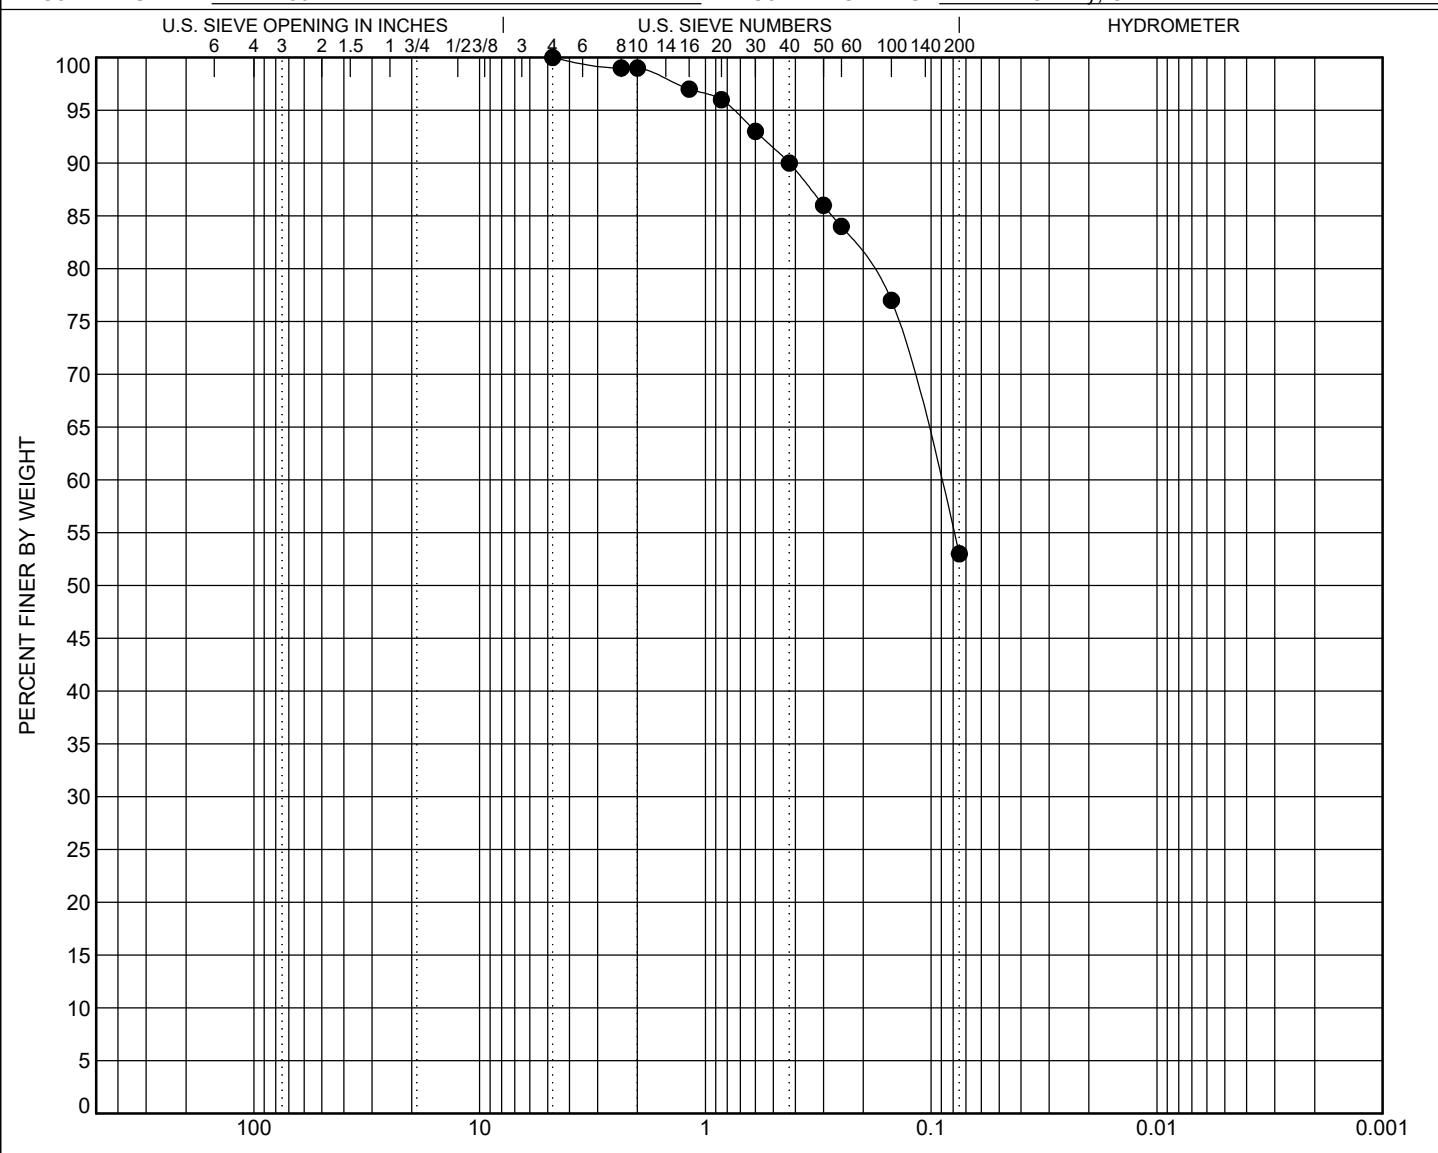
BOREHOLE	DEPTH	Classification					LL	PL	PI	Cc	Cu
● TP-4	4.0	SANDY LEAN CLAY(CL)					25	17	8		
BOREHOLE	DEPTH	D100	D60	D30	D10	%Gravel	%Sand	%Silt	%Clay		
● TP-4	4.0	4.75	0.092			0.0	47.0	53.0

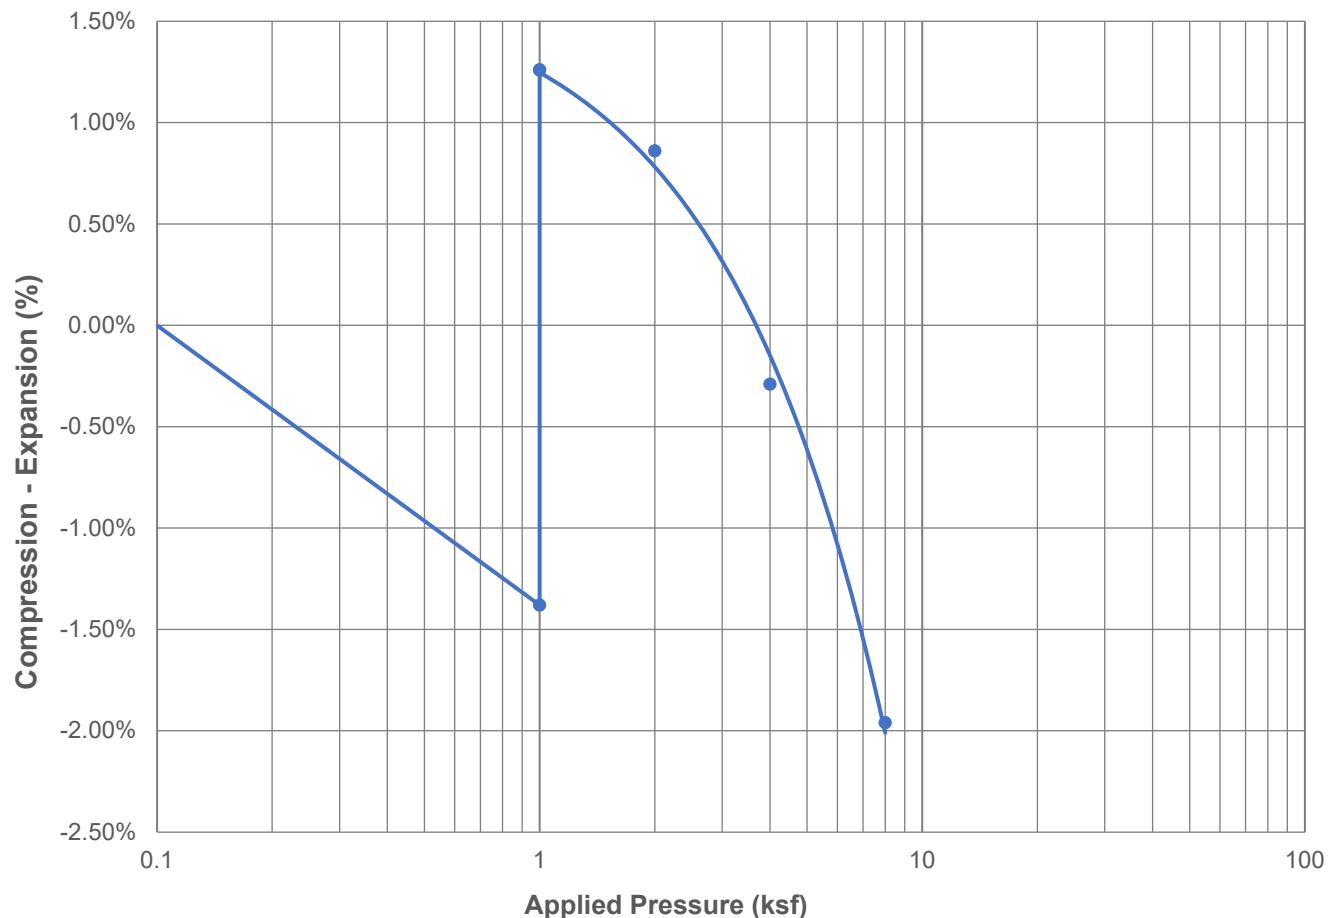
Borehole: TH-1
 Sample Depth: 4 Ft
 Classification: SC

Values	
Applied Load (lbs)	Displacement (in)
0	0.0000
1,000	-0.0138
Add Water	0.0126
2,000	0.0086
4,000	-0.0029
8,000	-0.0196

Sample Info	
Native Moisture:	9.29%
Post-Test Moisture:	13.11%
Expansion Potential:	2.64%
Deadload (psf):	6,600

The results of the Swell/Consolidation testing revealed that there does exist some low to moderately expansive SC material on the west and northwest side of the site. This expansive material was found in Test Hole 1 (TH-1) at the depth of 4 feet, and in Test Hole 2 (TH-2) at the depth of 9 feet. The soil beneath the foundation components near these areas will need to be mitigated as outlined in the foundation recommendations section below. The swell/consolidation potential in the other Test Holes was found to be negligible and is not anticipated to affect foundation components resting on this native material.

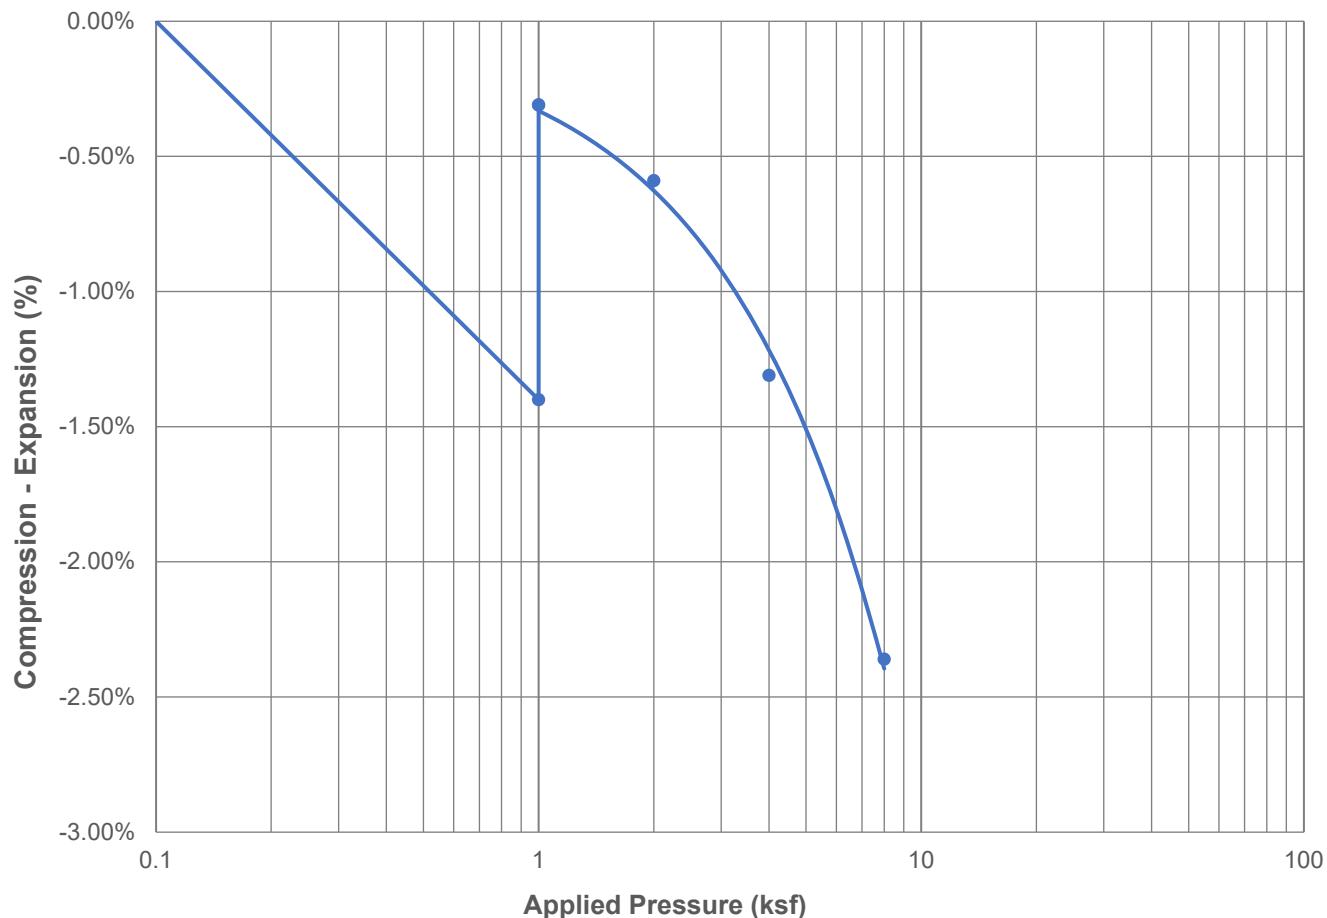
Borehole: TH-2
Sample Depth: 9 Ft
Classification: SC

Values	
Applied Load (lbs)	Displacement (in)
0	0.0000
1,000	-0.0140
Add Water	-0.0031
2,000	-0.0059
4,000	-0.0131
8,000	-0.0236

Sample Info	
Native Moisture:	9.15%
Post-Test Moisture:	13.11%
Expansion Potential:	1.09%
Deadload (psf):	4,600

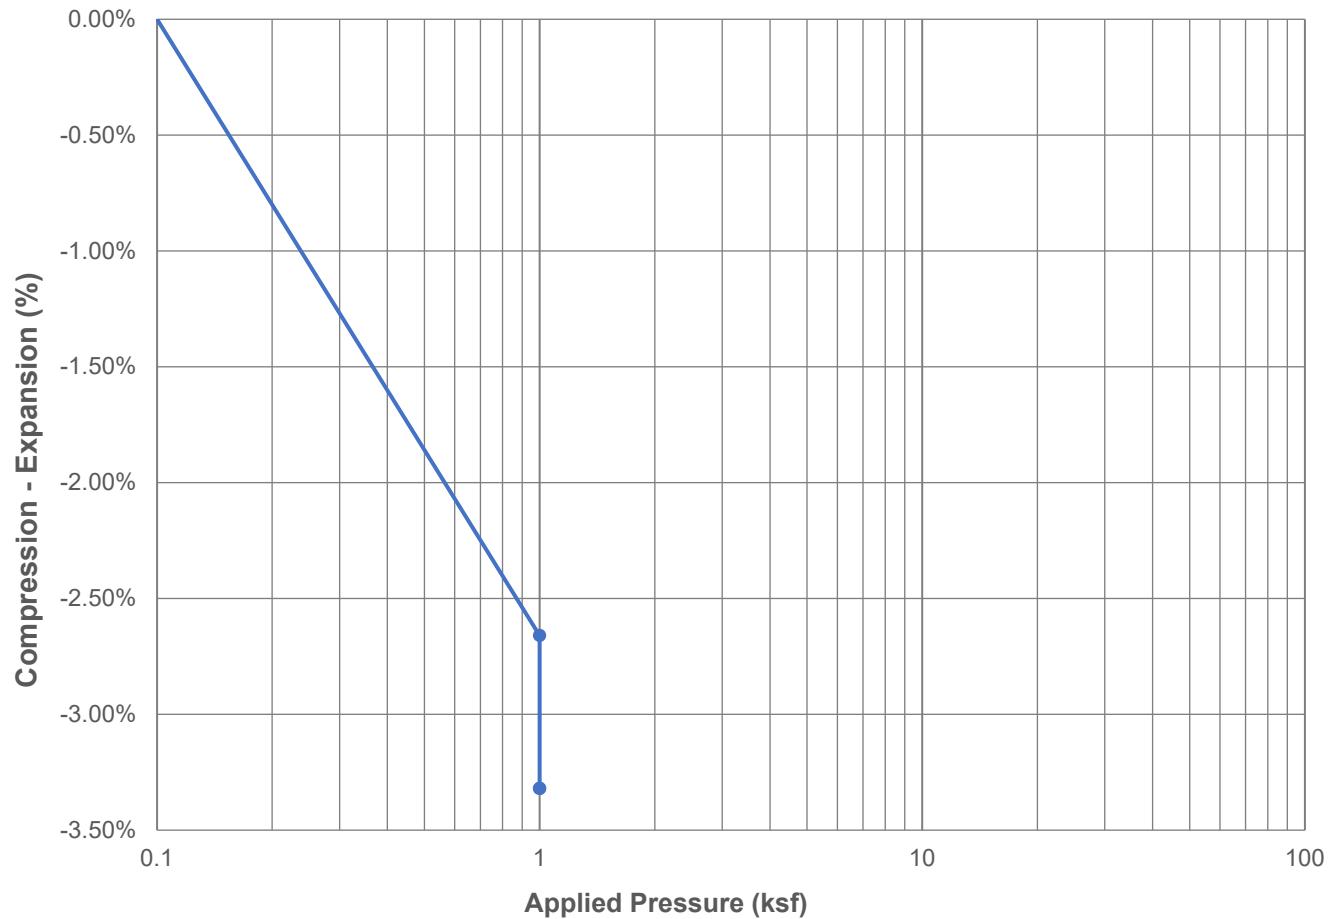
Borehole: TH-2
Sample Depth: 14 Ft
Classification: SC

Values	
Applied Load (lbs)	Displacement (in)
0	0.0000
1,000	-0.0266
Add Water	-0.0332

Sample Info	
Native Moisture:	8.49%
Post-Test Moisture:	12.72%
Expansion Potential:	-0.66%
Deadload (psf):	1,000

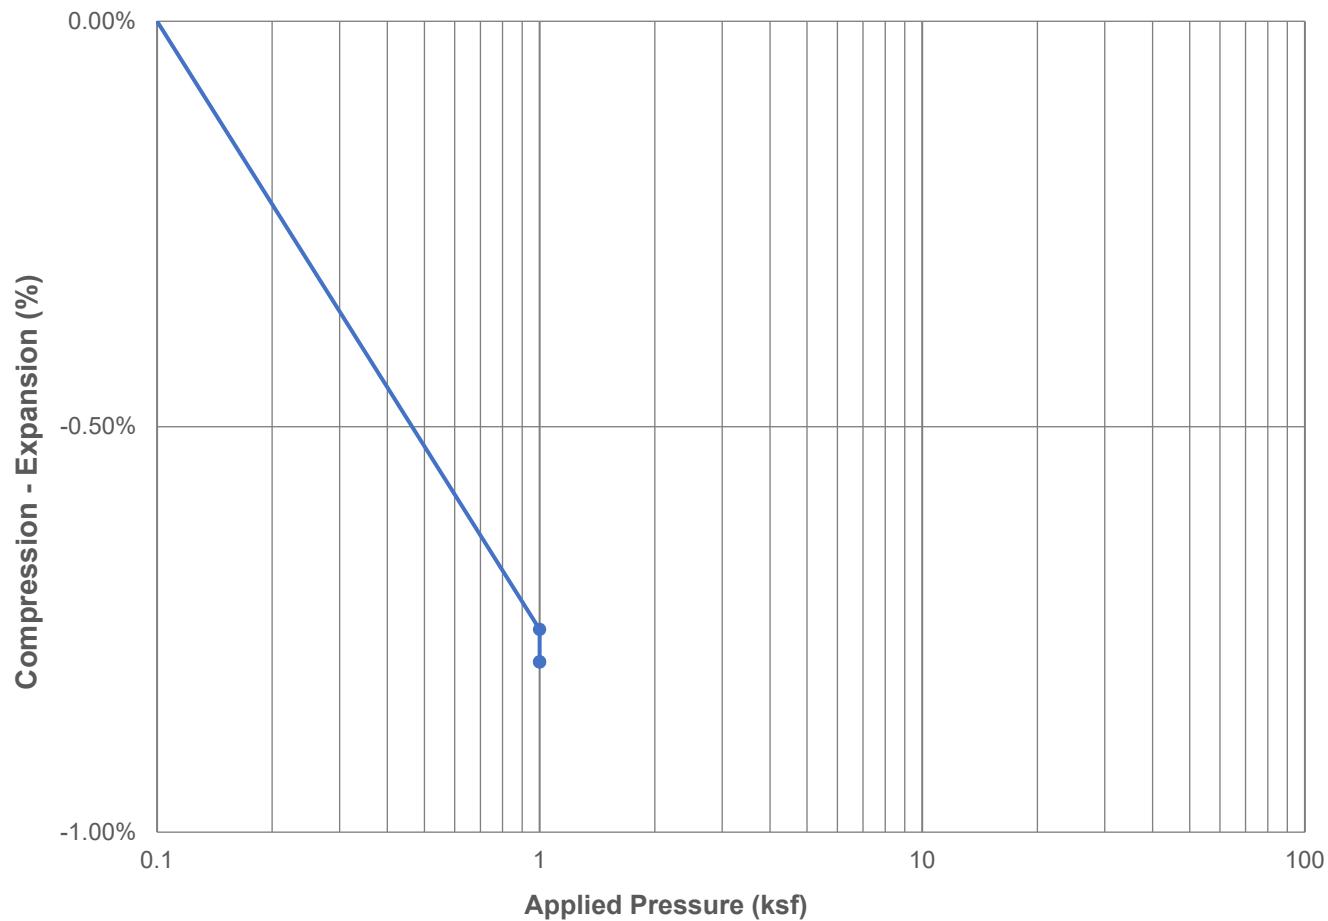
Borehole: TH-3
Sample Depth: 14 Ft
Classification: SM

Values	
Applied Load (lbs)	Displacement (in)
0	0.0000
1,000	-0.0075
Add Water	-0.0079

Sample Info	
Native Moisture:	9.93%
Post-Test Moisture:	11.97%
Expansion Potential:	-0.04%
Deadload (psf):	1,000

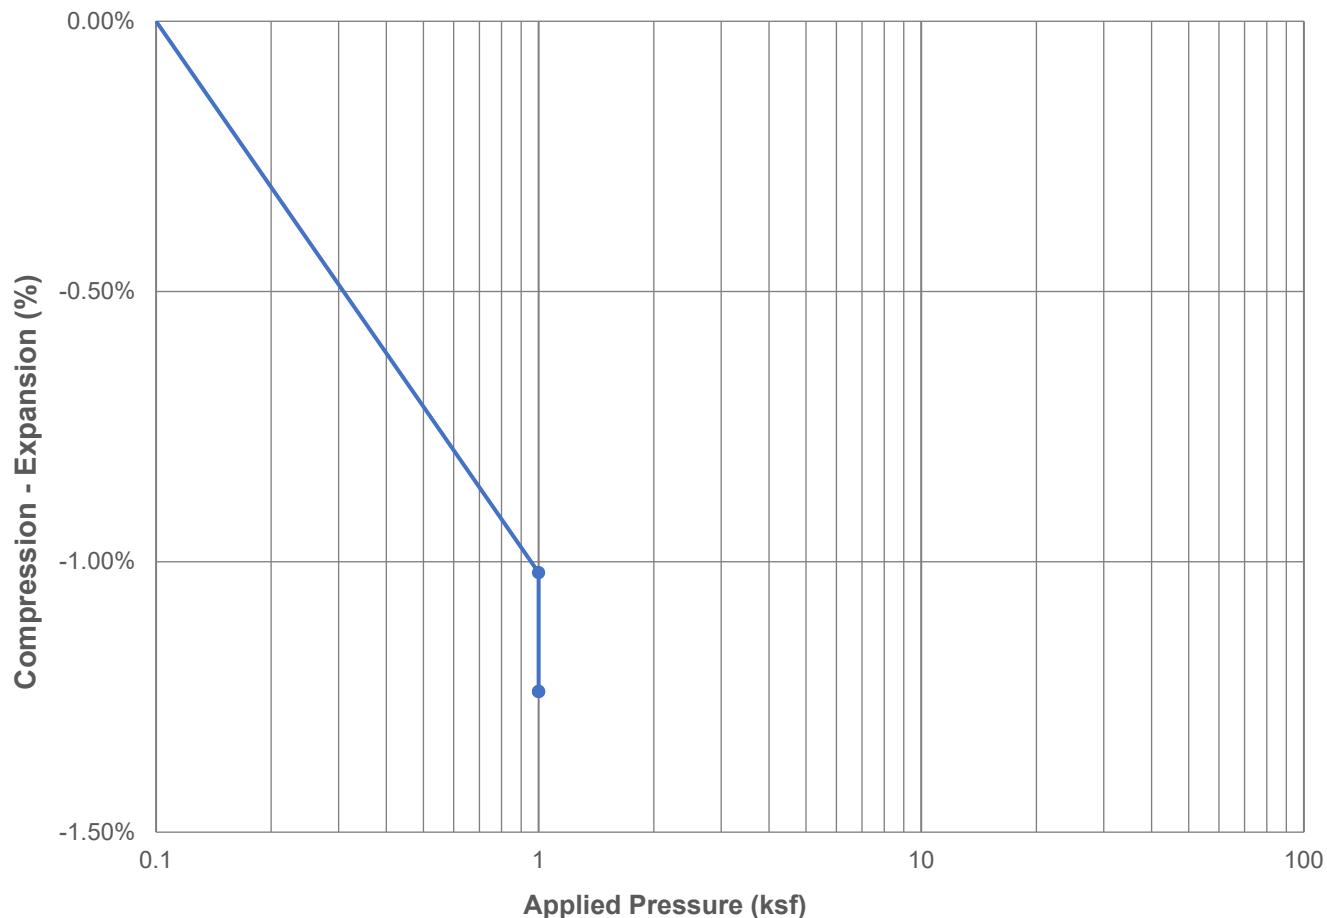
Borehole: TH-4
Sample Depth: 4 Ft
Classification: SM

Values	
Applied Load (lbs)	Displacement (in)
0	0.0000
1,000	-0.0102
Add Water	-0.0124

Sample Info	
Native Moisture:	7.91%
Post-Test Moisture:	14.33%
Expansion Potential:	-0.22%
Deadload (psf):	1,000

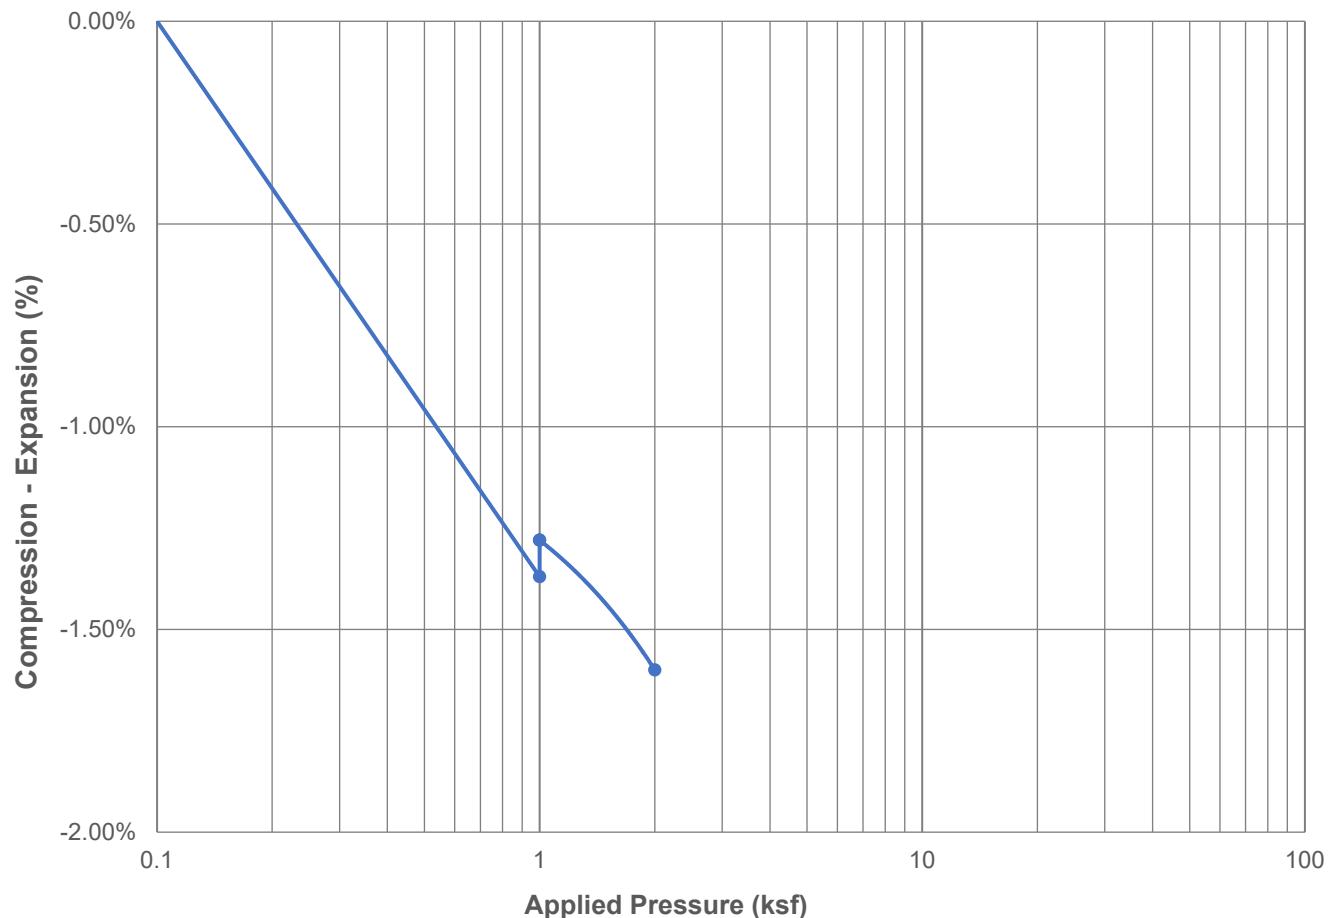
Borehole: TH-5
Sample Depth: 4 Ft
Classification: SC

Values	
Applied Load (lbs)	Displacement (in)
0	0.0000
1,000	-0.0137
Add Water	-0.0128
2,000	-0.0160

Sample Info	
Native Moisture:	17.85%
Post-Test Moisture:	16.31%
Expansion Potential:	0.09%
Deadload (psf):	1,300

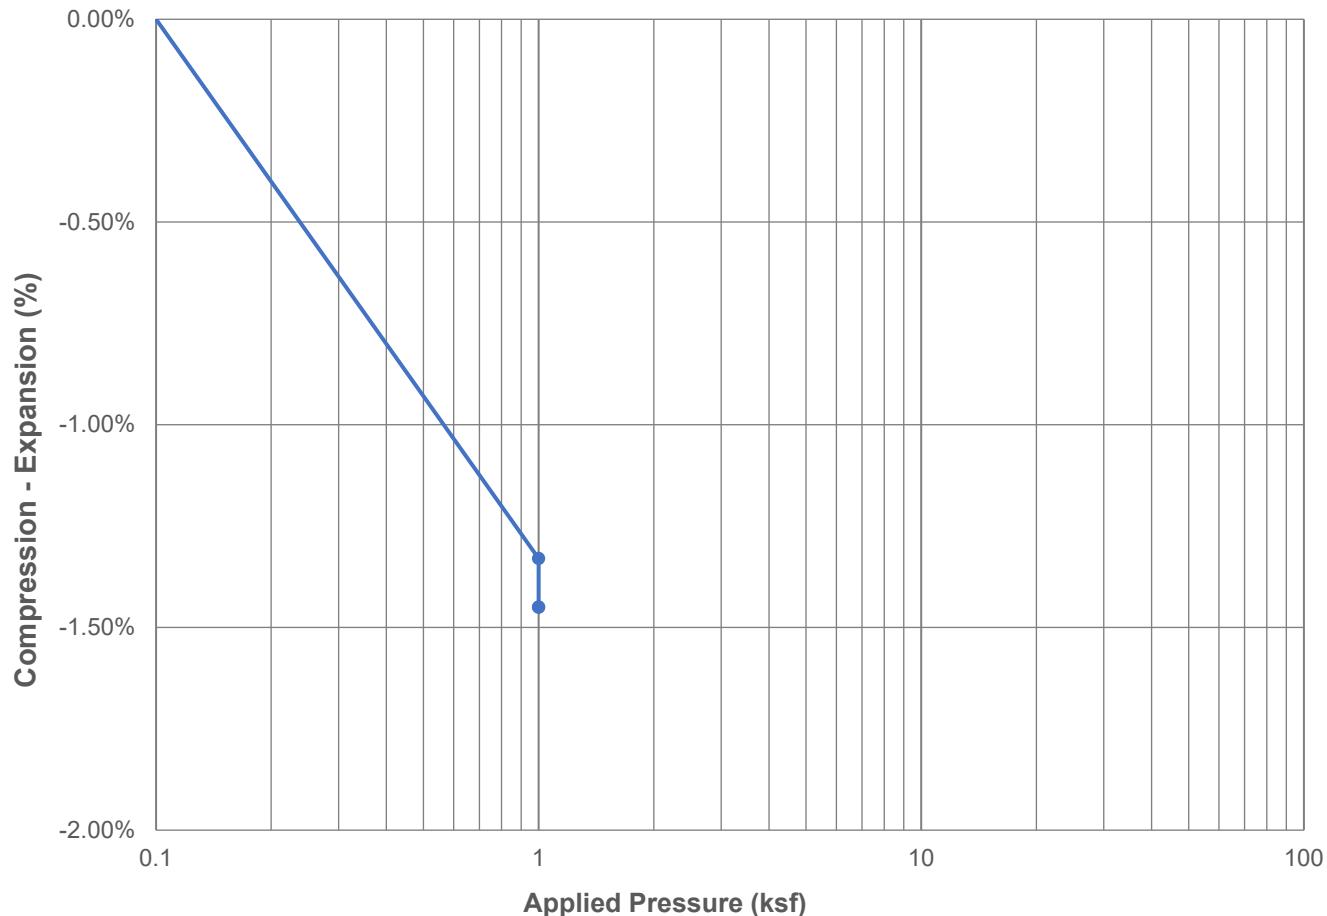
Borehole: TH-6
Sample Depth: 4 Ft
Classification: SM

Values	
Applied Load (lbs)	Displacement (in)
0	0.0000
1,000	-0.0133
Add Water	-0.0145

Sample Info	
Native Moisture:	6.35%
Post-Test Moisture:	11.52%
Expansion Potential:	-0.12%
Deadload (psf):	1,000
