PRELIMINARY WASTEWATER REPORT

SKYE VISTA DEVELOPMENT

Project No. 24.1676.001

VIVID Project No.: D24-2-807

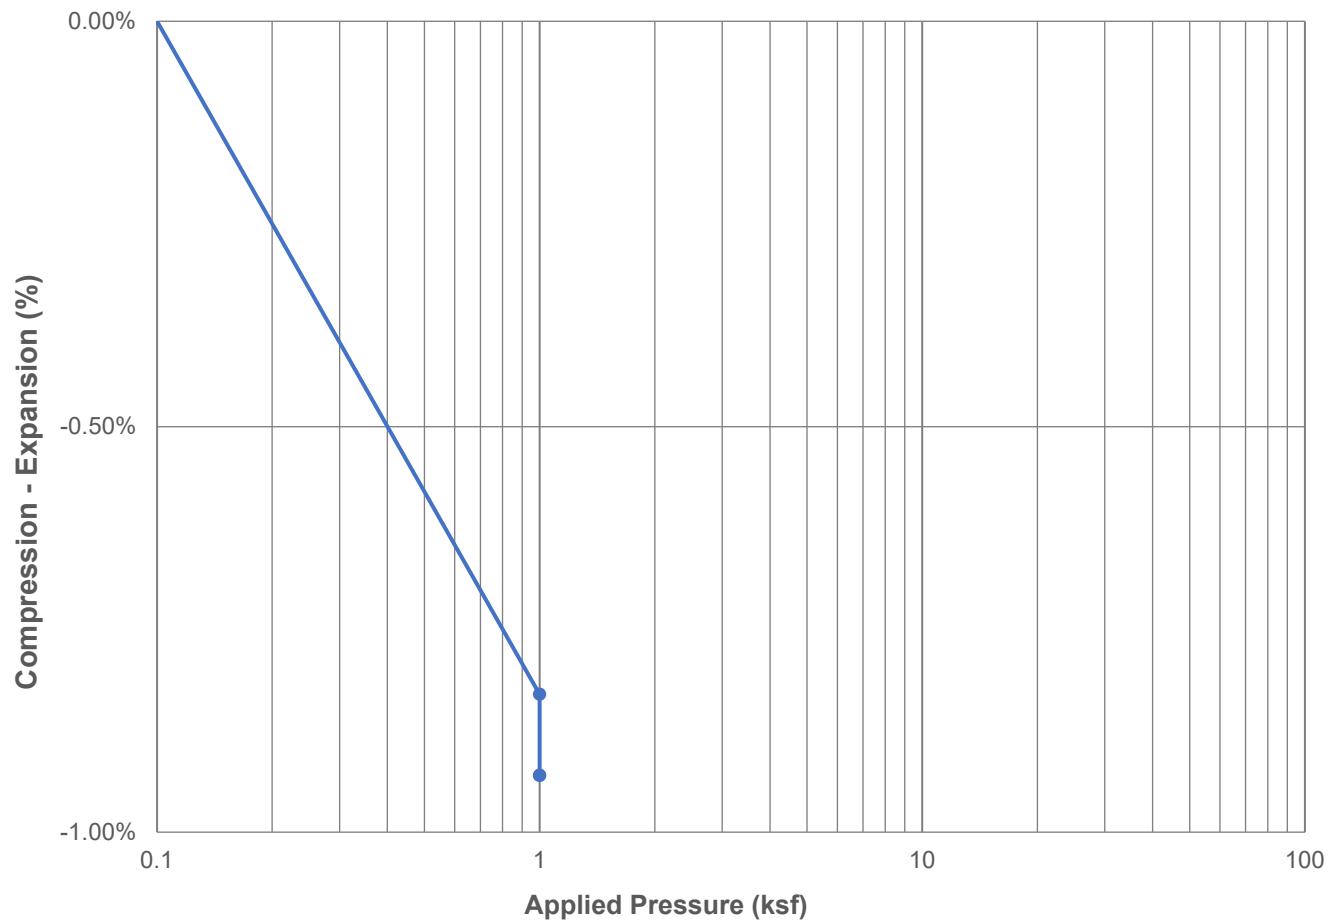
Borehole: TH-6
Sample Depth: 9 Ft
Classification: SM

Values	
Applied Load (lbs)	Displacement (in)
0	0.0000
1,000	-0.0083
Add Water	-0.0093

Sample Info	
Native Moisture:	6.69%
Post-Test Moisture:	13.82%
Expansion Potential:	-0.10%
Deadload (psf):	1,000

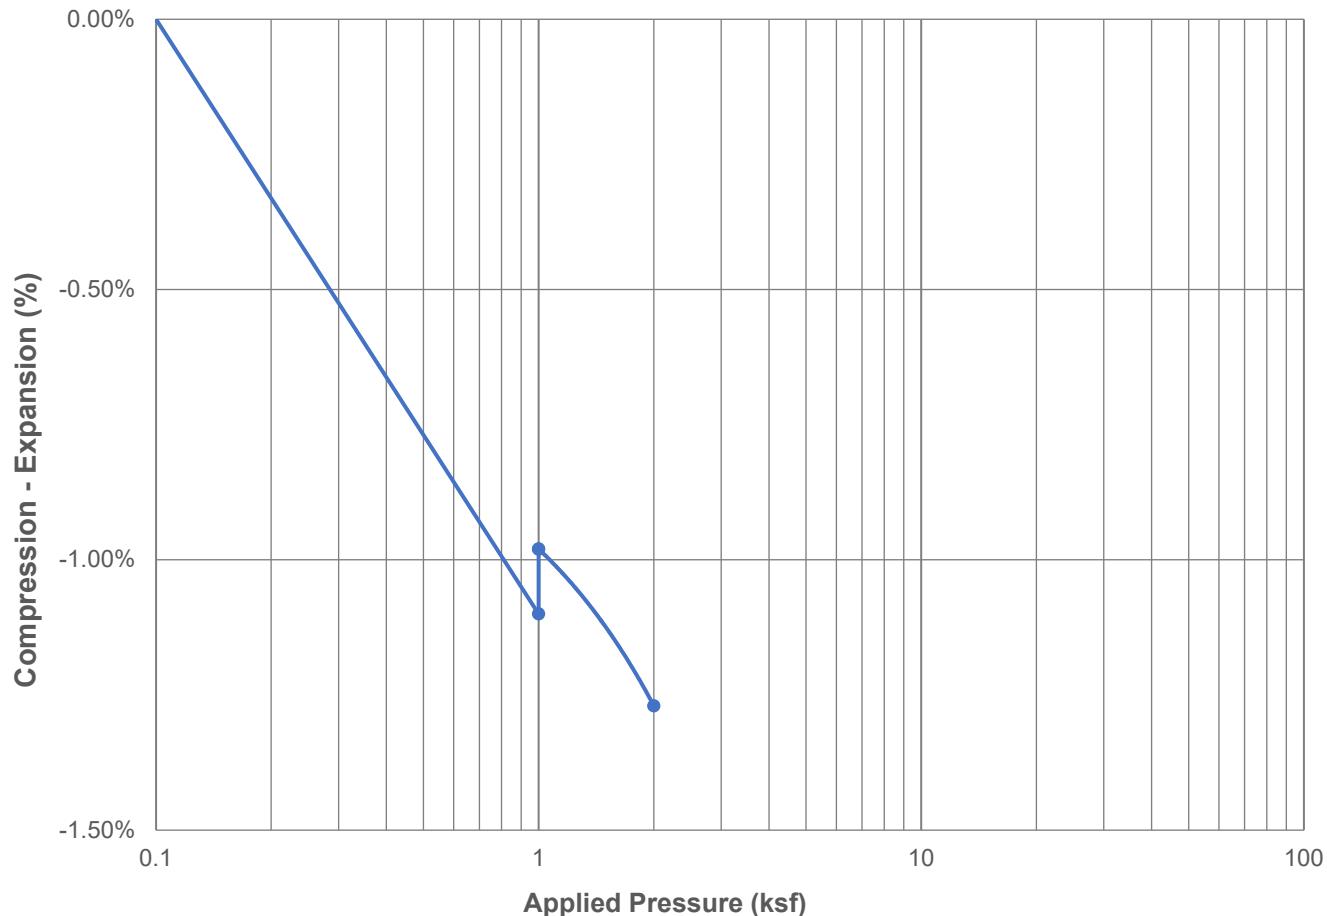
Borehole: TH-7
Sample Depth: 4 Ft
Classification: SC

Values	
Applied Load (lbs)	Displacement (in)
0	0.0000
1,000	-0.0110
Add Water	-0.0098
2,000	-0.0127

Sample Info	
Native Moisture:	15.84%
Post-Test Moisture:	14.99%
Expansion Potential:	0.12%
Deadload (psf):	1,400

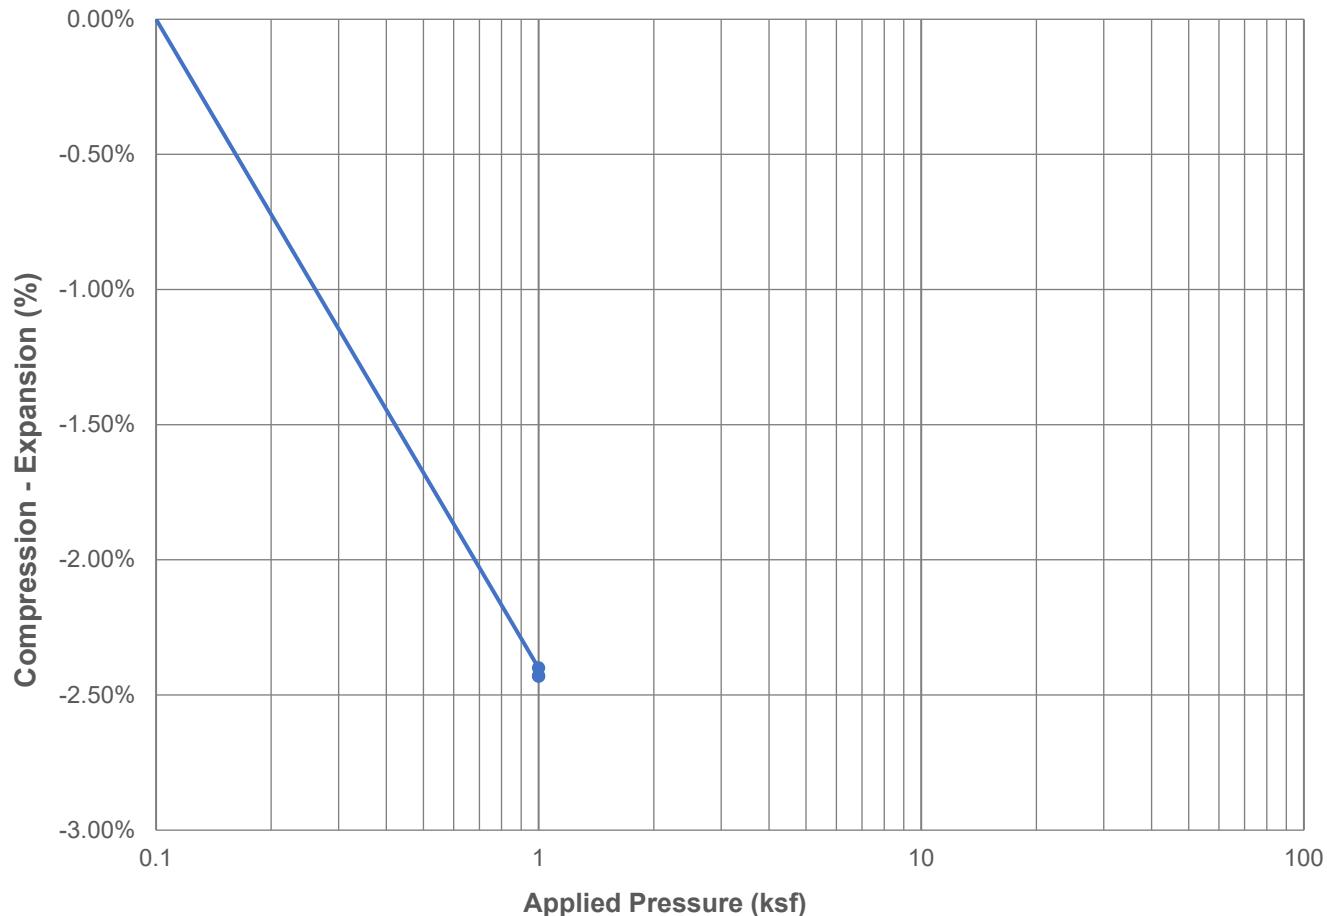
Borehole: TH-7
Sample Depth: 9 Ft
Classification: SC

Values	
Applied Load (lbs)	Displacement (in)
0	0.0000
1,000	-0.0240
Add Water	-0.0243

Sample Info	
Native Moisture:	18.67%
Post-Test Moisture:	14.44%
Expansion Potential:	-0.03%
Deadload (psf):	1,000

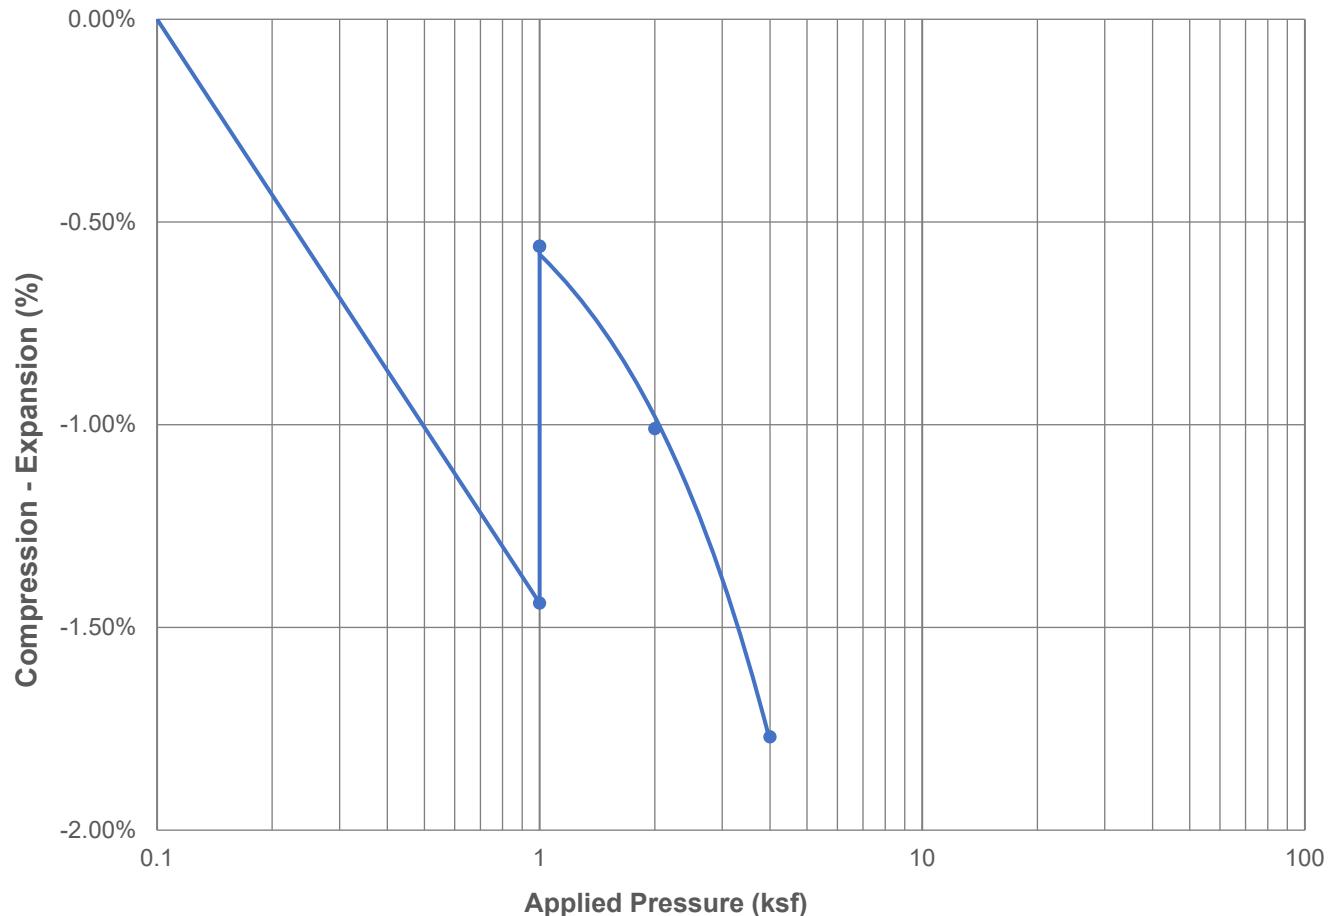
Borehole: TH-7
Sample Depth: 19 Ft
Classification: CL

Values	
Applied Load (lbs)	Displacement (in)
0	0.0000
1,000	-0.0144
Add Water	-0.0056
2,000	-0.0101
4,000	-0.0177

Sample Info	
Native Moisture:	13.83%
Post-Test Moisture:	13.36%
Expansion Potential:	0.88%
Deadload (psf):	3,200

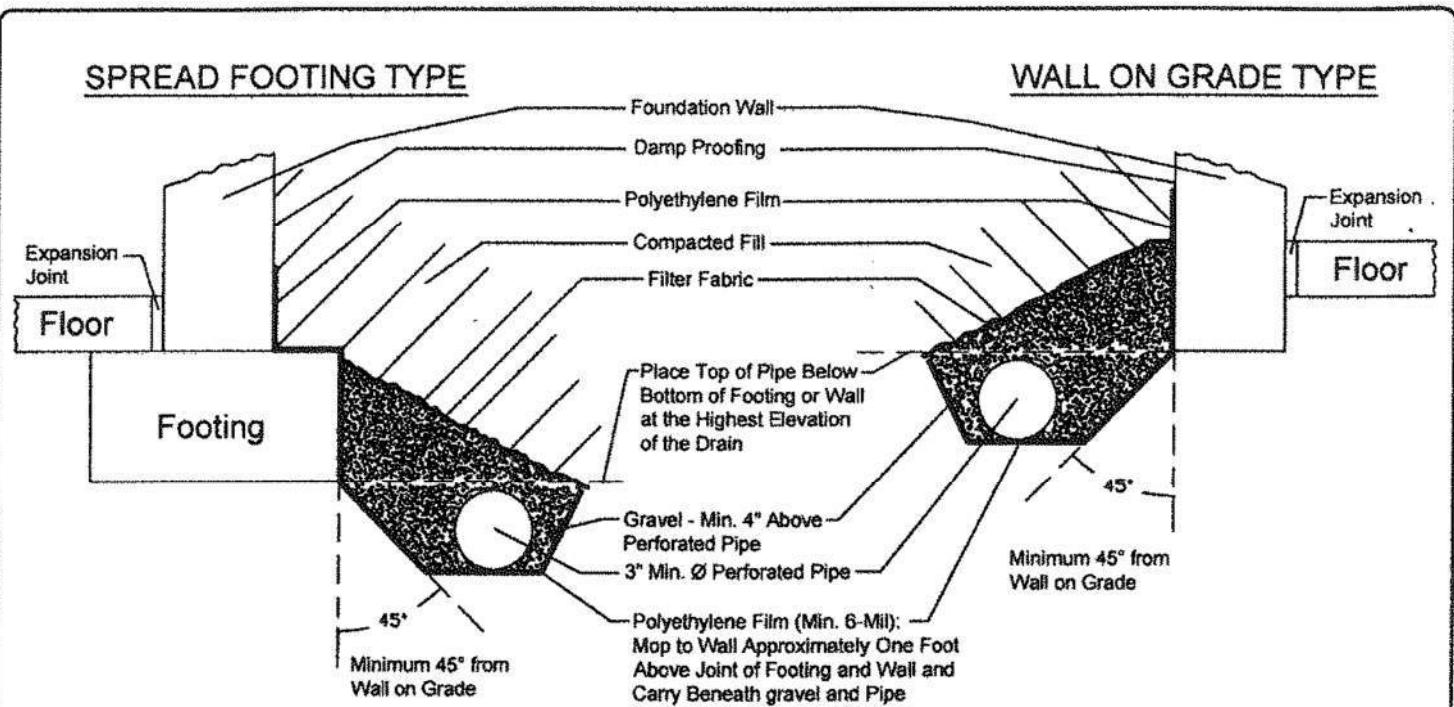
Exterior Drain Detail

1. Gravel to be Not More Than 1-1/2" and Not Less Than 1/2" Diameter.
2. Perforated Pipe Diameter Varies With Expected Seepage. 3"Ø and 4"Ø are Most Common. ABS and PVC are Most Common Materials for Pipe. We approve the use of an "EZ Flow Drainage System" by Infiltrator. All specifications in this drain detail are still applicable.

3. Pipe to be Laid out in a Minimum Slope of 1" in 10'.
4. Gravity Outfall is Desired if Possible. Portion of Pipe in Area Not Drained Shall be Non-Perforated. Daylight Must be Maintained Clear of Debris in Order to Function Properly.
