PRELIMINARY WASTEWATER REPORT
FOR
SKYE VISTA DEVELOPMENT

Project No. 24.1676.001

This report presents the results of a wastewater evaluation report performed for the proposed Skye Vista Subdivision to be developed at 16850 Stepler Road in El Paso County, Colorado. An attached Vicinity Map (Figure 1) shows the general location of the project. Our evaluation was performed for Herebic Homes and was authorized by Mr. Bill Herebic.

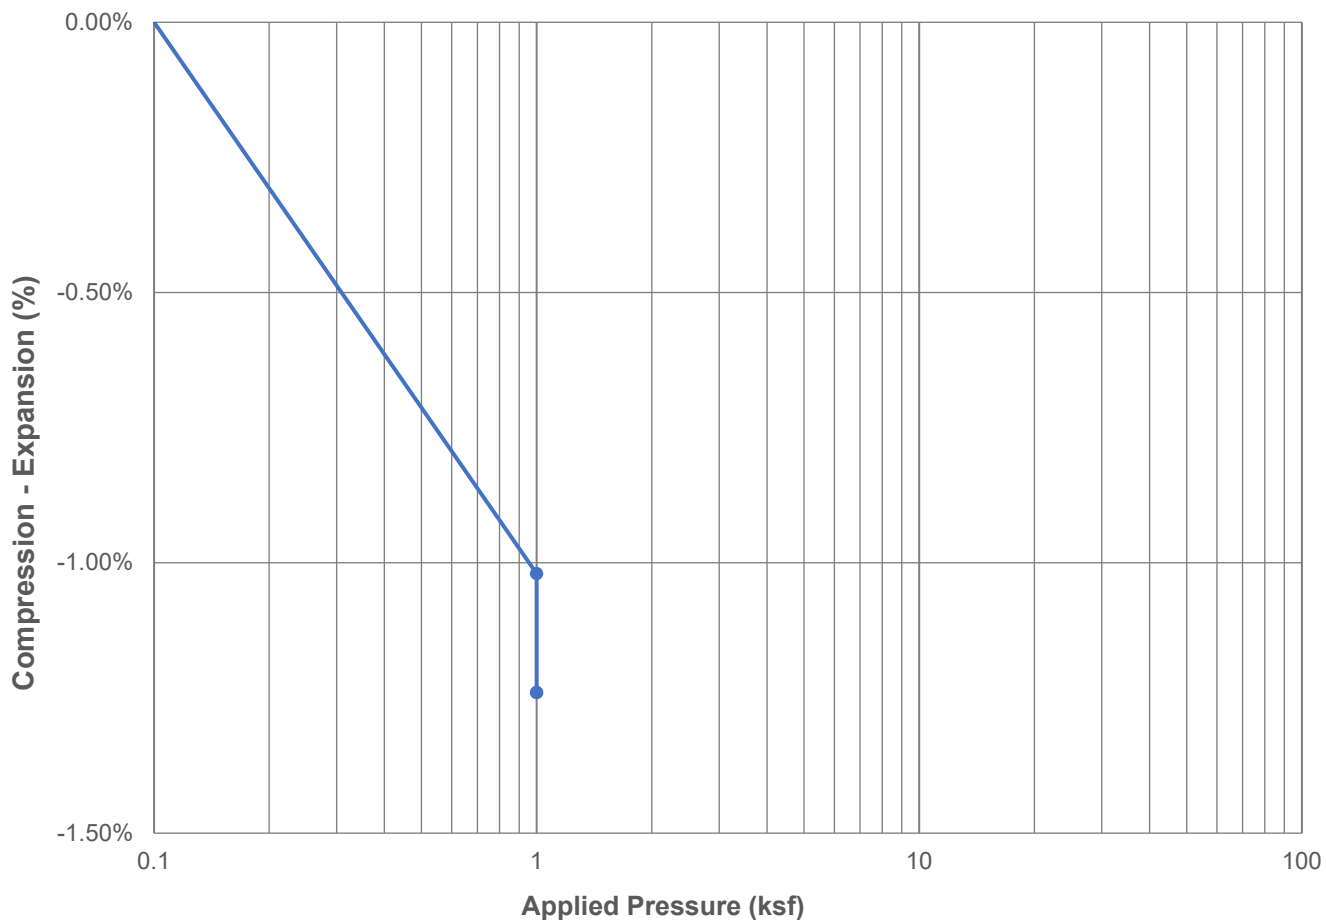
Borehole: TH-4
 Sample Depth: 4 Ft
 Classification: SM

Applied Load (lbs)	Displacement (in)
0	0.0000
1,000	-0.0102
Add Water	-0.0124
