Geology and Soils Evaluation Report

VIVID Project No.: D24-2-807

GEOLOGY AND SOILS EVALUATION REPORT
Proposed Skye Vista Subdivision
16850 Stepler Road
El Paso County, Colorado
VIVID Project No. D24-2-807

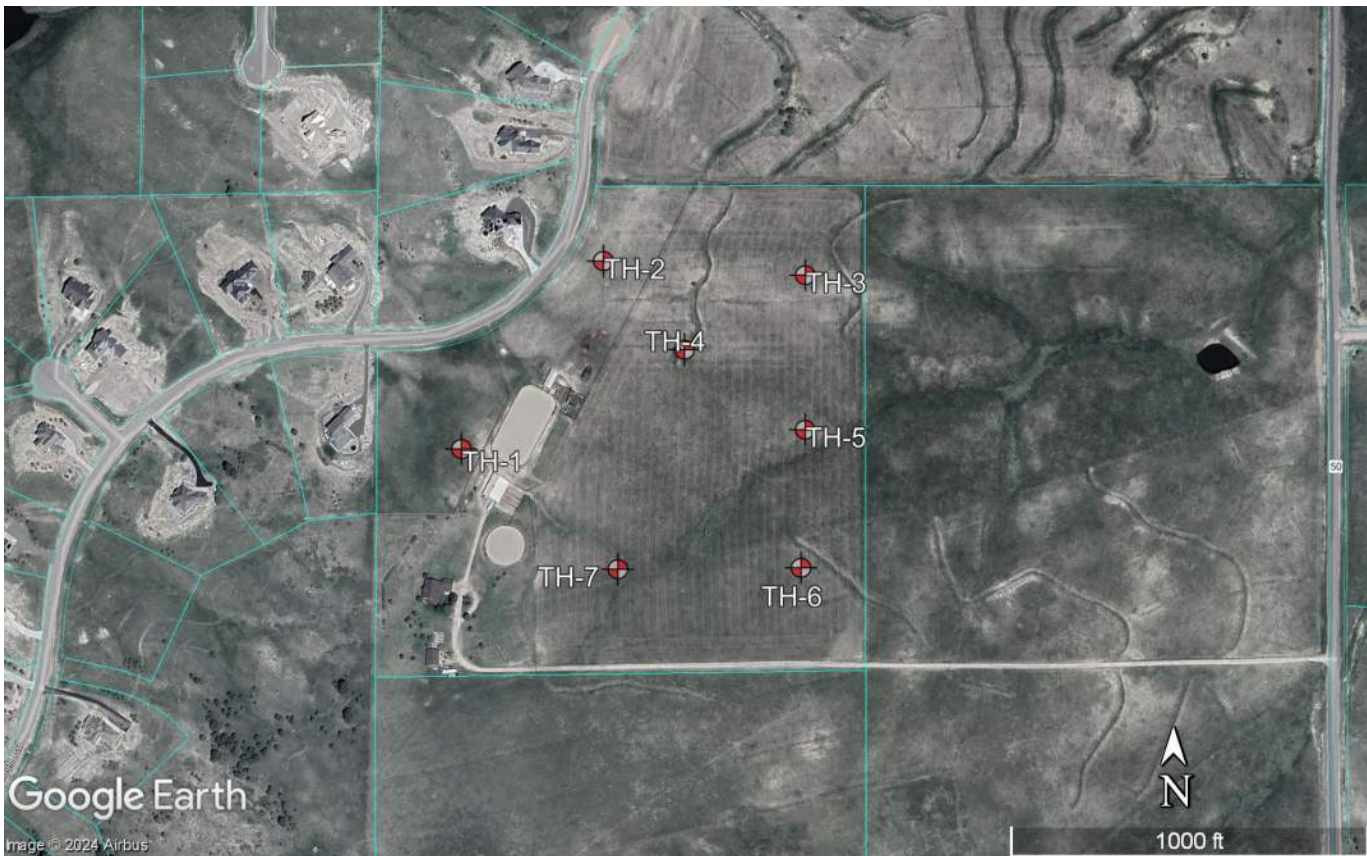
Coordinates

Bore Hole	Latitude	Longitude
TH-1	39.076165	-104.742139
TH-2	39.077563	-104.740765
TH-3	39.077471	-104.738812
TH-4	39.076908	-104.739986
TH-5	39.076309	-104.738808
TH-6	39.075274	-104.738857
TH-7	39.075265	-104.740630
